REPORT 69

Light Rail Service: Pedestrian and Vehicular Safety

**HANS W. KORVE, BRENT D. OGDEN, JOAQUIN T. SIQUES, AND
DOUGLAS M. MANSEL**
Korve Engineering, Inc.
Oakland, CA

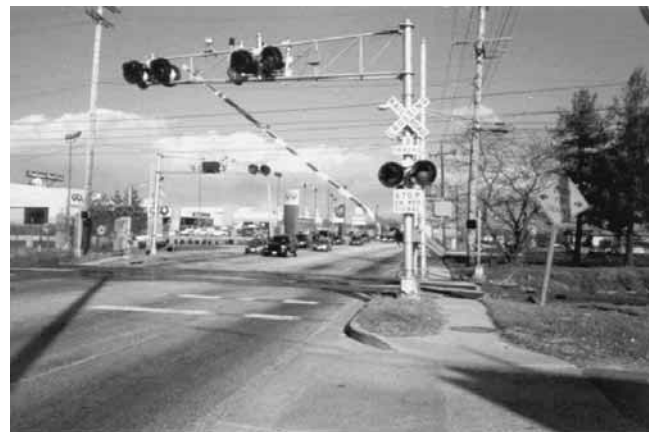
Figure 2-7. Second Train Approaching sign demonstration project site. (Baltimore, Maryland, Timonium Road crossing.)

that examined the use of a Second Train Approaching sign at the Timonium Road crossing (Figure 2-7). The LRV-activated sign was designed to notify motorists that the automatic gates and flashing light signals remain active after the first LRV passes because a second LRV is approaching. Results from an evaluation of the Baltimore Second Train Approaching sign by the Baltimore Mass Transit Administration indicate that the Second Train Approaching sign has reduced the number of risky behaviors by motorists at the crossing. The number of motorists who began to cross the tracks as the gates were raised partially and then lowered, between the departure of the first train and the arrival of the second train, was reduced by 26 percent. The number of motorists who began to move forward after the departure of the first train and before the arrival of the second train, while the gates remained in the

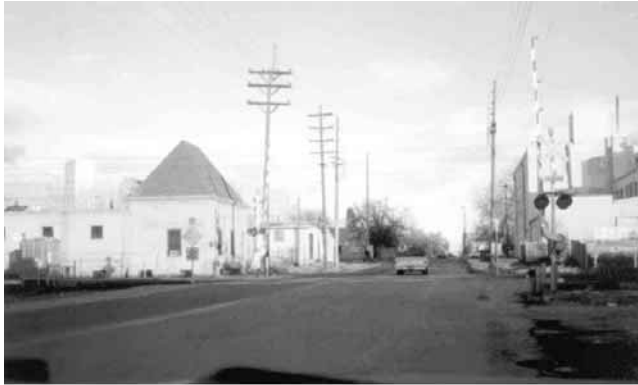
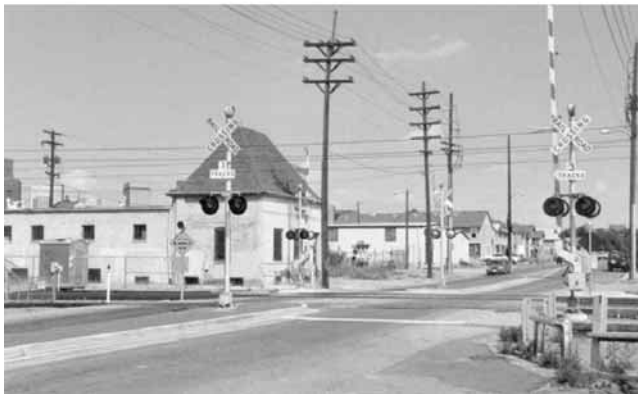
Figure 2-13. Raised median with barrier curbs. (Denver, Colorado, West 13th Ave. crossing.) Top: before median installation; bottom: after installation.

gate violations. RTD has since installed raised medians with barrier curbs to deter motorists from crossing into the opposing lane of traffic to drive around the automatic gates. According to RTD representatives, this has reduced the rate of violations to almost zero.

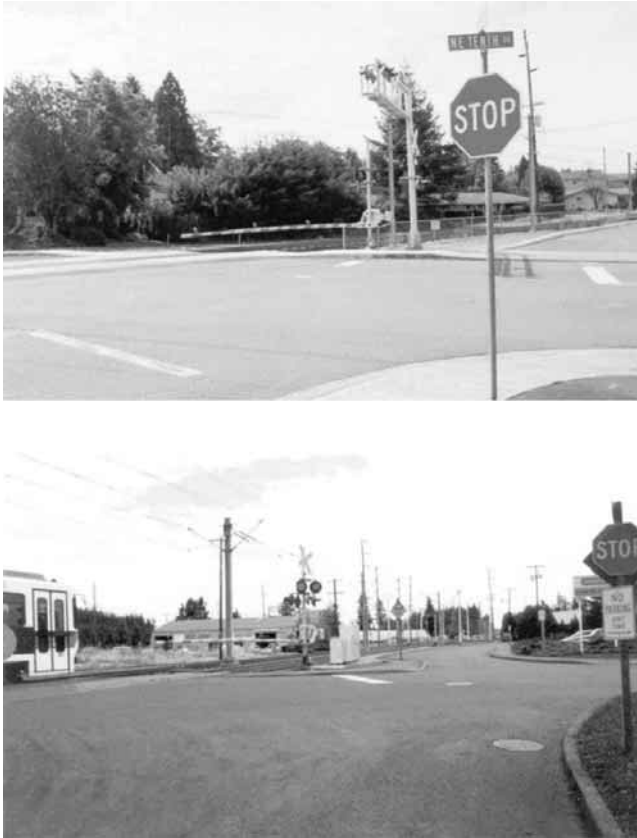
Figure 2-21. Automatic gates installed parallel to LRT tracks. (Portland, Oregon—Above: North Main Ave. Below: NW Eleven Mile Ave.)

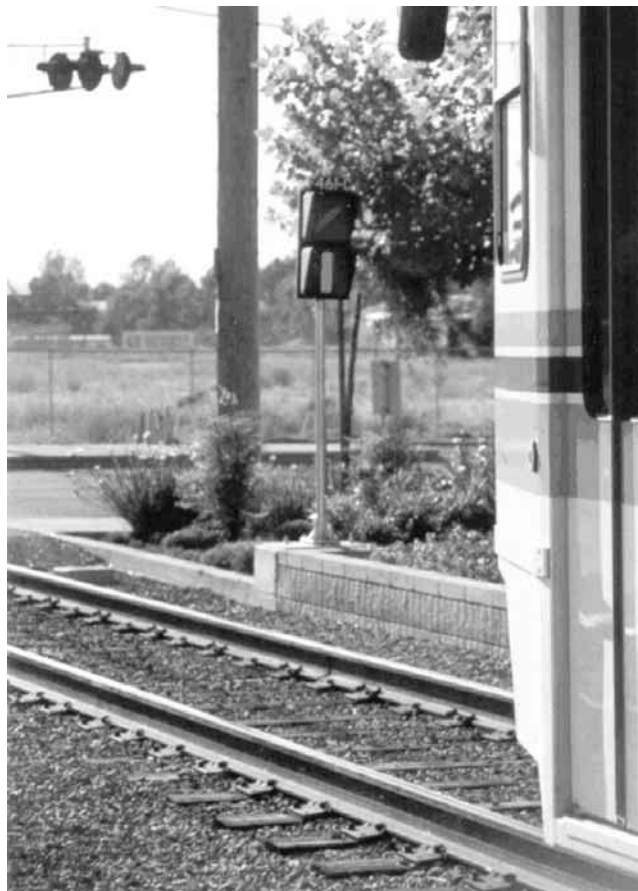
Figure 2-26. LRV operator gate indication signal. (Sacramento, California, 65th Street crossing.)

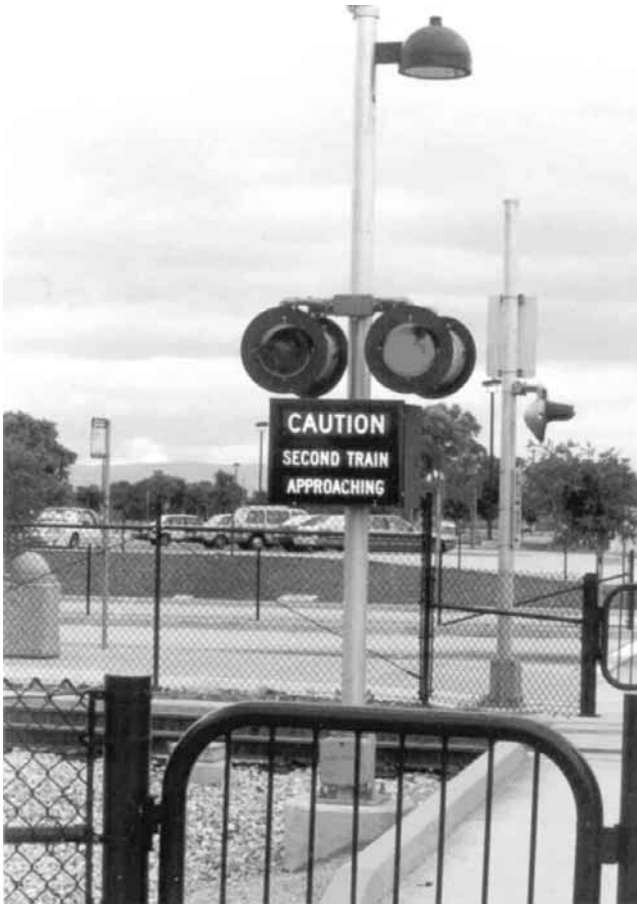
Figure 2-33. Second Train Approaching sign. (San Jose, California, Ohlone–Chynoweth Station.)

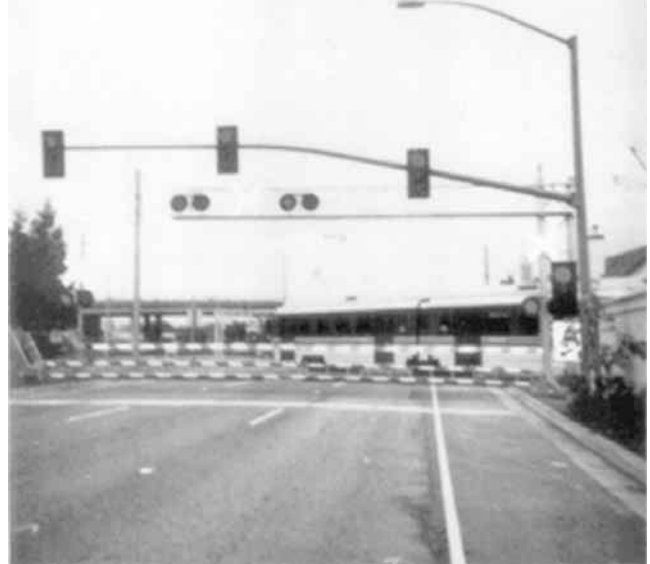
Figure 2-34. VTA barrier gate.

ment crossing of the Central Expressway at-grade, the hazards include high motorist speeds on the Central Expressway, poor sight distance for motorists on the Central Expressway, possible freight train movements between the Joint Powers Board Tracks and the NASA facility, and vehicles backing up onto the track. To address these hazards, VTA has installed a barrier gate at the at-grade crossing of the Central Expressway for the westbound motorist approach as a demonstration project (Figure 2-34). The safety barrier gates have been tested successfully, stopping a pickup truck traveling at 72 km/h (45 mph). The safety barrier gate is lowered with a vertical pivot action, with a positive locking device at each end of the arm to secure the gate across the roadway. Energy absorption steel cables internal to the gate arm tubing enable the safety barrier gate to arrest a vehicle. The purpose of the safety barrier gate is to stop the vehicle before the railroad tracks and prevent a collision between the vehicle and the train. When the gate is in the closed position, the cables and aluminum framework fit into endlock assemblies

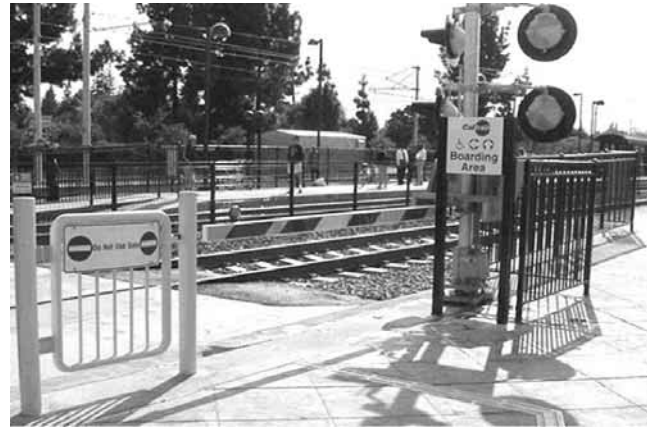
Figure 2-35. Pedestrian automatic gate and swing gate combination.

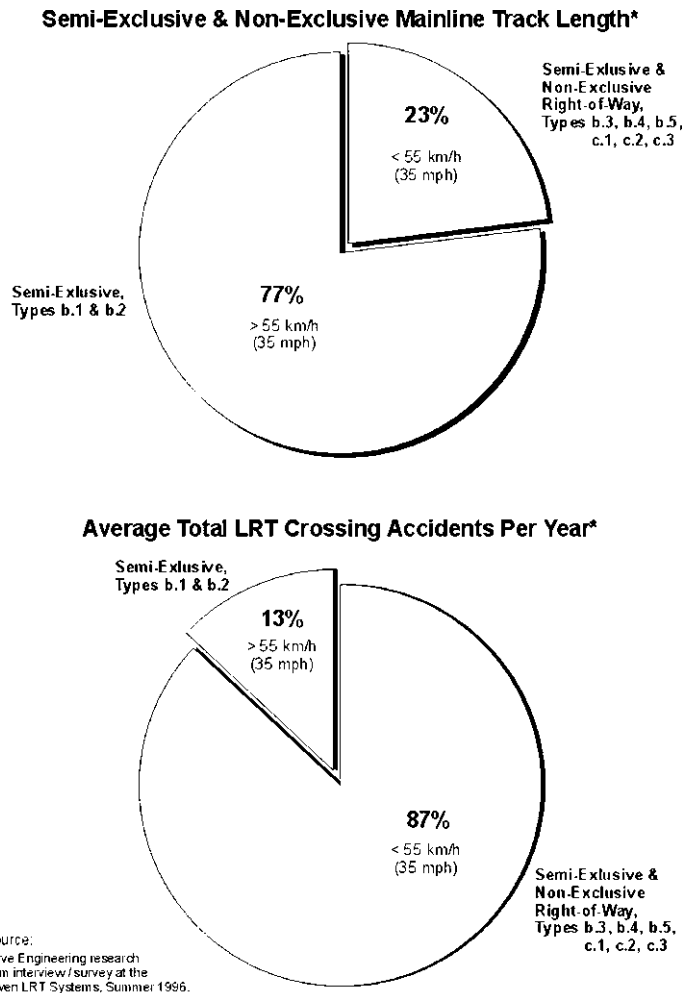
Figure 2-36. Mainline track length and accident comparison.

As indicated in Table 2-16, the rate of accidents per crossing along semiexclusive rights-of-way where LRVs travel at greater than 55 km/h (35 mph) is less than the rate of accidents

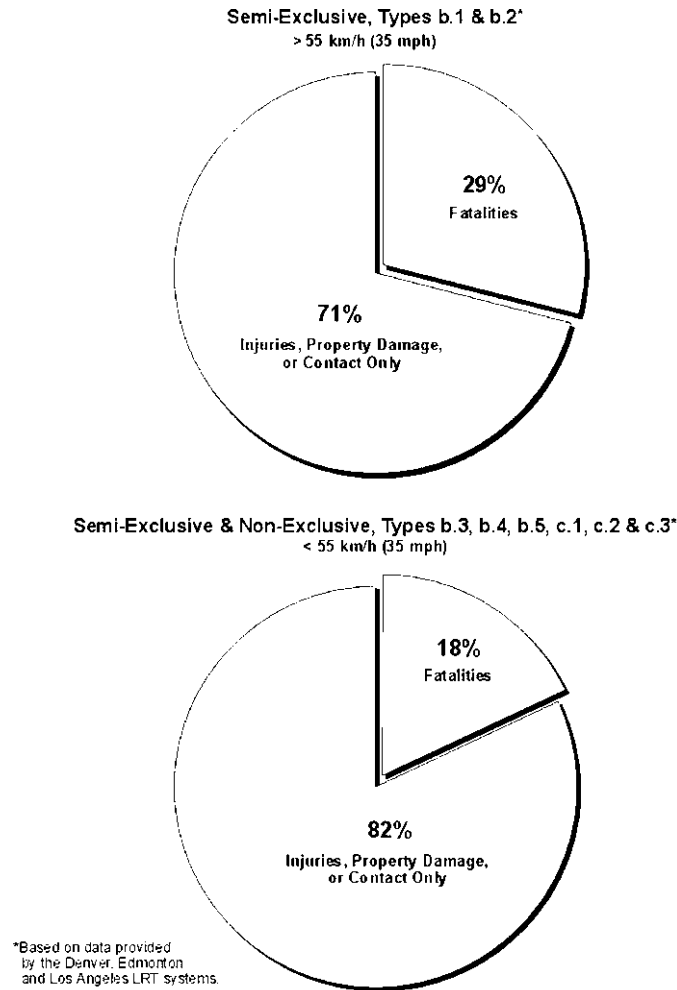
Figure 2-38. LRV-pedestrian collision severity comparison.

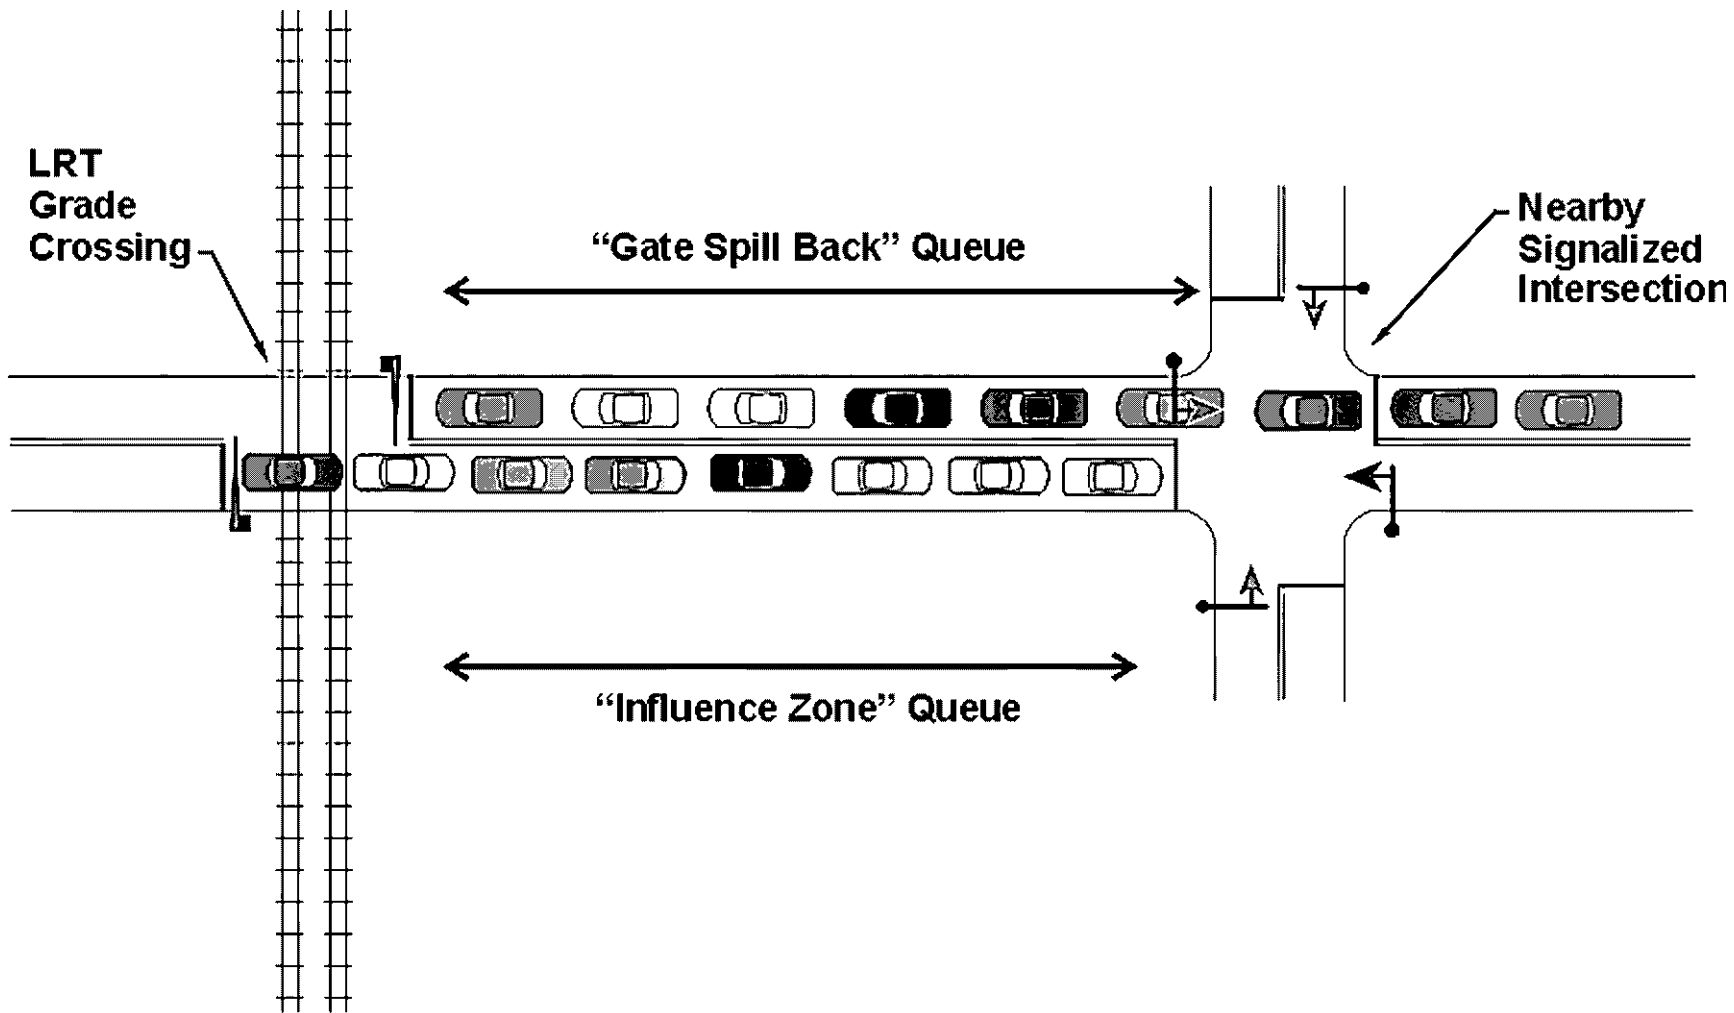
Figure 3-12. Grade crossing queues.

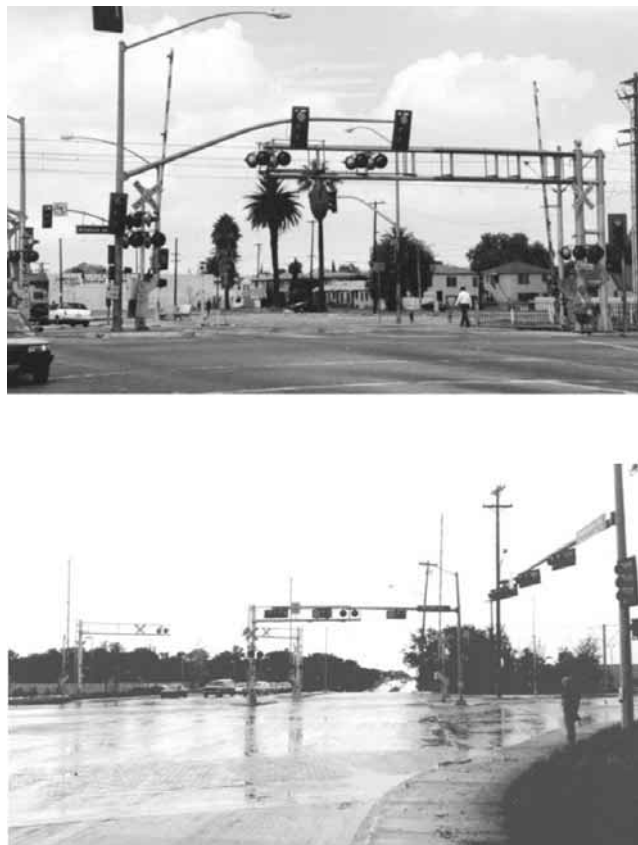
Figure 3-14. LRT crossings with cantilevered flashing light and traffic signals. (Above: Los Angeles, California. Below: Dallas, Texas.)

Typically, flashing light signals are mounted on cantilevered structures, which allows railway signal maintainers to walk out on the structure over the roadway for routine maintenance (thus not blocking any lanes of traffic), whereas traffic signals are typically mounted on simple cantilevered poles (mast arms); it is standard practice for traffic signal maintainers to use a "bucket truck" for routine maintenance. When these two different cantilevered supports are installed immediately adjacent to one another, each supporting its respective signal, motorists may become confused. The level of motorist confusion during the traffic signal preemption sequence may be high, as the traffic signals display solid red indications (not allowing any further vehicles to enter the LRT crossing) while the immediately adjacent flashing light signals display two red

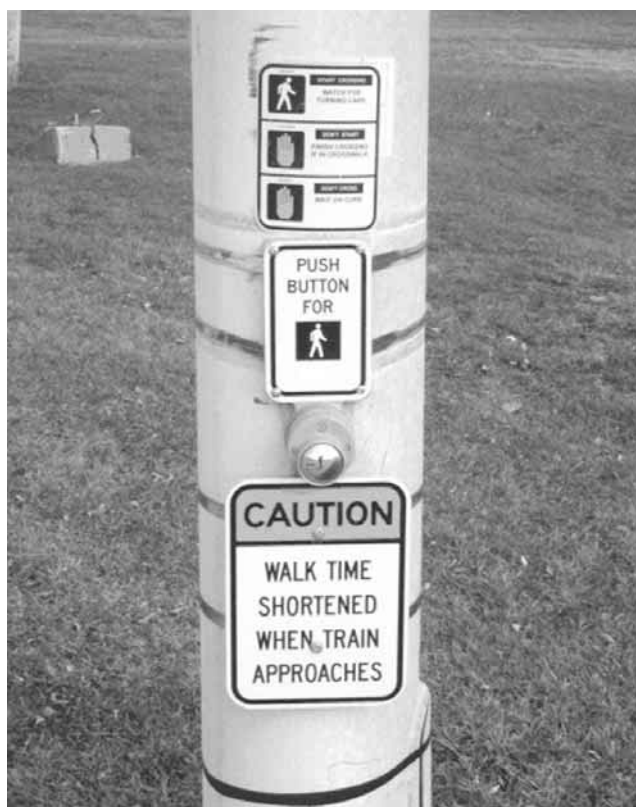
Figure 3-16. Pedestrian phase truncation sign. (Chicago, Illinois.)

On existing LRT systems where the LRV detection points have already been set, pedestrian clearance phases may be abbreviated (but should not be terminated) to clear motor vehicles off the tracks before the LRV arrives at the crossing. If the pedestrian clearance phase will be abbreviated during preemption, a notice to pedestrians should be mounted above the pedestrian push button, if one exists, or on the traffic signal pole, which is standard practice in Illinois (Figure 3-16). Another treatment that is emerging to reduce sign clutter and to provide a message about the amount of time left to cross the intersection is the use of pedestrian signals that count down the time remaining in the pedestrian phase. Pedestrian signals should not blank out (turn off) when the LRT preemption is received by the traffic signal controller. If the motor vehicle clearance phase cannot be adequately provided with-

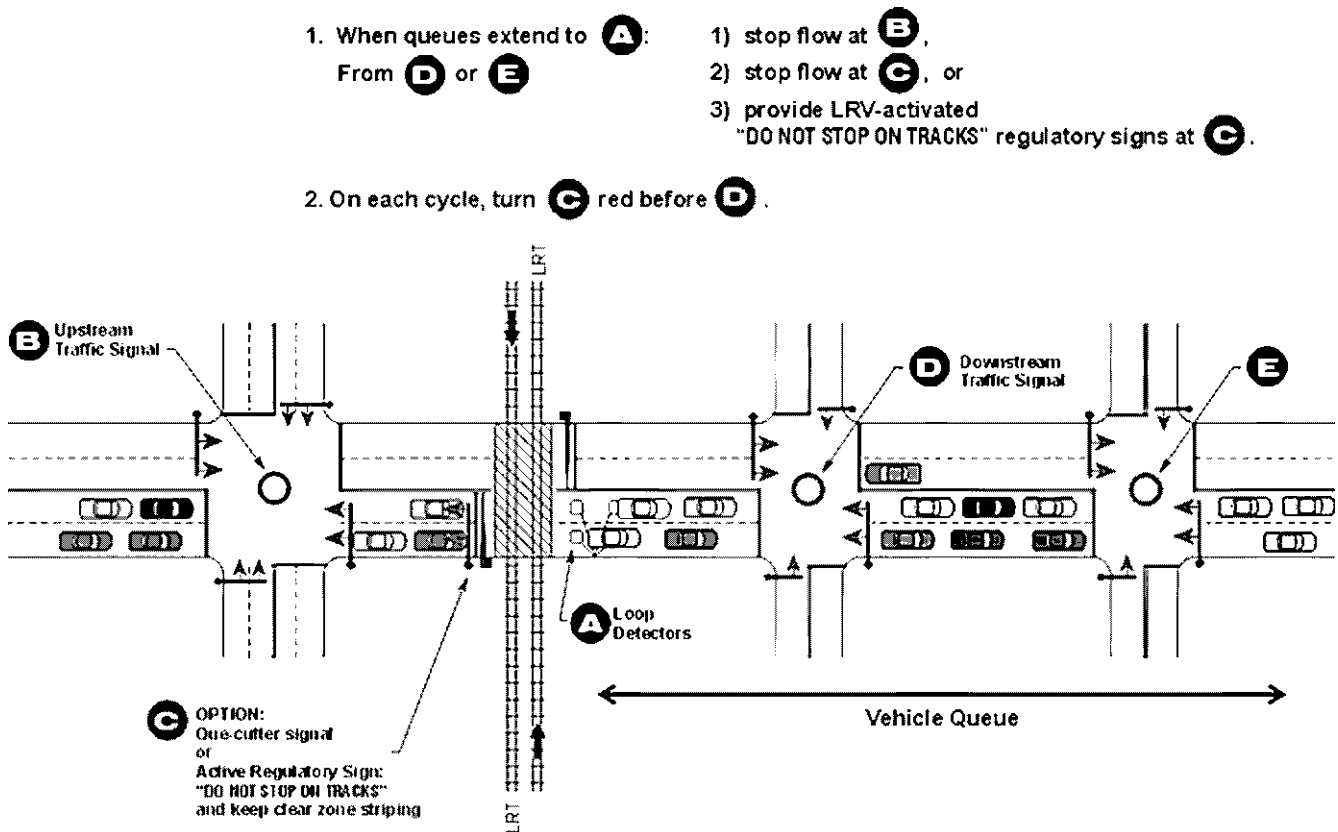
Figure 3-17. Queue prevention strategies.

- Stop the major flow of traffic at Signal B [depending on the level of traffic congestion and the distance between Location A and the tracks, it may be necessary to stop vehicles from turning onto the crossing roadway from the parallel roadway at Signal B by using either protected signal indications (red arrows) or LRV-activated No Right/Left Turn signs (R3-1, -2)];
- Stop the flow of traffic at Signal C by using traffic signals on the near side of the LRT crossing (i.e., presignals as described in Section 3.5.3);
- Remind motorists not to stop on the LRT tracks by providing LRV-activated, internally illuminated Do Not Stop on Tracks signs (R8-8) mounted on a mast arm over each lane of traffic at Location C (these signs would activate when queues are detected at Location A); or

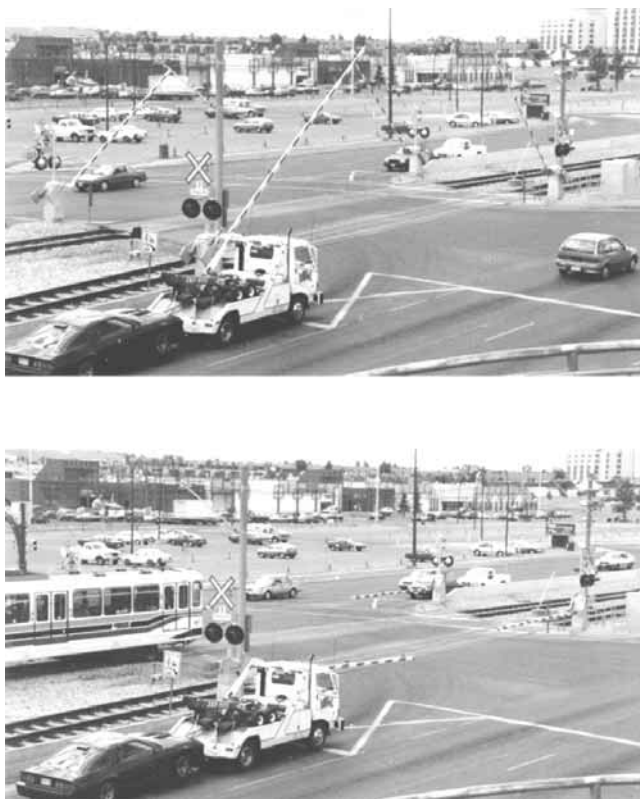
Figure 3-25. Example quasi-four-quadrant gate system. (Calgary, Alberta.)

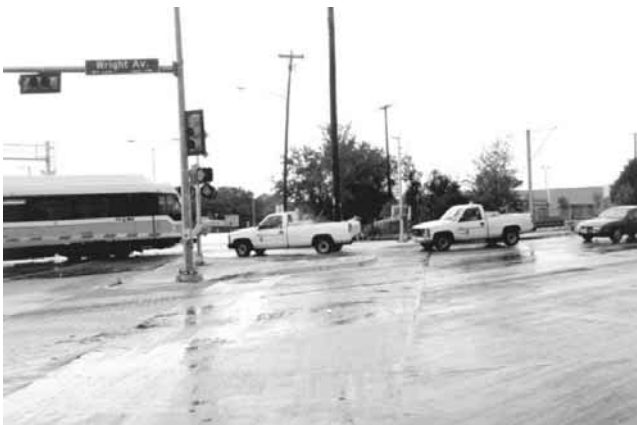
Figure 3-27. Motor vehicle stopped on wrong side of gate arm.

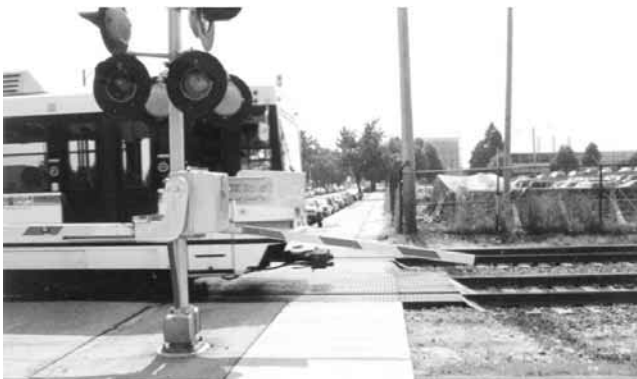
Figure 3-29. Example pedestrian automatic gate. (St. Louis, Missouri.)

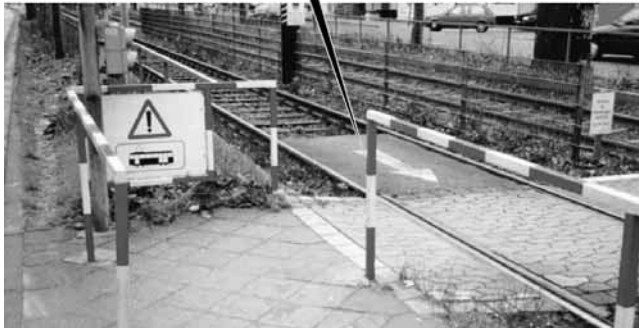
Figure 3-34. Example pedestrian crossing striping.
(Dusseldorf, Germany.)

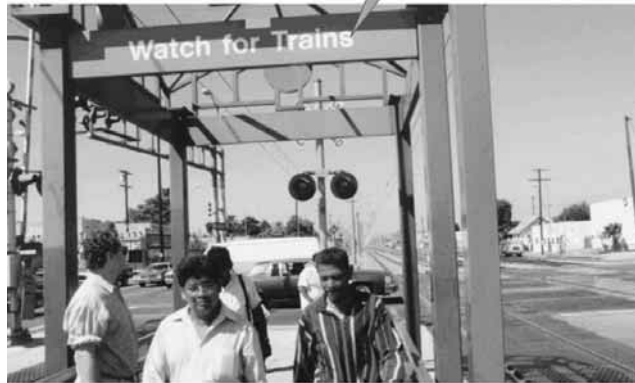
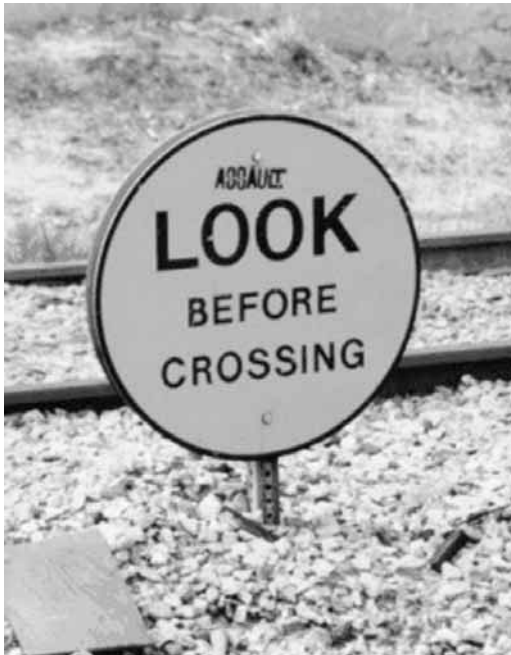
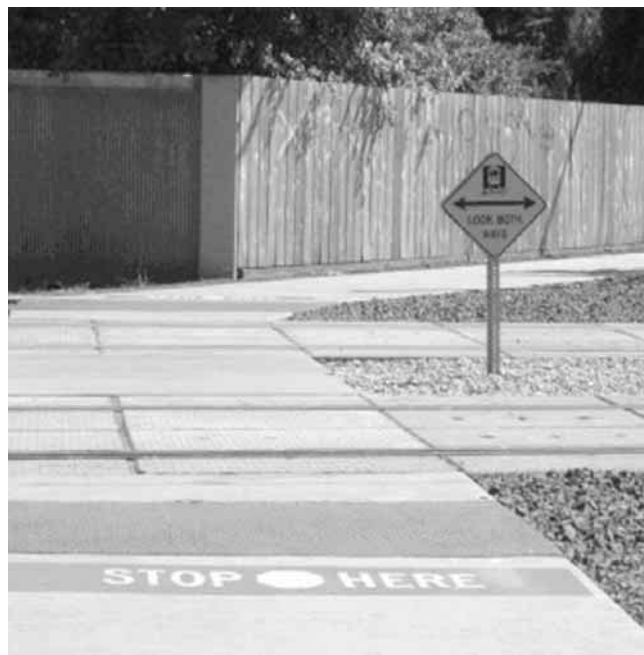
Figure 3-35. Pedestrian sign mounting examples. (Above: Los Angeles, California. Left: Boston, Massachusetts; Right: Portland, Oregon.)

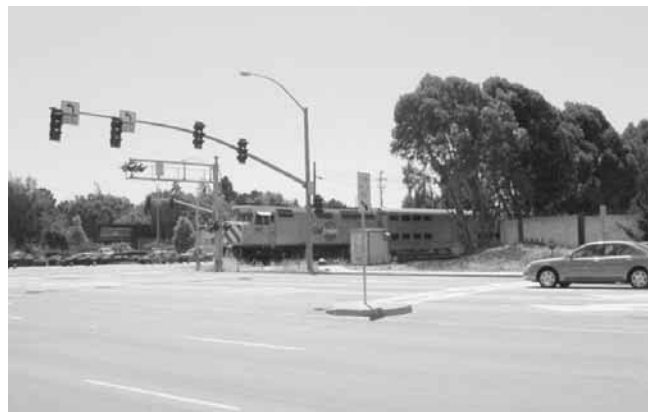
Figure 4-3. California presignal.

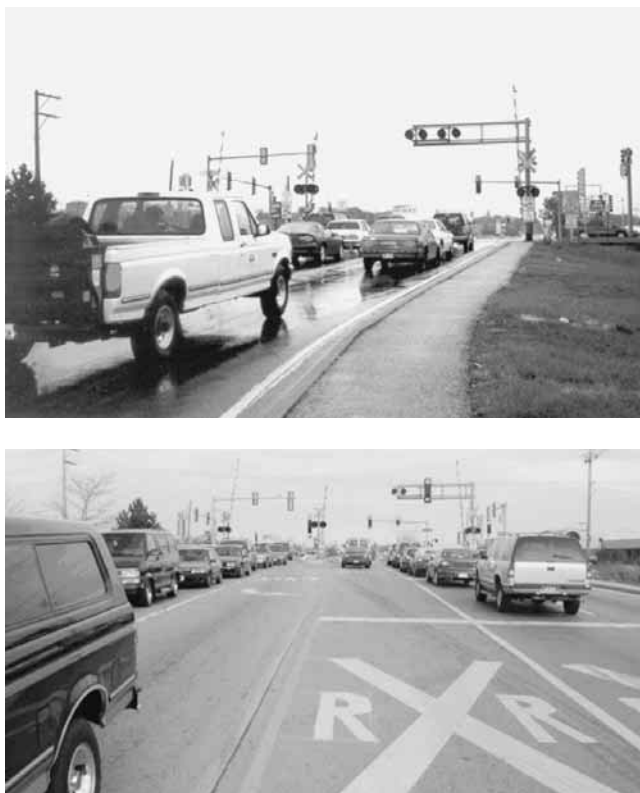
Figure 4-5. Rollins Road, Illinois. (Above: before presigned testing. Below: after.)

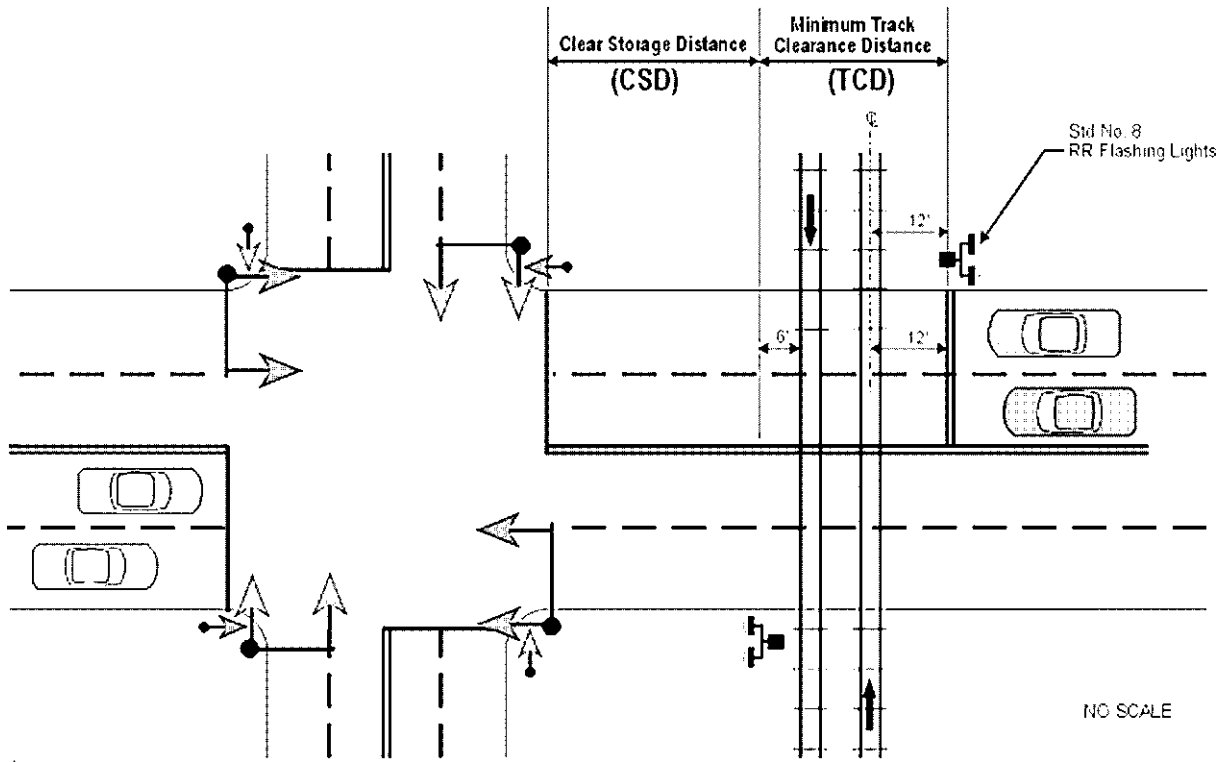
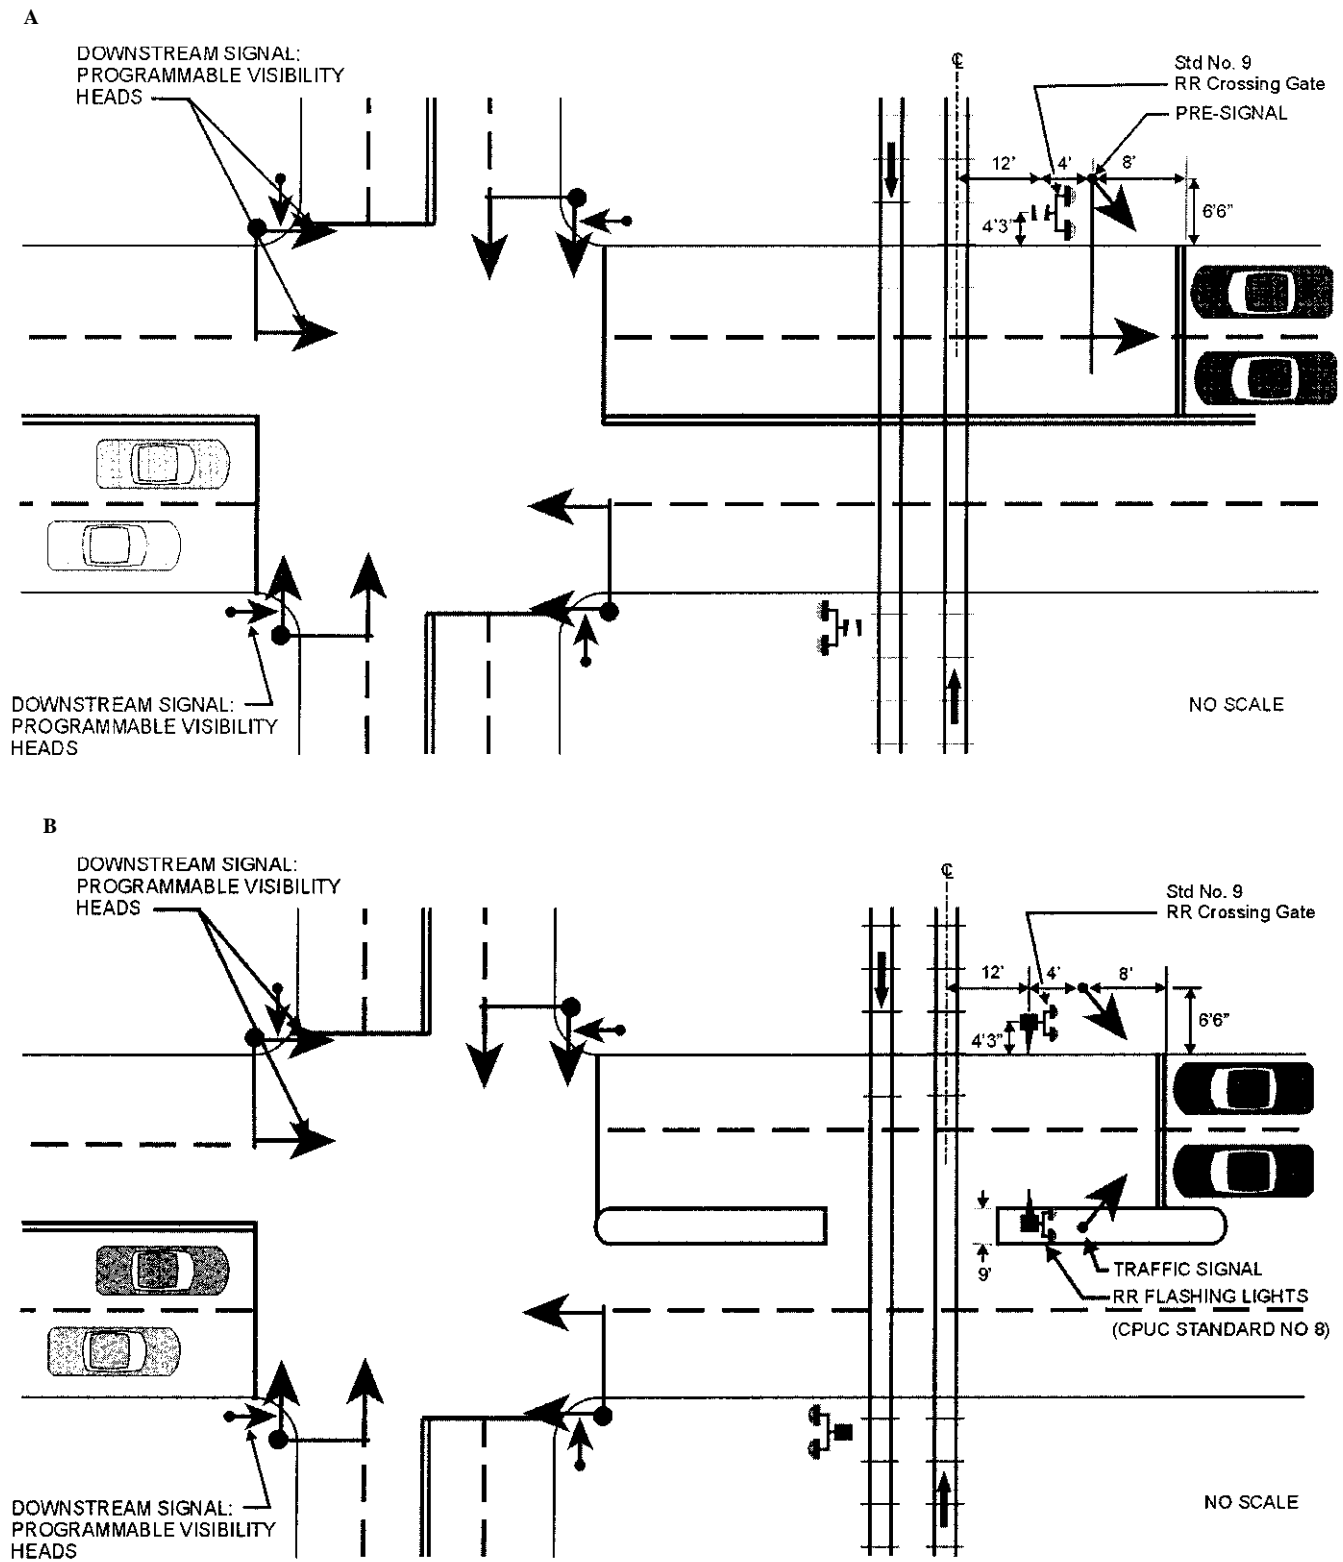
Figure 5-2. (A) Presignal location without median. (B) Presignal location with median.

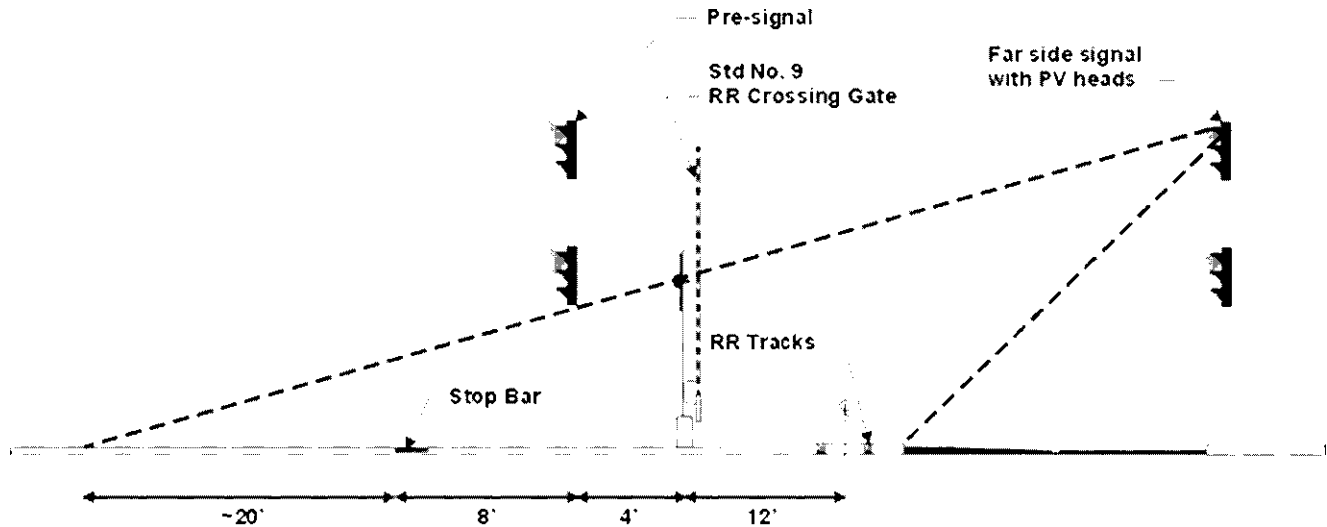
Figure 5-4. Programmable visibility (PV) head visibility.
