**Durability of Truncated Dome Systems  
(a.k.a. Detectable Warning Surfaces)**

**Evaluation Report**

Report No. FHWA-NH-RD-MPS 2002-2

**EVALUATION REPORT, WINTER 2002/2003**  
**DURABILITY OF TRUNCATED DOME SYSTEMS**  
(a.k.a. Detectable Warnings on Walking Surfaces)

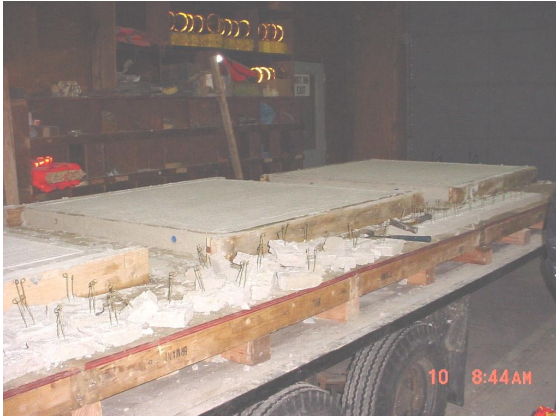
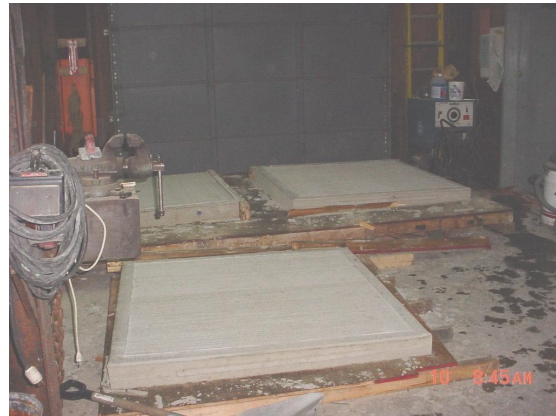
Concrete panel fabrication in the Bridge Maintenance Bureau shop

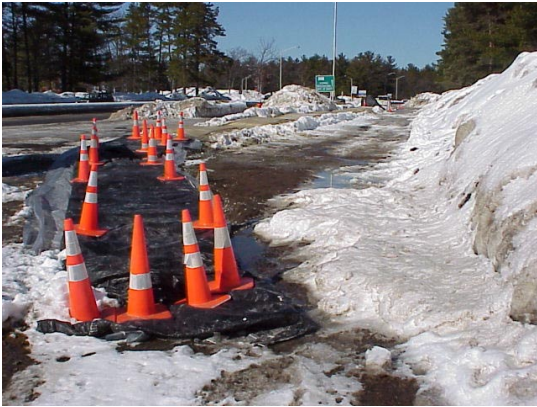
South Ramp, Looking North

During curing, February 20, 2003

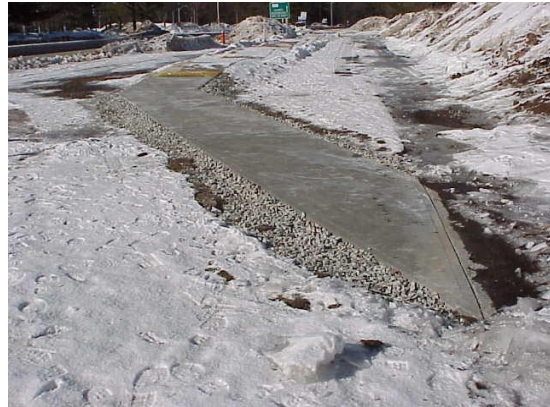
Ramp uncovered on February 26, 2003

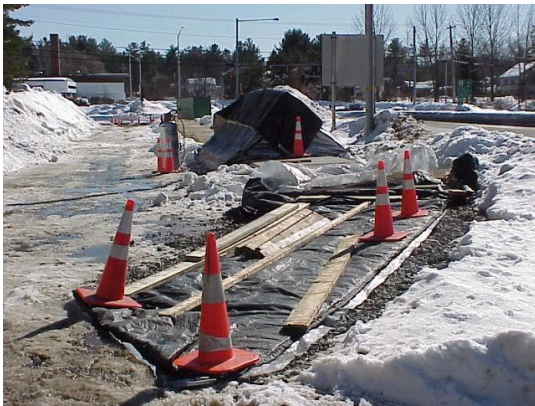
North Ramp, Looking South

During curing, February 20, 2003

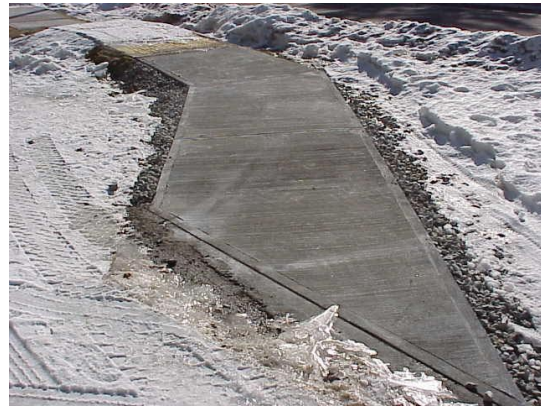
Ramp uncovered on February 26, 2003

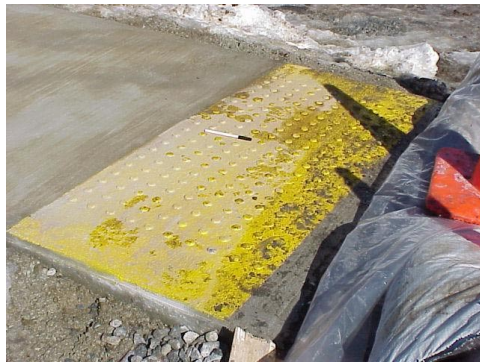
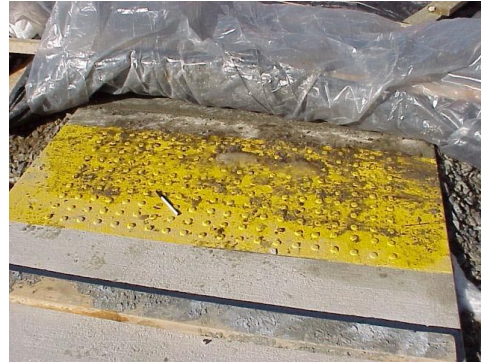
Section 1S

Product: SAFTI-TRAX Applied Domes Detectable Warning System  
Manufacturer: COTE-L Industries, Inc.  
Installation: Concrete panel cast December 10, 2002 in Bridge Maintenance shop. System installed January 17, 2003 in Bridge Maintenance shop by following manufacturer's application instructions. Individual domes on a plastic sheet were applied to the concrete surface using Durabak adhesive. Colored sealer was then applied over the domes. Installation is considered easy, but the number of steps are lengthy compared to the other systems.  
Product Cost: \$432.00 (both panels)

February 20, 2003  
Completed Field Installation

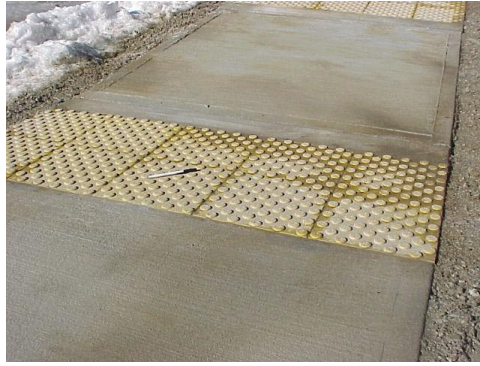
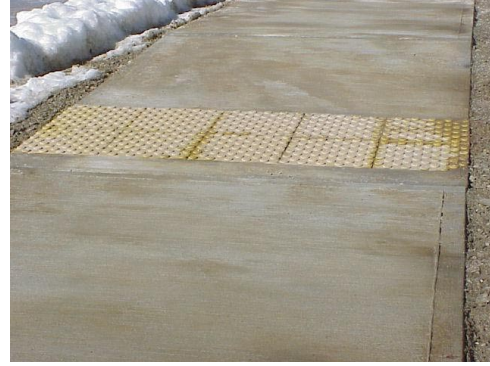
Section 2S

Product: Polymer Concrete "Step-Safe Tile"  
Manufacturer: Castek Division, Transpo Industries  
Installation: Concrete test panel was cast on December 20, 2002 in Bridge Maintenance shop.  $\frac{3}{4}$ " block out was created in the surface ( $\frac{1}{2}$ " for the tile,  $\frac{1}{4}$ " for the exterior grout). Grout was mixed and placed in block out area.  $11\text{-}\frac{7}{8}$ " x  $11\text{-}\frac{7}{8}$ " x  $\frac{1}{2}$ " tiles were installed in grout. Installation occurred on January 13, 2003 in Bridge Maintenance shop. Installation was considered easy.  
Comments: Diamond pattern domes do not appear to comply with current ADAAG requirements.  
Product Cost: \$265.95 (both panels)

February 20, 2003  
Completed Field Installation

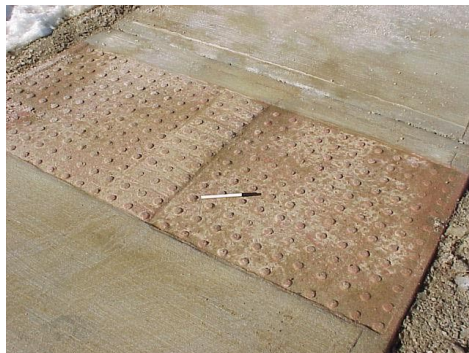
Section 3S

- Product: Stampcrete  
 Manufacturer: Stampcrete International, ltd.  
 Installation: Concrete test panel was cast on December 31, 2002 in the Bridge Maintenance shop. In accordance with the procedures outlined in the manufacturer's application instructions and video, domes were shaped into the surface of the fresh concrete by tamping a 24" square stamp immediately following finishing. Color pigmented sealer was applied to the domes on January 2, 2003 in the shop. Installation was considered easy.  
 Comments: The surface background is uneven. Domes heights vary, and many are deformed (perhaps an installation experience issue). NHDOT installers said quality of finish would improve with use of a stamp matching the sidewalk width. Approximately 10% of domes had lost their pigmented sealer at time of photos, below. Snow removal had been limited to hand shovels at that time.  
 Product Cost: \$321.75 (both panels), primarily for re-usable stamping equipment.

February 20, 2003  
Completed Field Installation

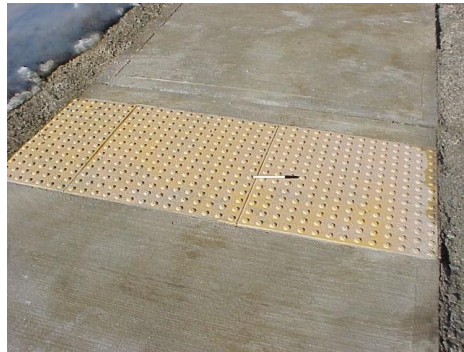
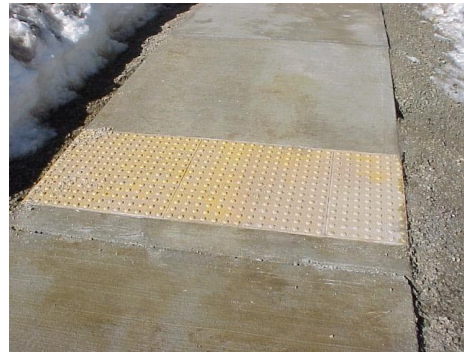
Section 5S

Product: Thin Paver  
Manufacturer: ADA Fabricators, Inc. (supplied by Genest Concrete)  
Installation: Concrete test panel was cast on December 16, 2002 in the Bridge Maintenance shop. The installation surface was left with a 1/8" recess and a broom finish. Edges were saw cut where required for flanges on the dome panels. A manufacturer's representative was on hand January 29, 2003 when the 2' x 2' panels were set on a layer of adhesive, applied with a 1/4" x 1/4" square notch trowel. Several holes

February 20, 2003  
Completed Field Installation

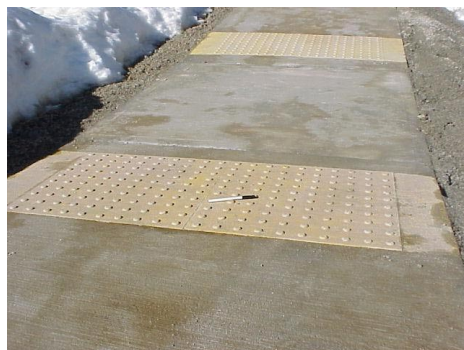
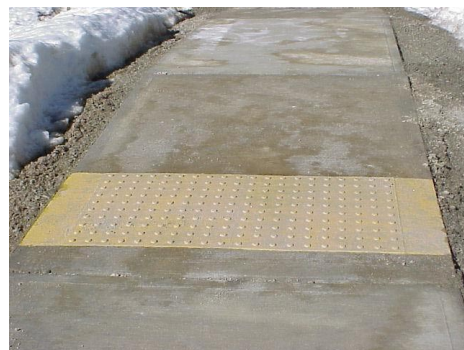
Section 6S

Installation: Concrete test panel was cast on December 10, 2002 in the Bridge Maintenance shop. The dome mats were installed on January 16, 2003 by applying and spreading adhesive to the masked concrete surface in accord with manufacturer's application instructions. The mats were then pressed into place with a maximum 1 square foot flat board. This product was easiest to install.

February 20, 2003  
Completed Field Installation

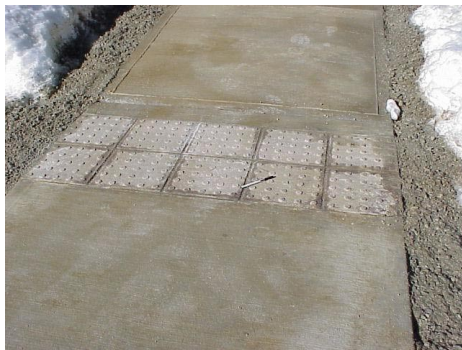
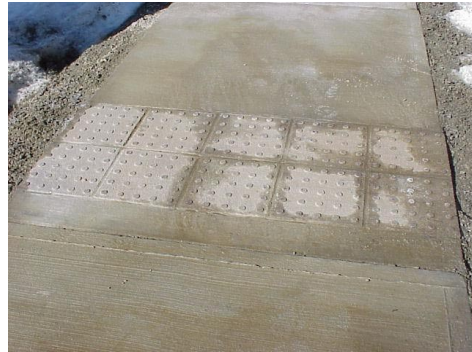
Section 7S

Product: Pressed Stone Block  
Manufacturer: Hanover Architectural Products, Inc.  
Installation: Concrete test panel was cast on December 20, 2002 in the Bridge Maintenance shop. A 2-3/8" recess was left in the concrete surface (2-1/8" for the block, 1/4" for the exterior grout). Exterior bonding mortar was mixed and applied to the concrete in the shop on January 13, 2003, followed by setting the 11-3/4" x 11-3/4" x 2-1/8" blocks into place. The joints were grouted on January 14, using sanded exterior grout. Installation was easy, requiring 2 days to apply products.  
Product Cost: \$420.50 (both panels)

February 20, 2003  
Completed Field Installation

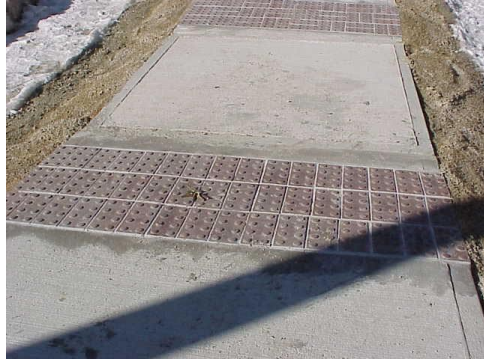
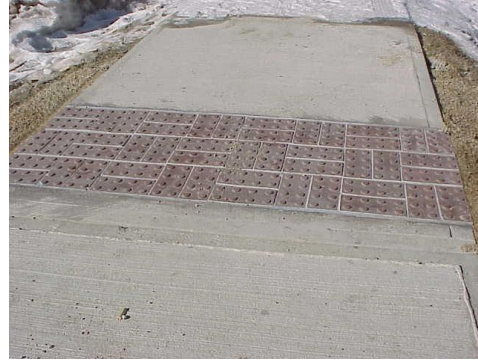
Section 8S

Product: Brick Paver  
Manufacturer: Endicott Clay Products  
Installation: Concrete test panel was cast on December 31, 2002 in the Bridge Maintenance shop. A 2-3/8" recess was left in the concrete surface (2-1/8" for the block, 1/4" for the exterior grout). An enclosure was constructed to heat the test panels, which had already been assembled at the test site. Exterior bonding mortar was mixed and applied to the concrete in the field on February 19, 2003, followed by setting the 7-3/4" x 3-1/2" pavers into place. The joints were grouted on February 19, using sanded exterior grout. The protective tent was removed on February 26, 2003. Installation was easy, requiring 2 days to apply the products.  
Product Cost: \$305.00 (both panels)

February 26, 2003  
Completed Field Installation

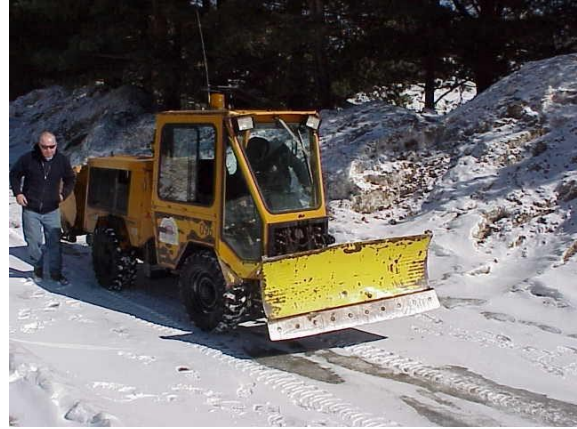
frequency as the City's walks. The plow blade is generally free-floating (no down pressure). Blade angle settings are determined by a variety of factors such as whether the vehicle is traveling with or against traffic, driveways or other features. Snow is typically pushed toward the street/curb. This day's operator lead with the left end of the blade.

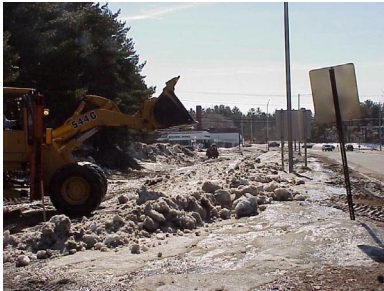
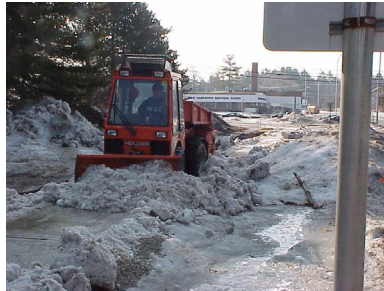
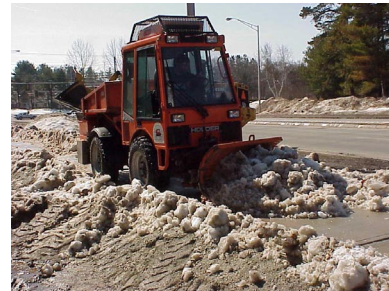
The NHDOT Mechanical Services Bureau provided a John Deere 544C front-end loader to place snow on the test sections on a sunny March 18 with temperatures in the mid-50s. The City-owned Holder C9700H plow vehicle cleared the snow eighteen times, generating much data. By the end of the “rally”, Sections 1, 4S and 6 had suffered severe damage; Section 6 (COTE-L SAFTI-TRAX mats) had been totally peeled off the sidewalk by this day’s 11<sup>th</sup> pass (a total of 13 passes).

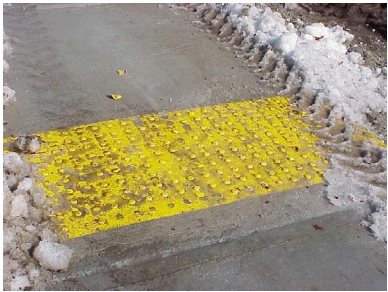
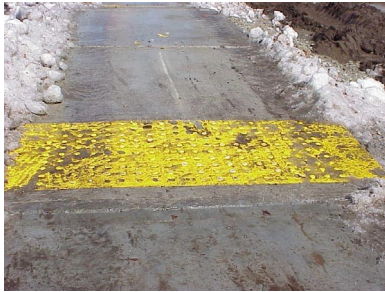
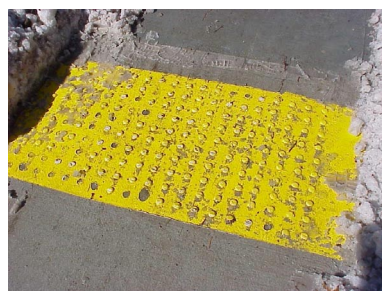
- System does **not** appear to comply with the ADAAG:
  1. Dome tops are 67 percent of the base dimension.
- Domes are surface mounted, extending above the plane of the sidewalk surface.
- Dome failure typically began by shearing at the contact face with the plow. Repeated cycles resulted in loss of top or of entire dome.
- The product material is soft and resilient, not very durable against plowing.

1S at 5 passes

1S at 7 passes

1N at 17 passes

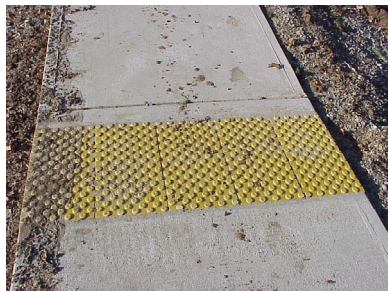
- System does **not** appear to comply with the ADAAG:
  1. Domes are not positioned in a square grid pattern.
  2. Dome top is 94 percent of the base dimension.
- The tile is mainly flush with the plane of the sidewalk surface; domes extend above the plane, resulting in greater wear of the first row encountered by the plow.
- Materials showed high durability.

2S after 20 passes

Although they do not appear to meet the ADAAG requirements at this time, the Polymer Concrete “Step-Safe Tile” and the Brick Paver systems (Sections 2 and 8, respectively) performed well. These systems would be acceptable if brought into dimensional compliance, or if ADA requirements are waived or revised.

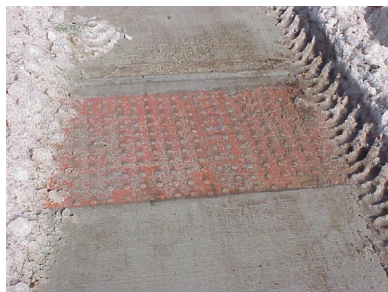
- System specifications comply with the ADAAG.
- Uneven installation results in domes being above and below the sidewalk surface plane.
- Some domes were misshapen from fabrication
- Top of the higher domes showed wear at 20 plow passes.
- Color seal deteriorated soon after installation; continued wear under plowing.

3S at 6 passes

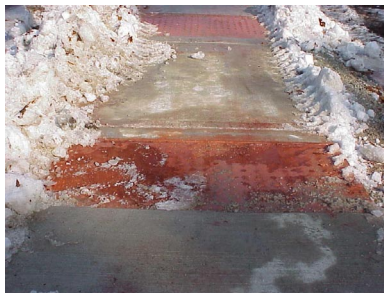
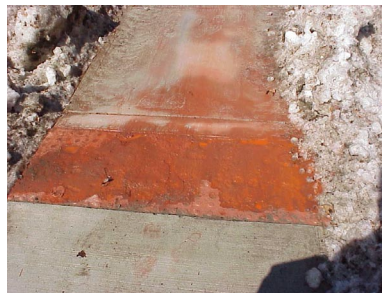
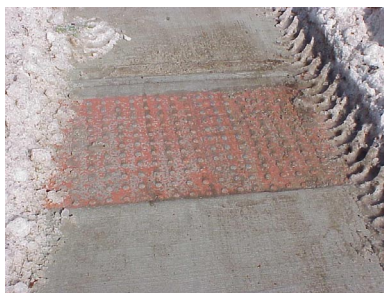
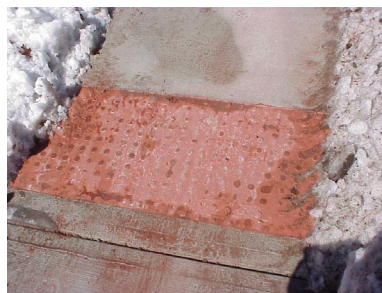
Deterioration of Section 4S (ADA Retrofit Kit) was noted in the period between the test site completion and the beginning of plowing. The shell of the red applied product had been broken off several domes, exposing a powdery base. The material could be readily penetrated, appearing to have no particle bonding properties. In contrast, Section 4N was sound, apparently not suffering from the problem. Both panels had been installed from the same batch of mix.

- System specifications comply with the ADAAG.
- Installation occurs in a recess in the concrete; domes are below the sidewalk surface plane.
- Actual installation resulted in misshapen domes of varying height; some barely visible.
- 4S was totally destroyed in 5 plow passes. In spite of both panels being fabricated from the same batch of mix, this panel was easily damaged, even prior to plowing, as opposed to the sound condition of 4N.
- Color seal of 4N began peeling; top of domes wearing at 20 plow passes.

4S at 3 passes

4S at 14 passes

4N at 5 passes

4N at 14 passes

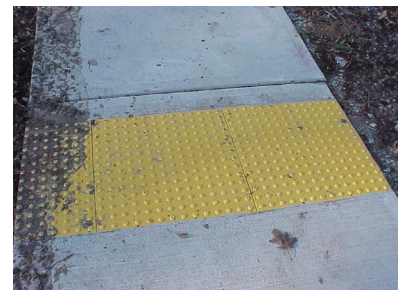
- System complies with the ADAAG.
- Mats are installed in a shallow recess in the concrete, making it flush. The domes extend above the sidewalk surface plane.
- At 11 plow passes, water would squeeze out from beneath the mat, perhaps indicating breakdown of adhesive.
- After 20 plow passes, minor wear to 11% of domes and the removal of some of the dots located at the top of the domes.

5S after 20 passes

The Bureau recommends the use of Thin Pavers and Pressed Stone Blocks for the 2003 construction season, as they are most durable of the compliant products tested. These products will be observed for long-term performance, including a second winter plowing season.

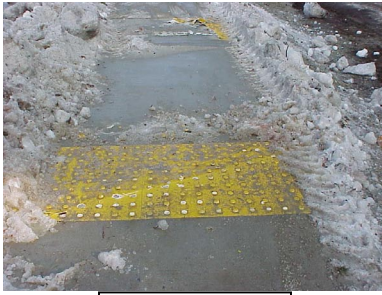
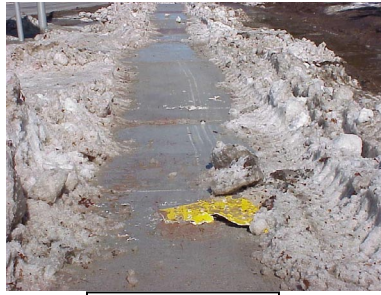
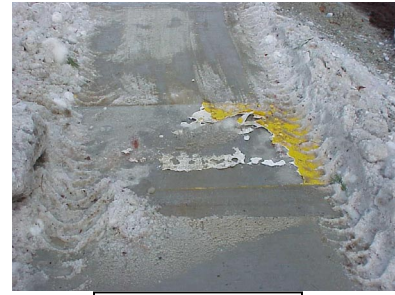
- System does **not** appear to comply with the ADAAG:
  1. Base diameter is 0.84 inch.
  2. Dome top is 79 percent of the base dimension.
- Material is soft and resilient
- Early damage resulted due to the lack of a recess in the concrete surface; the plow caught the mat edge and peeled the system off the concrete.

6S at 6 passes

6S at 9 passes

6N at 3 passes

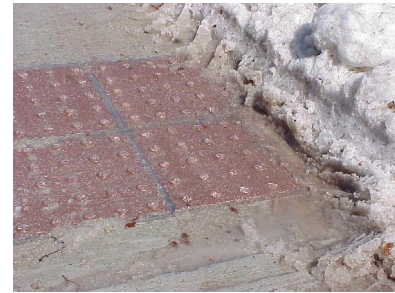
- System complies with the ADAAG.
- Tiles are set flush with the sidewalk surface plane; domes extend above the plane.
- Although generally resistant to plow damage, the first row of domes encountered by the plow showed progressive wear extending across the test panel.

7N at 10 passes

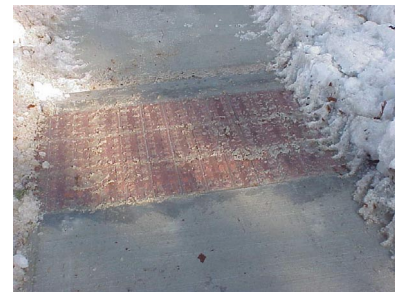
- System does **not** appear to comply with the ADAAG:
  1. Dome top is 86 percent of the base dimension.
- Pavers are set flush with the sidewalk surface plane; domes extend above the plane.
- Front end loader bucket damaged domes of 8S, rows 8 through 11 while preparing for fourth plow pass
- Four 8S domes lost by plow pass 3; no others through 20 passes.
- One 8N dome lost through 12 plow passes; no others through 20 passes.

8S at 4 passes
