Application of Infrared Thermographic Imaging  
to Bituminous Concrete Pavements – Final Report

Report Number  
2229-F-03-7

Submitted to the Connecticut Department of Transportation

Connecticut Advanced Pavement Laboratory  
Connecticut Transportation Institute  
School of Engineering  
University of Connecticut

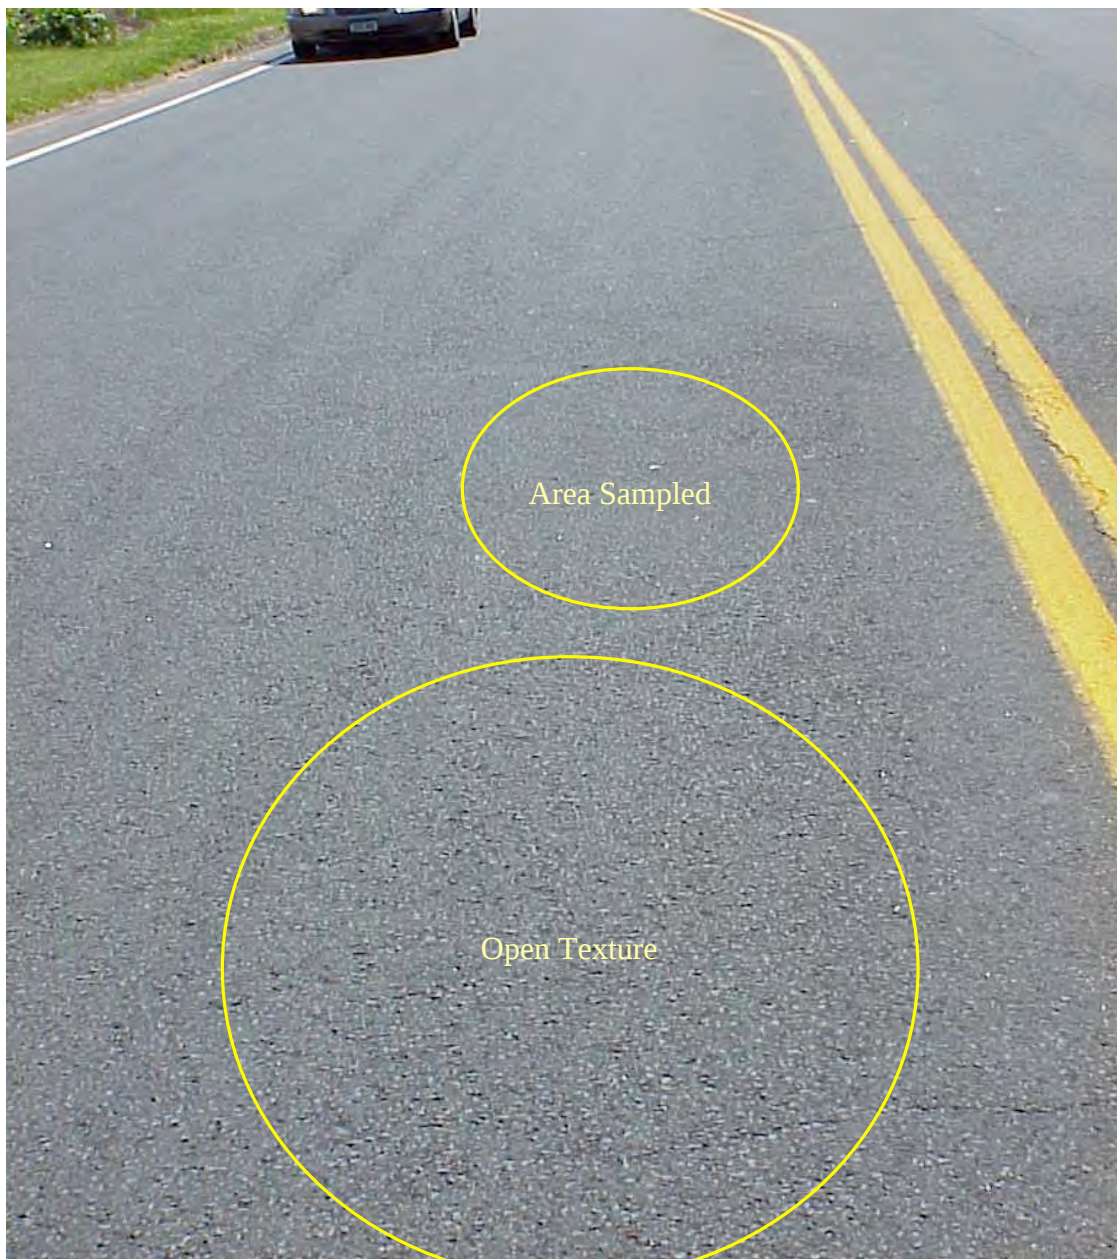
**Figure 8, Pavement Texture after Approximately 1 Year.**

Figure 6 shows the thermal image of the location where Cold Spot Sample number1 was being obtained. The maximum temperature differential for that location was 95.4°F. Figure 7 shows the thermal image for the location where Cold Spot Sample number 2 was taken. The maximum temperature differential for that location was 75.5°F. The sample was obtained in the darkest portion of the image. Both of these sampling locations exhibited visual segregation. Figure 8 shows the segregation observed in the pavement at the location seen in the Figure 7 approximately one year later.

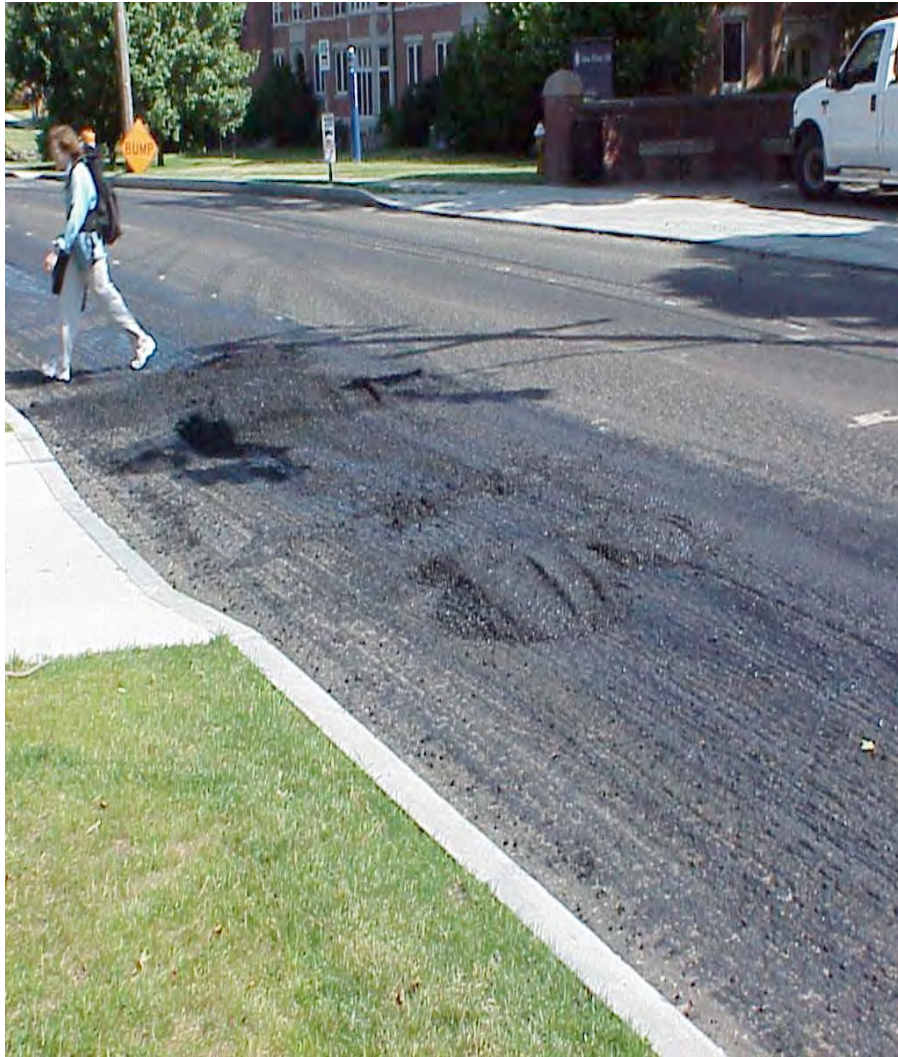
**Figure 11 - Visual image of a spill**

the cones could cool off quicker because of less mass for the surface area and therefore when the paver screed ran into the pile it would pick up the cool material and create a cold spot. Larger spills then tend to form larger cold spots provided they have time to cool. Figures 11 and 12 show a visual image of a spill along with the corresponding thermal image. The thermal image clearly shows the effect of the large mounds of loose material that were present. The temperature differential in the thermal image was 81.6°F. Figure 13 shows a thermal image of material spilled in front of the paver hopper. Figure 14 is a thermal image of exactly the same location after the paver has passed over the spilled material and prior to compaction.

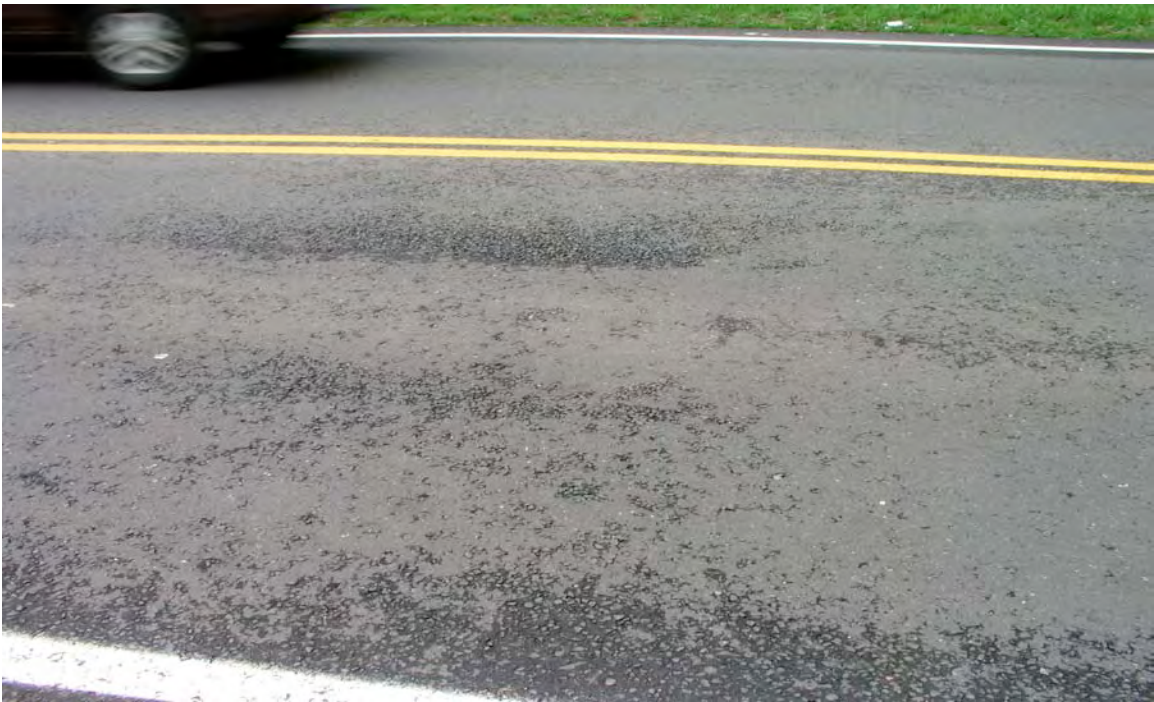
**Figure 31 – Visible image of Figure 30 taken one year after placement (Image taken from shoulder)**

Figure 30 shows a thermal image taken on a roadway that exhibited highly visible segregation at the time of placement. Figure 31 is a visible image of that same spot approximately one year later. Figure 31 is showing some signs of early distress.

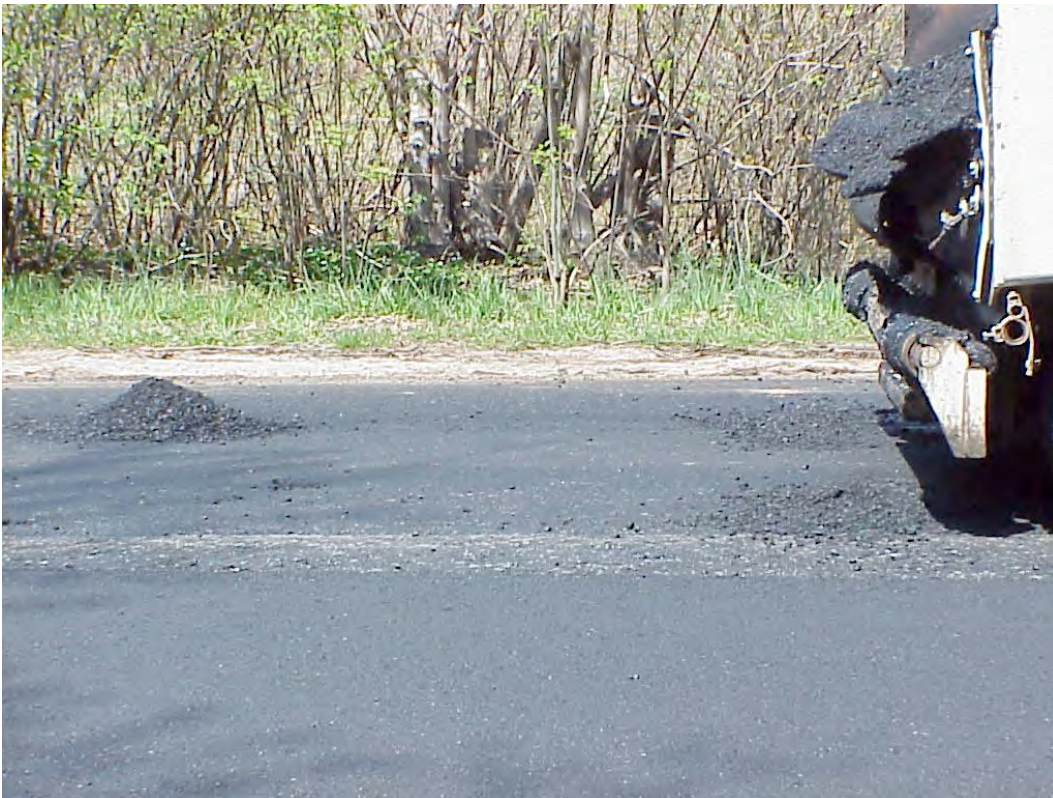
**Figure 34. Material Spilled By Truck Pull-Out After Discharge into Paver.**

Spillage onto the pavement under certain conditions will cause a cold spot to form. Spillage tends to become more problematic based upon the size of the spill, ambient air temperatures and the length of time before the paver passes over. Figure 34 shows a spill of loose HMA onto the existing pavement caused by the haul unit cleaning the loose material from its bed by raising the dump body after pulling away from the paver. Hopper wing folding may also cause material to be spilled ahead of the paver. If there is a delay between trucks and this material is allowed to stay on the existing surface, this material is already cooler than desired and will continue to cool before the paver spreads fresh hot material over it. Cooler weather conditions exacerbate this problem as well as having extended waiting periods for materials to arrive at the paving site. Figures 11 and 12 show a cold spot that corresponds to the location of spilled material on the existing surface from the raising of the truck bed to remove loose material. Figure 35 is an example of a V-shaped cold spot. The V-shape of the cold spots indicates that cold material came from the hopper as it was being moved out laterally by the auger as the paver moved forward.

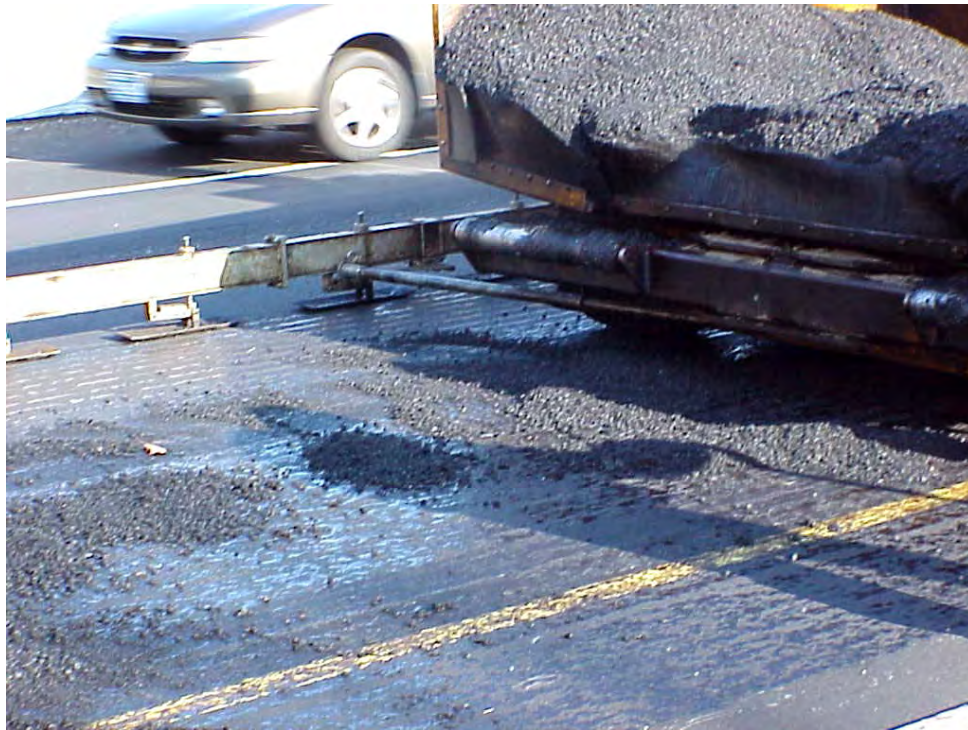
**2.0-inch Virgin, Non-Silo – Smaller V-shaped Cold Spots**

**Figure A3: Effect of Mat Thickness, 1.5 versus 2.0 inch, Shown in Thermal Images of Cold Spots in Paved Section I-395.**

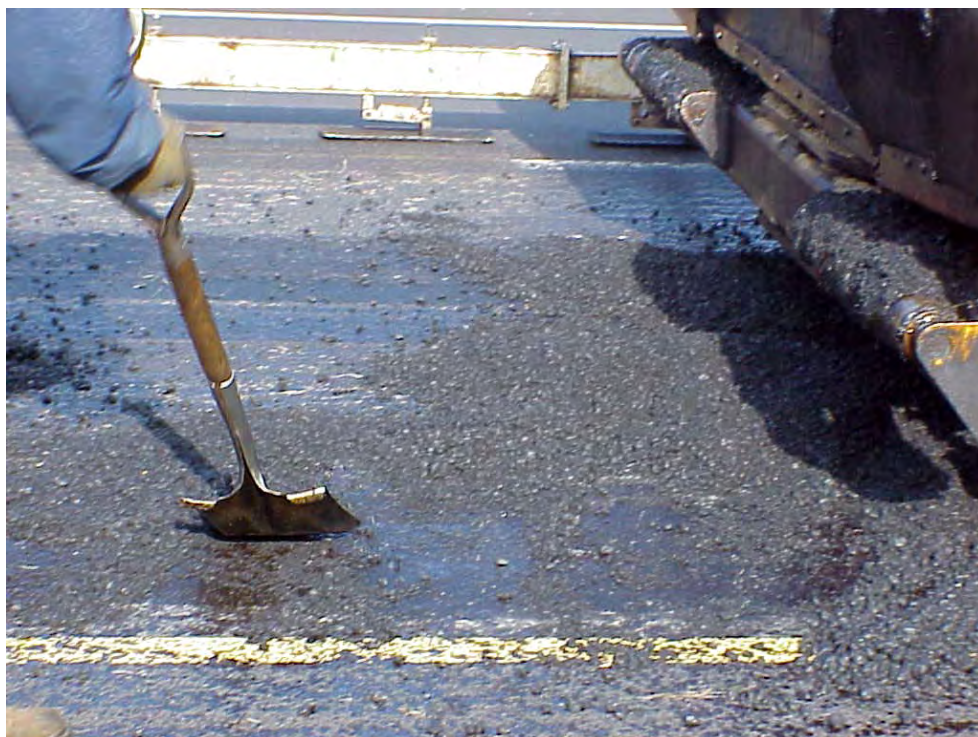
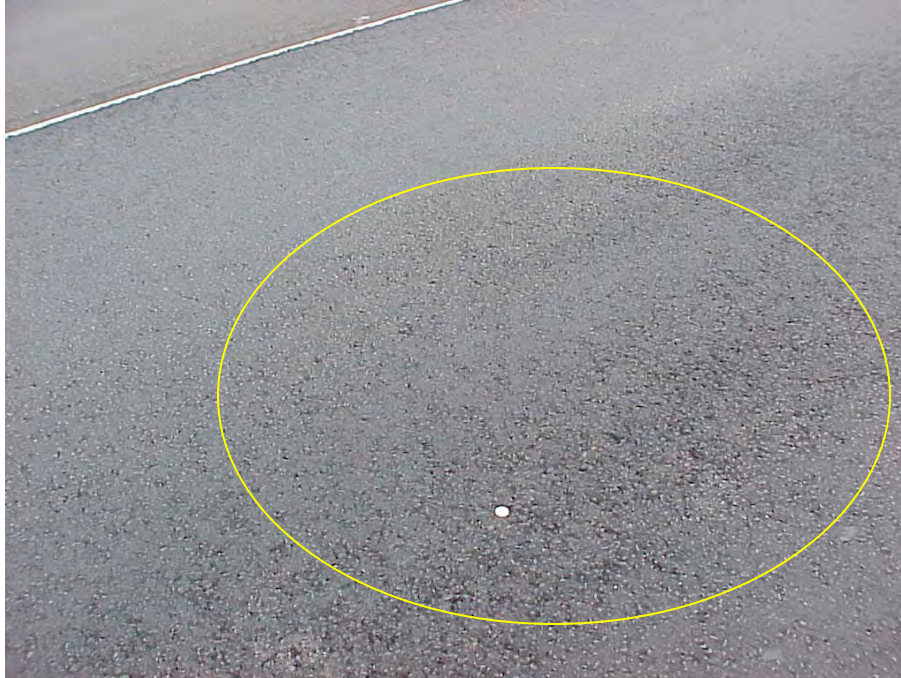
**Spillage of Material in Front of Paver and Out of Hopper Bed**

**Figure A4: Two Examples of Material Spillage in Front of Paver on I-395.**

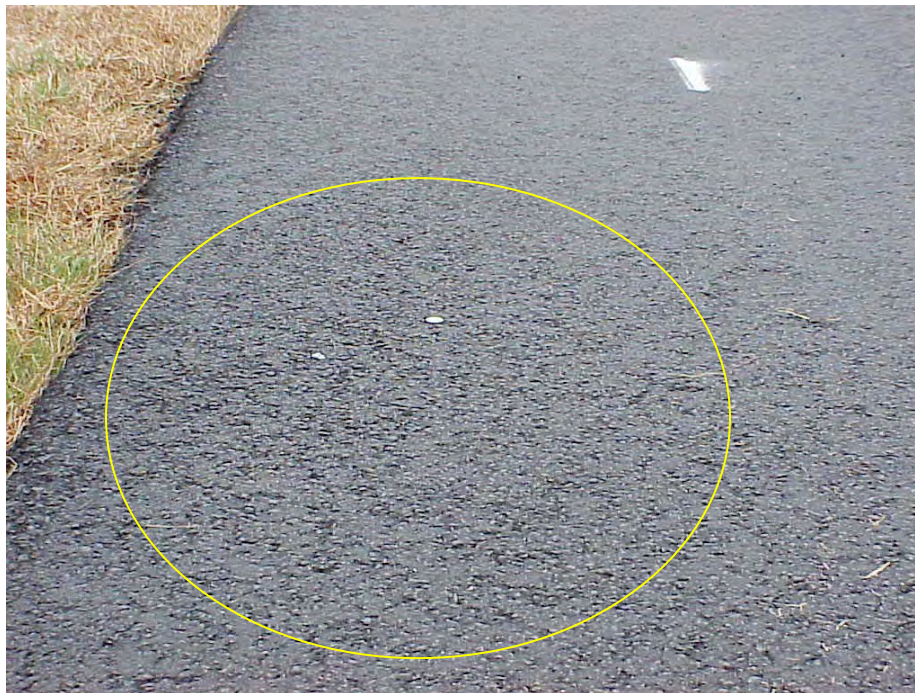
**10% RAP, Silo, 1.5" Lift Thickness – Open Texture in Compacted Mat Corresponding to Cold Spot**

**Figure A5: Two Examples Where Cold Spots, Found with Infrared Thermal Camera, Are Visible on Surface of Pavement on I-395.**

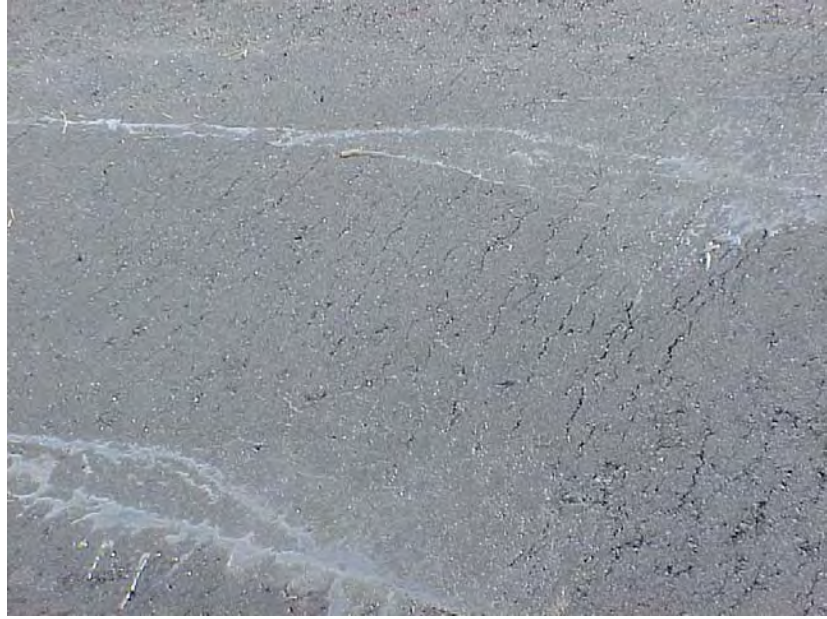
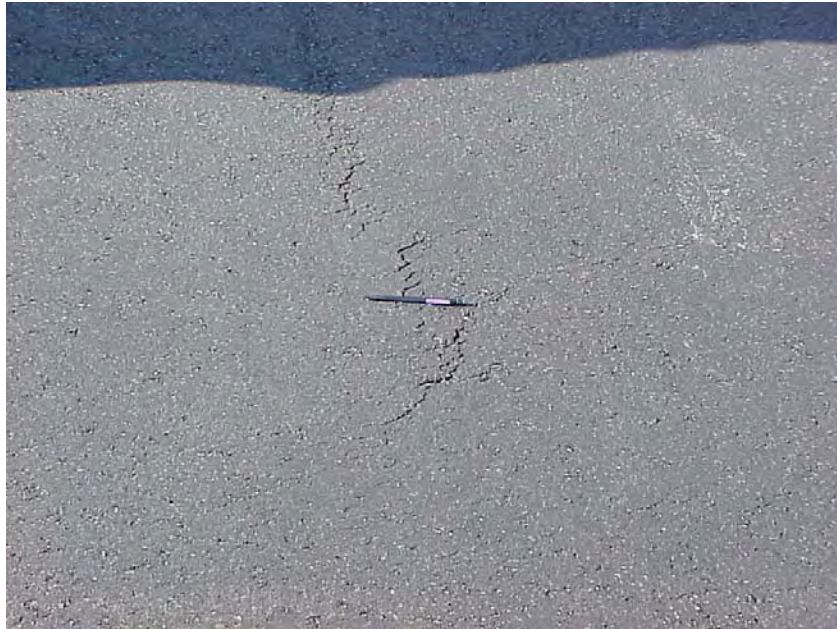
**1.5-inch 20% RAP, Silo, Material Transfer Device Used – Cold Rolling Cracks**

**2.0-inch Virgin, No Silo – Cold Rolling Cracks**

**Figure A7: Effect of Roller Spacing – Cold Rolling Cracks When Rollers Were Not Spaced Tightly.**

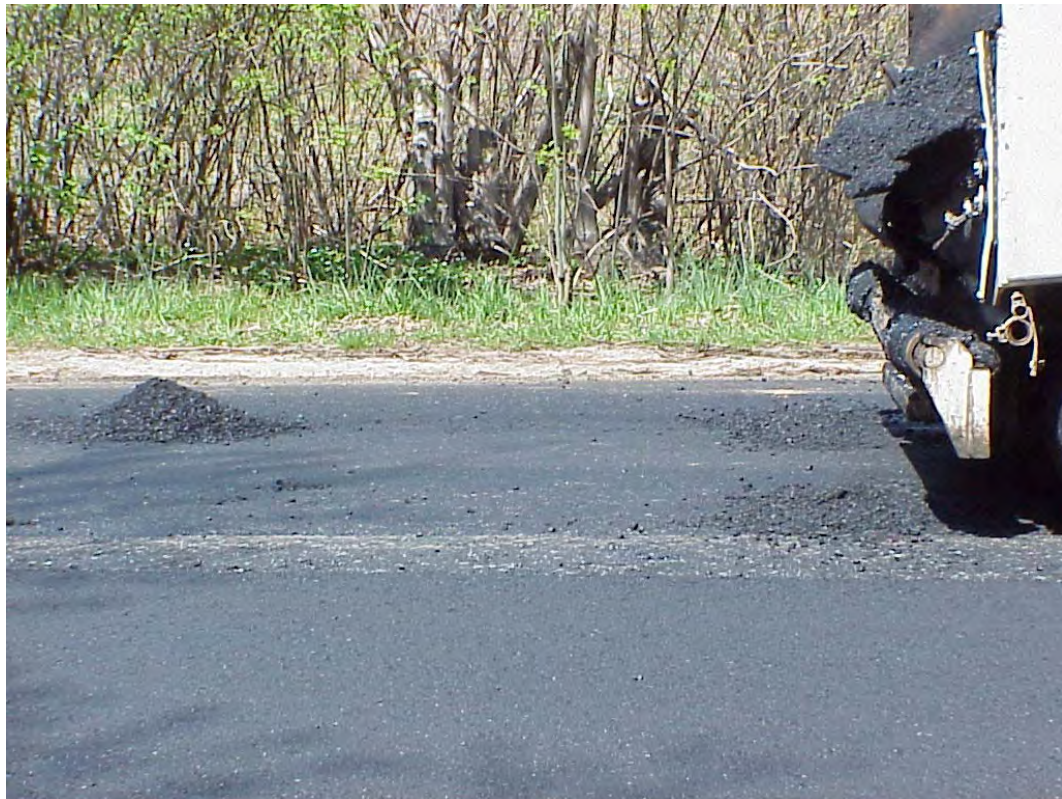
**Figure A9. Material Spilled By Truck Pull-Out After Discharge into Paver.**

The paving contractor used a Cedar Rapids Greyhound CR551 paving machine and loosely-tarped tri-axle dump trucks carried the material from the mix plant. There was no remixing of any kind implemented. An Ingersoll-Rand DD110 breakdown vibratory roller was used along with an 18-ton Hypac 50 C340CW finishing roller. A simple truck configuration study was conducted both days on site to determine pivot height, pivot-to-lip distance, pull-out height of lip, and pull-out spillage. There was a considerable amount of material spilled in front of the paver after each load was discharged into the hopper, as seen in Figure A9. Additional material was spilled on the existing surface when the haul units shook the beds and cleaned out the tailgates after discharging their loads into the paver.

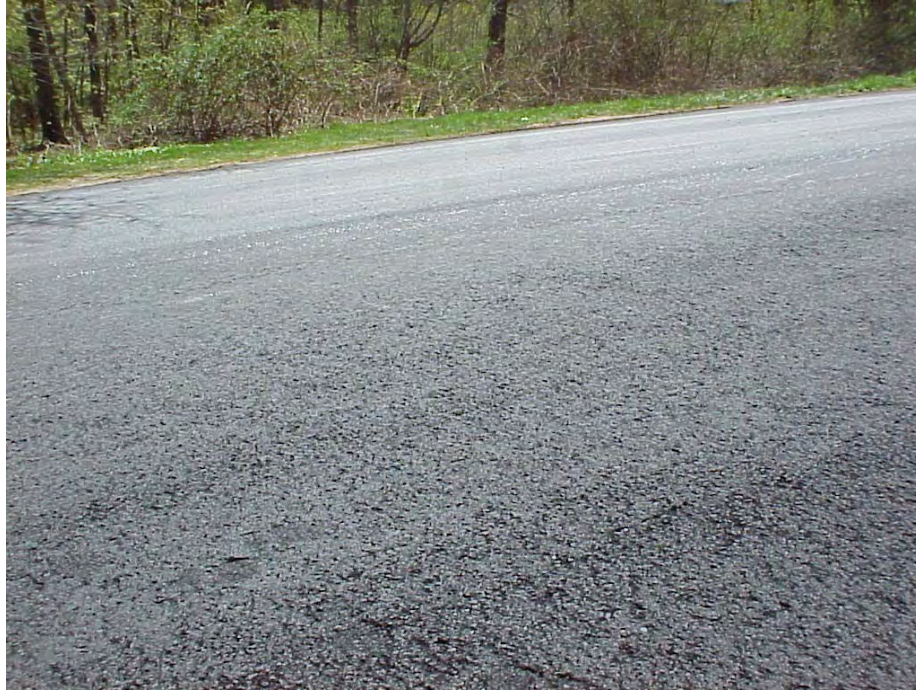
**Figure A12. Open-textured Mat Observed Prior to Compaction.**

A nuclear gauge was not available; therefore, no compaction data for determining the change in air voids or range of air voids was gathered, however, visual inspection showed areas of open-textured mat, such as that seen in Figure A12, that were observed as cool spots in the same location using the infrared thermographic camera.

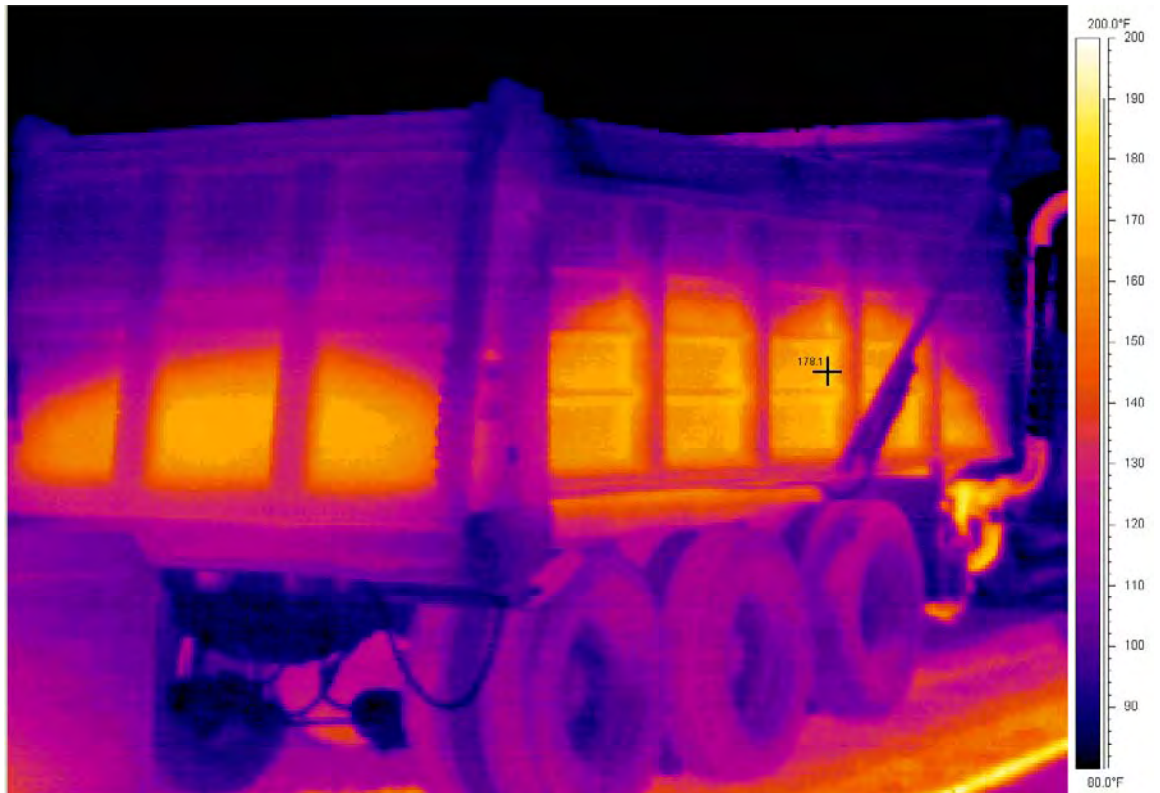
**Figure A88 - Typical thermal image of a heated truck body**
