**Demonstration and Evaluation  
of SUPERPAVE Technologies**

**Final Evaluation Report for CT Route 2**

Report No.  
2219-F-02-7

Connecticut Department of Transportation  
Bureau of Engineering and Highway Operations  
Research and Materials

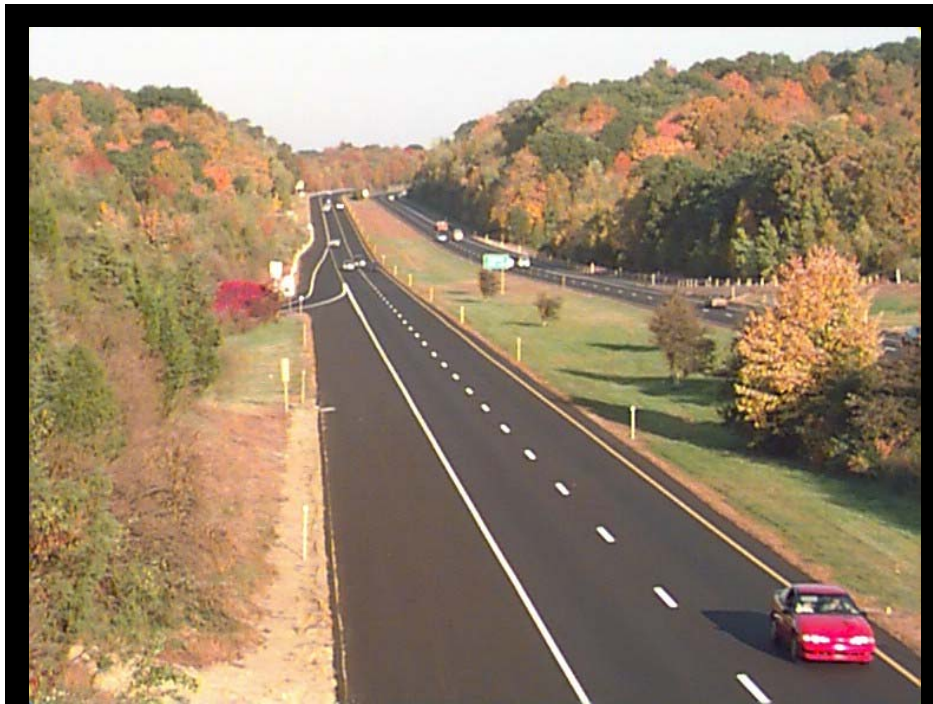
IMAGE #1 - ROUTE 2, BOZRAH/LEBANON TOWN LINE, FACING EAST IN WESTBOUND DIRECTION, SHORTLY AFTER PAVING (SEPTEMBER 1997)

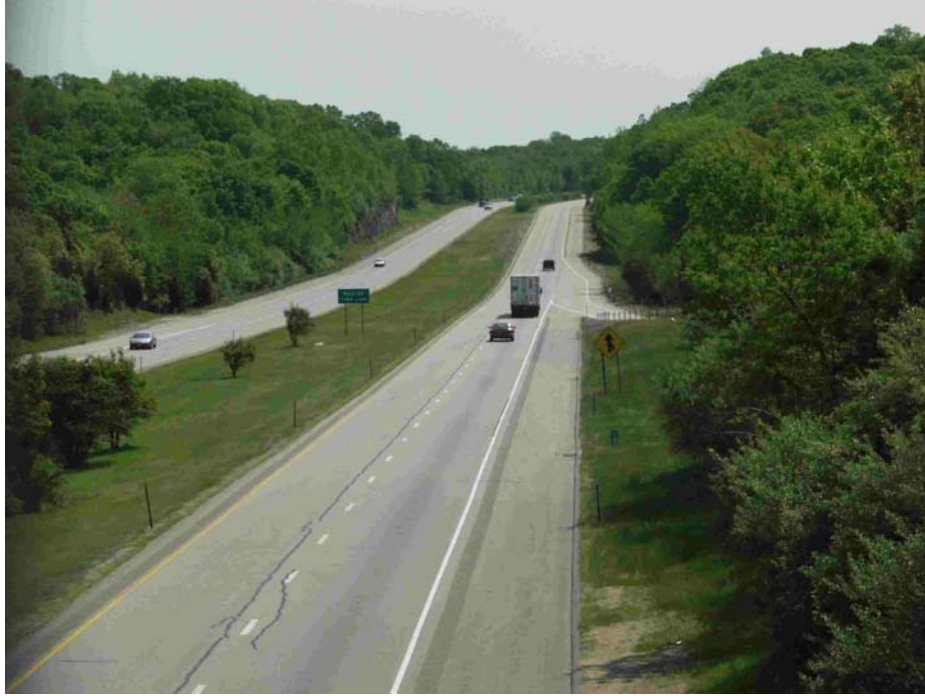
IMAGE #2 - ROUTE 2, BOZRAH/LEBANON TOWN LINE, FACING EAST IN EASTBOUND DIRECTION, PAVEMENT AGE 5-1/2 YEARS (JUNE 2003)

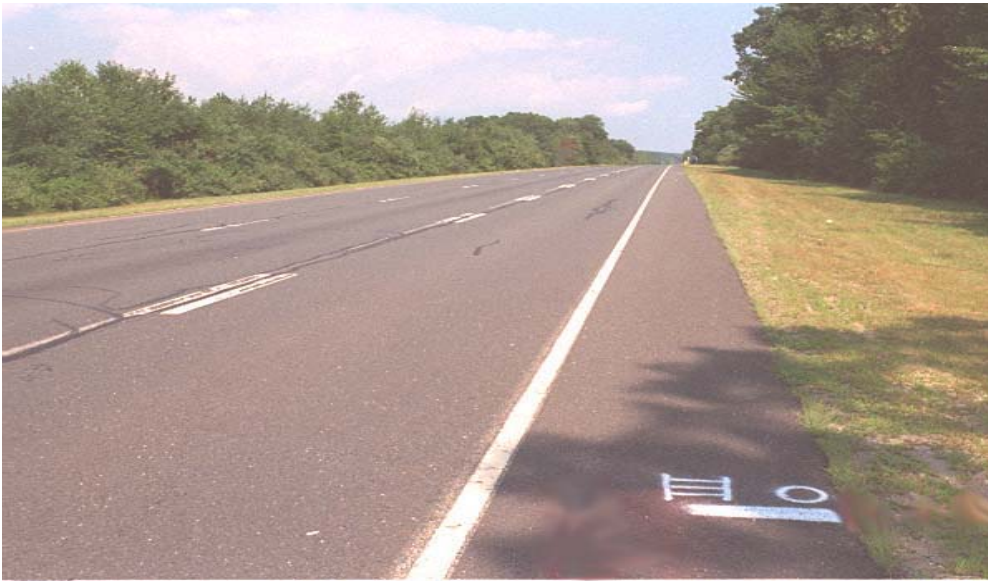
There was a considerable amount of sealed longitudinal and transverse cracking observed in the existing pavement surface, prior to construction in 1997. Occasional areas of raveling and patching, possibly as a result of isolated areas of segregation in the class 114 mix, were also noted (see Images #3 and #4). Twelve-inch diameter pavement cores removed in September 1996 provided no indication of stripping within the 1986 or underlying 1970 pavement layers.

IMAGE #3. ROUTE 2 EASTBOUND PRIOR TO CONSTRUCTION (AUGUST 1996)

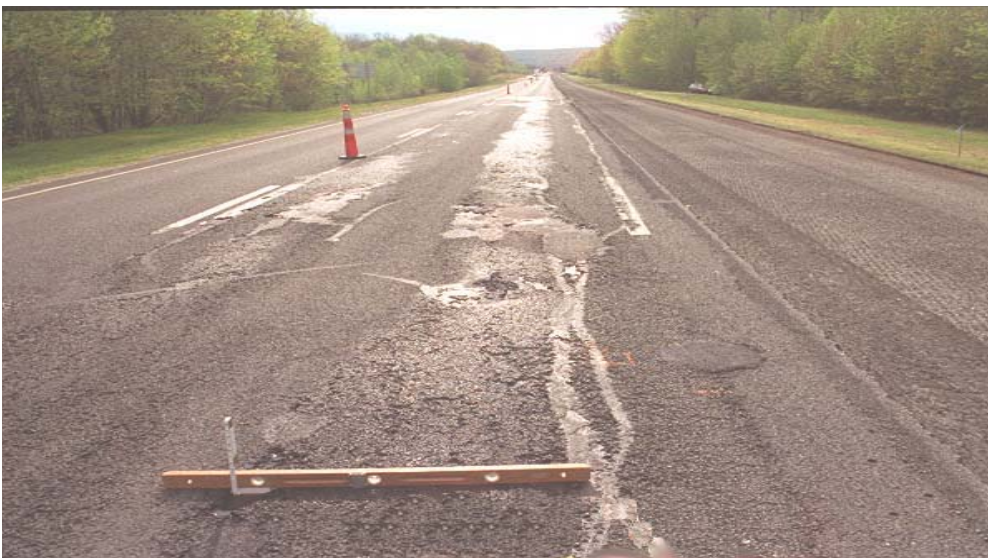
IMAGE #4. ROUTE 2 WESTBOUND AT THE COLCHESTER/LEBANON TOWN LINE, JUST PRIOR TO MILLING (MAY 1997)

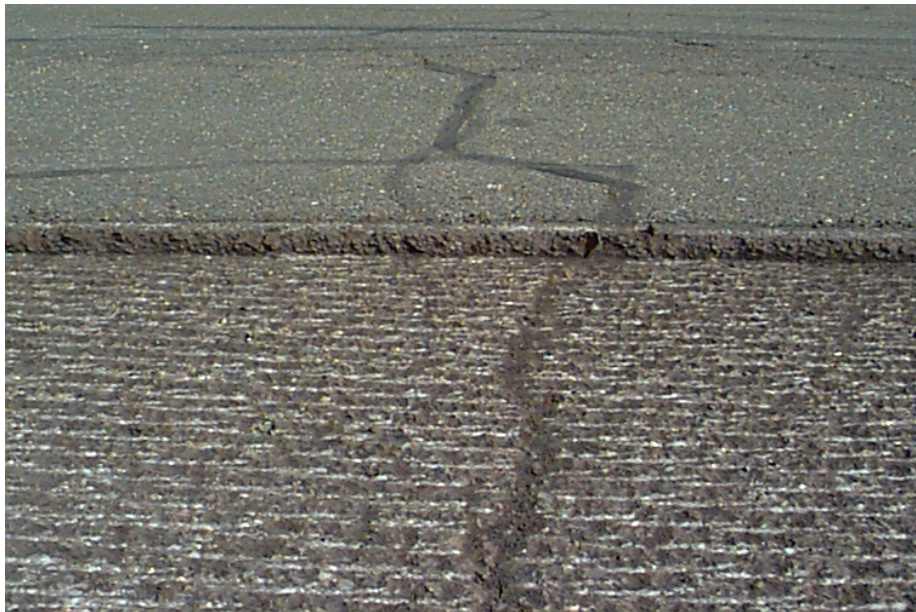
After the pavement was milled in 1997, it was difficult to see any cracks, since dust had filled in the cracks during the milling operation. One reflection crack can be seen, however, in Image #5 taken during the milling operation. There is also evidence from viewing 1986 ConnDOT photolog images of Route 2 that prior to the 1986 overlay, the old pavement (placed in 1970) contained considerable distress, primarily in the form of block cracking at a moderate level. This appeared to be fairly uniform throughout the project, but was more prevalent in the high-speed lane than in the low-speed lane (see Figure 12). Also, the final mile of section WB 6 contained much more severe transverse cracking, with some areas of patching (see Figure 13).

IMAGE #5     CRACKS EVIDENT THROUGH BOTH SURFACE AND MILLED PAVEMENT (MAY 1997)

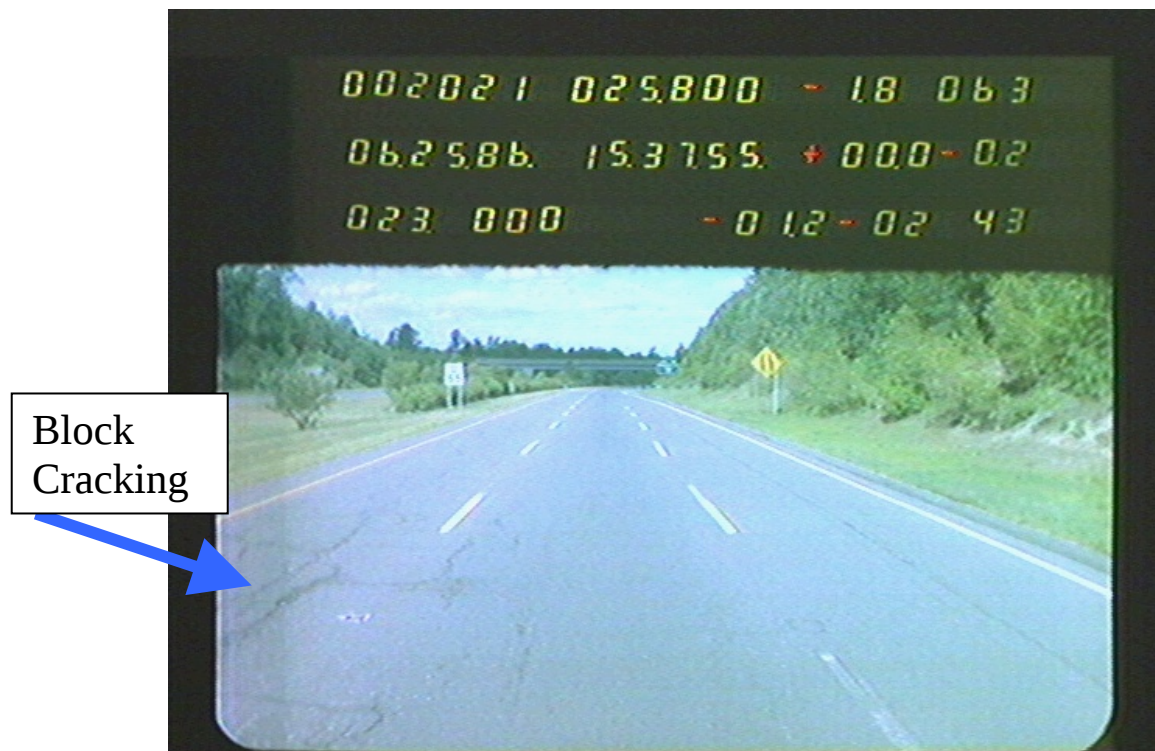
FIGURE 12. ROUTE 2, SECTION EB 1, JUNE 25, 1986 (TYPICAL BLOCK CRACKING PREVALENT THROUGHOUT MOST OF THE PROJECT)

On the assumption that the rest of the project (i.e., sections EB 1, EB 2, EB 3, WB 4, and WB 5) had fairly uniform block cracking in 1986, then the differences in observed surface cracking in 2003, as presented in Table 13 for these sections, might be attributed more to variations in the pavement mix. If this assumption is made, then overall, based upon transverse cracking alone, sections EB 1 and WB 5 and the first mile of WB 6 are performing the best. However, due to the unknown reliability of the assumption, very little confidence can be given to this conclusion.

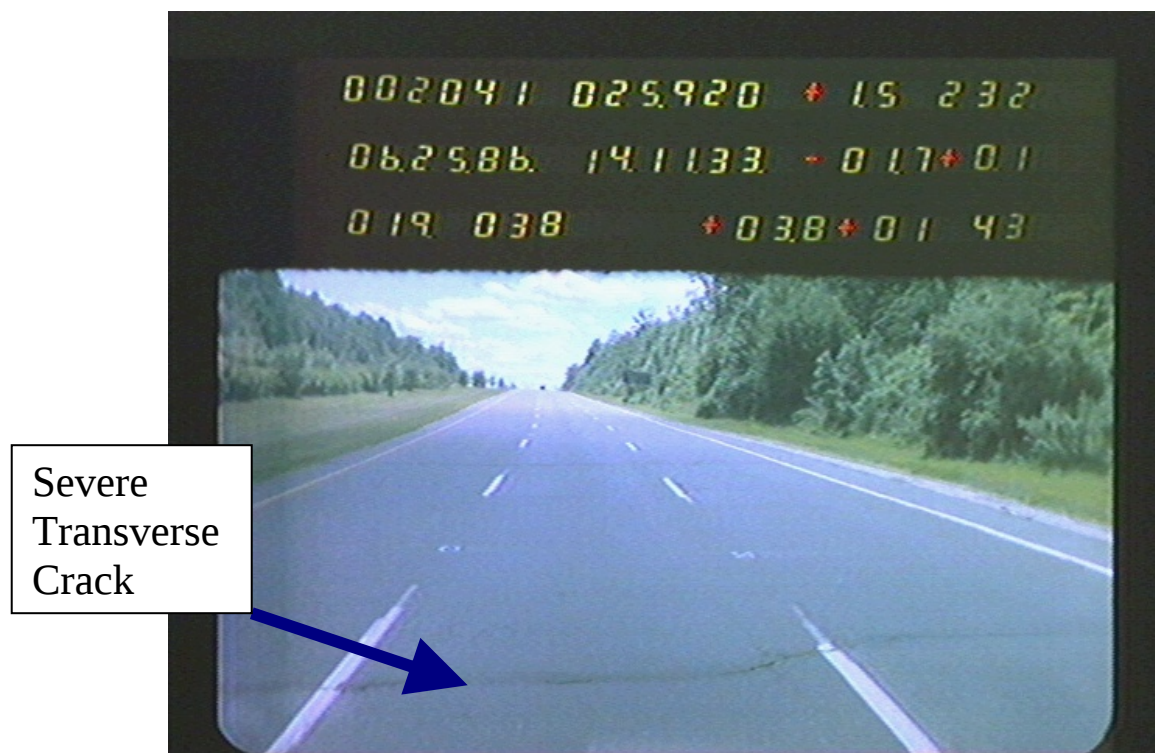
FIGURE 13. ROUTE 2, SECTION WB 6, JUNE 25, 1986. (SEVERE CRACKING THAT EXISTED ONLY AT THE END OF SECTION WB 6)

current surface cracking between the sections could be done, for example, using the data in Table 13 as previously discussed, to determine the difference in five-year performance of the various surface mixes. Transverse cracks are generally shrinkage-induced tension cracks that occur during cold weather. It is very difficult to prevent these cracks from re-occurring above a layer that already contains transverse cracks. However, block cracking in the size of less than 5 ft by 5 ft can be more easily contained, as total movement at the cracks is less during expansion and contraction. This could explain why the second mile of section WB 6, which contained the severe transverse cracks in 1986, contains more cracking (presumably reflection) than the rest of the project.

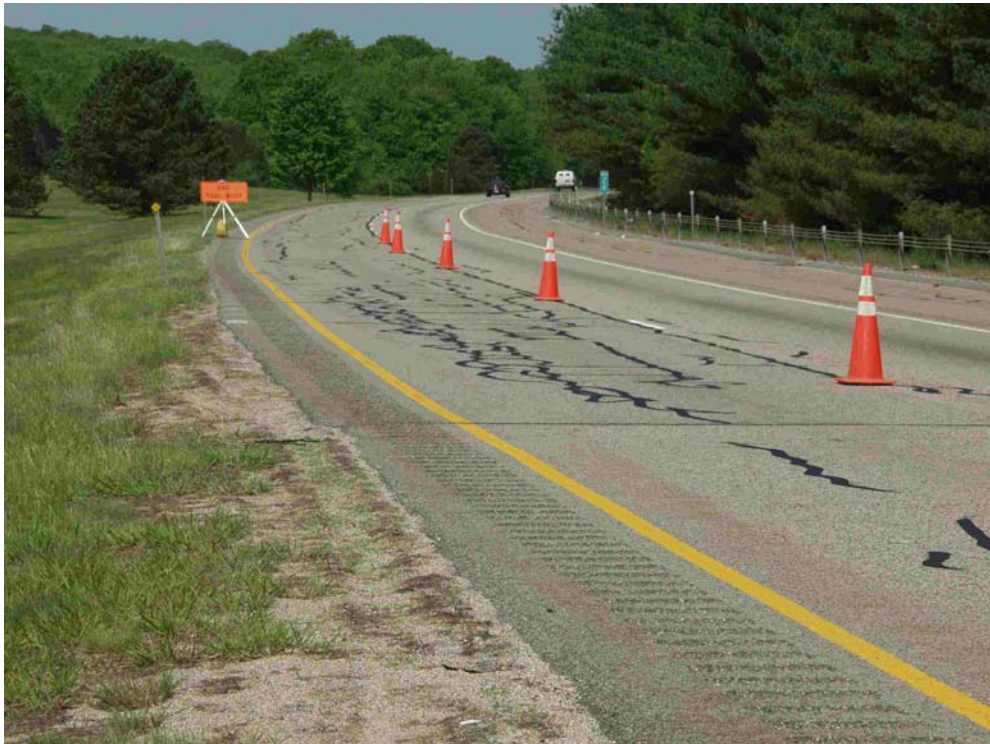
At the end of five years and seven months, three short sections, (each 100 to 500 ft long) in the westbound direction, high-speed lane, contained considerably more cracking than the overall average for the sections. Each of the deteriorated areas begins at a transverse paving joint representing the start of a new day's pavement placement. An example of a deteriorated portion of the high-speed lane of Section WB 5 can be seen in Image #6. Sealed cracks are visible, with almost no cracking apparent in the adjacent low-speed lane, or in the foreground of the high-speed lane. The adjacent low-speed lane was paved the same day as the distressed high-speed lane, approximately six hours later. A closeup view showing raveling and lack of fine aggregate at the surface can be seen in Image #7.

IMAGE #6 - SURFACE CONDITION IN SECTION WB 5, WESTBOUND MILEPOINT 29,  
(JUNE 2003)

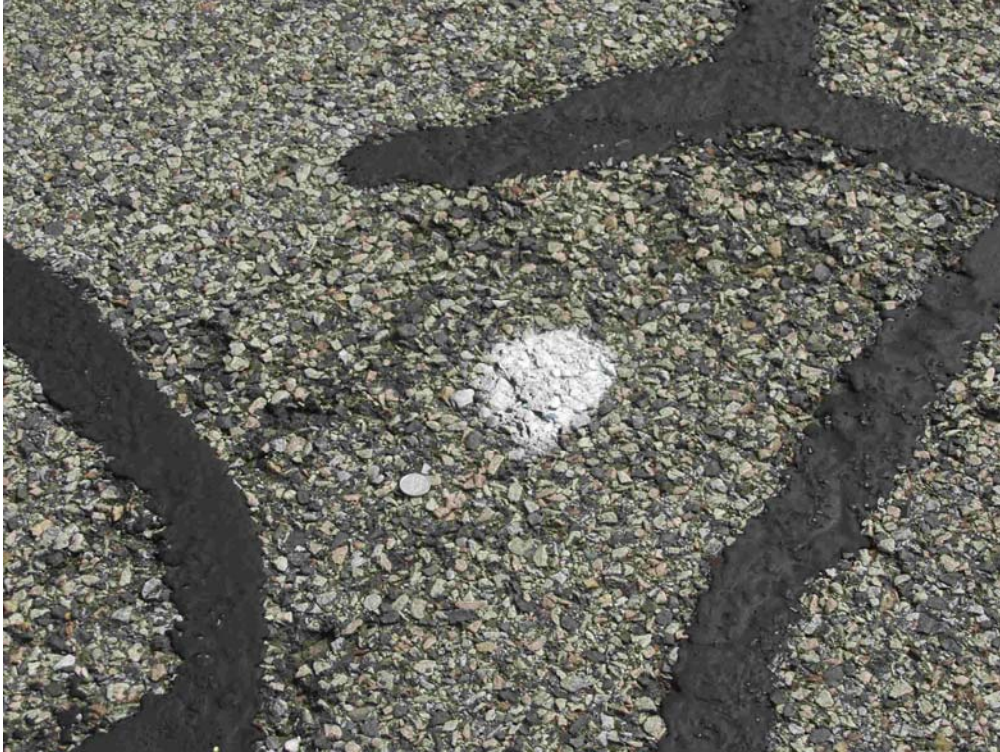
IMAGE #7 - SECTION WB 5, CLOSE-UP OF DETERIORATED SECTION WITH CRACKING AND RAVELING
