# Fixing the Bump at the End of the Bridge

**August 30, 2021**

**NCHRP 20-68A**  
**US Domestic Scan Program**  
**Domestic Scan 19-01**

**“Leading Practices for Detailing Bridge Ends  
and Approach Pavements To Limit Distress  
and Deterioration”**

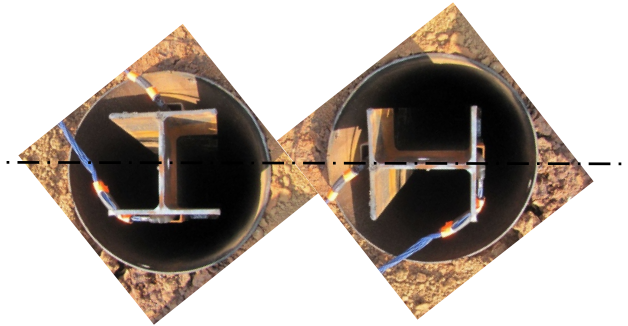
Transverse  
Bridge Axis

Strong  
Axis

Weak  
Axis

Abutment Beam

Exposed Pile

Settled or Eroded  
Fill

Accelerated Corrosion at interface

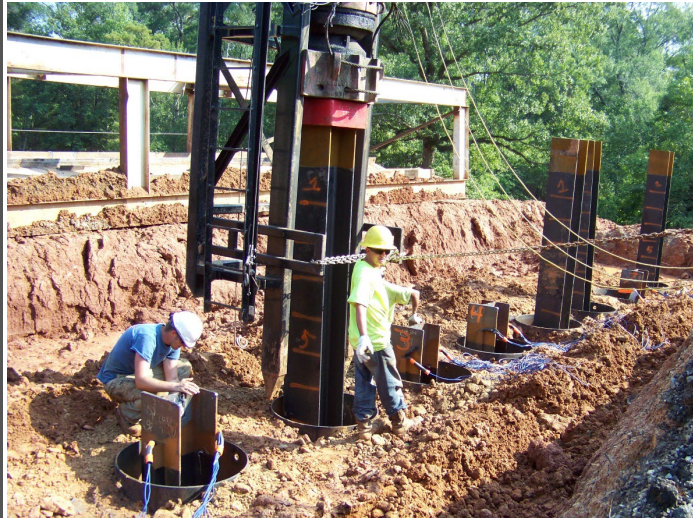
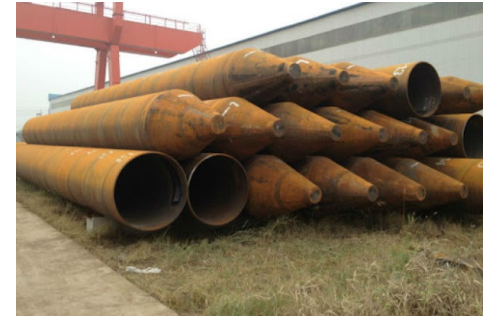
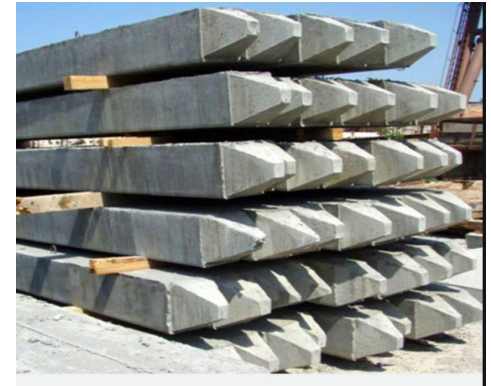
Steel Pipe Piles  
Prestressed Concrete Piles  
Strong Axis Only

Embedment depth

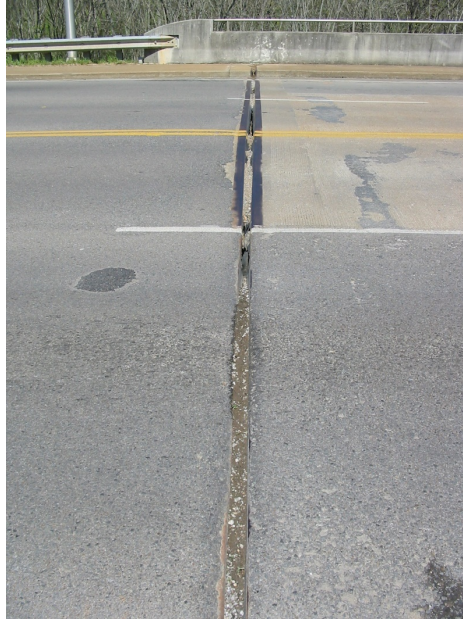
Joints paved over to mitigate the bump which is detrimental to joint operation.

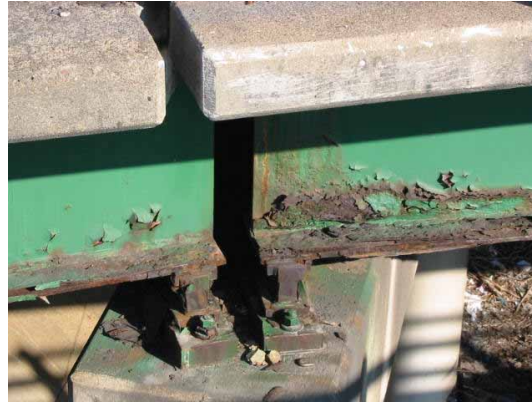
Joint leakage can lead to deterioration on both steel and concrete beam ends.

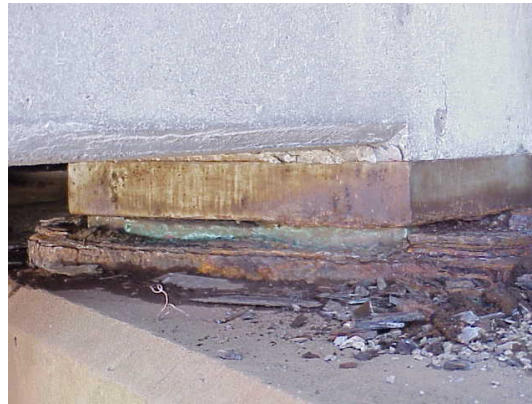
Joint leakage can cause joints to freeze and deteriorate limiting the useful life and overall operation.

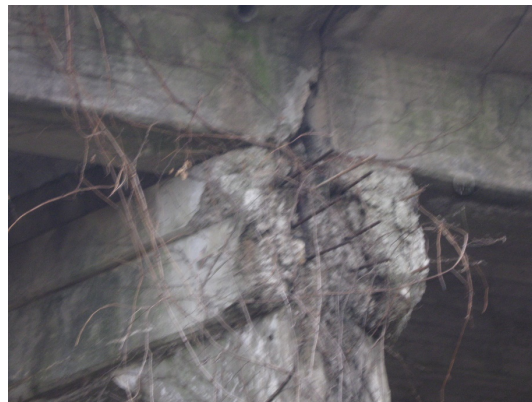
Deterioration can extend into the substructures resulting in loss of bearing area and overall concrete deterioration.

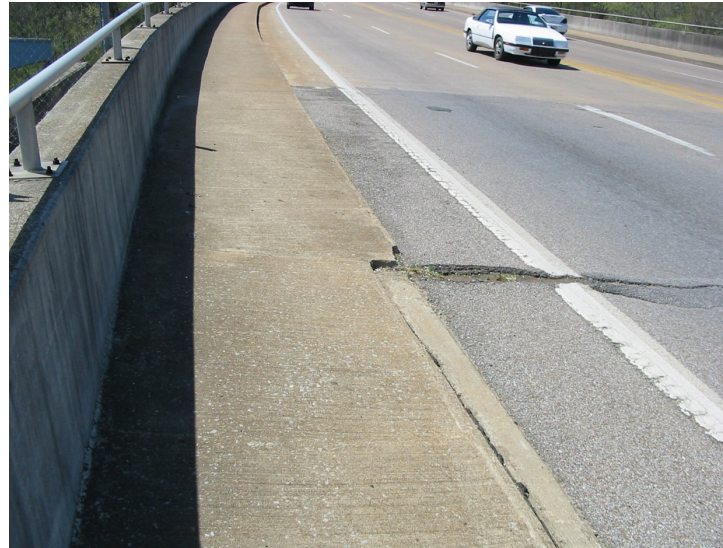
Slab settles causing bump and also allowing water to seep into the approach embankment and also lead to damage at the abutments.

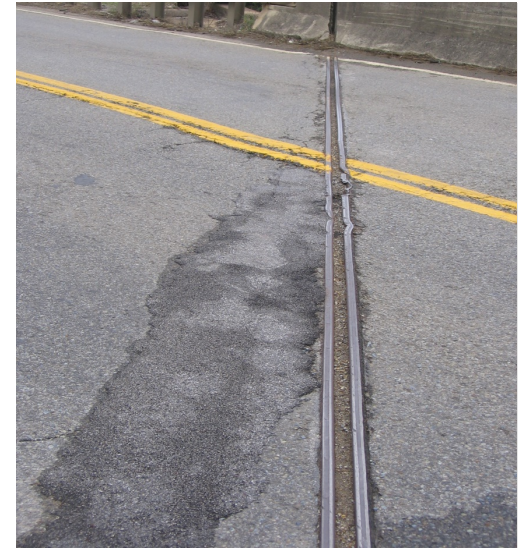
Settled slab will rotate at the abutment leading to rideability issues and, possible joint damage.

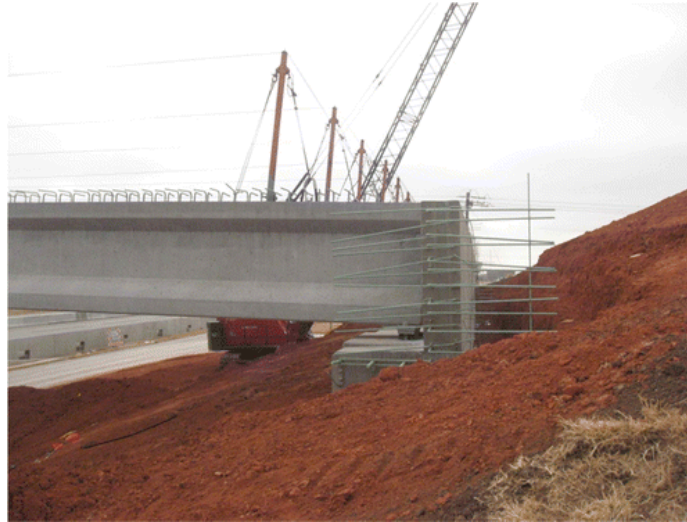
Poor draining soil and poorly compacted fill behind abutments compound settlement issues.

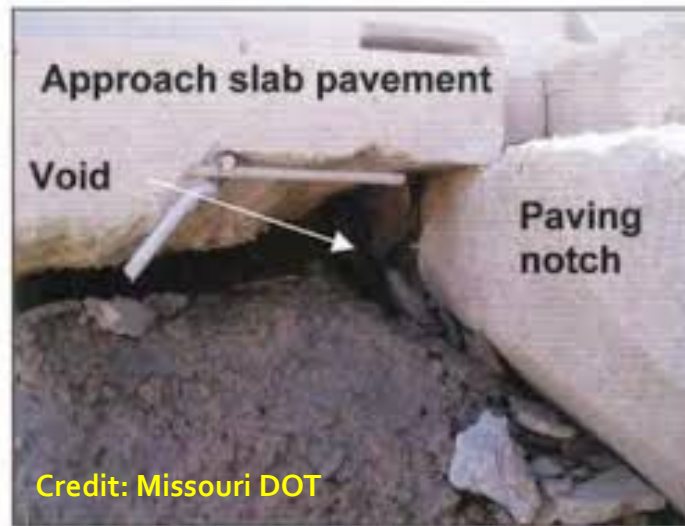
Settlement under the slab promotes drainage issues and can result in slab dropping from support.

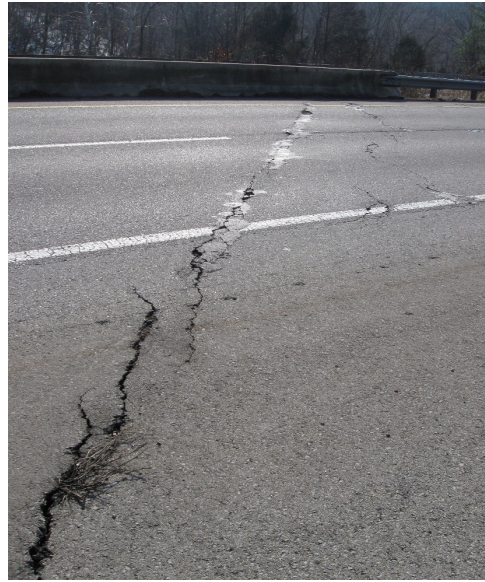
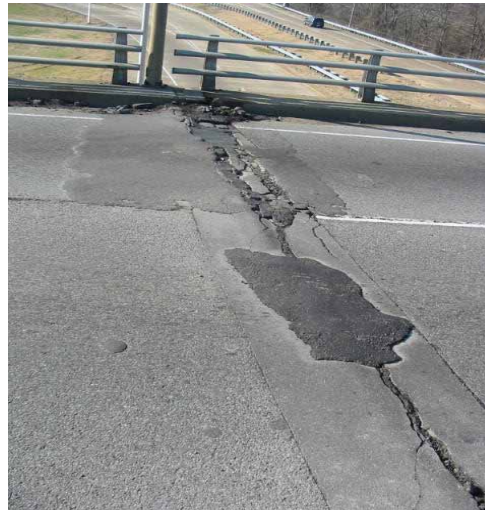
Some states mentioned that open deck drains are not permitted on many structures.

Water flowing along the bridge rail or curb will find cracks along the bridge surface and seep in to cause damage.

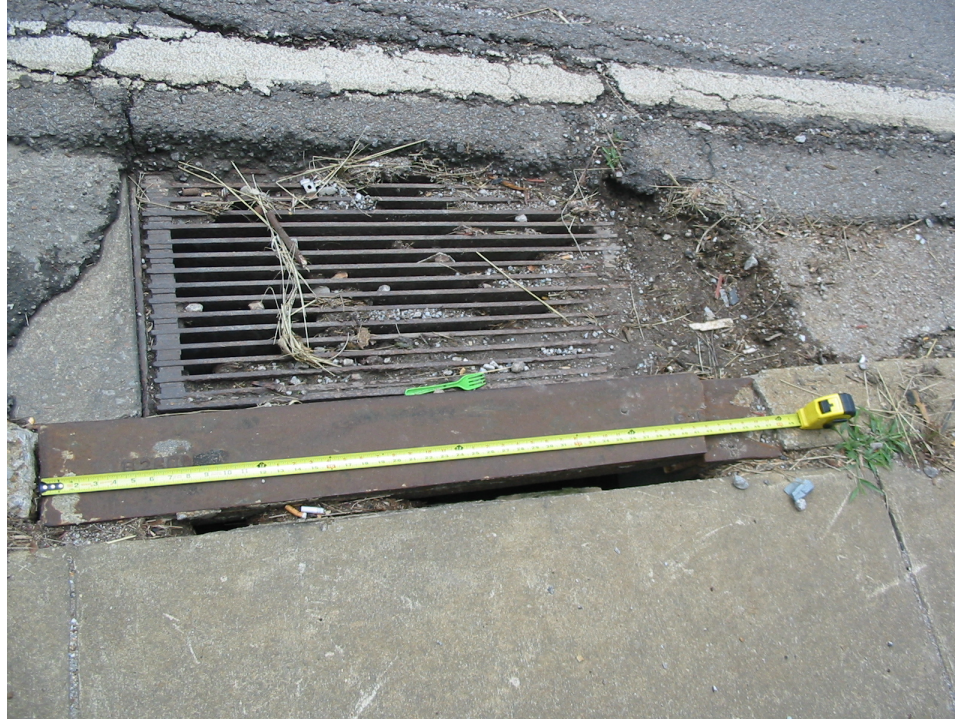
Clogged drains in the approach slab will allow water to find other paths that naturally cause damage to the bridge structure of approach roadway fills.

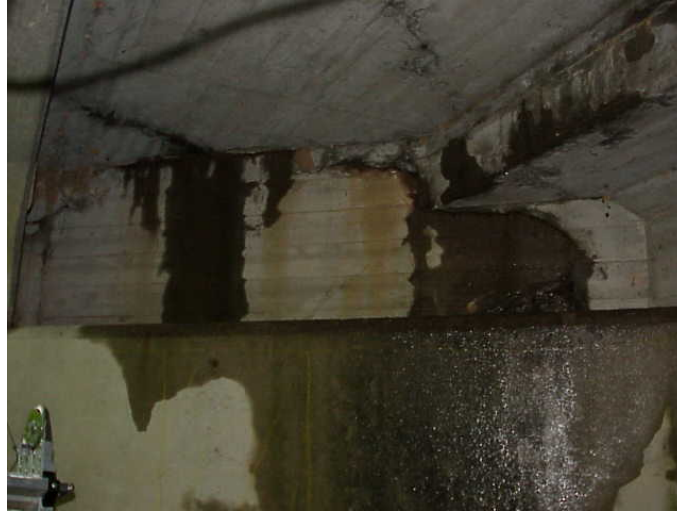
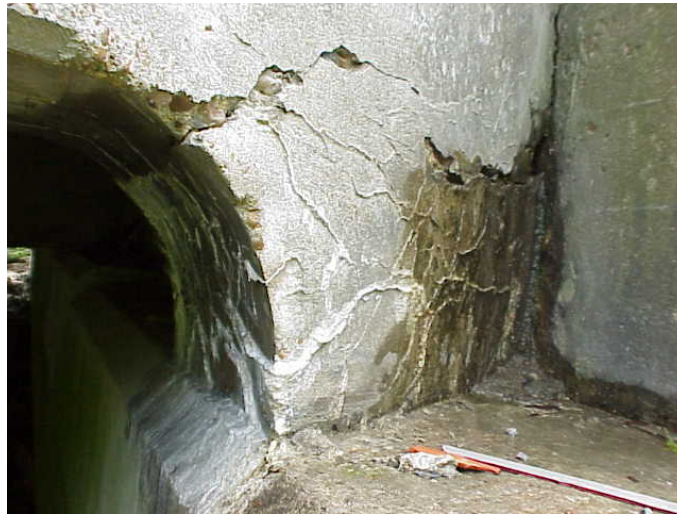
Water seeping from the bridge surface will cause deterioration or other structural damage.

Corrosion of structural steel, prestressing strands or rebar will shorten the service life of various components and increase the overall maintenance costs of bridge assets.

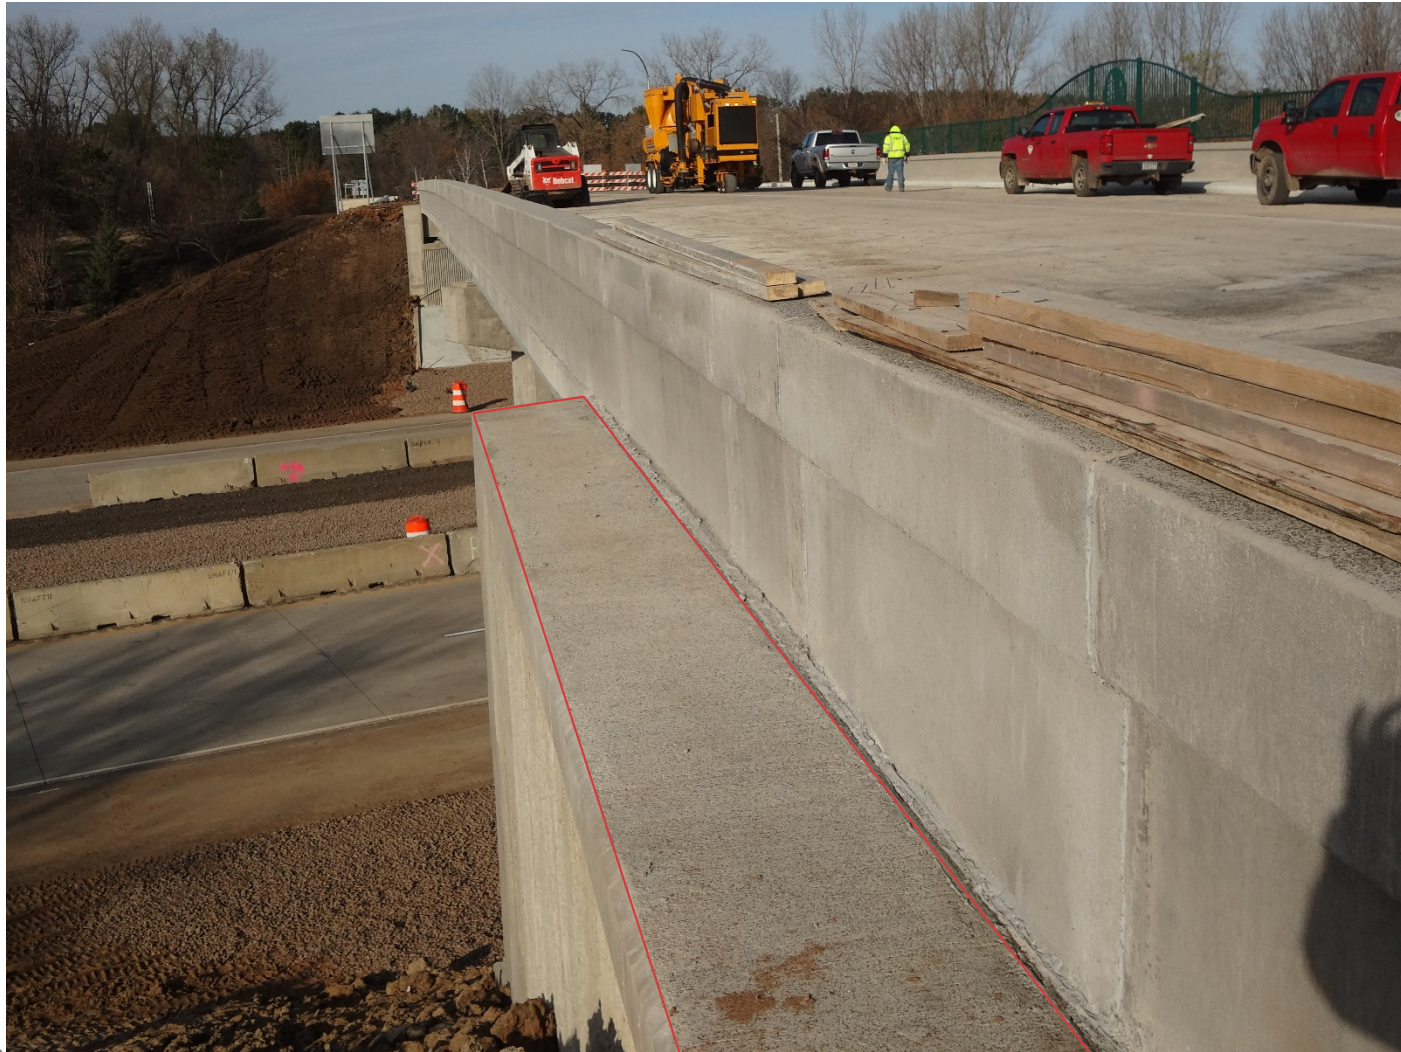
Barrier cast on top  
of approach panel

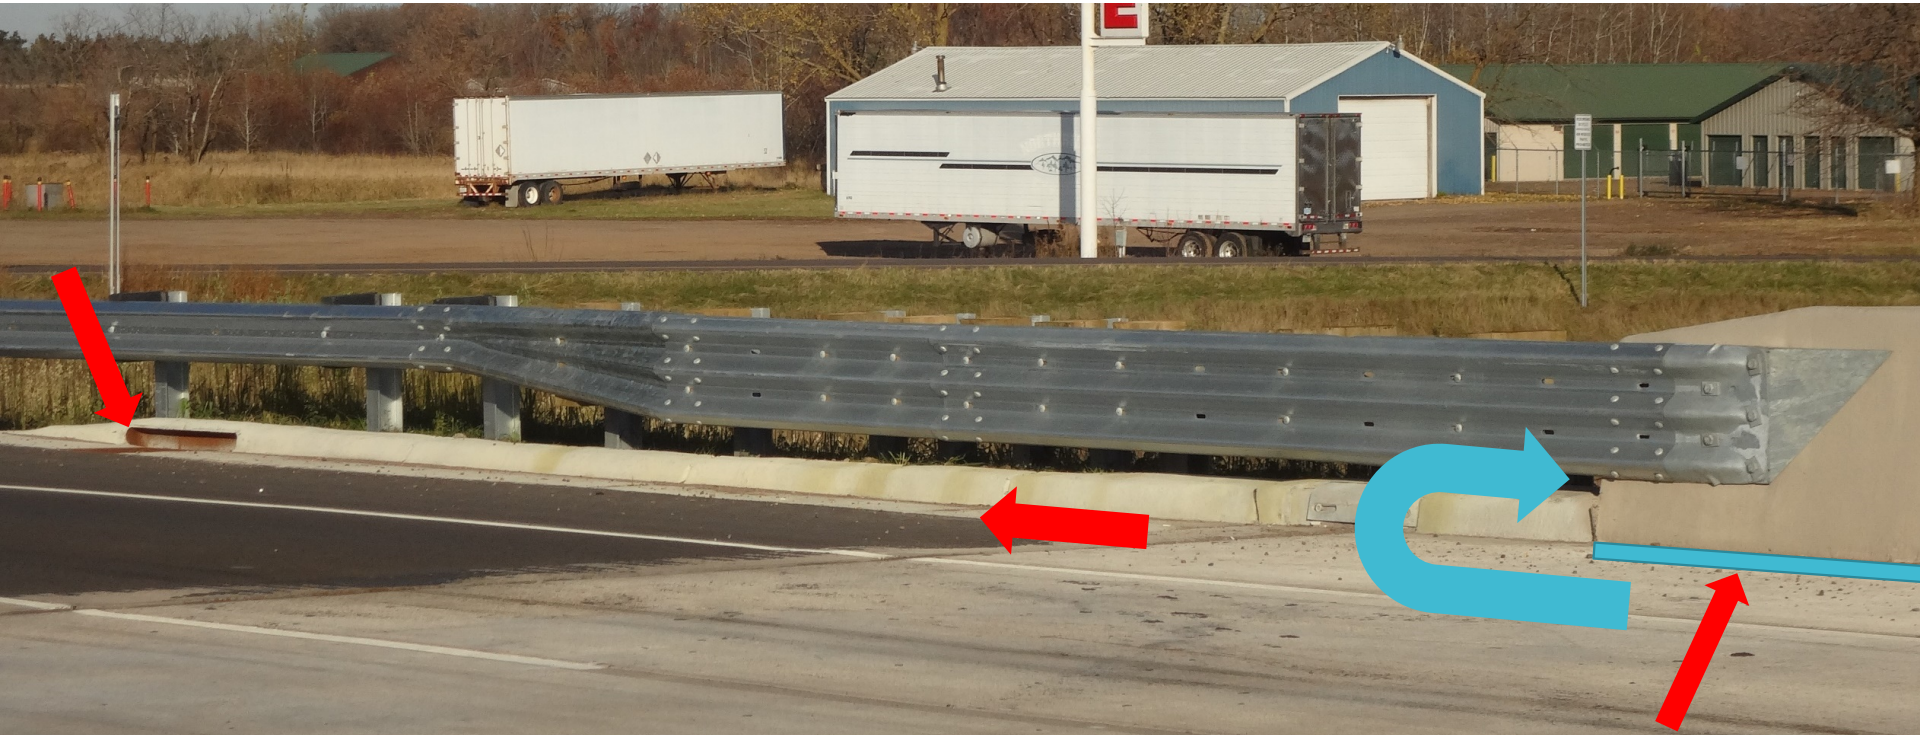
Eliminates saturation of the backfill – reduces potential for settlement and voids.

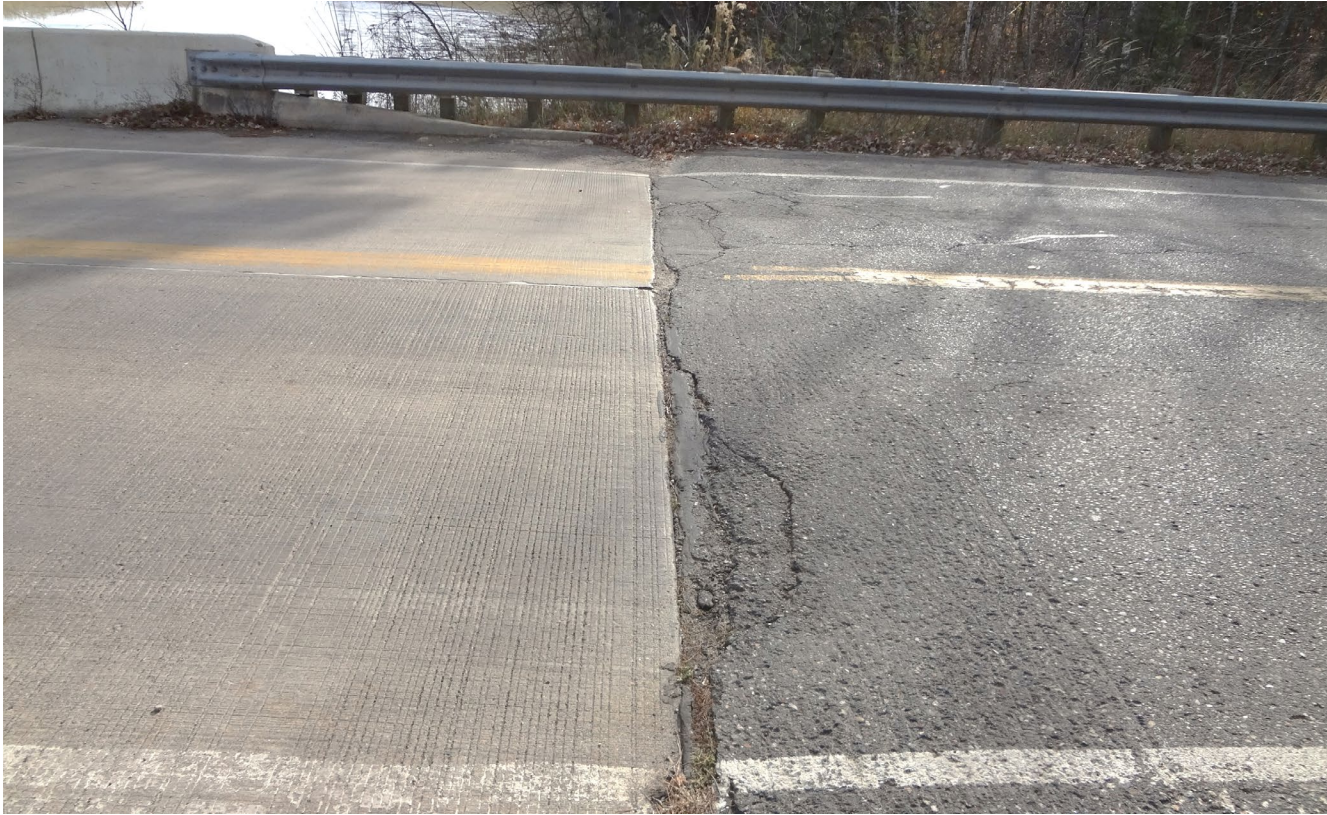
275' Long Bridge , 500 ADT, 20 Years Old

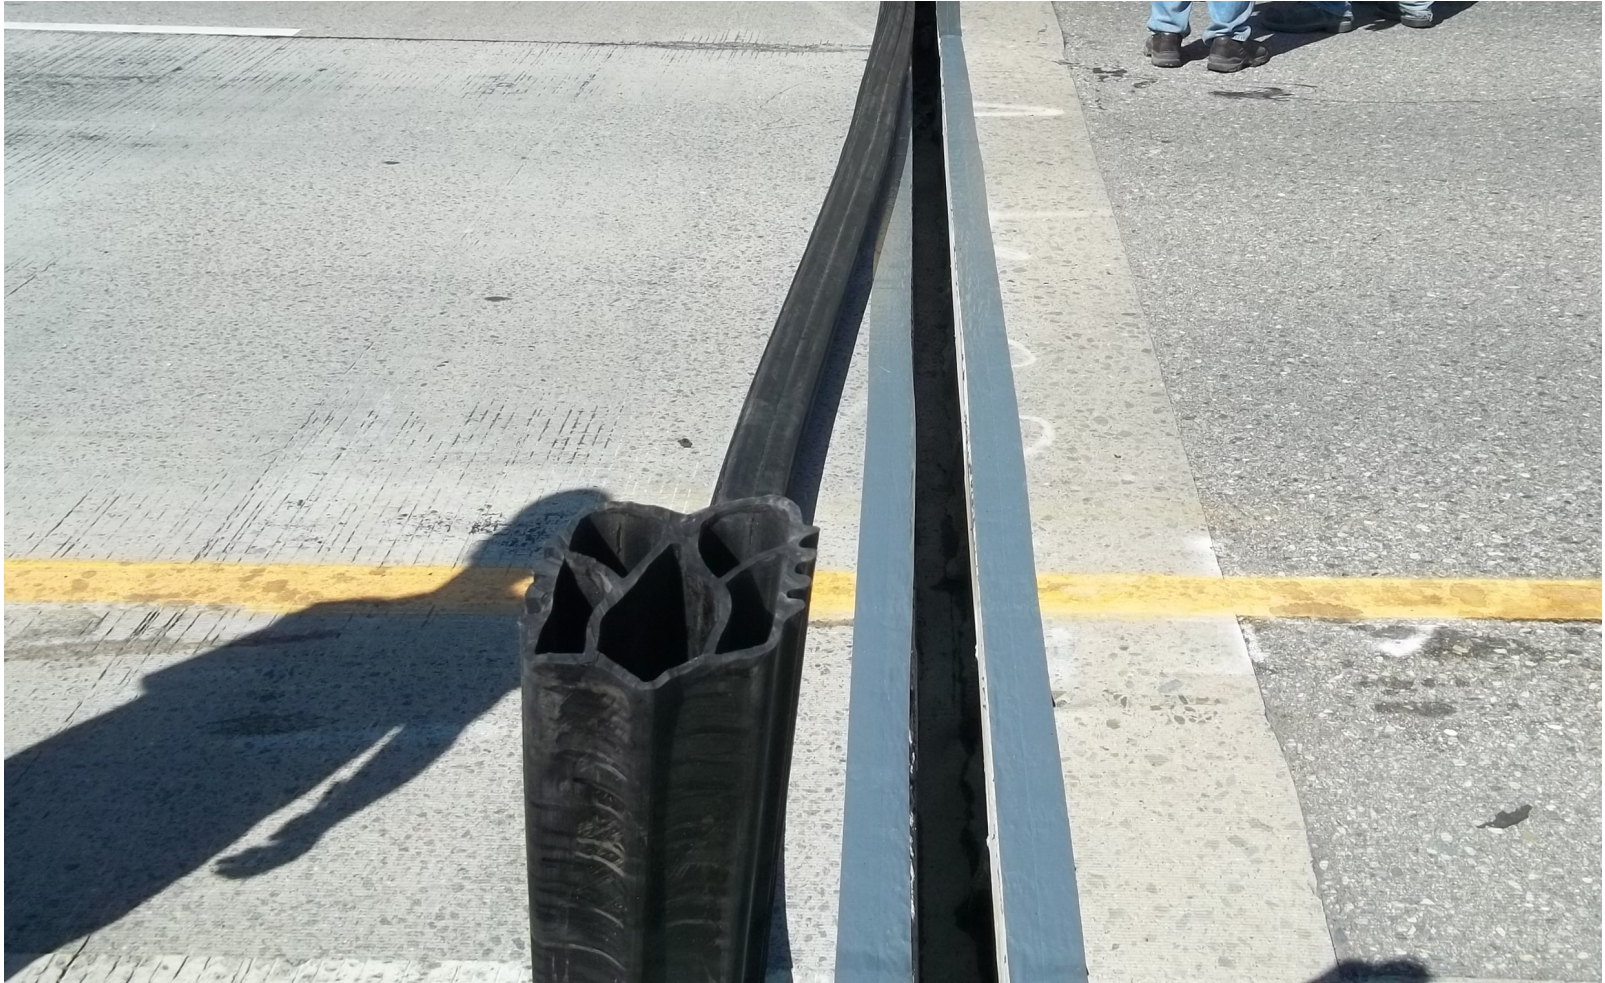
Rubber Gland

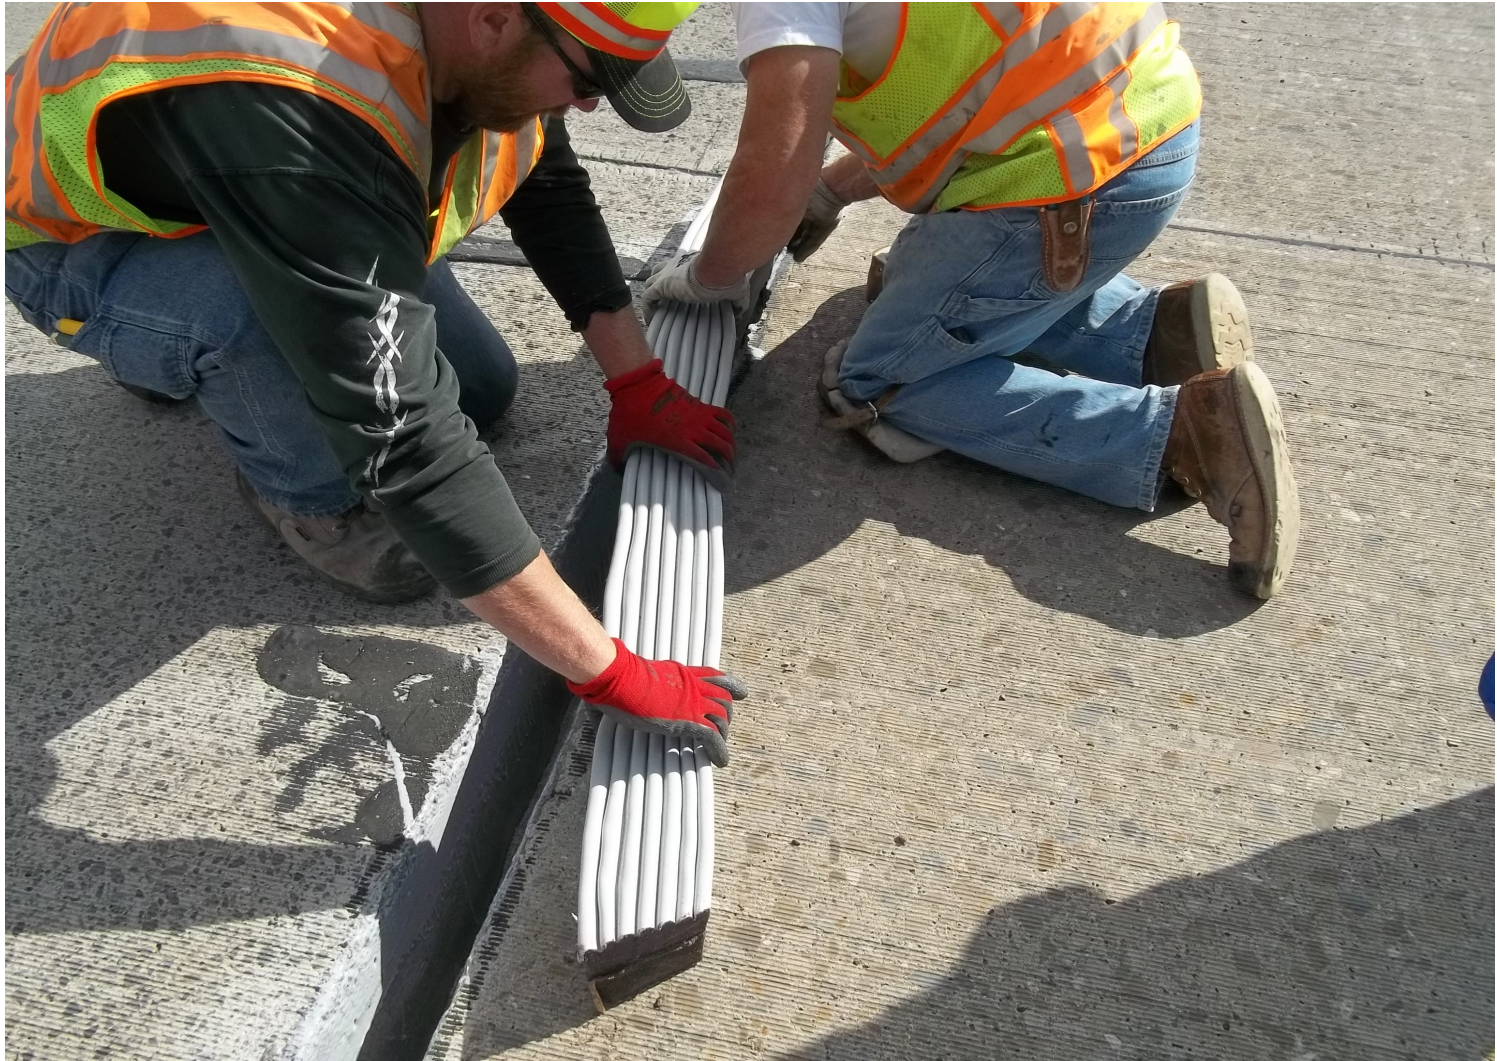
Closed Cell Foam
