NATIONAL COOPERATIVE
HIGHWAY RESEARCH PROGRAM REPORT **302**

FATIGUE AND FRACTURE EVALUATION FOR RATING RIVETED BRIDGES

J. W. FISHER, B. T. YEN, D. WANG
Fritz Engineering Laboratory
Lehigh University
Bethlehem, Pennsylvania

TRANSPORTATION RESEARCH BOARD
NATIONAL RESEARCH COUNCIL
WASHINGTON, D.C.   DECEMBER 1987

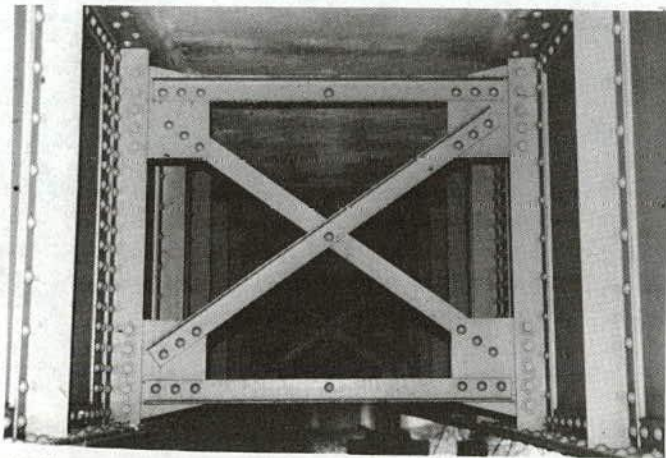
Figures 45a and 45b show examples of end connection angle cracking as a result of end rotation of the longitudinal members. Eventually, complete failure of the end connection is possible as illustrated in Figure 45b. Girder end connections (whether

Figure 45a. Crack in stringer connection angle.

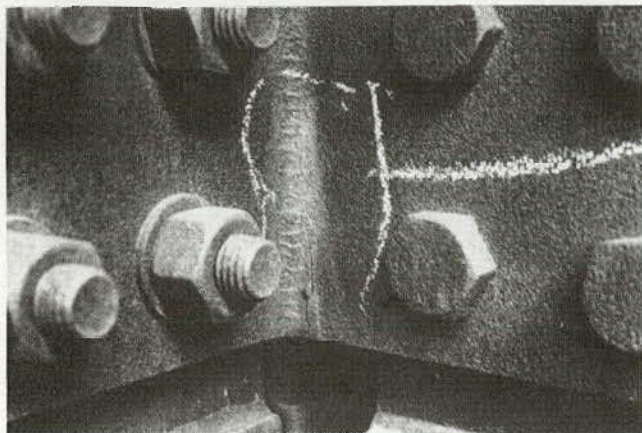
Figure 45b. Failure of stringer connection angle.

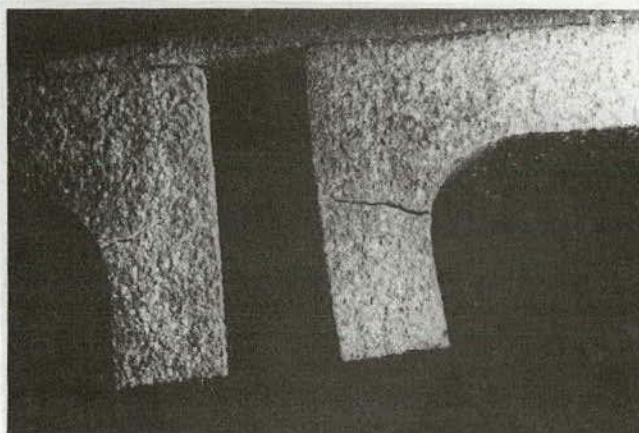
Figure 47. Crack viewed from bottom of connection—note preload deformation.

riveted or bolted), as illustrated in Figure 46, can also result in cracking of the angle on the "compression side." In the bolted connection shown in Figure 46, construction tolerances resulted in the angles being preloaded so that the portion on the compression side of the girder was also susceptible to cyclic tensile stress. Section 3.5 reviews the available test data on connection angles. Figure 47 shows a view of the ends of the angles, and the deformed outstanding legs resulting from construction preloading can be seen. Apparently, the tolerance of the holes in the cross-girder resulted in the deformed shape and caused the angle to become more susceptible to cyclic end rotation of the longitudinal girder.

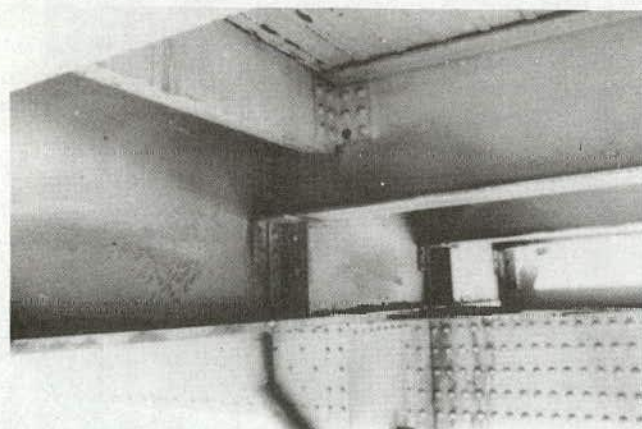
Figure 48. Cracked riveted head in outstanding leg of diaphragm end connection.

Depending on the angle thickness and the gage length of the rivet or bolt lines, the distortion can also result in the cracking of the rivet head or bolt. Figures 48 and 49 show the head of a rivet and several cracked bolts at two diaphragm end connections. In both instances out-of-plane movement of the outstanding angle leg has caused the fasteners to crack because of the axial stress and bending in the fastener.

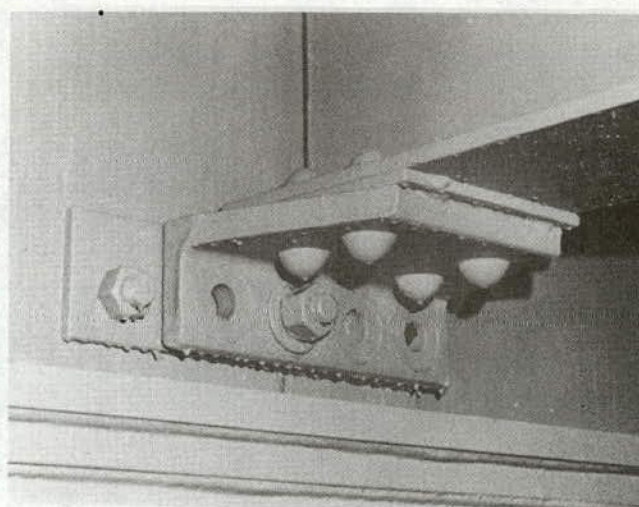
Figure 49. Cracked bolts with cracks forming in the threads under the nut.

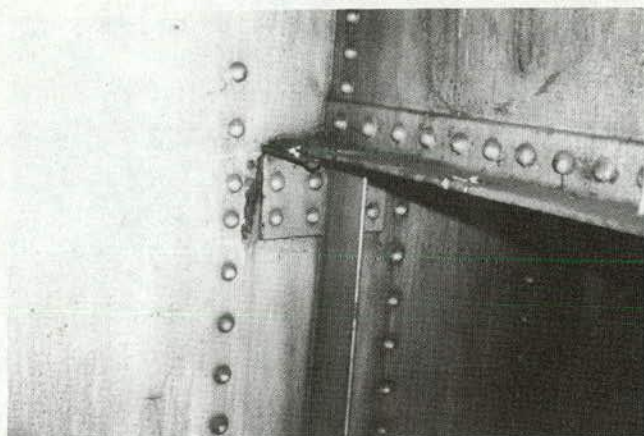
Figure 56. Stringer end seat with crack in floor-beam web.

Small gaps at end connections can also result in web cracking, as shown in Figures 56 to 58. A stringer framing into a floor-beam has its beam seat opposite transverse stiffeners on the backside of the floor-beam, as shown in Figure 58. This creates a small web gap susceptible to the stringer end rotation between the beam seat and the transverse stiffener angles. As a result, the vertical cracking seen in Figures 56 and 57 developed.

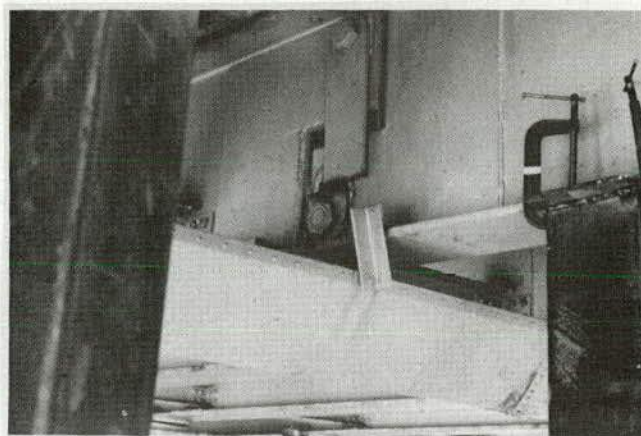
Figure 59. Cracked hanger plate under roadway relief joint.

Examples of the types of cracking that have been observed in the hangers of several types of bridges are shown in Figures 59 to 63. In Figure 59, a cracked hanger plate can be seen with the crack developing in the gross section of the plate. Strain measurements on a number of these types of members have indicated that the corrosion packout (expansion of the corroded material) glues the components together to provide a rigid connection. As a result, the hanger experiences in-plane bending, and the maximum cyclic stress develops at the plate edge and initiates a fatigue crack.

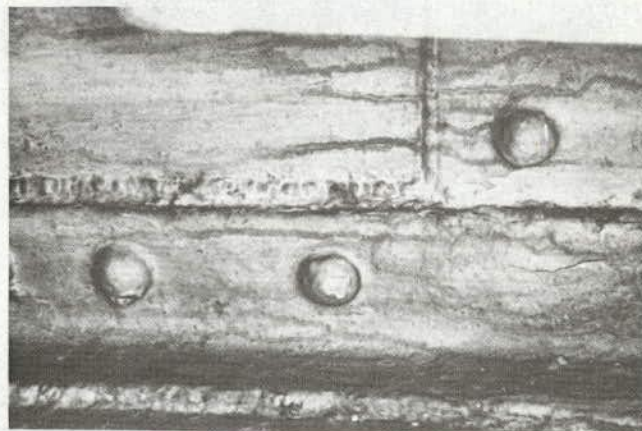
Figure 65. Close-up view showing longitudinal weld to flange angle and transverse weld to stiffener angle.

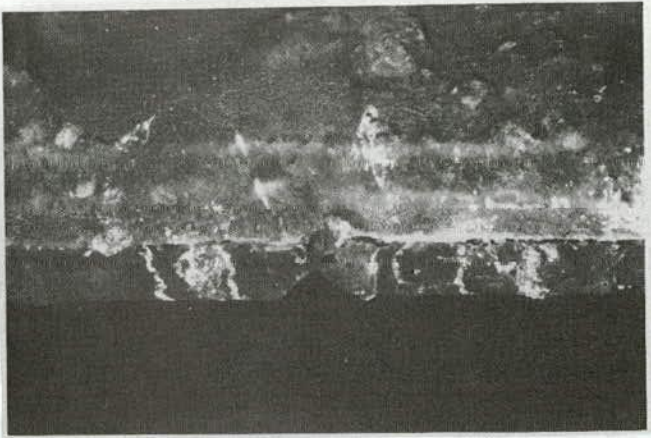
Figure 67. Lack of fusion in coverplate reinforcing added to flange angles.

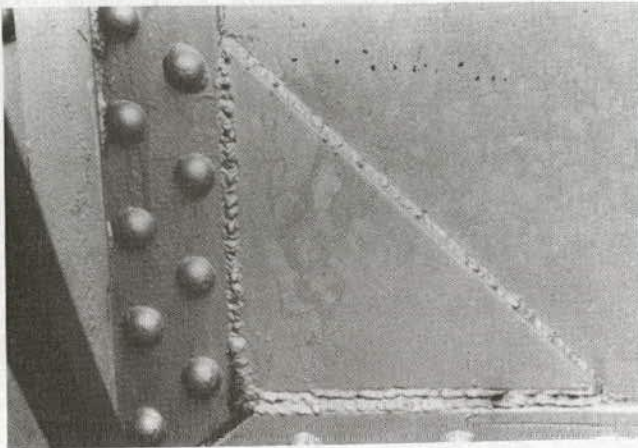
Figure 69. Welded reinforcement at cracked web gap between flange and connection angles.

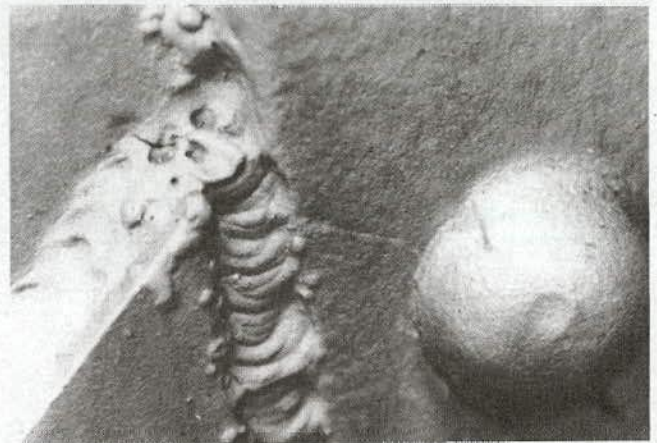
Figure 70. Crack forming in connection angle at weld termination.

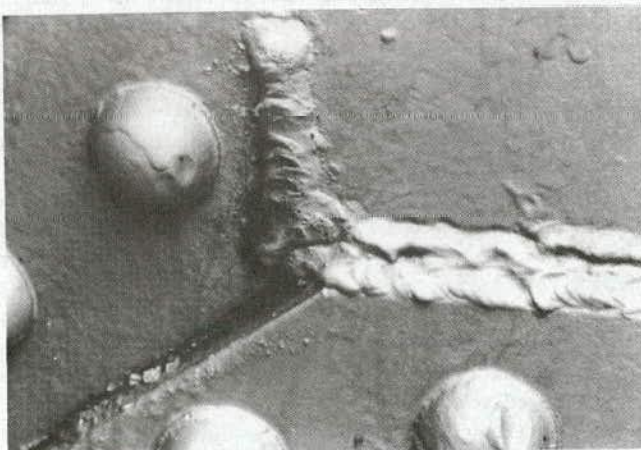
Figure 71. Crack forming in weld at gap.

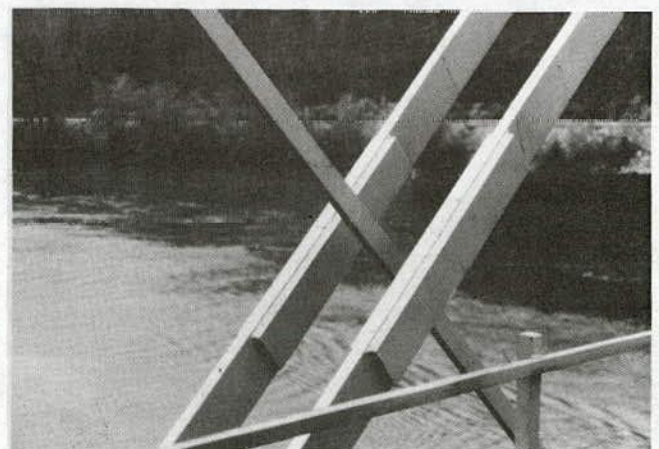
On occasion, splice plates have been welded to truss members in order to reinforce the structural member or to aid in tightening loose members. Figure 72 shows splice plates welded to the surfaces of eyebar diagonals. These were used to splice the eyebar after it was cut and tightened. Fatigue cracks can be seen to develop at the ends of the splice plates as shown in Figure 73.

Figure 72. Welded splice plates added to truss eyebars.

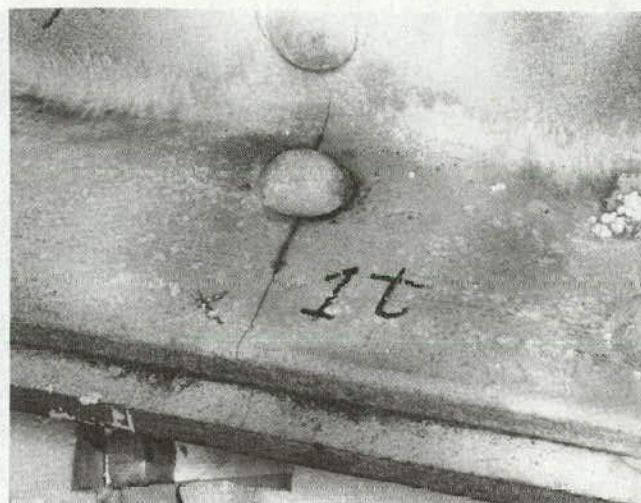
For all of the test girders without significant corrosion loss of section, cracks formed at the net section in a rivet hole. Figure 84 shows typical fatigue cracks extending beyond the rivet head. As these cracks continued to propagate, as shown in Figure 85, a powder generally formed under the rivet head at the hole and was extruded because of fretting. This was a general indication of the increased movement of the connected

Figure 85. Powder formed under rivet head and extruded because of fretting (girder 2).

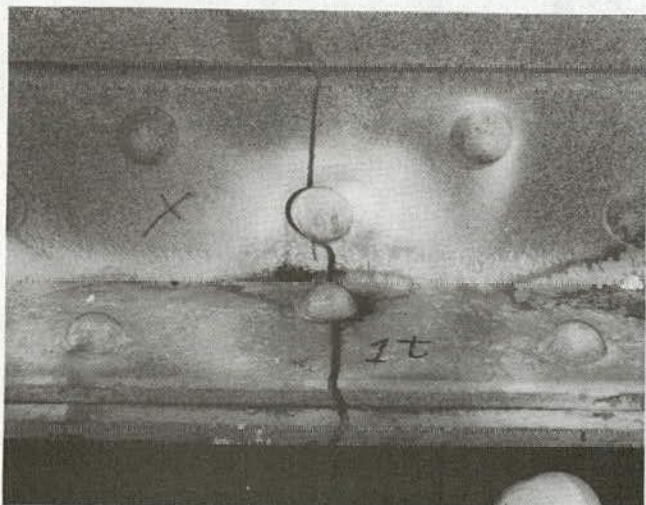
Figure 86. Cracked tension flange components: angle and coverplate (girder 2, south side).

parts caused by cracking. For the continuous web-flange and continuous flange coverplate connection shown in Figures 84 and 85, eventually one or more of the components cracked in two, as shown in Figure 86 for girder 2. Those components that did not fracture exhibited significant plasticity and in some cases substantial crack opening displacement as shown in Figure 87.

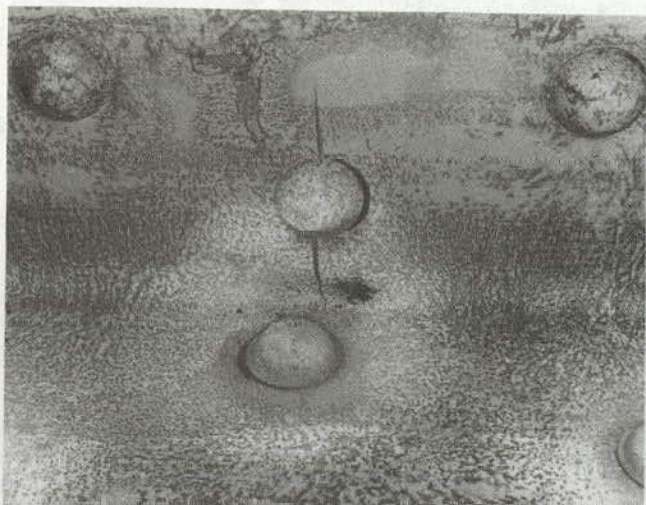
Figure 87. Plasticity and crack opening at component not fractured (girder 2, north angle).

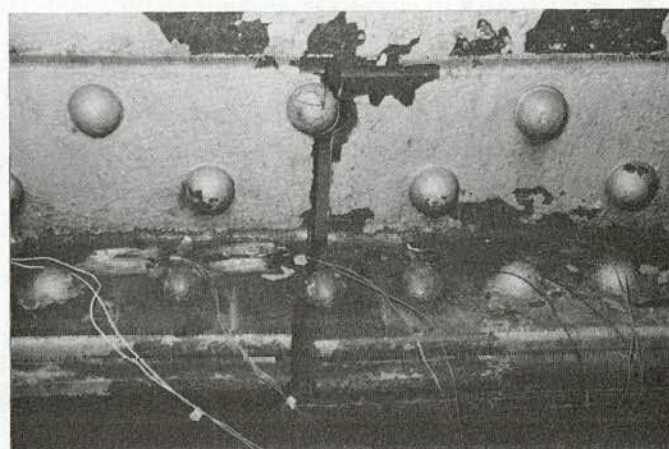
When cracks formed at the ends of coverplates, they often formed at the net section of the last row of rivets connecting the terminating plate to the angles and continuous plate. Figure 88 shows the final cracks that developed in girder 14. Both flange angles and the continuous coverplate were fractured during the final reduced temperature test.

Figure 88a. Final cracks at coverplate termination (girder 14, north side).

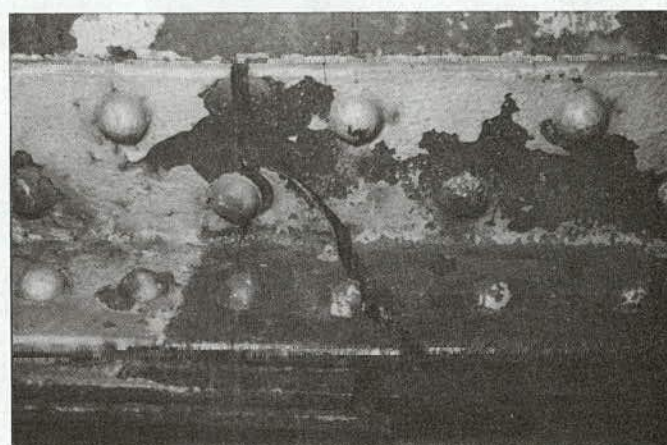
Figure 88b. Final cracks at coverplate termination (girder 14, south side).

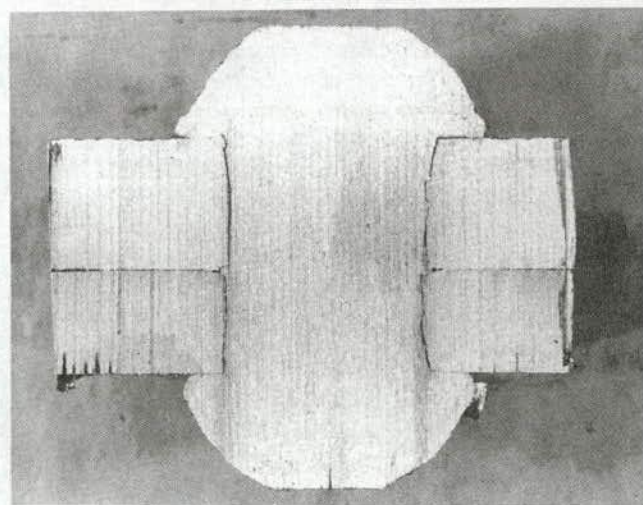
The other condition that caused cracking was corrosion notching, as shown in Figure 89. As can be seen from the figure, extensive corrosion loss of the flange angle outstanding leg resulted in the fatigue crack forming at the gross section. Similar behavior was reported in Ref. 30 on other corrosion notched members.

Figure 89. Extensive corrosion loss of tension flange outstanding leg (girder 11, north side).

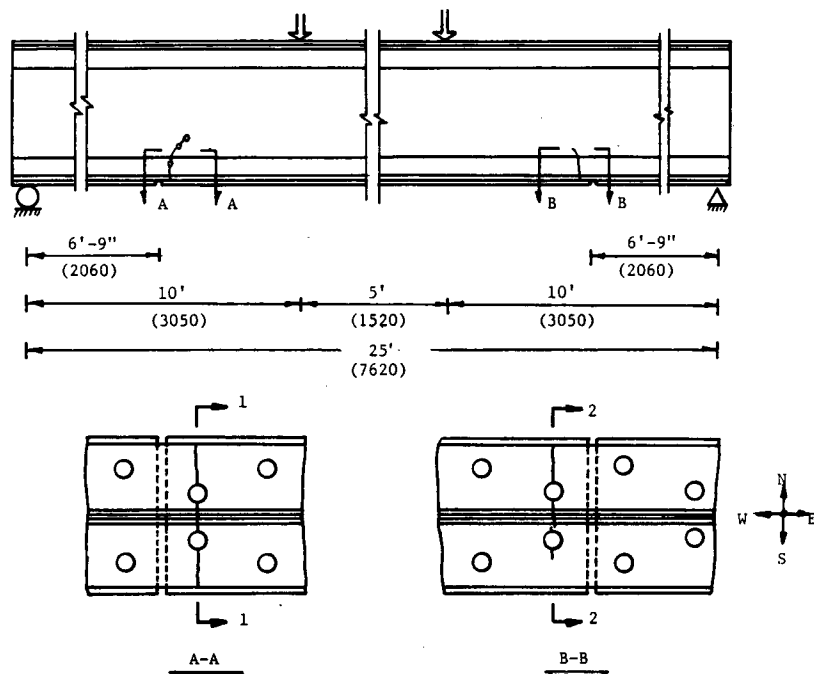
Girder No. 1: S_r=15 ksi (103 MPa), S_{min}=2 ksi (14 MPa)

Fatigue crack initiation: at coverplate termination, through rivet holes.

Load redistribution: As one of the component cracked, the other took over the load, and the girder moved sideways. Bottom flange lateral bracing prevented lateral movement and increased fatigue life.

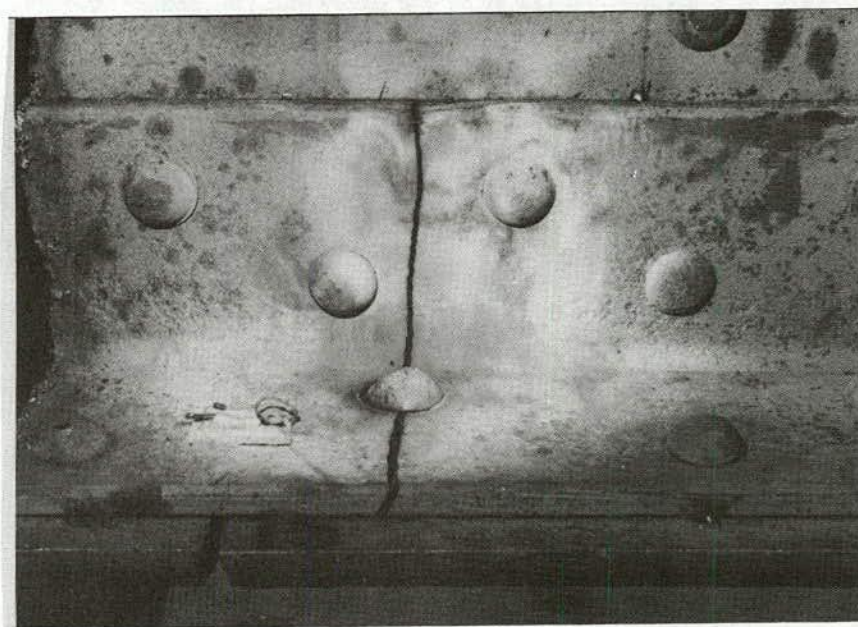
Figure B2. Girder 1 at 916,000 cycles (section 2-2, north side).

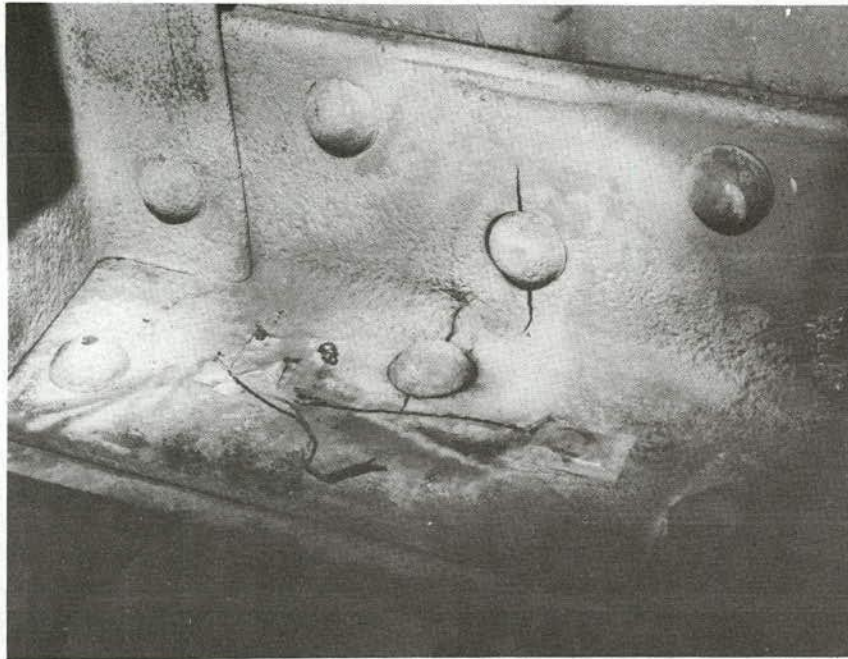
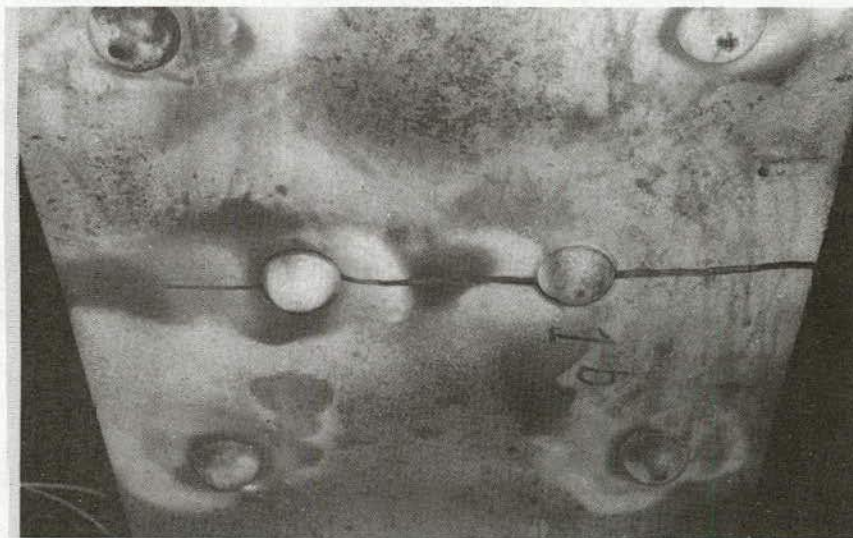
Figure B3. Girder 1 at 916,000 cycles (section 2-2, south side).

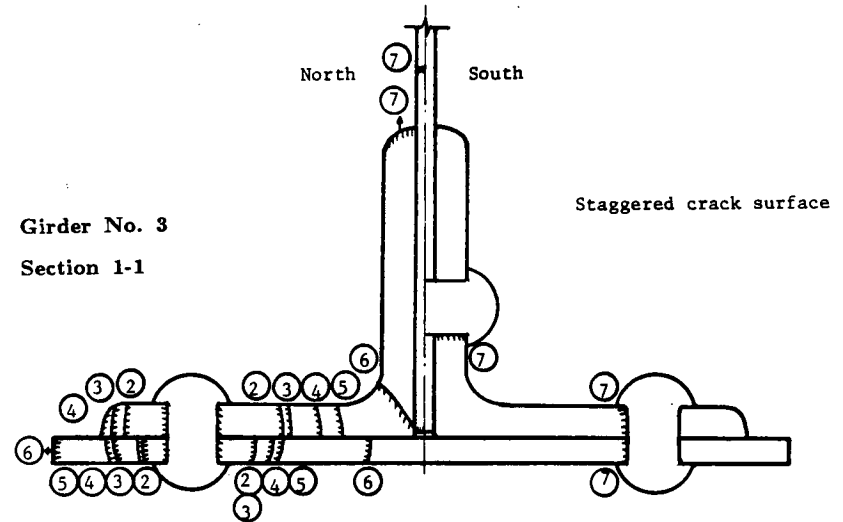
Figure B6. Girder 3 at 1,623,000 cycles (section 1-1, north side).

Stage	Cycles x10⁶	A_c/A_n %	Temp. °F (°C)	P_{max} kip (KN)	$S_{max,net}$ ksi (MPa)	Note
1	1.410	–	Rm.T.	105 (467)	14.0 (97)	Strain gage reading change indicated crack initiation.
2	1.435	9	Rm.T.	105 (467)	15.4 (107)	Cracks were detected at two net-sections in constant moment region.
3	1.509	12	-40 (-40)	105 (467)	15.8 (109)	Reduced temperature test did not cause fracture. A third crack was detected.
4	1.548	15	Rm.T.	105 (467)	16.6 (114)	Stable crack growth
5	1.575	17	-70 (-57)	105 (467)	16.9 (116)	Reduced temperature test did not cause fracture.
6	1.599	30	Rm.T.	105 (467)	20.1 (138)	Stable crack growth
7	1.623	82	-70 (-57)	105 (467)	>F_u	Reduced temperature test caused fracture.
8	1.623	82	Rm.T.	110 (489,static)	>F_u	No overall failure was observed.

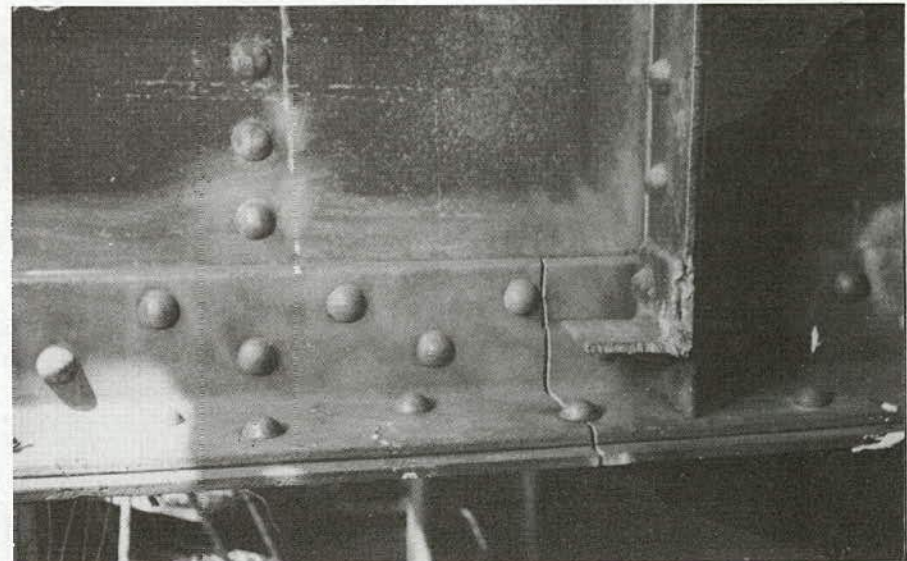
Figure B9. Girder 5 at 2,728,000 cycles (section 3-3, south side).

1	2.344	4(1-1) 3(2-2)	Rm.T.	100 (445)	20.8 (144)	Crack initiation in constant moment region
2	2.370	6(1-1) 6(2-2) 5(3-3)	Rm.T.	100 (445)	21.1 (145)	Stable crack growth
3	2.727	9(1-1) 6(2-2) 9(3-3)	Rm.T.	100 (445)	21.9 (151)	Stable crack growth
4	2.727	12(1-1) 6(2-2) 26(3-3)	Rm.T.	100 (445)	27.1 (187)	Stable crack growth
5	2.728	100 (3-3)	-100 (-73)	100 (445)	$>F_u$	Brittle fracture under reduced temperature
6	2.728	100 (3-3)	Rm.T. Rm.T.	30 (133,static)	$>F_u$	Residual static capacity

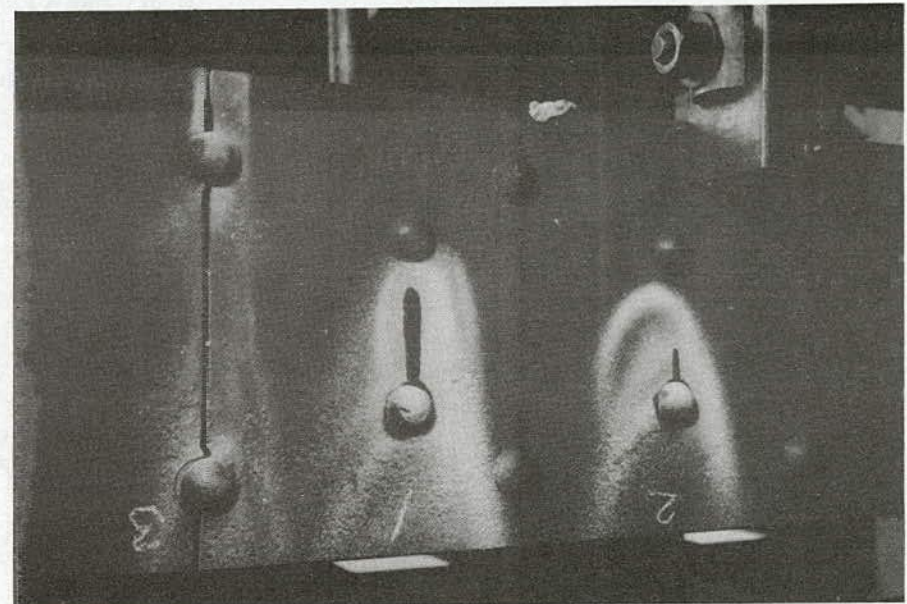
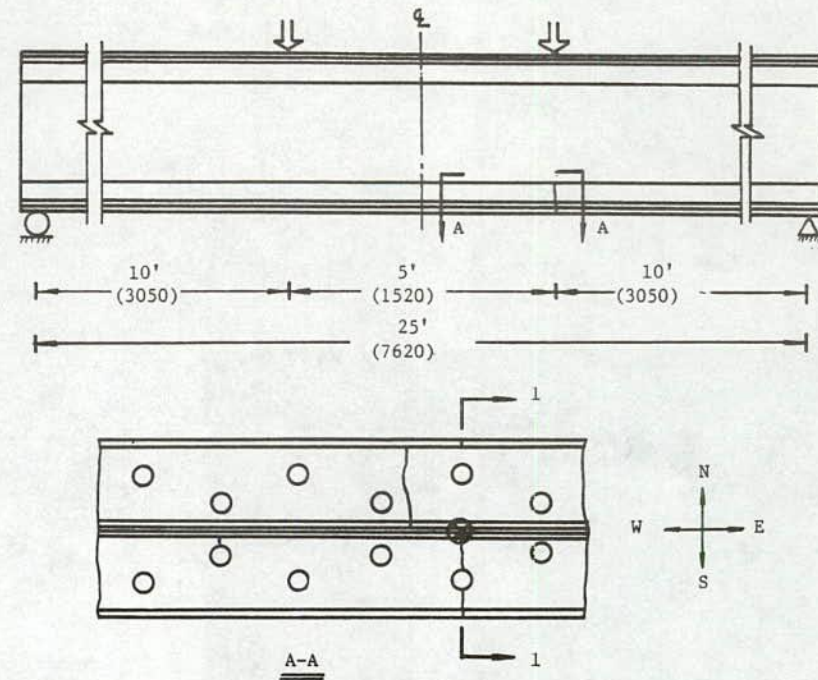
*Figure B10. Girder 5 at 2,728,000 cycles (section 3-3, bottom view).*

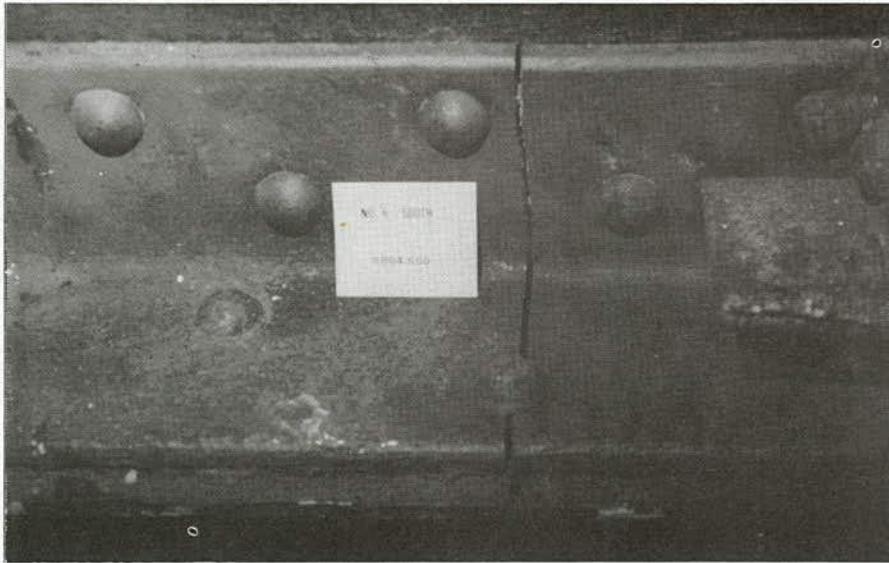
Figure B11. Girder 6 at 3,005,000 cycles (section 2-2, south side).

Stage	Cycles $\times 10^6$	A_c/A_n %	Temp. °F (°C)	P_{max} kip (KN)	$S_{max,net}$ ksi (MPa)	Note
1	2.575	–	Rm.T.	95 (423)	20.0 (138)	A crack was detected at section 1-1.
2	2.790	4	Rm.T.	95 (423)	20.8 (143)	Second crack was detected at section 2-2.
3	2.922	8	Rm.T.	95 (423)	21.6 (149)	Stable crack growth
4	2.963	18	Rm.T.	95 (423)	24.5 (169)	Stable crack growth
5	2.976	22	-60 (-51)	95 (423)	25.5 (176)	No fracture under reduced temperature
6	3.001	34	Rm.T.	95 (423)	30.3 (209)	Stable crack growth
7	3.004	36	-60 (-51)	95 (423)	31.3 (215)	No fracture under reduced temperature
8	3.005	95	-60 (-51)	95 (423)	>F_u	Brittle fracture under reduced temperature
9	3.005	95	Rm.T.	47 (209,static)	>F_u	Residual static capacity

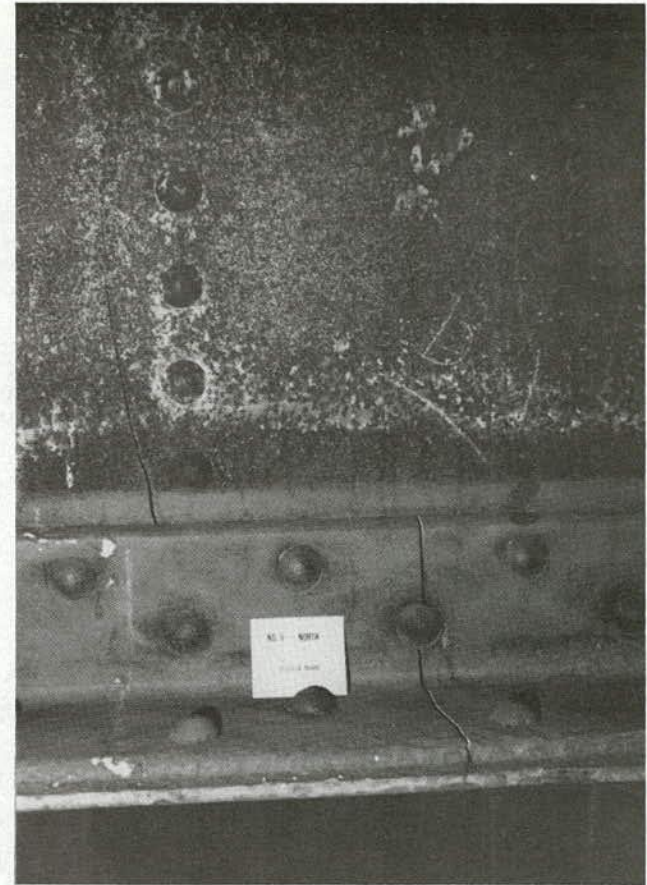
Figure B13. Girder 6 at 3,005,000 cycles (section 2-2, north side).

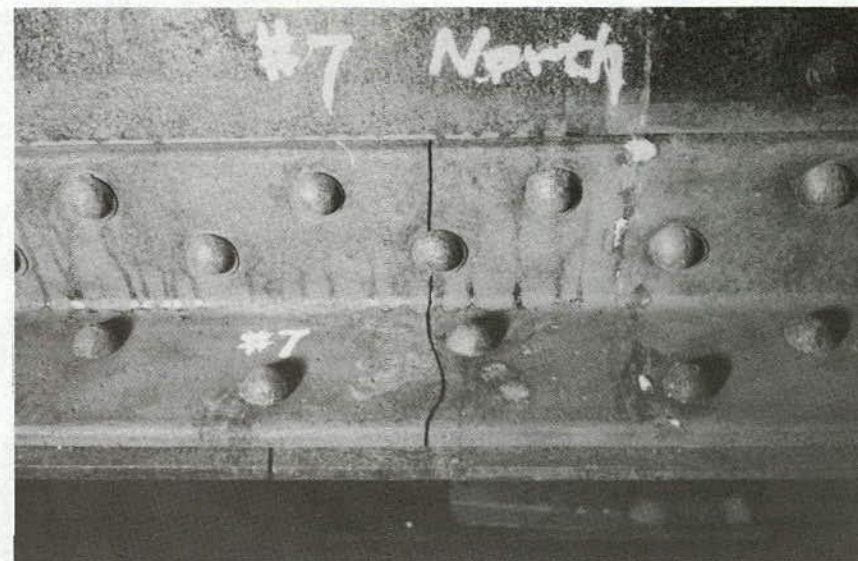
Figure B15. Girder 7 at 773,000 cycles (section 1-1, north side).

Stage	Cycles $\times 10^6$	A_c/A_n %	Temp. °F (°C)	P_{max} kip (KN)	$S_{max,net}$ ksi (MPa)	Note
1	0.601	6	Rm.T.	90 (400)	21.3 (147)	Crack initiated at two net-sections at constant moment region.
2	0.651	9	Rm.T.	90 (400)	22.0 (152)	Stable crack growth
3	0.673	10	-65 (-54)	90 (400)	22.1 (153)	No fracture under reduced temperature
4	0.739	15	Rm.T.	90 (400)	23.6 (163)	Stable crack growth
5	0.751	21	-40 (-40)	90 (400)	25.3 (175)	No fracture under reduced temperature
6	0.766	28	Rm.T.	90 (400)	27.8 (192)	Stable crack growth
7	0.773	100	-60 (-51)	90 (400)	$>F_u$	Brittle fracture under reduced temperature
8	0.773	100	Rm.T.	43 (191,static)	$>F_u$	Residual static capacity

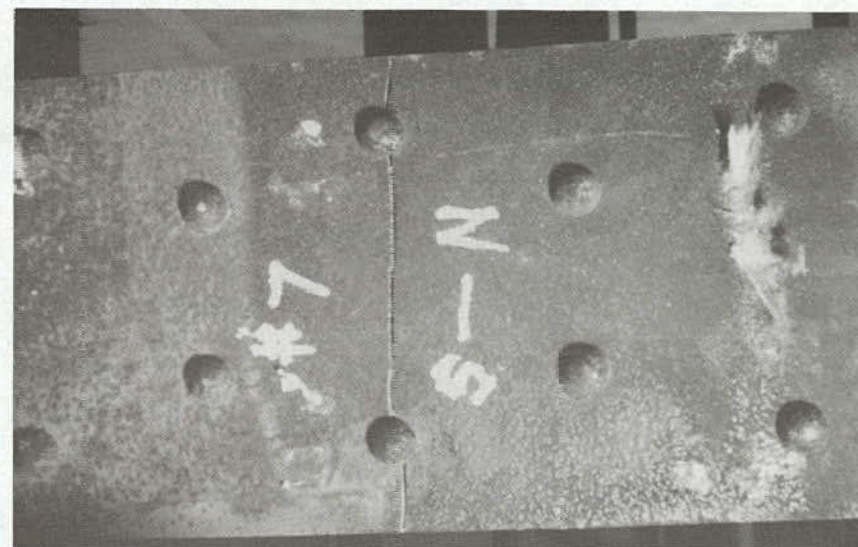
Figure B16. Girder 7 at 773,000 cycles (section 1-1, bottom view).

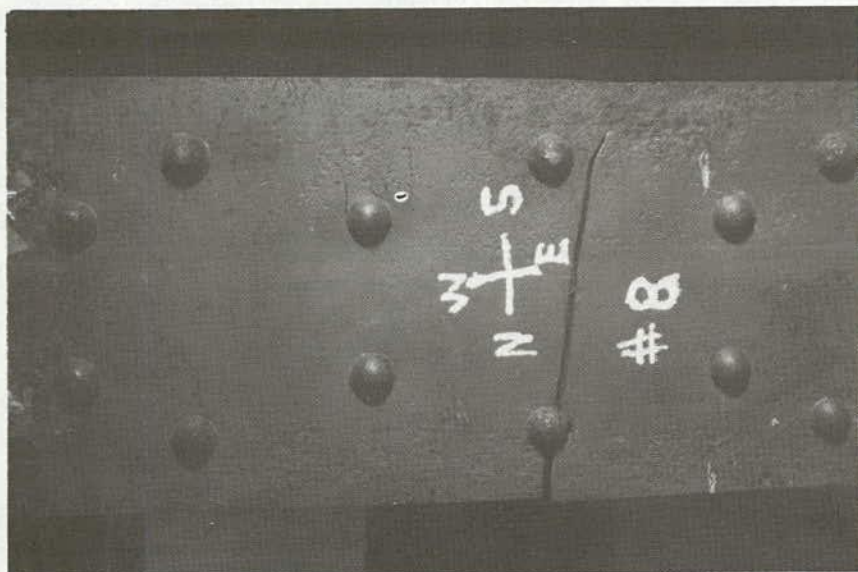
Figure B19. Girder 8 at 1,315,000 cycles (section 2-2, bottom view).

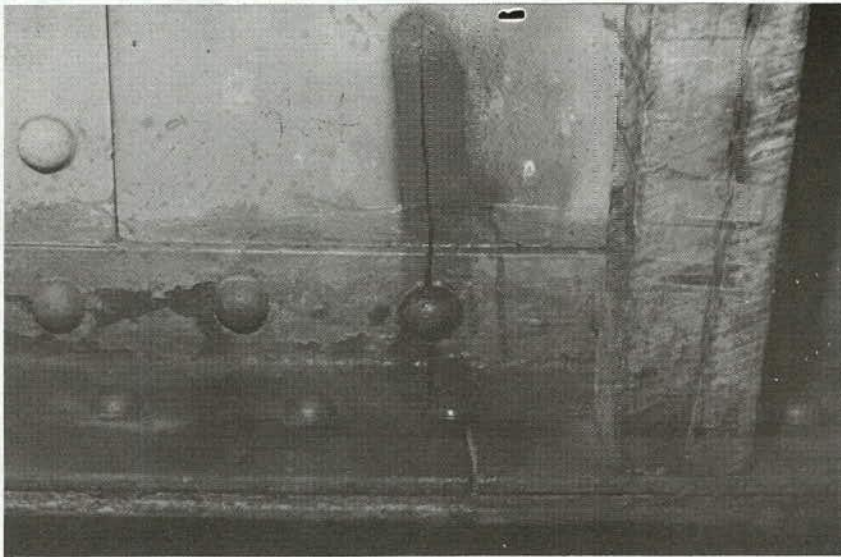
Figure B20. Fractured flange angles of girder 9 (section 1-1, south side).

Angle fracture under static loading: due to the combination of overloading, stress concentration near external coverplate termination, and material property.

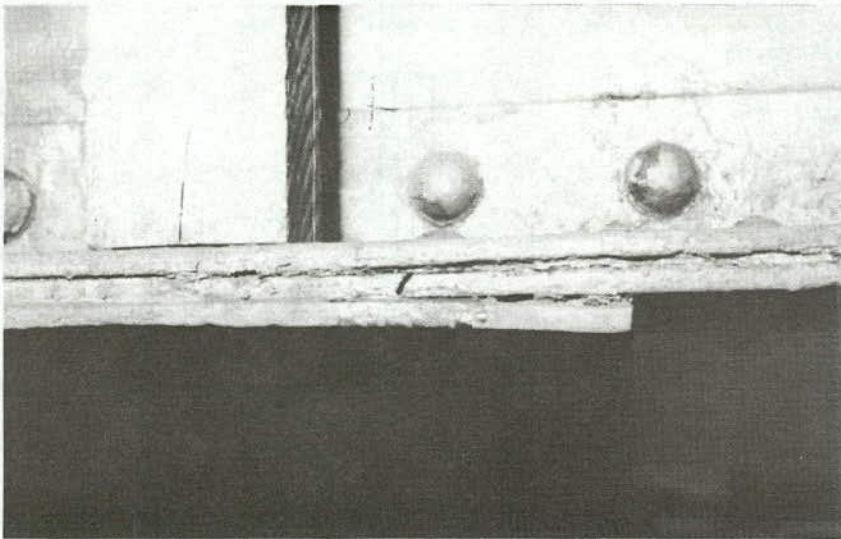
Figure B21. Girder 9 at 415,000 cycles (section 2-2, south side).

Stage	Cycles $\times 10^6$	A_c/A_n %	Temp. °F (°C)	P_{max} kip (KN)	$S_{max,net}$ ksi (MPa)	Note
$1_{a,b,c}$	0	37(1-1) 11(2-2)	Rm.T.	90 (400)	$>F_Y$	Angles fractured under static proof test.
2	0.240	37(1-1) 11(1-1)	Rm.T.	42 (187)	26.9 (186)	Rust powder was seen around rivet in section 2-2.
3_a		37(1-1) 17(2-2)	Rm.T.	42 (187)	30.4 (210)	Stable crack growth
3_b		37(1-1) 24(2-2)	Rm.T.	42 (187)	35.9 (248)	Stable crack growth
3_c	0.415	37(1-1) 30(2-2)	Rm.T.	42 (187)	$>F_Y$	Most components failed. A crack grew into web. Coverplate end separated
4	0.415	45(1-1) 38(2-2)	Rm.T.	27 (120,static)	$>F_u$	Residual static capacity

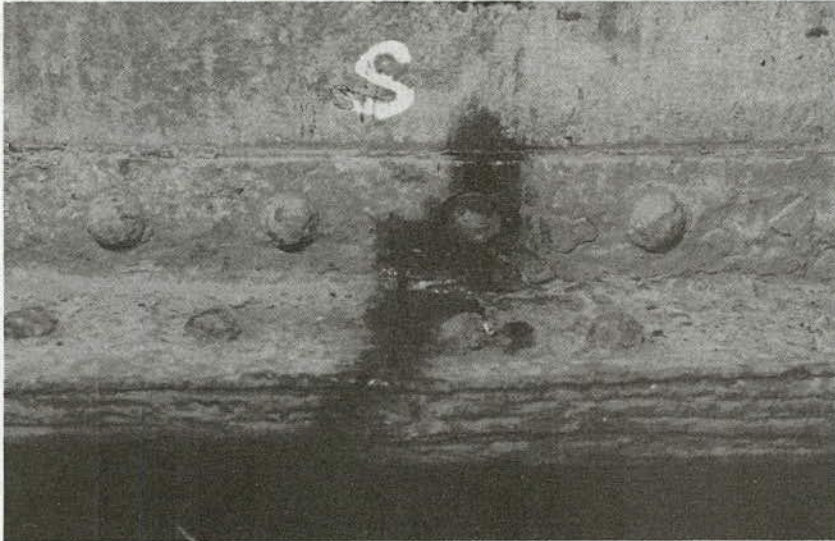
Figure B23. Girder 10 at 512,000 cycles (section 1-1, south side).

| Stage	Cycles x10^6	A$_c$/A$_n$ %	Temp. °F (°C)	P$_{max}$ kip (KN)	S$_{max,net}$ ksi (MPa)	Note
1	–	25	–	–	–	Corrosion reduction of net area.
2	0.471	40	Rm.T.	90 (400)	38.3 (264)	Crack initiated at cover-plate termination, through corrosion reduced cross-section.
3	0.512	85	Rm.T.	90 (400)	>F$_u$	Most components failed. Machine stopped by deflection control device.
4	0.512	100	Rm.T.	64 (285,static)	>F$_u$	Residual static capacity

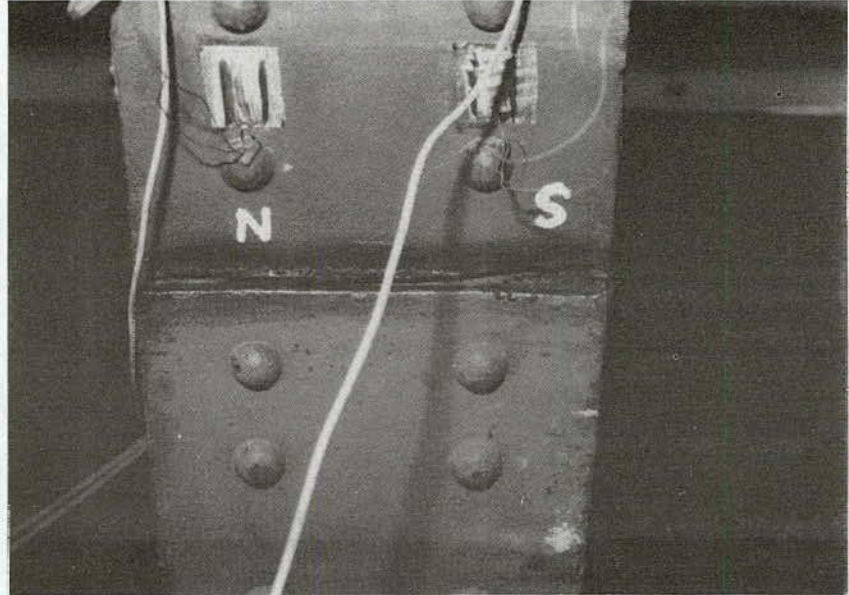
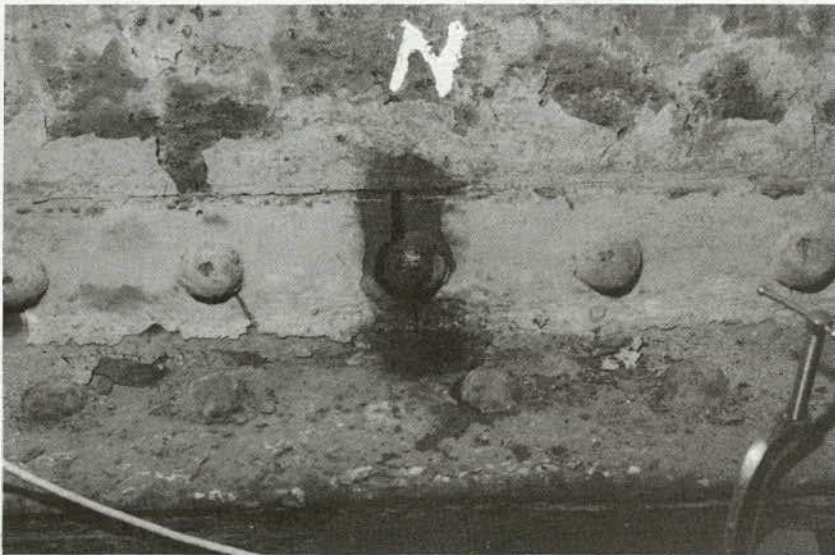
Figure B25. Girder 10 at 512,000 cycles (section 1-1, bottom view).

Figure B24. Girder 10 at 512,000 cycles (section 1-1, north side).

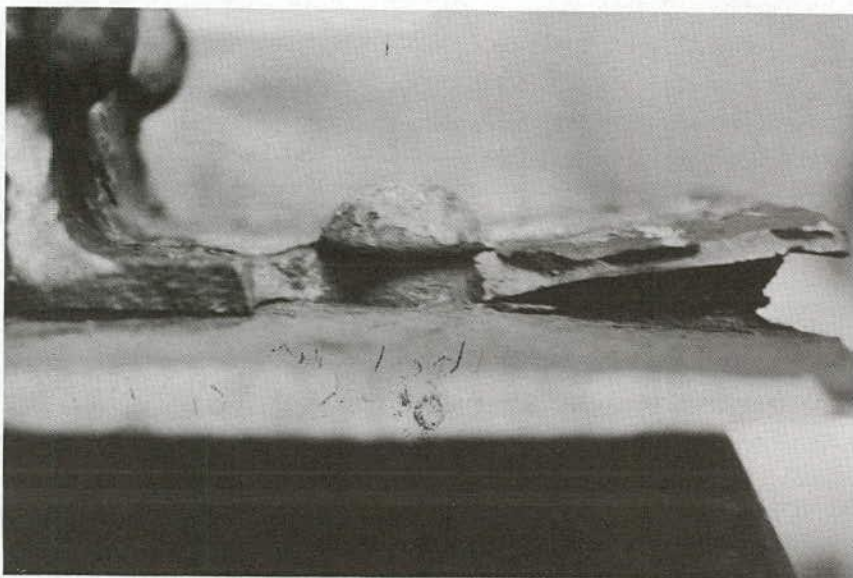
Figure B26. Cracked section 1-1 of girder 10.

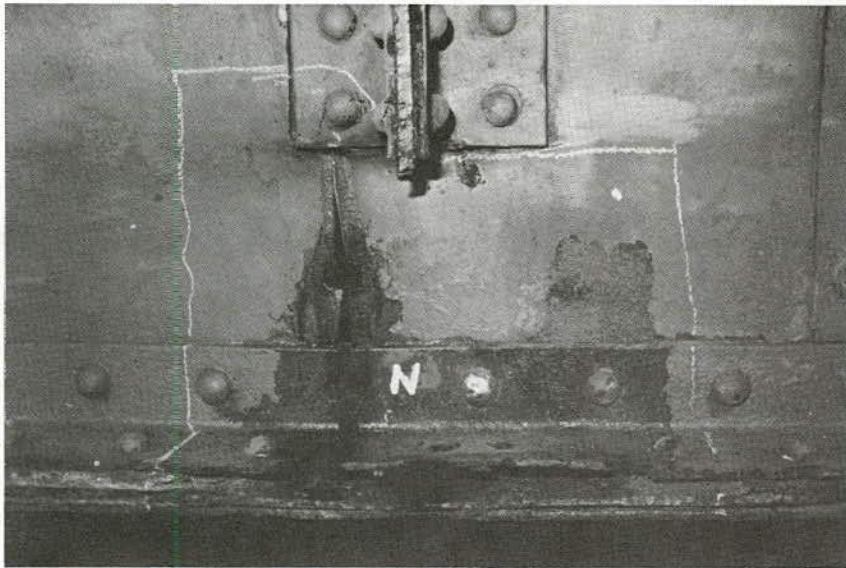
Figure B28. Girder 11 at 657,000 cycles (section 1-1, north side).

| Stage	Cycles $\times 10^6$	A_c/A_n %	Temp. °F (°C)	P_{max} kip (KN)	$S_{max,net}$ ksi (MPa)	Note
1	–	20	Rm.T.	–	–	Corrosion reduction of net-section area
2	0.522	35	Rm.T.	90 (400)	32.0 (221)	Cracks initiated at corrosion-notched cross-section.
3	0.542	43	Rm.T.	90 (400)	36.0 (252)	Crack reinitiated at north angle.
4	0.549	55	Rm.T.	90 (400)	$>F_Y$	Crack extension to angle tips.
5	0.611	60	Rm.T.	90 (400)	$>F_u$	Crack growth at mid-coverplate.
6	0.618	63	Rm.T.	90 (400)	$>F_u$	Stable crack growth
7	0.631	65	Rm.T.	90 (400)	$>F_u$	Stable crack growth
8	0.640	70	Rm.T.	90 (400)	$>F_u$	Stable crack growth
9	0.649	75	Rm.T.	90 (400)	$>F_u$	Crack growth at external coverplate.
10	0.656	90	Rm.T.	90 (400)	$>F_u$	Rapid crack growth
11	0.657	100	Rm.T.	90 (400)	$>F_u$	All components failed. Machine stopped by deflection control device.

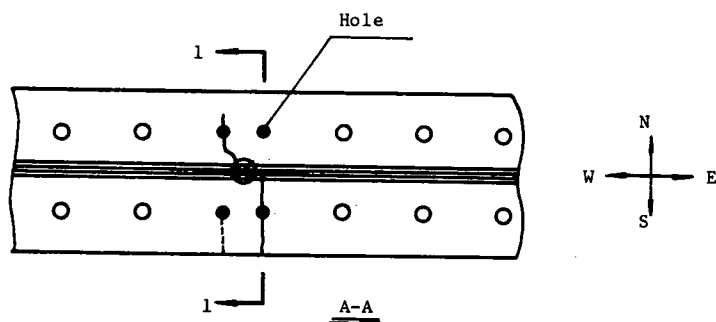
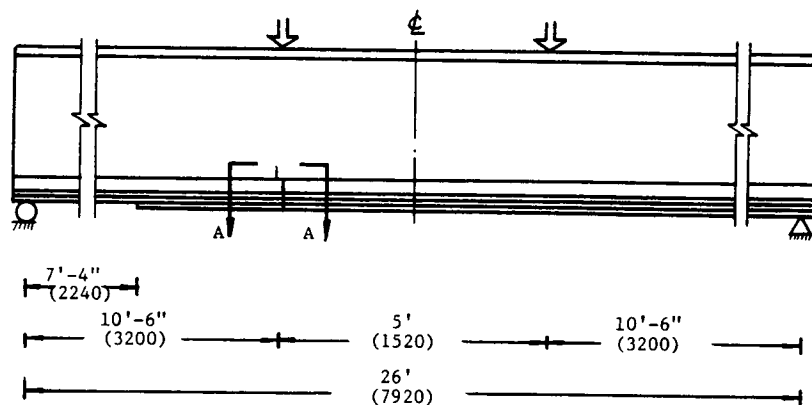
Figure B30. Corrosion-reduced cross section of girder 11.

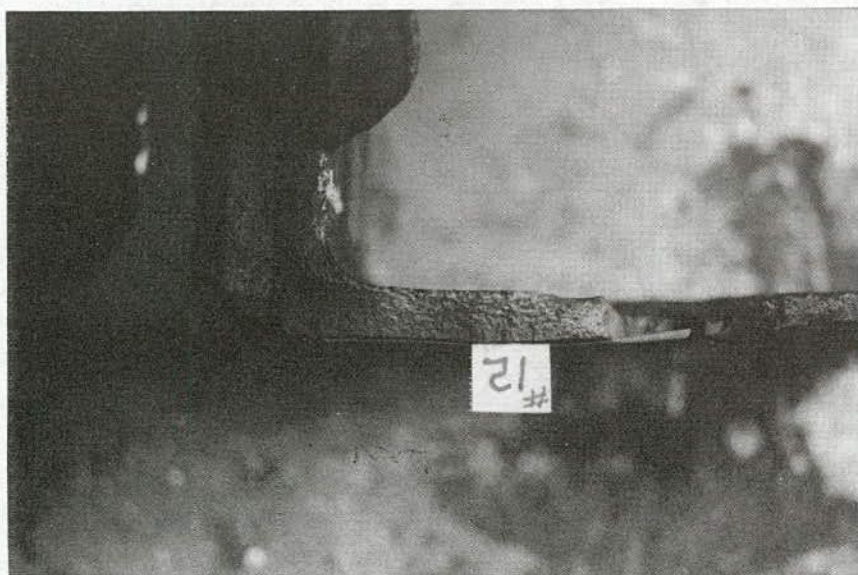
Figure B31. Girder 12 at 827,000 cycles (section 1-1, south side).

| Stage	Cycles x10^6	A_c/A_n %	Temp. °F (°C)	P_{max} kip (KN)	$S_{max,net}$ ksi (MPa)	Note
1	–	40	Rm.T.	–	–	Corrosion reduction of net area
2	0.827	90	Rm.T.	57 (254)	>F_u	Sound of fracture was heard. Failure occurred at corrosion reduced area.
3	0.827	100	Rm.T.	48 (214,static)	>F_u	Residual static capacity

At failure: 100% net section area lost; all components failed; the residual static capacity of the girder was 84% of the maximum fatigue loading.

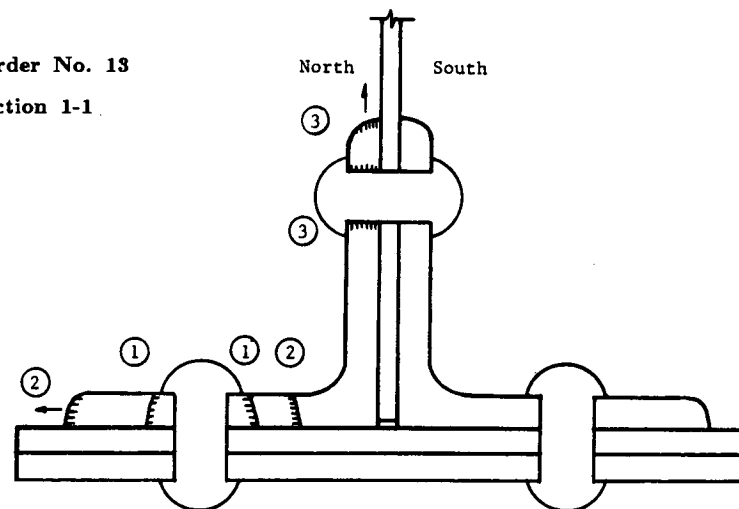
Section 1-1

Fatigue crack initiation: within constant moment region, through rivet holes.

Load redistribution: As one component cracked, the others took up the load and the girder moved sideways. Bottom flange lateral bracing was added.

At failure: More than 70% net section area lost; most components failed; deflection increment of more than one inch was observed; girder failed in a ductile way with crack opening of more than half an inch; residual static capacity of the girder was more than 100% of the maximum fatigue loading.

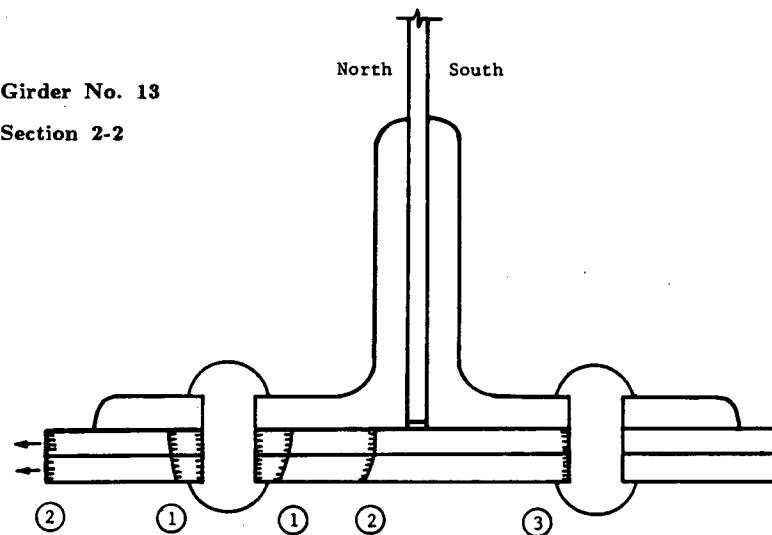
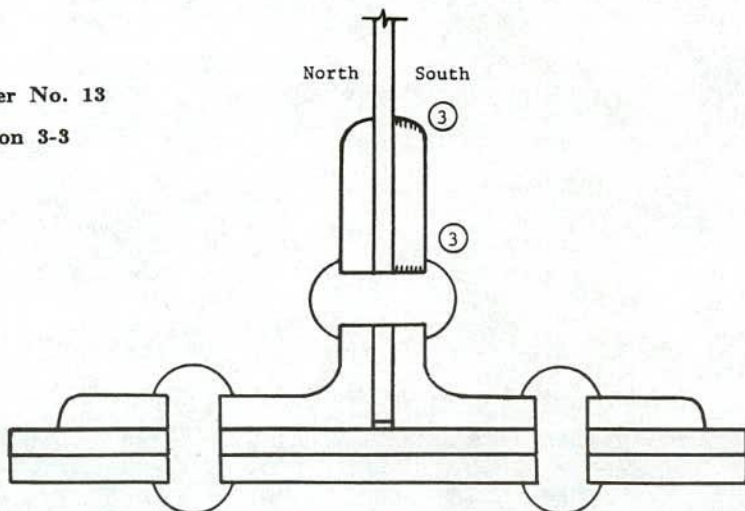
Section 3-3

| Stage	Cycles $\times 10^6$	A_c/A_n %	Temp. °F (°C)	P_{max} kip (KN)	$S_{max,net}$ ksi (MPa)	Note
1	3.040	5(1-1) 5(2-2)	Rm.T.	104 (463)	22.2 (153)	Cracks initiated at sections 1-1 and 2-2.
2	3.568	9(1-1) 21(2-2)	Rm.T.	104 (463)	28.7 (198)	Stable crack growth
3	3.613	25(1-1) 36(2-2) 8(3-3)	-40	104 (463)	>F_u	Brittle fracture under reduced temperature
4	3.613	25(1-1) 36(2-2) 8(3-3)	Rm.T.	110 (489,static)	>F_u	Residual static capacity

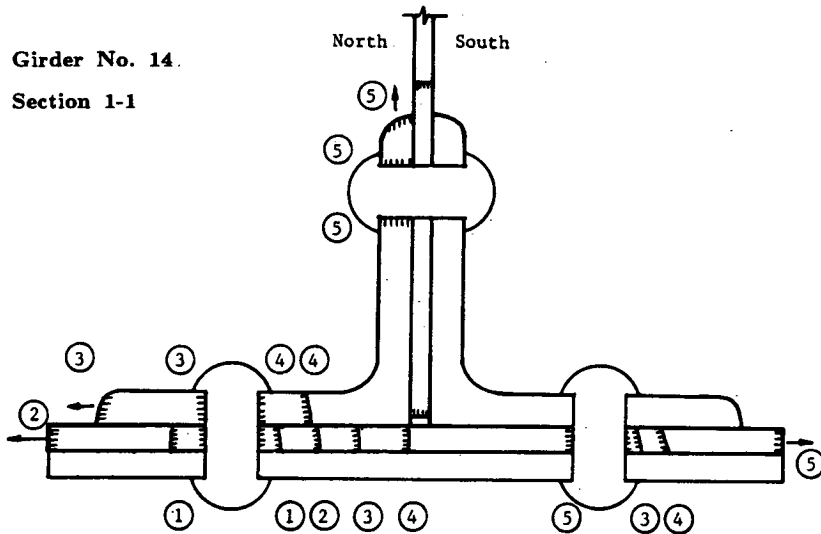
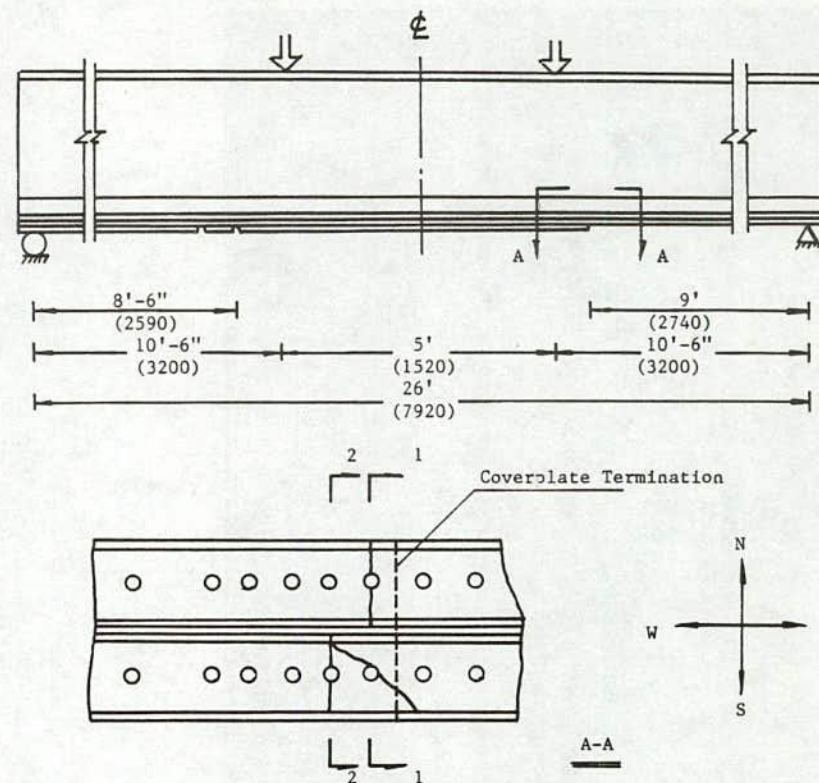
A-A

Fatigue crack initiation: near coverplate termination, through rivet holes.

At failure: More than 85% net section area lost; most components failed; deflection increment of more than one inch was observed; the residual static capacity was 57% of the maximum fatigue loading.
