REPORTS ON EXPERIMENTS WITH CONTINUOUS REINFORCEMENT IN CONCRETE PAVEMENTS—CALIFORNIA

THOS. E. STANTON, *Materials and Research Engineer, California Division of Highways*

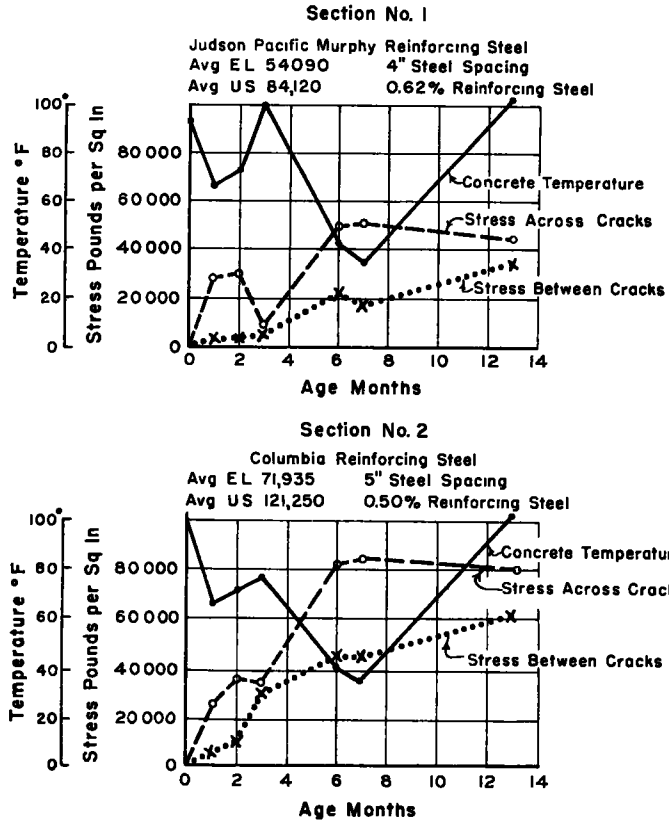
Figure 7. Average Stress in Reinforcing Steel

The average measured stress in the reinforcing steel, between cracks, increased steadily (Fig. 7) irrespective of temperature and moisture conditions in the pavement at the time readings were taken. Readings taken at 18 months (not shown on Fig. 7) were exceptionally high.

The average measured stress in the reinforcing steel, across formed cracks, increased with diminishing temperatures to a high at age of 6 mo. (Fig. 7) and dropped only slightly with a raise in temperature at age of 13 mo. Measurements taken at 18 mo. (not shown on Fig. 7) were beyond any reasonable figure.

sistance of the active gages, indicates that stress readings beyond the 3 mo. period are not reliable and indicate stresses far in excess of those actually developed in the steel.

Now that the active gages are inoperative, it is in order to cut some cores through the steel bars to inspect the condition of the bars at the points of highest indicated stress.

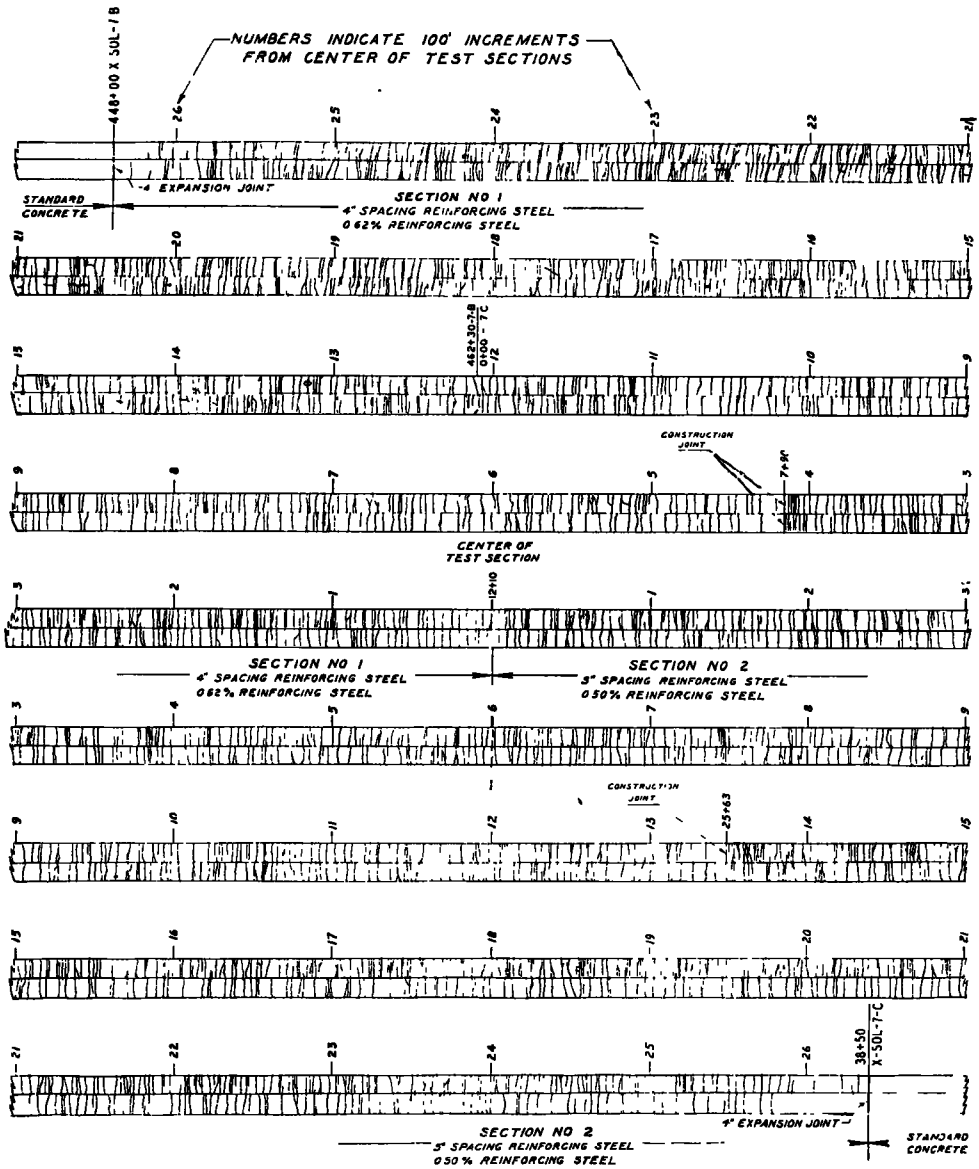
Figure 16. Crack Formation during First Year

Crack Record—Initial shrinkage crack records were made early in the morning following each day's pour. As anticipated numerous transverse cracks have developed (Figs. 16, 17 and 18). This report includes the crack record up to one year at which time the average number of cracks per 100 ft. of pavement equaled 22 with an average slab length of 4.5 ft. except for the first 140 ft. from each end, where the slab lengths were substantially greater.

As will be noted in the crack record diagrams (Fig. 16) the slab lengths were greater just before the construction joint at the end of each day's pour but quite short at the start of the next day's pour, notwithstanding the continuity of the reinforcing across the construction joint (Figs. 16 and 19).

The crack incidence is high in a continuously reinforced slab of the design and length of this project (one mile without substantial expansion or shrinkage relief).

These cracks, although not wide at present may subsequently develop decidedly adverse and objectionable characteristics. In a few cases they have already done so.

To avoid numerous shrinkage cracks it appears necessary to break the continuity of the reinforcing at relatively short intervals—say 100 to 200 ft. This checks with experience elsewhere.[3]

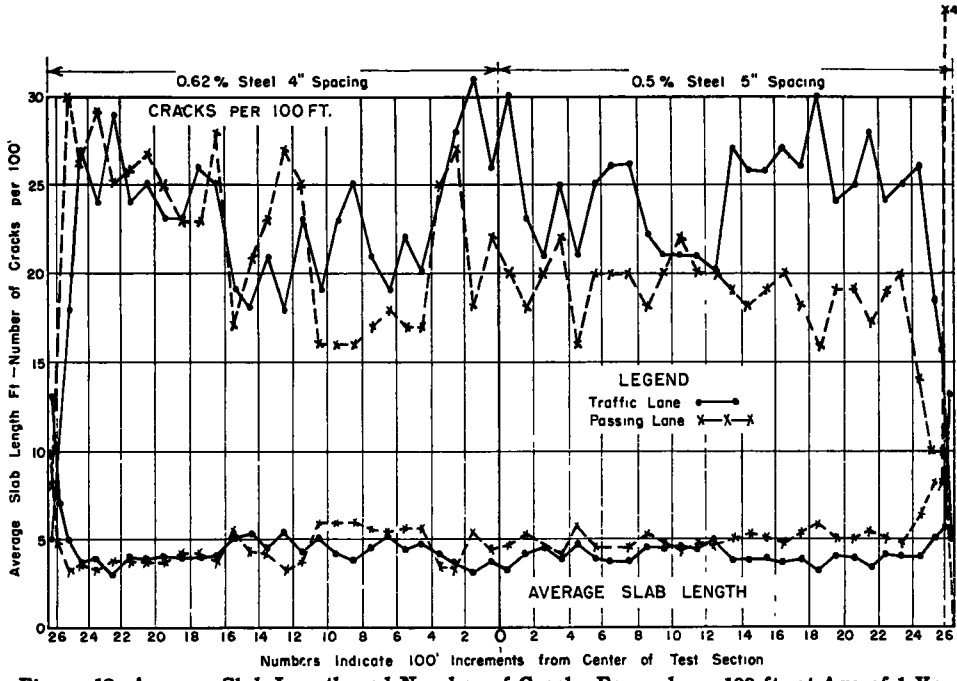
Figure 18. Average Slab Length and Number of Cracks Formed per 100 ft. at Age of 1 Yr.

Up to one and one half years the crack incidence was not materially affected by the percentage of steel, the incidence being substantially the same for the 0.50 percent—5-in. spaced high yield bars as for the 0.62 percent—4-in. spaced standard medium yield bars.

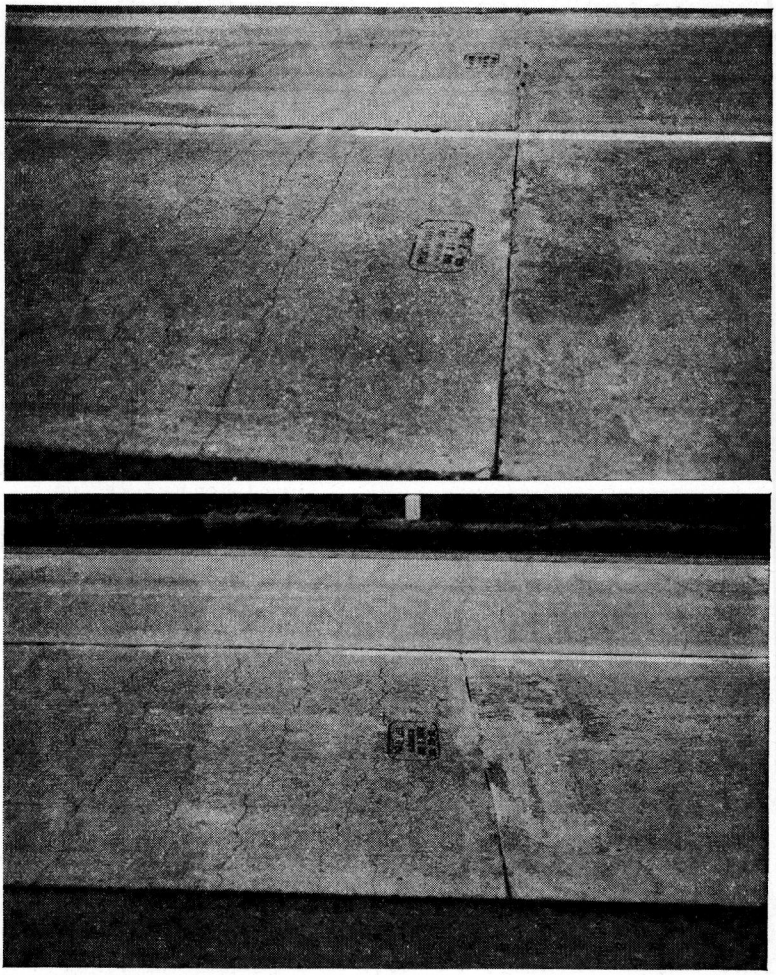
Figure 19. Photographs of Pavement at Construction Joints Showing Difference in Crack Pattern at End of One Days' Run and Start of Next Days' Run—Top at Sta. 7 + 90, Bottom at Sta. 25 + 63.

The effect of time of day and (or) order of construction also is apparent from the crack development at the construction joints where even though the reinforcing steel is carried continuously across the construction joint the crack incidence is much less at the end of the day's run, just before reaching the construction joint, than during the first hour of the succeeding day when the incidence is somewhat greater than the average.
