SALVAGING OLD PAVEMENTS BY RESURFACING

N. A. Billingsley, Jr., Sr. Laboratory Engineer, Texas Highway Department, District Eight

Two methods of salvaging old concrete pavement by resurfacing were compared to new construction on a section of highway built by District Eight of the Texas Highway Department. The purpose of this project was to determine the best method of rehabilitating an old section of highway containing concrete pavement.

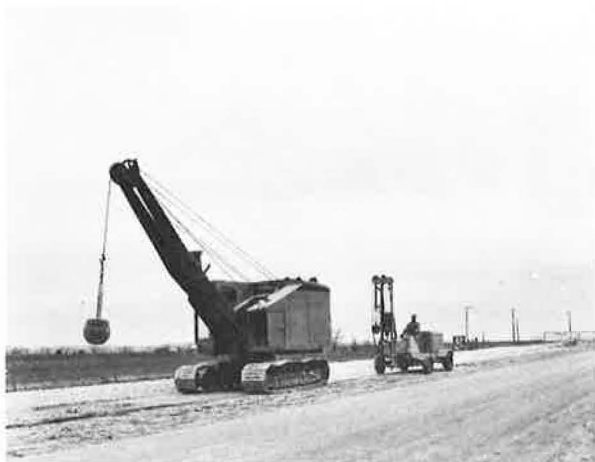
The contractor used two types of machinery for breaking up the old concrete (Fig. 6).

Figure 6. Machinery used in breaking up and compacting old concrete.

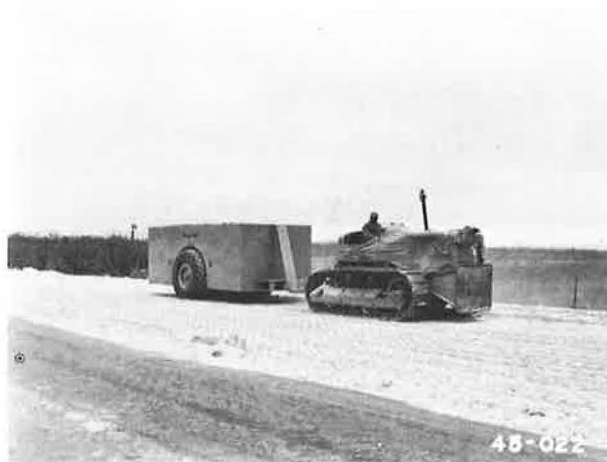
These broken-up chunks of concrete were then seated into the underlying soils by use of heavy rollers in accordance with the following special item (see Fig. 7):

Figure 7. Machinery used in breaking up and compacting old concrete.

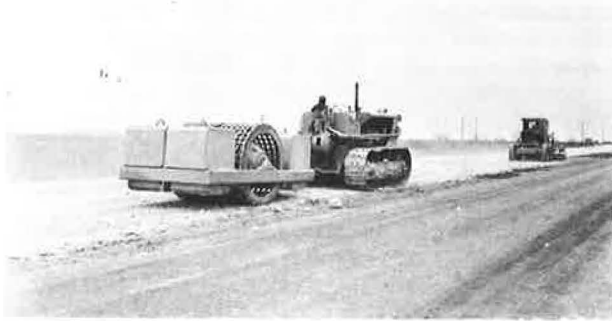
The foundation course material was placed on the broken concrete pavement prior to heavy pneumatic rolling. It was pit run and contained large chunks of loosely cemented material. These were broken up by use of a heavy grid roller. Only 35 percent was retained on a 40 mesh sieve (Fig. 8). Thus, the chunks of broken concrete were easily surrounded (Fig. 9).

Figure 9. Grid roller used in the compaction process.

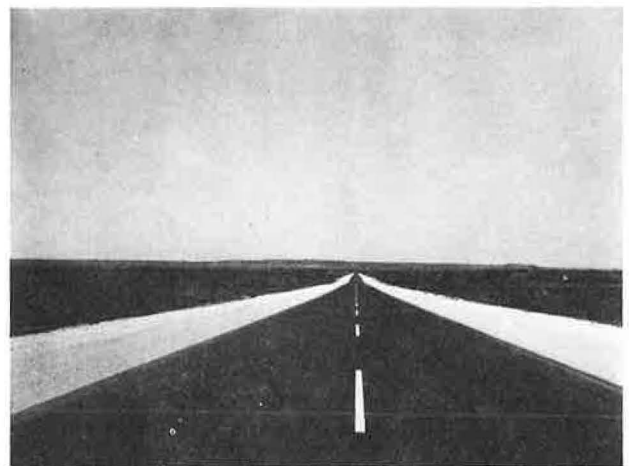
Figure 12. A section of completed highway.

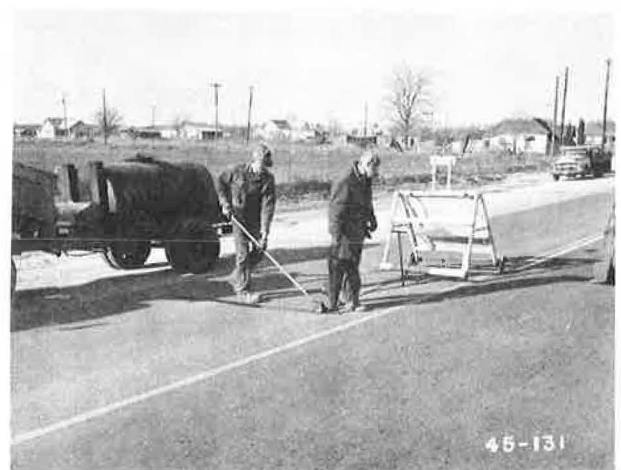
The first section to show signs of distress was that of section No. 1. Cracks began to show at joints of the old concrete pavement.

These cracks began to show (Fig. 13) within three months after job completion. Crack sealing operations were started (Fig. 14) on this section in January 1958. Figures 15, 16, and 17 show how one particular failure had progressed through March 1959, and Figure 18 shows the general condition of typical section No. 1 in April 1961.

Figure 14. Crack sealing operations in progress.

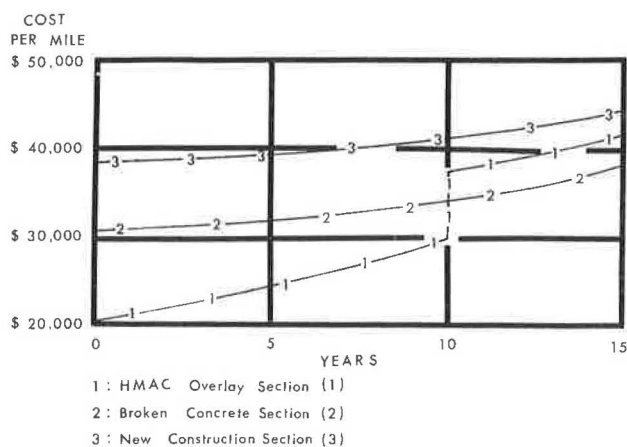
Figure 26. Total cost of construction and maintenance projected to 15 years.

Figure 26 shows the relationship indicating total cost of construction and maintenance for the three sections projected to a 15-yr life. After 10 years it would be advisable to spend an estimated \$8,000 per mile on the HMAC pavement overlay section No. 1 for level up and surface course of asphaltic concrete. The same would be true for the other two sections after 15 or 20 years.
