# Evaluation of Fatigue-Sensitive Details Used in Moline Viaduct, Illinois

Richard A. Walther and Michael J. Koob, *Wiss, Janney, Elstner Associates, Inc.*

A comprehensive study was undertaken to assess the performance of fatigue-sensitive details used in the Moline Viaduct. This 26-span, 872-m (2,860-ft) structure constructed in 1973 is located on Interstate 74 in Rock Island County, Illinois. The complex bridge superstructure includes variations in span length and width along with curved and superelevated geometries. The superstructure is fabricated from ASTM A36 steel and includes longitudinal plate girders supported by box-shaped cross-girders at the mainline piers. The cross-girder extends continuously through the web plates of the longitudinal girders. Full-penetration welds are used to complete the girder to cross-girder connection. This detail is considered potentially fracture sensitive by an FHWA notice dated April 24, 1978. This notice was issued following the brittle fracture of several steel support bents of the Chicago Transit Authority's Dan Ryan Transit Structure in January 1978. A brief discussion of these brittle fractures is presented to introduce the fatigue b

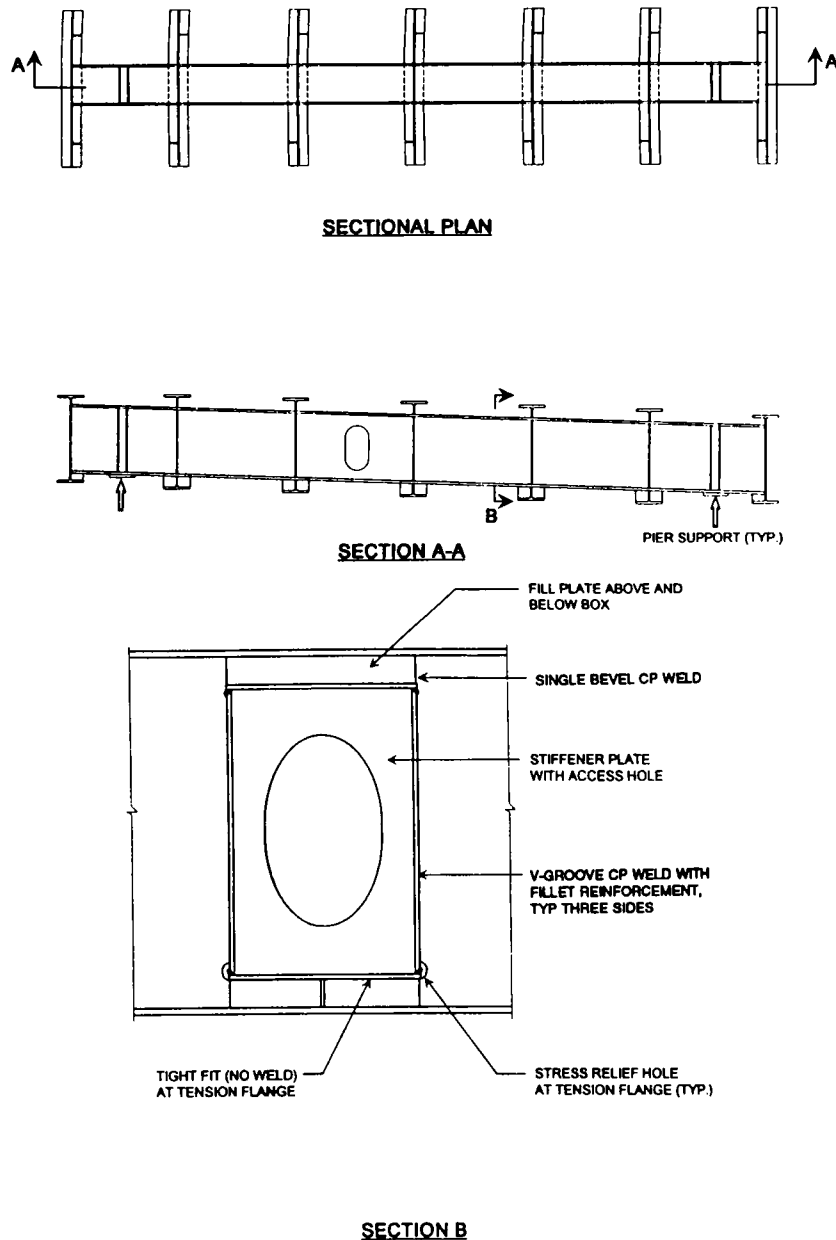
FIGURE 2 Typical cross-girder details.

the box-shaped members. Backing bars are attached to the box interior with short intermittent fillet welds. Interior diaphragms are provided and align with longitudinal girders that frame into the box. Interior diaphragms and bearing stiffeners are fillet welded to the cross-girder web plates and compression flange. The cross-girder web plates and compression flange are connected to the longitudinal girder web with complete-penetration, double-V groove welds reinforced with fillet welds from both sides. A tight fit is provided between the cross-girder tension flange and girder web. A 2.5-cm (1-in.)-radius, half-circle stress relief hole is furnished in the girder web near the cross-girder tension flange. Note that stress relief holes for northbound Piers 1 through 4 were omitted during fabrication. Typical cross-girder fabrication details are shown in Figure 2.

The inspection and nondestructive testing efforts concentrated on the girder to cross-girder connections in the vicinity of the cross-girder top and bottom flanges. At these locations vertical welds either terminate at a stress relief hole or intersect a horizontal weld [Figure 2(b)]. All 2,440 weld terminations or intersections were carefully inspected. For interior girders eight weld terminations or intersections, four on each side of the longitudinal girder, were inspected. At fascia girders four weld intersections were inspected. In general, the welds used to connect the longitudinal girders to cross-girders exhibit satisfactory workmanship. Typically, the vertical welds looked better than the horizontal welds.

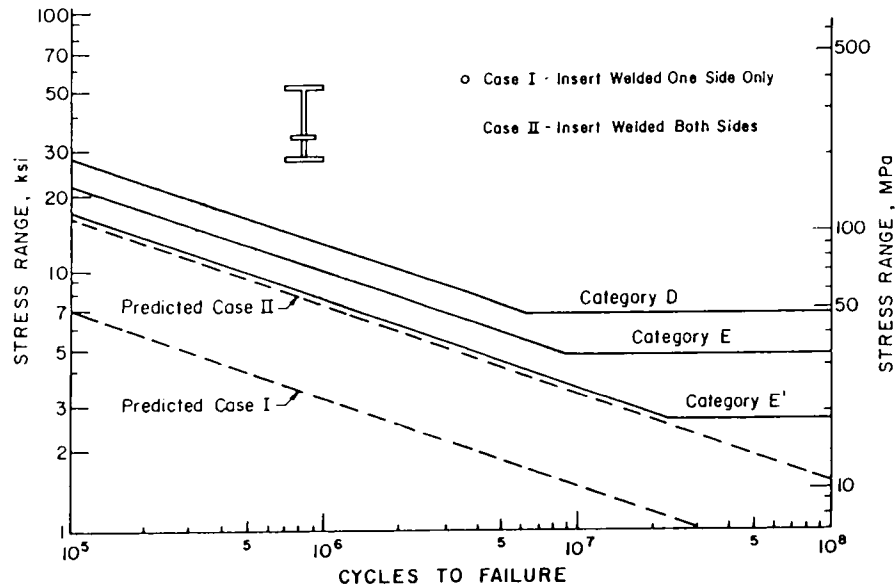
FIGURE 4 Comparison of fatigue life prediction of web penetration with unfused areas in the web (5).

penetrations welded from one side only. Member penetrations welded from one side only provide a fatigue resistance approximately one-half that of a Category E' detail and should be avoided. The predicted fatigue behavior for member penetrations welded on one or both sides is illustrated in Figure 4. Fatigue resistance is also dependent on web plate thickness when fillet welds are used to complete the connection. The ability of achieving complete penetration with the base metal is greatly reduced when the thickness of the member being penetrated is greater than 0.6 cm (0.25 in.). The presence of weld discontinuities creates cracklike defects that are susceptible to fatigue crack growth at reduced stress levels. Providing stress relief holes at the tip of a flange penetration that is attached to the slotted member by fillet welds was found to result in a member fatigue behavior less than Category E'.

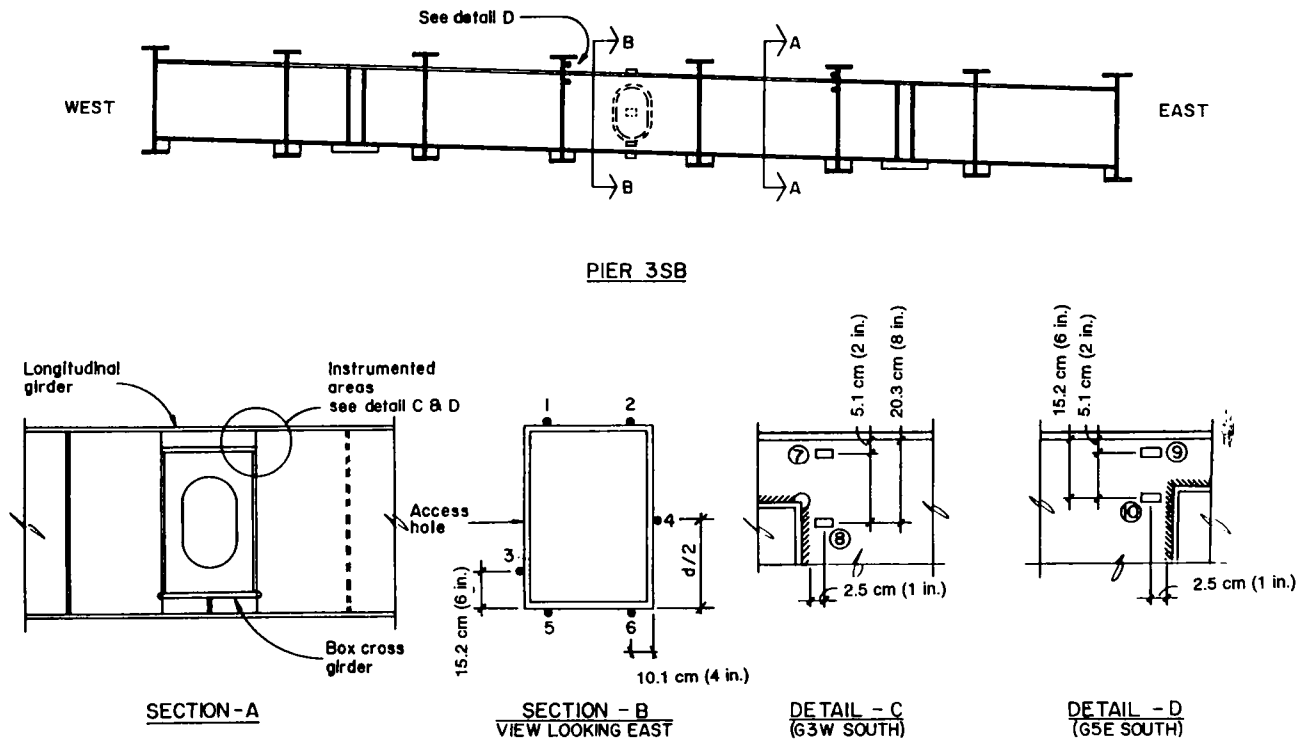
FIGURE 8 Strain gauge layout on cross-girder at southbound Pier 3.

A total of 54 single-element strain gauges were installed. Figures 8 and 9 show the gauge layout and numbering system. Strain gauges 1 through 6 and 49 through 54 were installed on cross-girders at southbound Pier 3 and northbound Pier 6, respectively, to measure the strains in the box-shaped member at maximum moment locations. Gauges 7 through 10 were installed on the girder web at southbound Pier 3 to measure strains in the vicinity of two cracks found at girder to cross-girder connections. Two longitudinal girders in northbound Spans 4–5, 5–6, and 6–7 were instrumented at maximum positive- and negative-moment locations. All gauges were aligned with the longitudinal axis of the member that was instrumented.

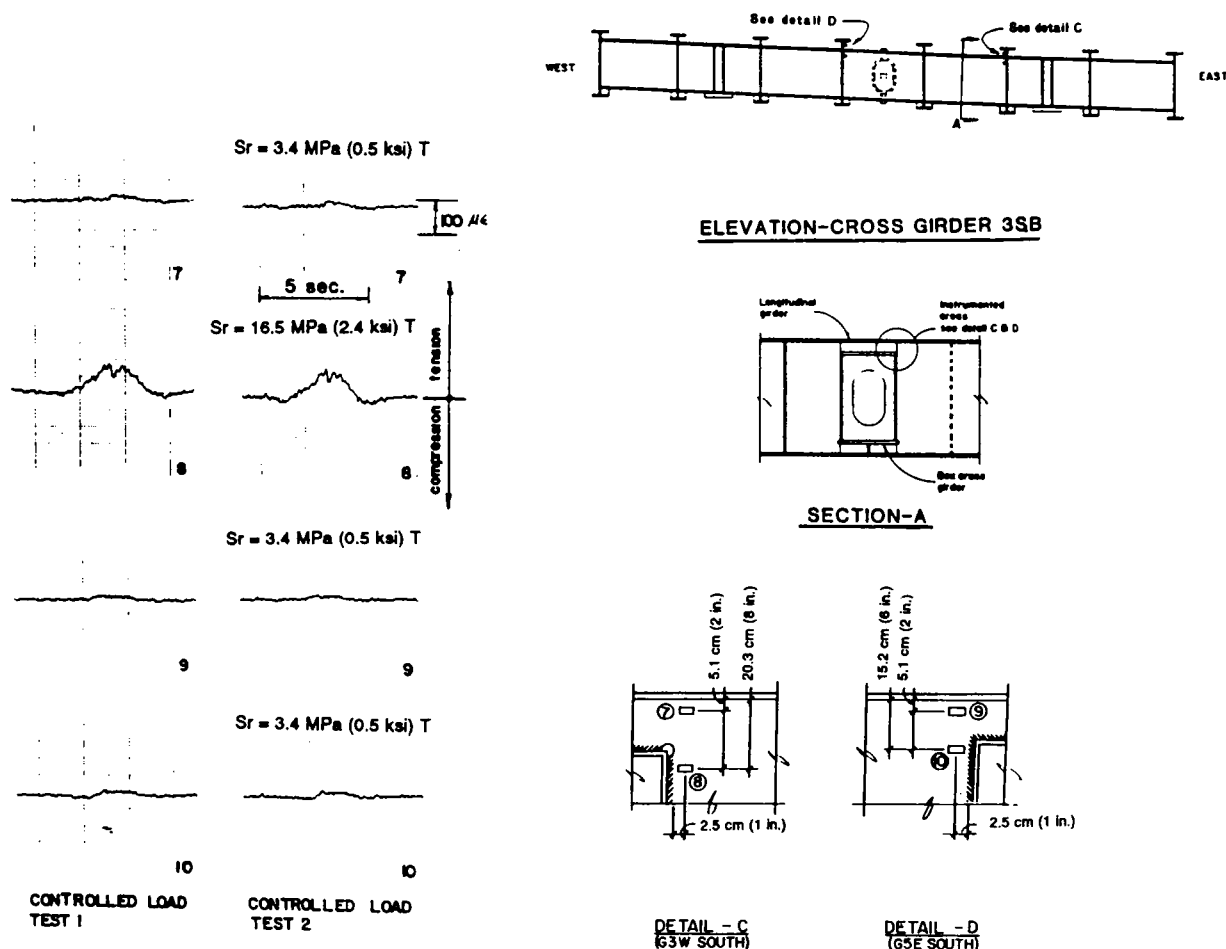
FIGURE 11 Representative strain response adjacent cracked girder to cross-girder connections.

Representative strain gauge responses for Gauges 7 and 10 are given in Figure 11. In general, these gauges indicated tensile stress ranges equal to or less than 3.4 MPa (0.5 ksi). However, Gauge 8 indicated a tensile stress range of 16.5 MPa (2.4 ksi). Additional strain gauge work is required to determine the reasons for this

The maximum stress range measured in the longitudinal girder web adjacent to a crack was 16.5 MPa (2.4 ksi) of tension. At other locations the maximum measured tensile stress range was between 2.1 and 3.4 MPa (0.3 and 0.5 ksi). On the basis of a finite-element model the calculated stress ranges were between 4.8 and 6.2 MPa (0.7 and 0.9 ksi) for the control loading (6). A stress histogram was not developed to determine an effective stress range. However, observations of the 6 hr of data obtained during a normal business day and review of the average daily truck traffic suggest that an effective stress range of approximately one-half of the maximum would not be unrealistic. Considering the redundant nature of the longitudinal girder and using the maximum stress range instead of an effective stress range, it can be shown that the measured stress levels are below the Category E' CAFL. Comparing the Category E' CAFL with the maximum stress range is conservative and suggests that crack growth would not be expected.
