Rejuvenating Highway Pavement

J. L. STACKHOUSE, Maintenance Engineer
Washington State Highway Commission

The paper describes the resurfacing with a flexible pavement of the Roy Junction - Muck Creek section of Primary State Highway 5, located 6 miles south of Tacoma, Washington, on the route to Mount Rainier National Park that was originally paved in August 1914 with a 16-foot-wide portland-cement-concrete pavement. This section, 5.46 miles in length, was widened to 22 feet in 1940, using a 3-inch-depth asphaltic-concrete-base mixture as a widening medium and the widened roadway was resurfaced with an average thickness of $2\frac{1}{2}$ inches of asphaltic concrete material.

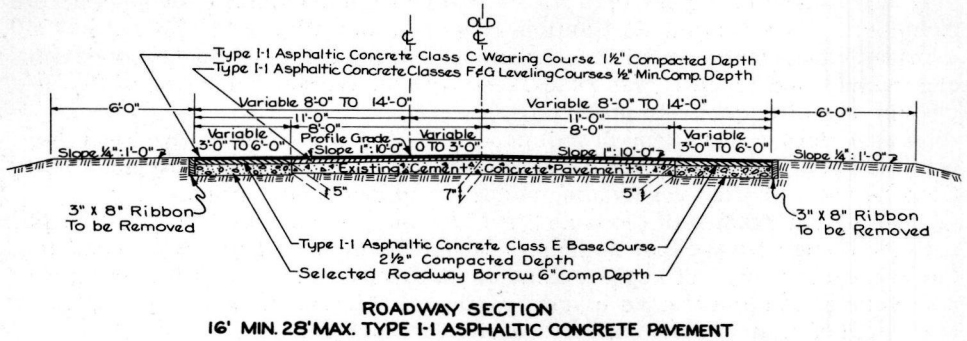
Figure 1.

A typical cross-section of this project, as shown in Figure 1, consisted of 3 feet of widening on each side of the old pavement with a $2\frac{1}{2}$ -inch asphalt-concrete base, after which a leveling course with a minimum thickness of $\frac{1}{2}$ inch over high points, or an average thickness of 1 inch was placed over the old 16-foot roadway. The depth of leveling mix on the new base course varied from $\frac{1}{2}$ to $\frac{3}{4}$ inch. A wearing surfacing of $1\frac{1}{2}$ -

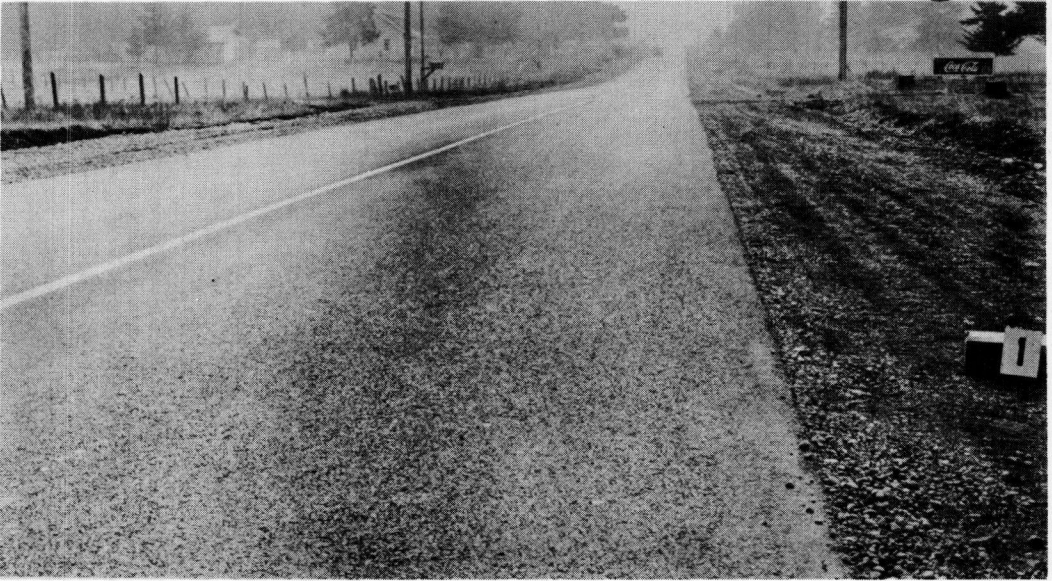
Figure 3.

Figure 2 shows the old pavement as it appeared in March 1940, or nearly 26 years after it was constructed. Note the transverse cracks and the indications of pumping movement of the slabs at the expansion joints by the light patches near the center line. Figure 3, taken in September 1940, illustrates the resurfaced pavement at the same location as Figure 2, while Figure 4 was taken in October 1954, showing the conditions of this pavement 14 years later. These three views were taken at the north end of the project at the same location.

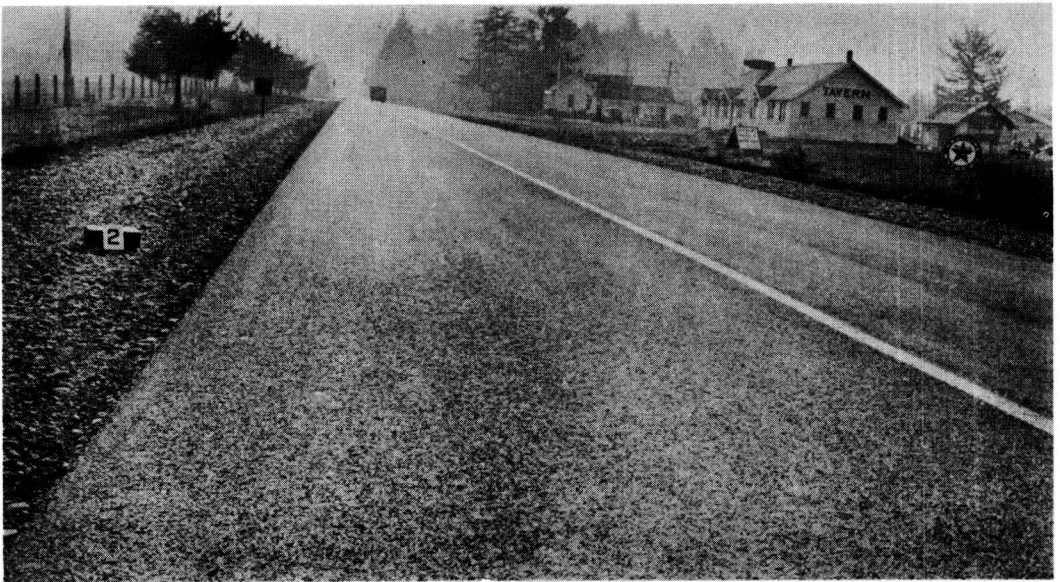
Figure 6.

Figure 6 exhibits the completed resurfacing work in September 1940, showing the rather granular texture of the wearing surface. Figure 7 discloses this same area in October 1954, or 14 years later.

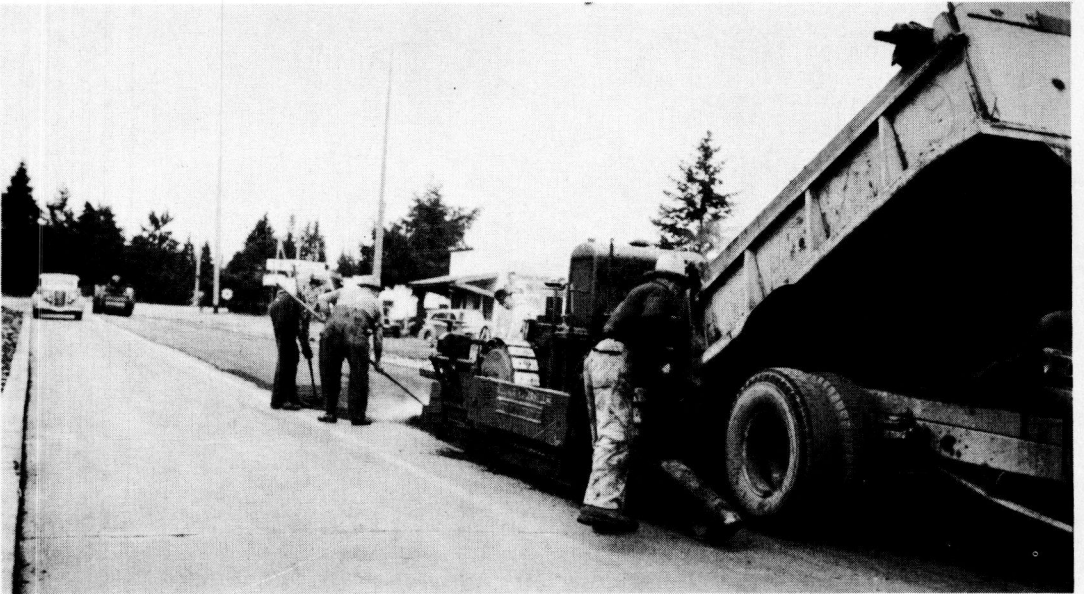
Figure 8.

leveling materials. These were placed with a heavy motor-patrol blade. The pavement was rolled with one 10-ton, three-wheel and one 8-ton tandem roller. Figure 8 shows the spreading machine working on leveling mix and the three-wheel roller can be seen in the background.

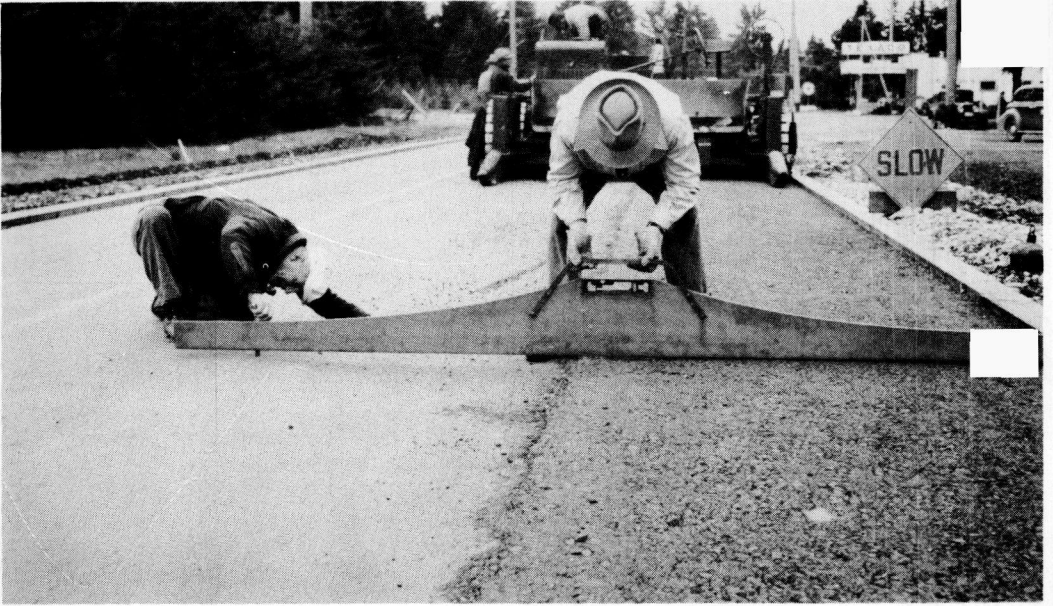
Figure 9.

Figure 9 demonstrates a straightedge equipped with an adjustable carpenter's level for obtaining the thickness of mat on the old pavement for correct crown. Marks indicating the thickness of the mat were placed on the pavement each 25 feet of length for the information of the machine operator and inspector.

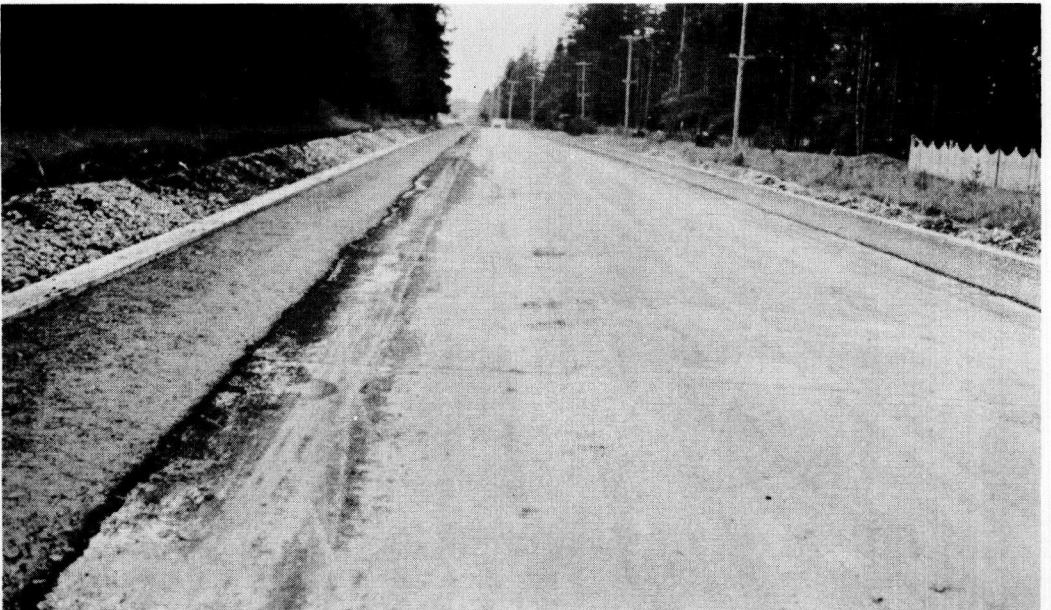
Figure 10.

Figure 10 discloses the base mix compacted in place on each edge of the old pave-

ment. Note the 3-by-8-inch wood form laid on edge at each side of the roadway. These forms were removed after the asphalt concrete was completed and before the shoulder material was placed. Present-day construction does not require forms of any type, since it has been found the mechanical self-propelled machines do not require side forms for grade or alignment.
