**Bulletin 182**

***Corrosion of Reinforcing Steel  
And Repair of Concrete  
In a Marine Environment***

## CAUSES AND REPAIR OF DETERIORATION TO A CALIFORNIA BRIDGE DUE TO CORROSION OF REINFORCING STEEL IN A MARINE ENVIRONMENT:

# **Causes and Repair of Deterioration to a California Bridge Due to Corrosion of Reinforcing Steel in a Marine Environment**

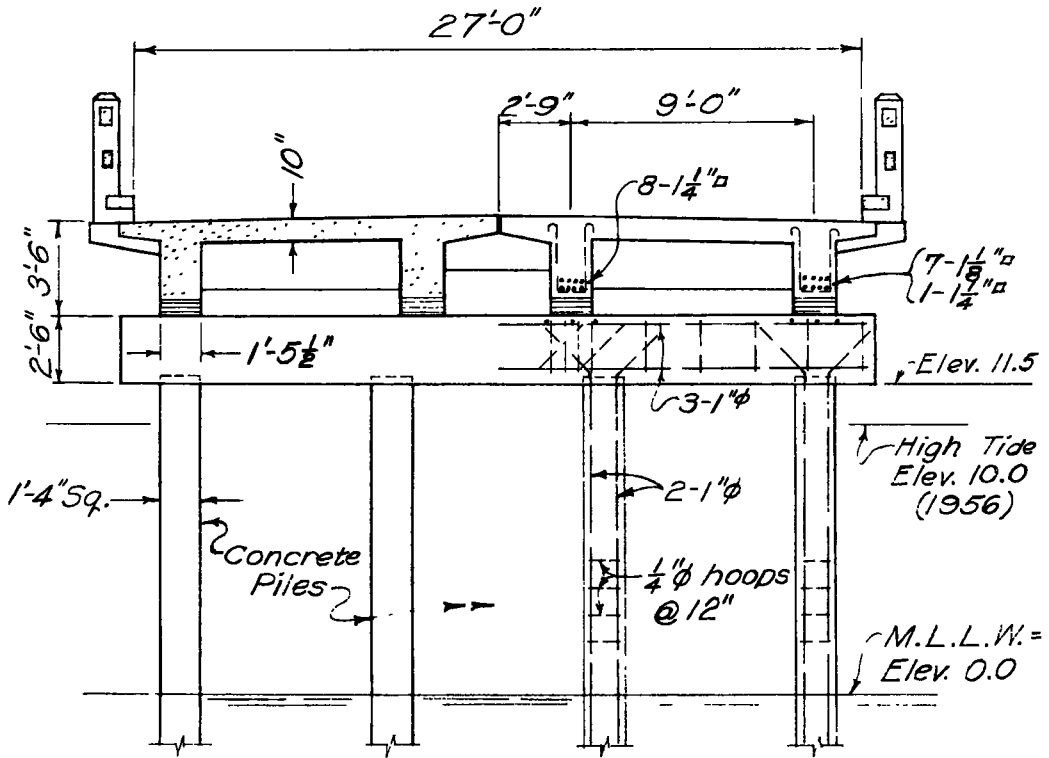
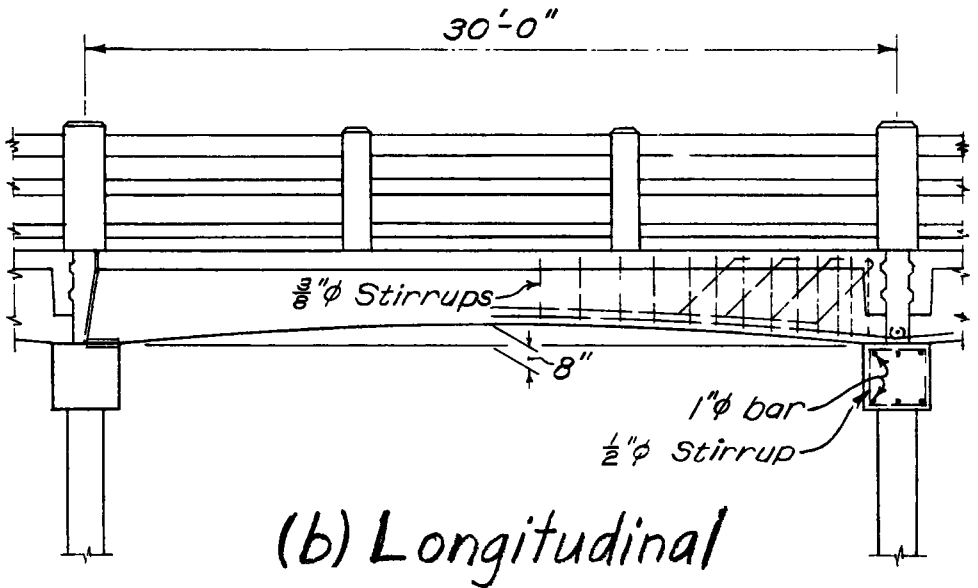
Figure 1. Typical sections of 30-ft span.

As shown on the typical cross-section of the structure (Fig. 1), the bottom of the caps on the trestle bents is 11.5 ft above mean lower low water, (mean lower low water = 0, mean higher high water = 5.7, extreme high tide 1956 = 10.0), and the bottom of the beams at the bearings is at Elev. 14.0. Waves of 2.5-ft half amplitude are of frequent occurrence. These structure elevations are practically constant throughout the length of the structure except for the 4-span ramped sections at each end of the structure where these elevations decrease by 1.75 ft, and at the 7-span ramped sections adjacent to either end of the steel truss spans at the navigable channel, where these elevations increase a maximum of 7.3 ft.

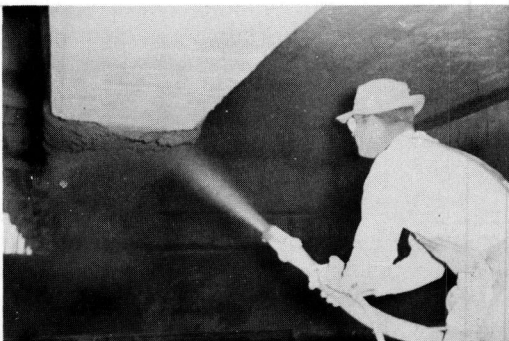
Figure 15. Nozzlemán "shooting" beam requiring repair through part of its length.

This serves to clean all welds and to remove any light film of rust which may exist on the added reinforcement, or may have developed overnight on previously cleaned reinforcement. Expanded metal lath is used on caps and piles instead of the normally used wire mesh due to its greater stiffness, which is of material benefit where support for the mesh provided by relatively closely-spaced stirrups and bar reinforcement is lacking. Rebound is less readily removed from behind the expanded metal lath than from areas covered with wire mesh. For this reason it is not considered suitable for

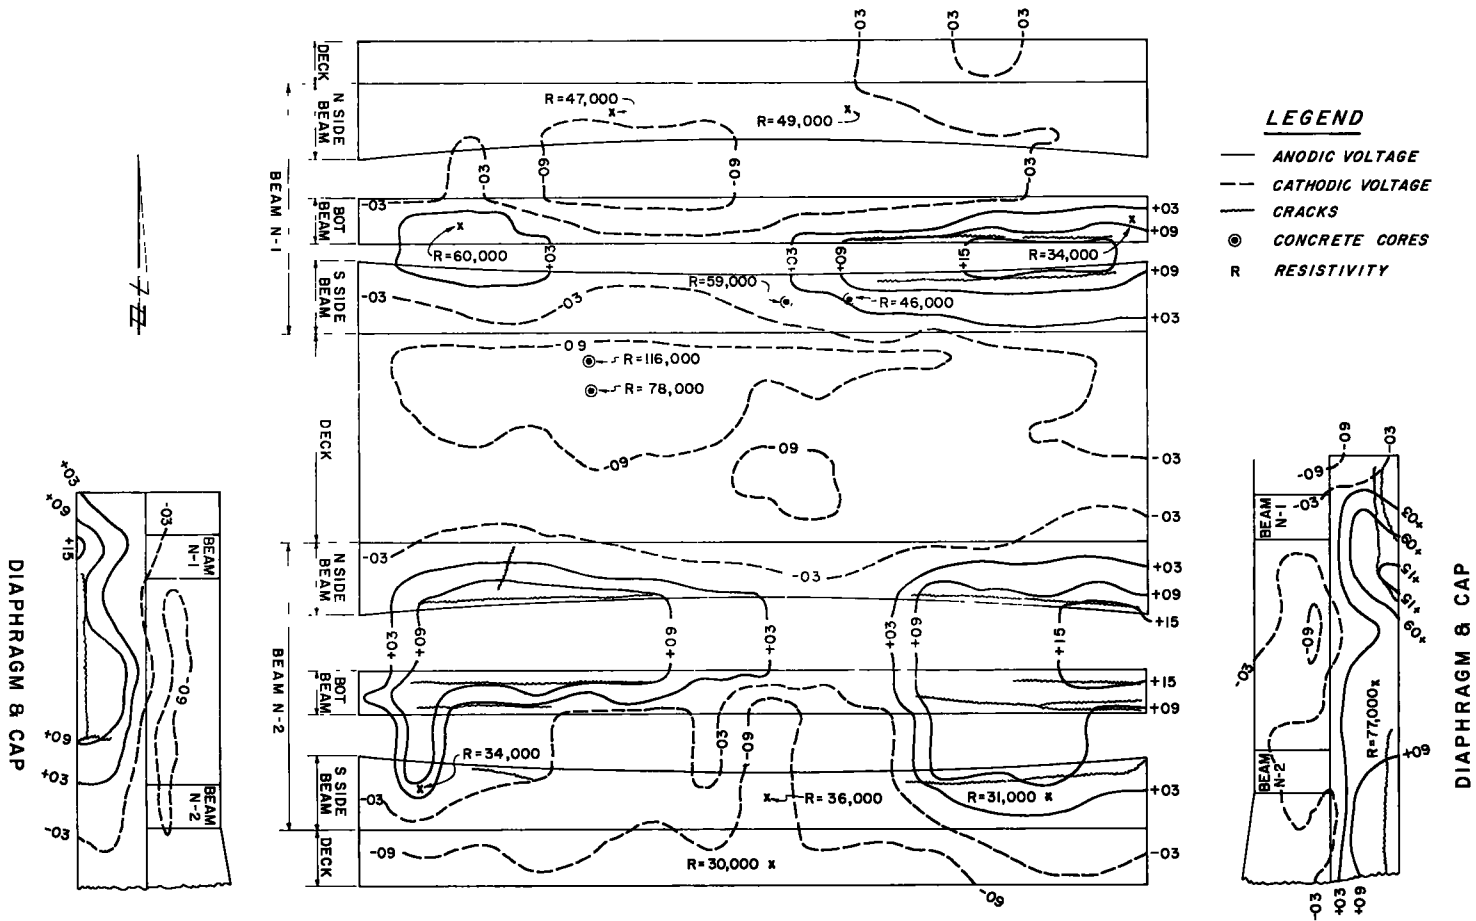
Figure 18. Equipotential contours, Span 553.

Figure 18 depicts span 553, which is representative of a badly deteriorated span that has not been repaired with shotcrete. The field crews observed longitudinal cracks in the concrete covering approximately 50 percent of the length of the underside of the beams. There are strong anodes where cracking has occurred, but elsewhere the beams are neutral or only weakly anodic. The entire deck slab is cathodic. The anodes in the caps appear to be related to the cathodic areas in the diaphragms. The resistivity in anodic areas averages 37,000 ohm-cm, and in the cathodic areas 50,000 ohm-cm.

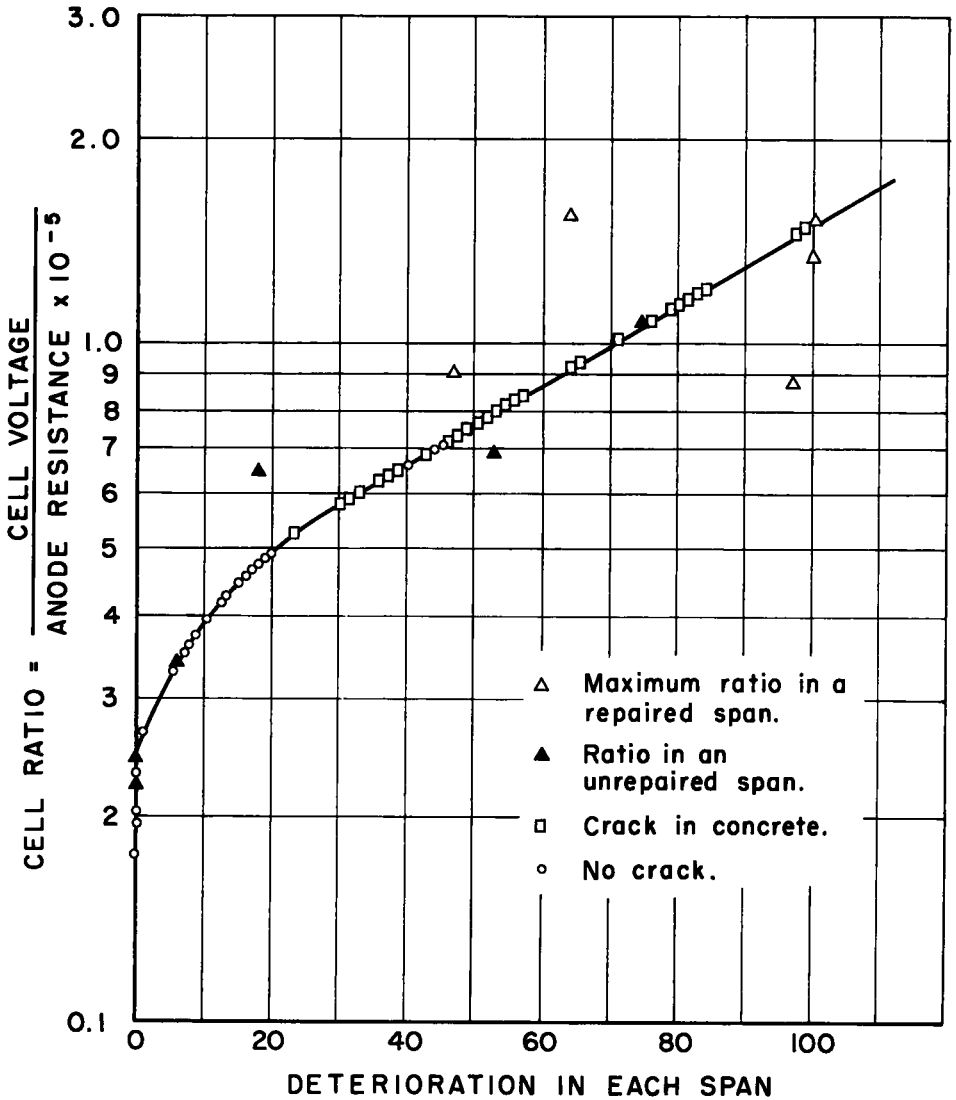
Figure 21. Concrete cracking against corrosion cell ratio.

The curve of Figure 20 has been reproduced in Figure 21. Each plotted point on the curve represents the cell ratio of an individual corrosion cell. Circles indicate that the concrete has not cracked and squares that it has cracked. No further distinction has been made as to degree of deterioration. It will be noted that no cracking has occurred when the cell ratio is less than 0.5. With two exceptions, the concrete has cracked when the cell ratio exceeds 0.5. This value appears to be of critical significance for this structure at the present time.

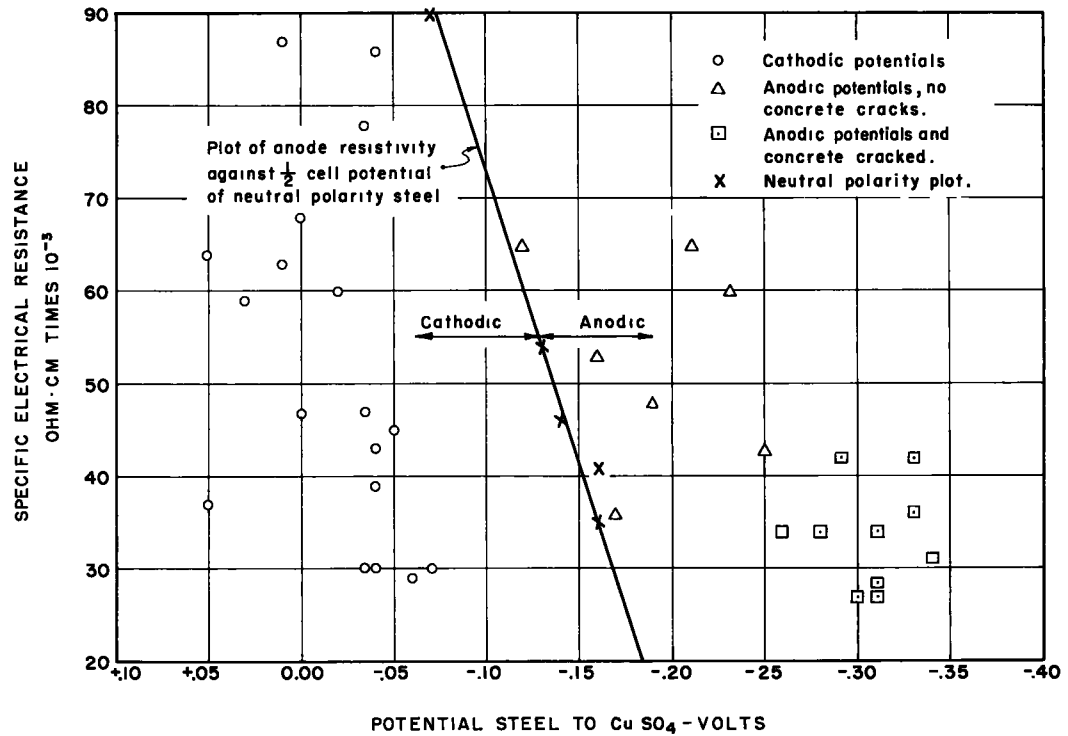
Figure 22. Half-cell potential of steel against resistivity of concrete.

In some of the spans potentials were measured by direct connection to the reinforcing steel; in others, the measurements were related to a fixed potential point on the surface of the concrete. In the later case, differences in potential were measured and the contours were plotted. The observed potential relative to steel was not known when this method was used. Five of the spans were in the first category and Figure 22 is presented to illustrate the relationships obtained in these spans. The crosses in this figure represent the apparent neutral half-cell potential of the steel to a copper sulfate reference cell. The sloping line represents the neutral potential of the steel for varying amounts of resistivity (specific electrical resistance of the concrete) as determined by the position of the crosses. Cathodic potentials fall to the left of the curve and anodic potentials to the right.

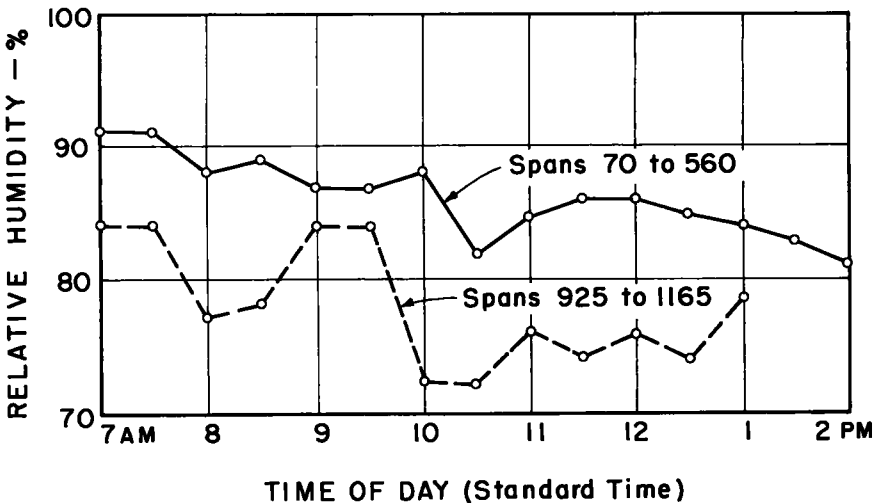
Figure 23. Relative humidity under bridge and shaded from sunlight, July-Oct. 1955.

The relative humidity beneath a particular span was recorded during the days that potential surveys were under way. Average results are shown in Figure 23 for measurements during July, August and September at spans 70 to 560 at the west end, and during October at spans 925 to 1165 at the east end. The average relative humidity at the east end is 9 percentage points lower than that at the west end. Although the determinations were not made concurrently, Weather Bureau records indicate that a differential of this order exists.

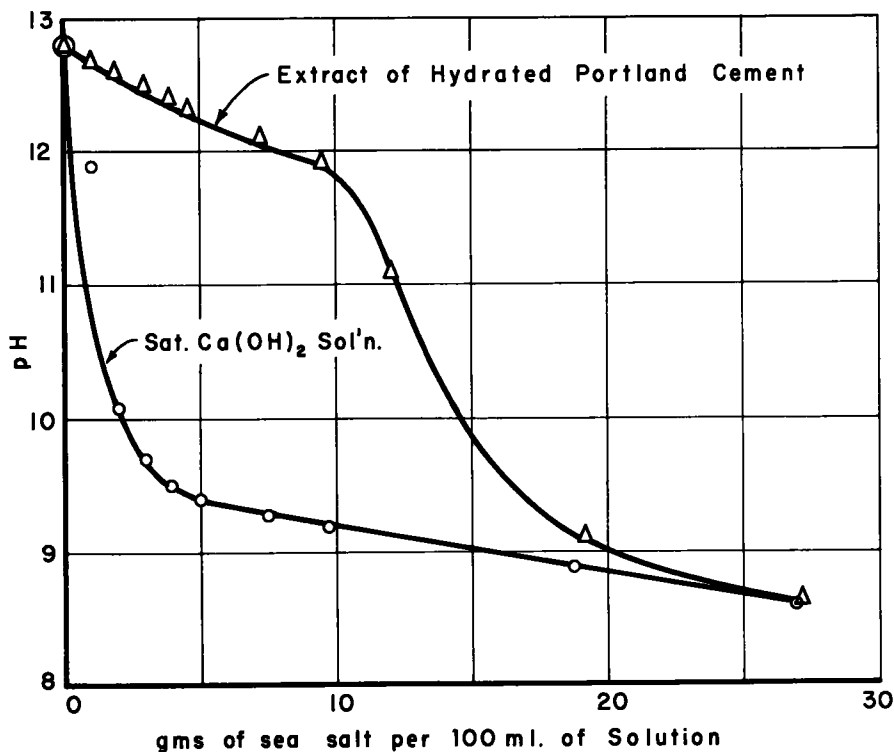
Figure 24. Effect of sea salt on pH of calcium hydroxide solution and hydrated Portland cement extract.

Examples of the possible range in pH are shown by Figure 24. Evaporated sea salt was added to the solutions indicated. The extract of hydrated portland cement was prepared from a hardened neat cement paste of Type I cement, containing 1.10 percent alkalis, similar to that used in the bridge. The hardened paste was oven dried and granulated. It was continuously agitated for three days in sufficient water to bring the total amount to 7½ gal. per sack of cement. After filtering, varying amounts of sea salt and a small amount of hydrated cement were added to portions of the extract.

Each sample was then analyzed for chlorides and calcium hydroxide in solution. The data (Fig. 24) represent only one series of tests and the shape of the curve has not been verified.

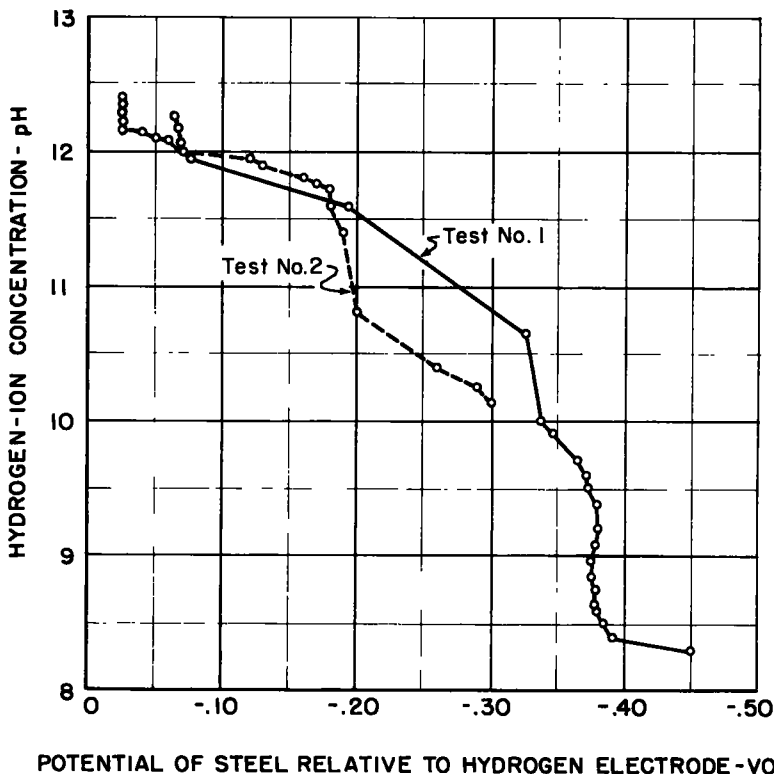
Figure 25. Potential of steel in cement extract solution of variable pH by addition of sea salts.

tial of a steel electrode relative to the calomel-cell has been determined. Adjusted results relative to the hydrogen cell are shown in Figure 25. In an extract containing no sea salt and having a pH of 12.5 the half-cell potential of the steel was approximately that of the hydrogen electrode. At pH 10, it was about -0.43v relative to the hydrogen cell. This value is close to that of iron going into solution in the ferrous state. The results indicate that salt can destroy the protective effect of normal concrete against the corrosion of steel.

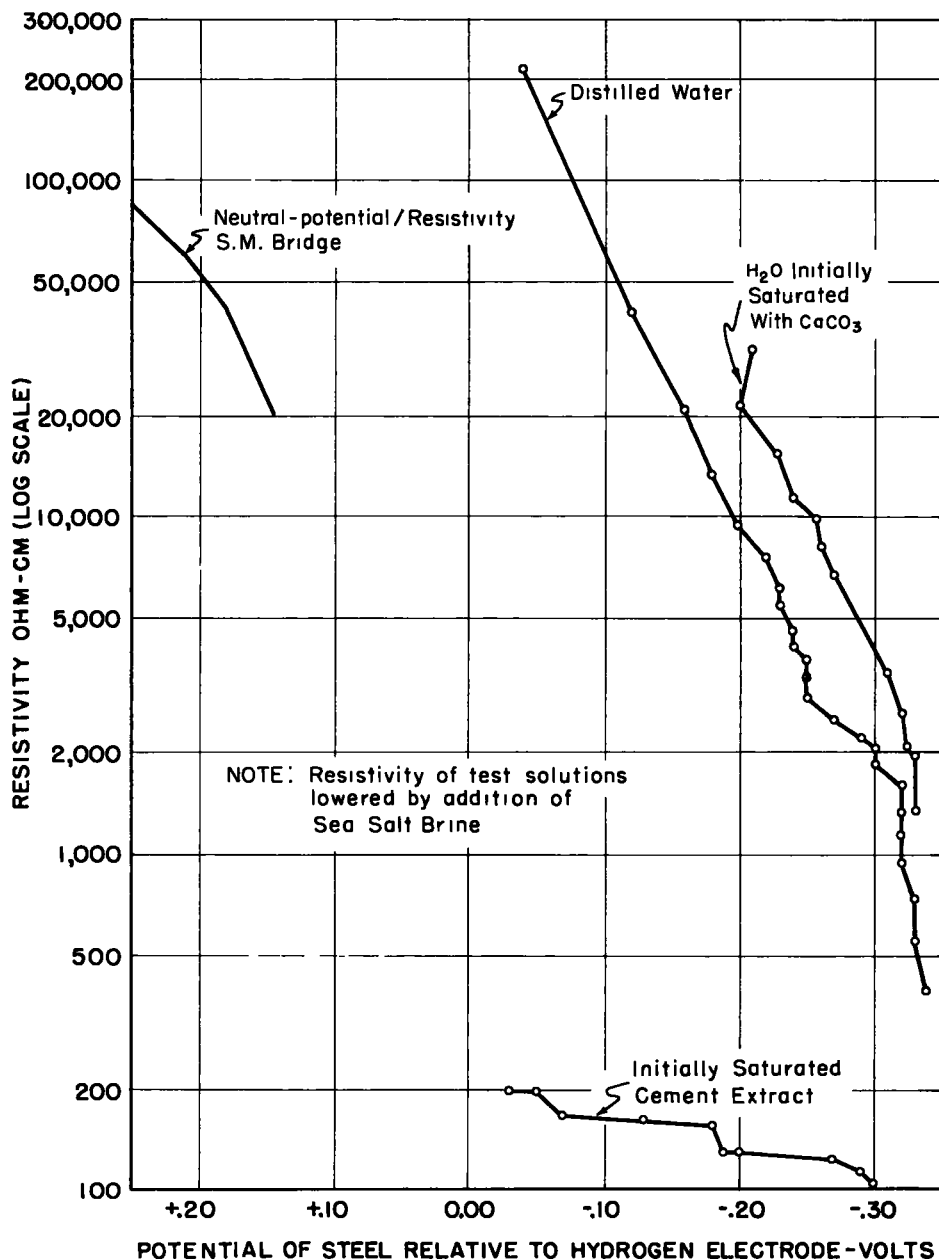
Figure 26. Potential of steel in solutions of variable resistivity by addition of sea salts.

Figure 26 is presented as experimental evidence that there is an interrelationship

between salt content, electrode potential, and resistivity, and thus suggests the possibility of using measurements of two of these factors to estimate the third. It is evident however, that calibration curves applying to the particular materials involved must be established before the unknown value can be estimated with accuracy.

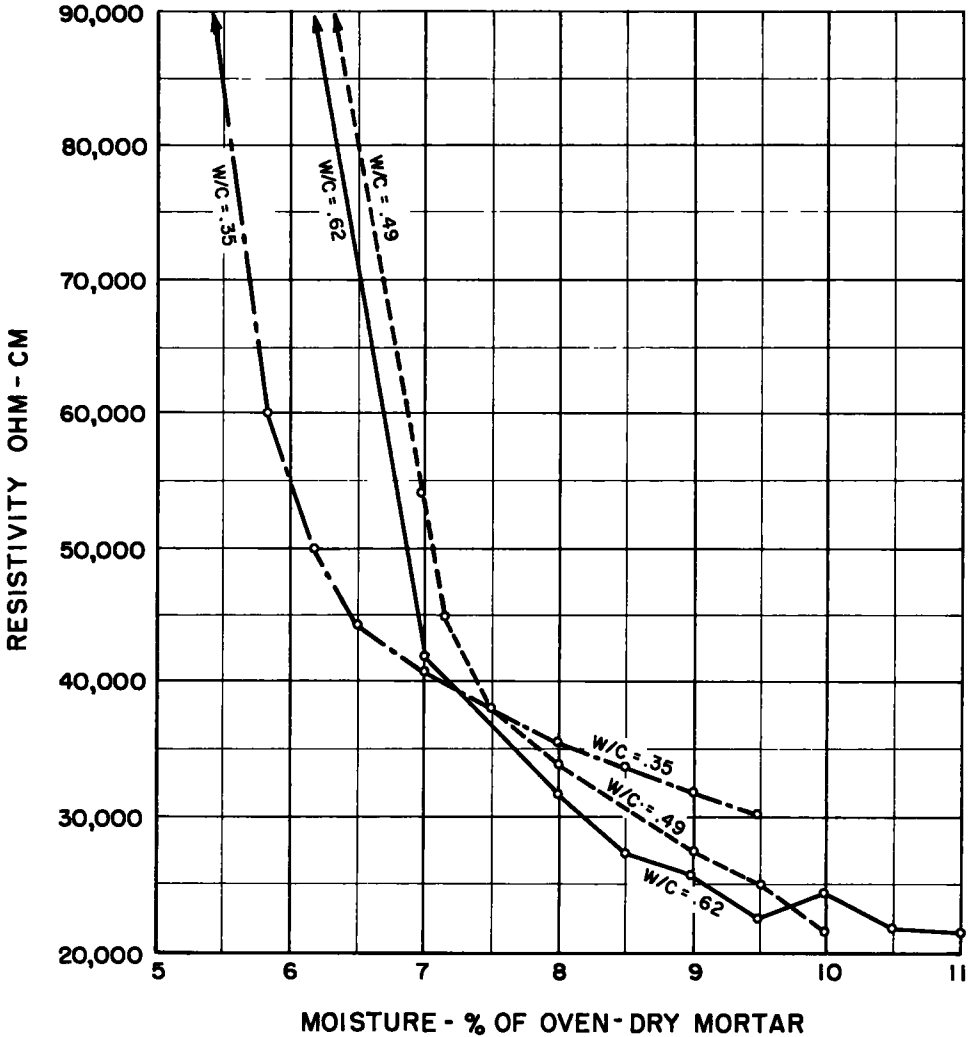
Figure 27. The effect of water cement ratio on the resistivity of mortar at various moisture contents (all salt contents averaged).

pressed as chloride ion in percentage by weight of air-dry mortar. The specimens were allowed to dry slowly in air and at intervals the loss in weight and resistivity was determined. Finally, the specimens were oven dried. Figure 27 shows that water-cement ratio, of itself, has less effect on resistivity than does change in moisture content due to drying. Likewise, Figure 28 shows that salt content is of minor effect on resistivity unless it exceeds 0.25 percent. The relative degree of saturation of the concrete is the major factor that determines its resistivity.

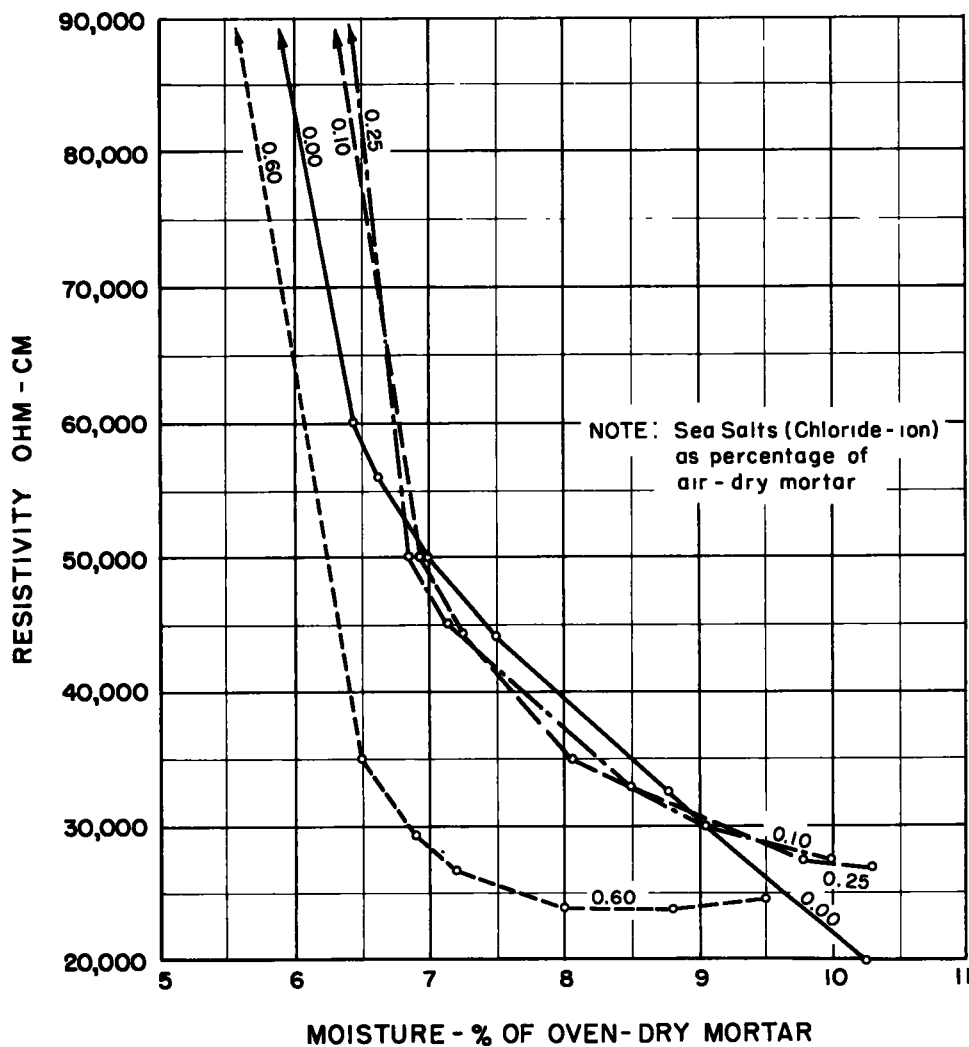
Figure 28. The effect of sea salts on the resistivity of mortar at various moisture contents (all water-cement ratios averaged).

which concrete containing sea salt will inhibit corrosion of the reinforcing steel. It will be recalled that in the discussion of resistivity and deterioration (Fig. 19) it was stated that cracks had not appeared in concrete of the bridge when its resistivity exceeded about 60,000 ohm-cm. Figures 27 and 28 indicate that in the cement mortar test specimens, the resistivity exceeded 60,000 ohm-cm when the moisture content was less than about 6 or 7 percent above its oven dry content. Since mortar ordinarily comprises about one-half the weight of concrete, it is indicated that if concrete containing salt does not contain more than 3 to  $3\frac{1}{2}$  percent of moisture above its oven dry
