A Ten-Year Report on the Illinois Continuously-Reinforced Pavement

J. D. LINDSAY, Engineer of Materials,
Illinois Division of Highways, Springfield, Illinois

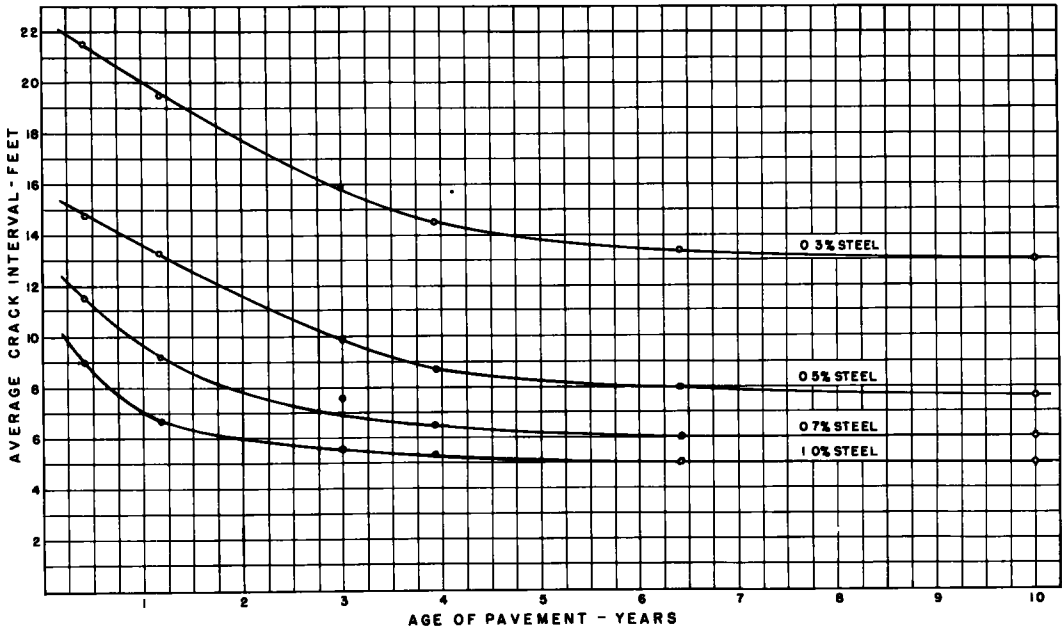
Figure 2. Relationship between average transverse crack interval and age, 7-in. pavement.

in March 1948 after the sections had gone through one winter and were less than six months old. Other surveys were made at approximately 1, 3, 4, 6, and 10 years. This chart shows a definite relationship between frequency of cracks and percentage of steel. Taking the results of the first survey as an example, the average crack intervals were 21.5 ft for the 0.3 percent section, 14.8 ft for the 0.5 percent section, 11.5 ft for the 0.7 percent section, and 9.0 ft for the 1.0 percent section. Expressed as frequency, these values correspond to 4.6, 6.8, 8.7, and 11.1 cracks per 100 ft. Similar relationships are also apparent for the data from the other surveys.

Another significant relationship shown by Figure 2 is that between crack development and age. It is seen that for each section the average crack interval decreased at a rather rapid rate for the first 3 or 4 years and afterward cracks developed at an increasingly slower rate until, at about 6 years the curves became very flat. It can be concluded, therefore, that transverse cracking has practically reached its equilibrium after 10 years and, barring unforeseen structural failures, few new transverse cracks may be expected to occur during the service life of the pavement. It is also apparent from Figure 2 that the development of transverse cracks approached an equilibrium somewhat earlier in the more heavily reinforced sections. The behavior of the 8-in. pavement sections with respect to crack development has been similar to that of the 7-in. sections, as shown by Figure 3.

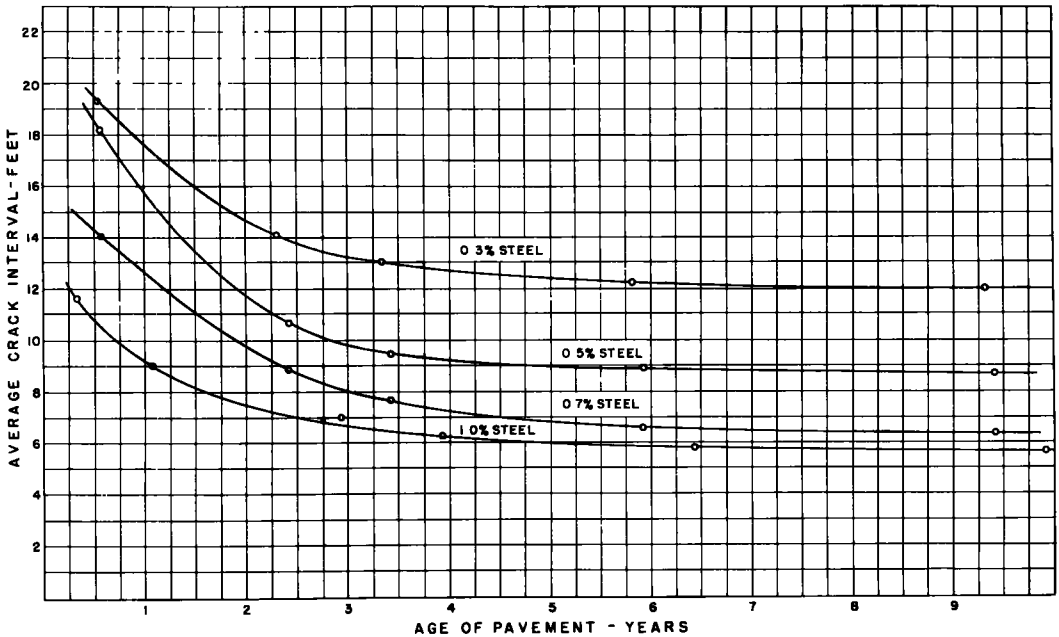
Figure 3. Relationship between average transverse crack interval and age, 8-in. pavement.
