Ten-Year Report on Experimental Continuously-Reinforced Concrete Pavements in New Jersey

WILLIAM VAN BREEMEN, Research Engineer,
New Jersey State Highway Department

This paper reports on the behavior and performance of two experimental sections of continuously-reinforced concrete pavement constructed in New Jersey in 1947. These sections, each approximately 1 mi long, have been subjected to relatively heavy truck traffic.

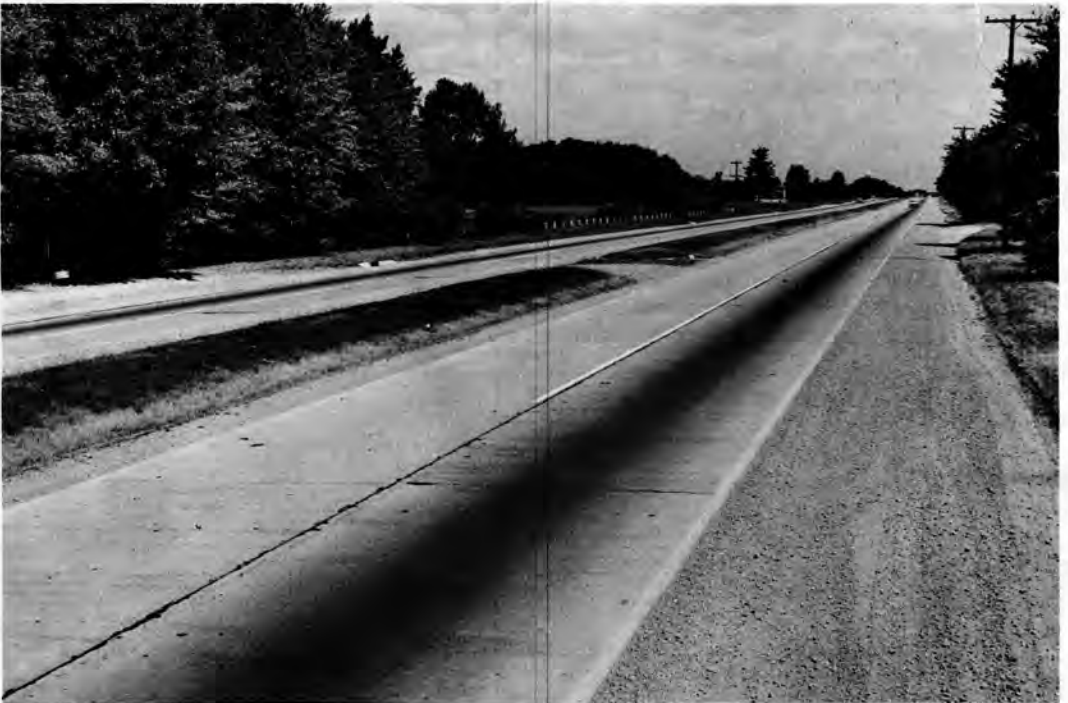
Figure 2. Eight-inch section looking north.

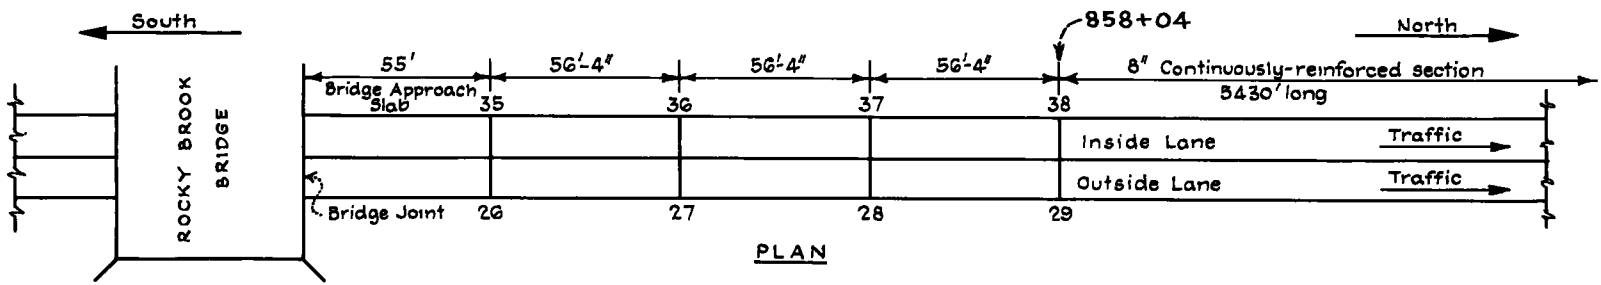
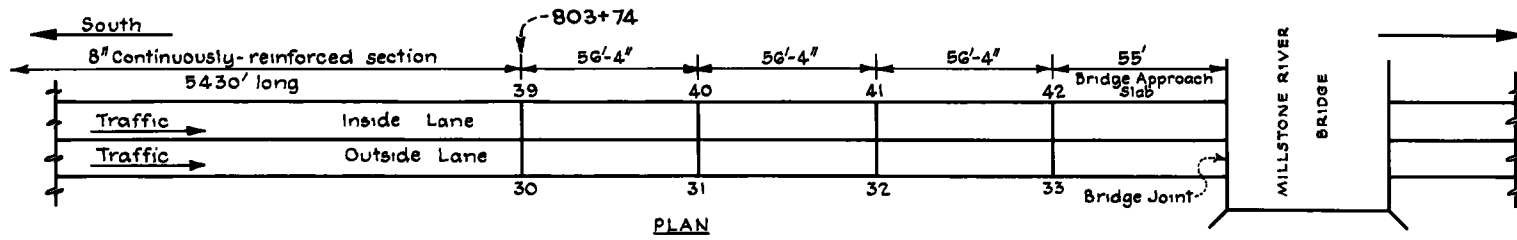
As previously indicated, the largest amount of displacement (1.69 in.) has occurred in connection with the slab adjacent to the south end of the outside lane of the 8-in. section. As shown in Figure 6, this displacement has resulted in considerable closure of Joints 26, 27, and 28, immediately to the south. It has also resulted in about 1 in. of closure of the joint adjacent to the bridge over Rocky Brook. It will also be noted that a similar action has taken place in the inside lane, but to a lesser degree. It therefore is apparent that all of the pavement adjacent to the south end of the 8-in. section has been moved an appreciable amount toward this bridge. And from the data shown in Figure 7 it is apparent that a similar displacement has taken place in connection with the pavement adjacent to the north end.

Figure 6. Pavement adjacent to south end of 8-in. continuously-reinforced section.

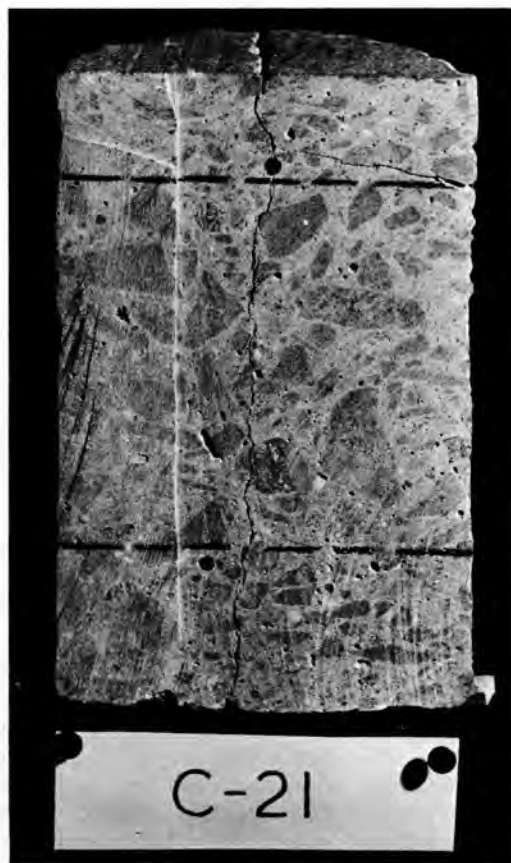
Figure 13 shows a core (C-21) obtained at 905+22 in the outside lane of the 10-in. section. It will be noted that in this core the crack, although very narrow, is traceable clear to the bottom. There was a slight sag in the grade line where this core was obtained, and this may account for the more or less uniform crack width below the upper line of steel. As in the case of Core C-2, this crack also occurred at a transverse member in the upper line of steel. Apparently this is typical of a great many of the cracks.

Figure 13. Core at crack in 10-in. section, Sta. 905+22.

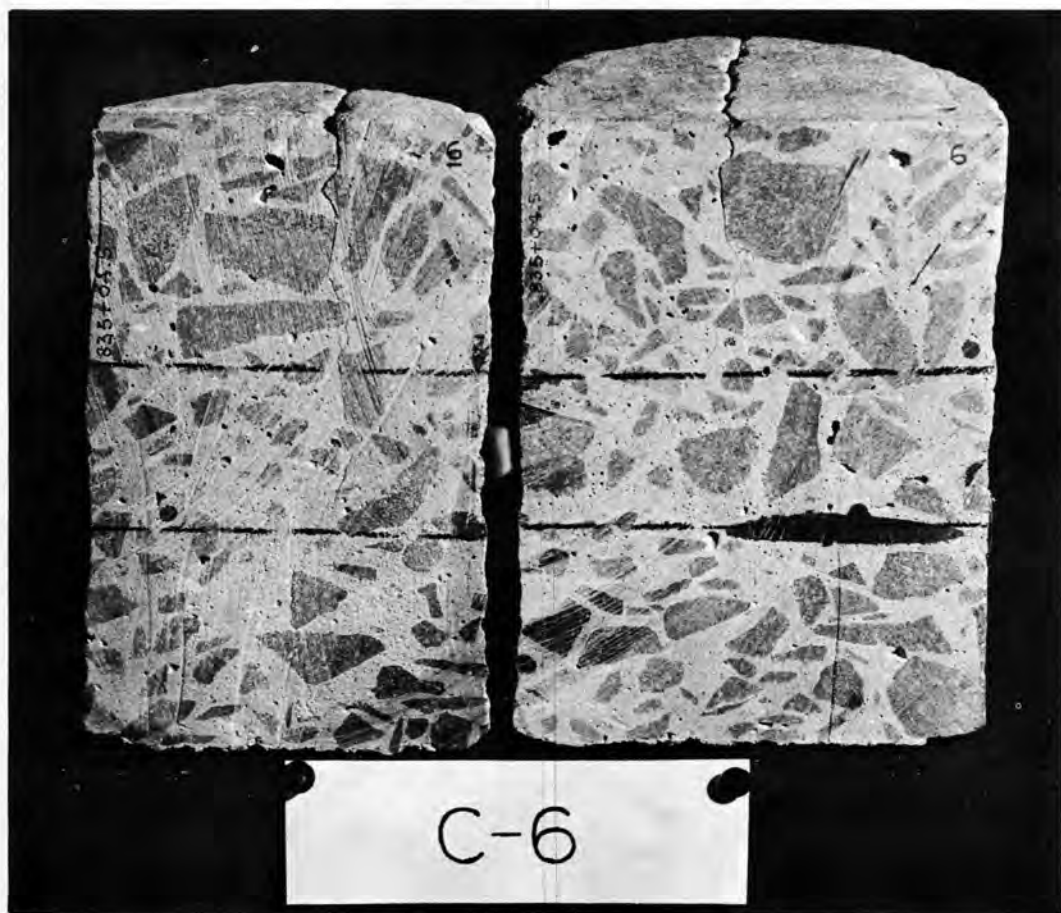
The core (C-6) obtained at this crack is shown in Figure 16, which also shows a thin slice of concrete sawed from the outer surface of the core. Oddly enough, despite the fact that there was no steel holding this slice together, it did not come apart at the crack. It was subsequently determined, however, that the slice was held together by about 2 in. of concrete near the bottom, notwithstanding the presence of a crack of microscopic width through this concrete.

Figure 16. Core at crack in 8-in. section, Sta. 835+04.5.
