# Latex-Modified Mortar in the Restoration of Bridge Structures

S. M. CARDONE, M. G. BROWN, and A. A. HILL, Respectively,  
Chief, Maintenance Operations Division and Chemical Engineer, Michigan State  
Highway Department; and Coatings Technical Service, Dow Chemical Company

A synthetic latex emulsion admixture was used with portland cement mortar in thin patching mixtures. Laboratory study showed improvement in shear bond strength, compressive strength, tensile strength, and a reduction of water-cement ratio as compared to regular mortar. The latex emulsion was added in amounts of 10 to 20 percent based on latex solids to cement weight. It was used in mortars having sand-cement ratios of 3:1 and 2:1 by weight.

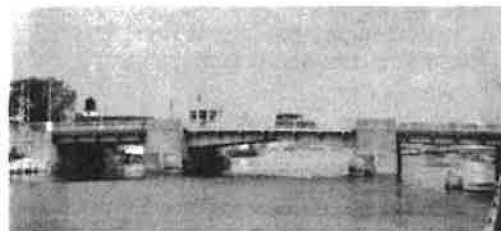
Figure 1. Bascule bridge on US 23, Cheboygan, Michigan.

Technical assistance was given by the manufacturer, and measurements and pictures taken by the Research Laboratory Division of the Office of Testing and Research. The structure chosen for this field test was a three-span bascule bridge over the Cheboygan River on US 23 in Cheboygan, Mich., Project B1 of 16-3-7 (Fig. 1).

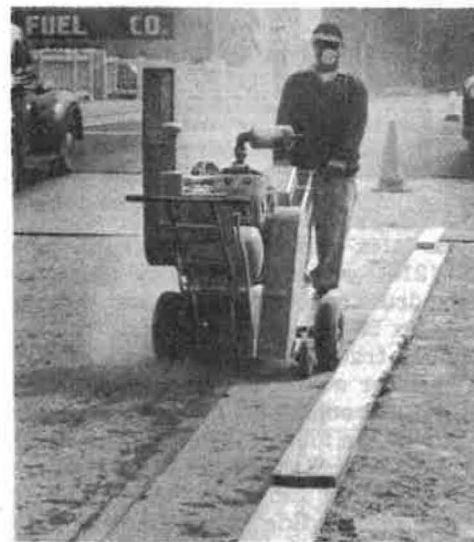
Figure 4. Cutting machine used to remove minimum of  $\frac{1}{2}$  in. of scaled concrete.

four-lane roadway with two 5-ft sidewalks, consisting of about 58 ft of concrete roadway at each end of 38 ft of open steel grid. It was built in 1940, with crushed limestone coarse aggregate, natural sand, and non-air-entrained cement. The roadway had become badly scaled from weathering and de-icing salts, and highly polished from traffic (Fig. 3). The unsound and scaled surface was removed with a cutting machine (Fig. 4), so that a latex-portland cement mortar layer of  $\frac{1}{2}$ -in. minimum thickness could be applied. Some areas of the filled-grid walk sections were chipped out to squared edges (Fig. 5). Small air chisels and sandblasting equipment were also used to prepare the deck for thin patching. Narrow steel strike-off bars were greased and set with anchor bolts along the edge of each lane, so that the proper depth of patch and crown of the deck surface would be maintained during screeding and finishing operations. These bars were removed after the latex-cement mortar had cured.

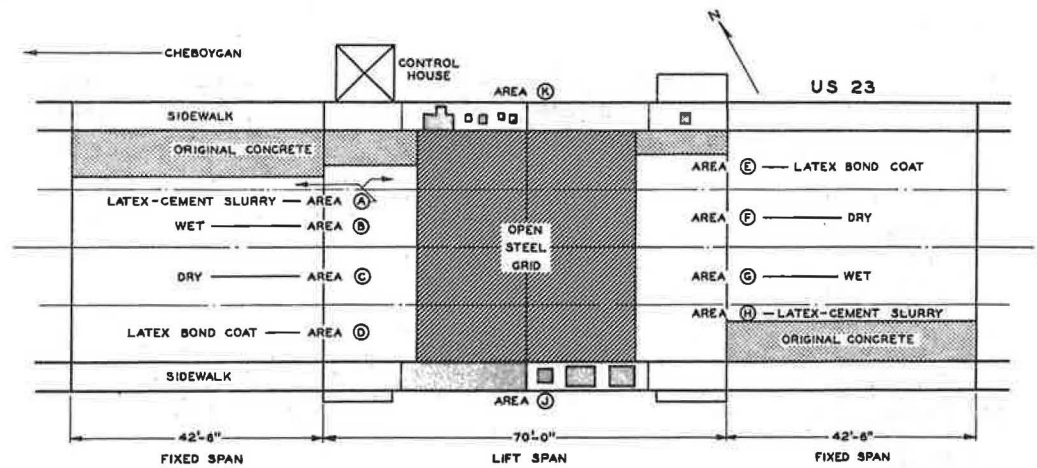
During the four days in September 1957 when thin patching was applied, a total of six loads of transit mixed latex-cement mortar were used. Data on these mixes are summarized in Table 2. The locations on the bridge, coded by letters, and the surface preparation where these mixes were placed are shown in Figure 7. Small cylinders and beams were made from the first batches of September 18 and 19; strength and durability results for these specimens are given in Table 3.

Figure 7. Placement of Latex 560 mortar mixes in September 1957 (see Table 2) with four types of substrate treatment.

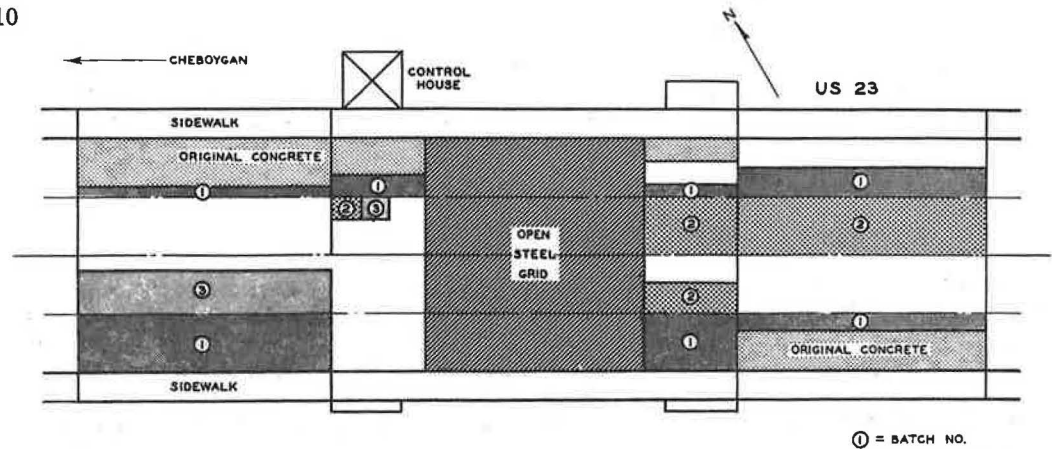
Figure 12. Placement of Latex X2130.1 mortar mixes in October 1958 (see Table 4).

All these loosened areas were removed and cleaned with pneumatic chisels and sandblasting. It was decided that these areas should be repaired using a latex-cement mortar containing the newer X2130.1 experimental latex emulsion. The tests reported in Table 1 had shown that this latex emulsion was superior to Latex 560 in some properties; in particular, the shear bond strength was about double.

On September 27 and October 6, 1958, the Latex X2130.1-cement mortar was used to replace all the loosened areas. The materials were handled and mixed essentially the same way as in September 1957. Mix data for the three mortar batches involved are given in Table 4 and the deck placement is shown in Figure 12. The deck areas to be replaced were cleared of loose patch material and then washed and soaked with water just before resurfacing.
