# HIGHWAY RESEARCH BOARD

Bulletin 260

***Repair of Structures and Pavement by  
Thin Concrete Patching***

# Latex-Modified Mortar in the Restoration of Bridge Structures

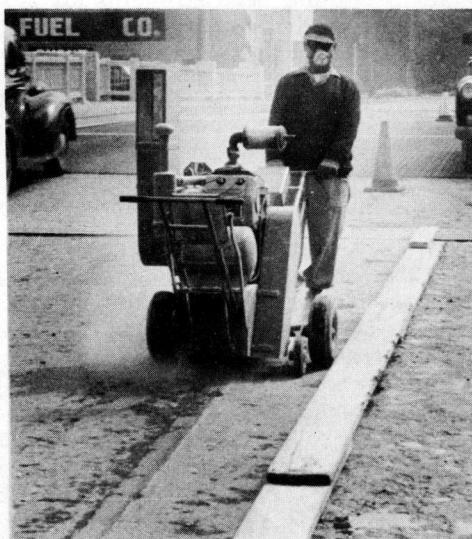
Figure 4. Cutting machine used to remove minimum of  $\frac{1}{2}$  in. of scaled concrete.

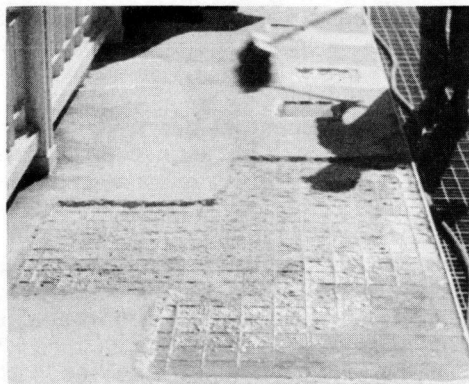
Figure 5. North sidewalk patches chipped to squared edges.

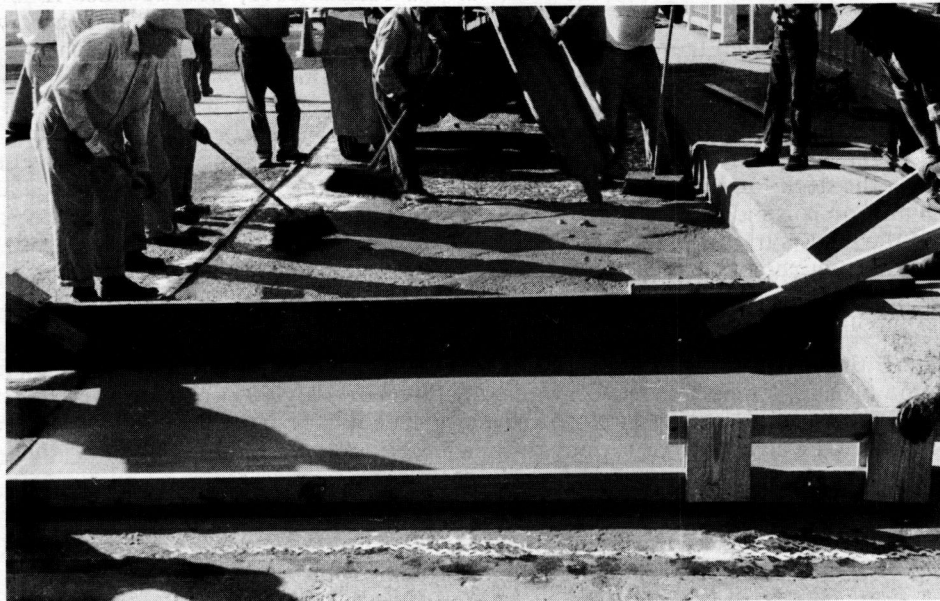
Figure 6. Typical placement and finishing procedure for latex-cement mortar.

The latex-cement mixes were made in a standard transit mix truck with moist sand (2NS) weighed and loaded first. The necessary bagged Type I cement was added as the drum continued to rotate. After mixing the sand and cement for 10 to 15 min, the Latex 560 was added from 55-gal drums, using a hoist truck. Mixing continued while the transit mix truck was traveling the few blocks from plant to bridge site. Little water was added, because about 6 percent water was contained in the sand. Typical placement and finishing are shown in Figure 6.

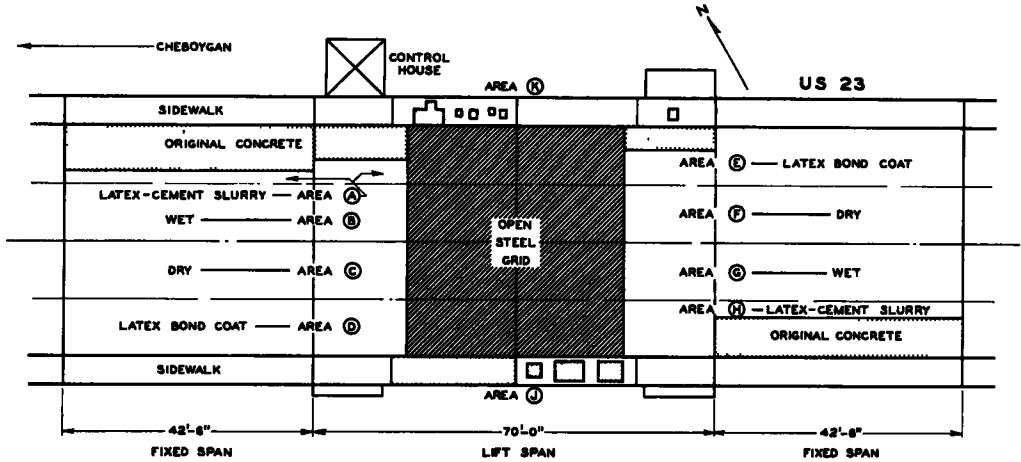
During the four days in September 1957 when thin patching was applied, a total of six loads of transit mixed latex-cement mortar were used. Data on these mixes are summarized in Table 2. The locations on the bridge, coded by letters, and the surface preparation where these mixes were placed are shown in Figure 7. Small cylinders and beams were made from the first batches of September 18 and 19; strength and durability results for these specimens are given in Table 3.

Figure 7. Placement of Latex 560 mortar mixes in September 1957 (see Table 2) with four types of substrate treatment.

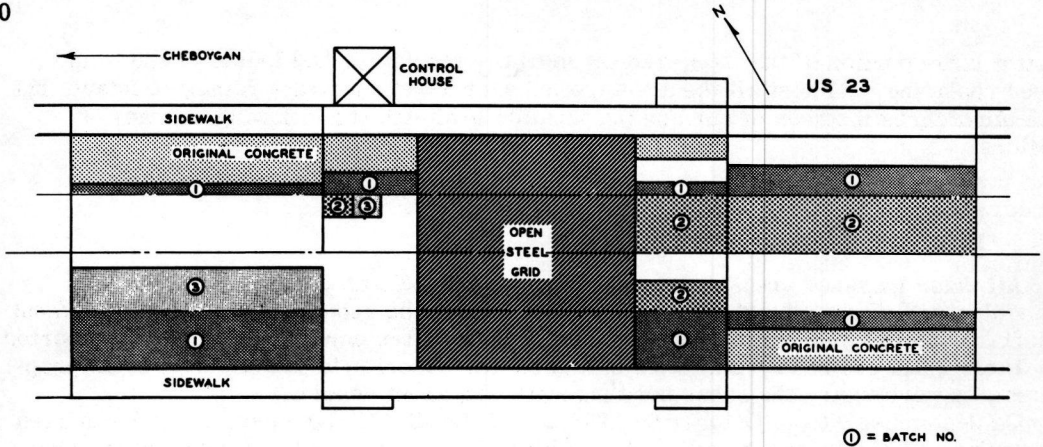
Figure 12. Placement of Latex X2130.1 mortar mixes in October 1958 (see Table 4).

The pour of September 27, 1958, was placed and finished during intermittent rain and the surface required some refinishing after 2 or 3 hr. Some shrinkage cracks were noted in various areas of this pour. All three pours had a considerable amount of rain during their 7-day curing period.

On September 27 and October 6, 1958, the Latex X2130.1-cement mortar was used to replace all the loosened areas. The materials were handled and mixed essentially the same way as in September 1957. Mix data for the three mortar batches involved are given in Table 4 and the deck placement is shown in Figure 12. The deck areas to be replaced were cleared of loose patch material and then washed and soaked with water just before resurfacing.

About 5 percent diethylene glycol was added to the mortar to increase the finishing time and reduce the tendency of the latex mortar to skin over and produce shrinkage cracks. The glycol reduced but did not entirely eliminate this tendency.

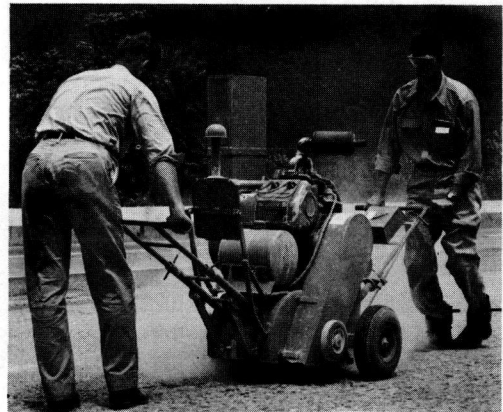
Figure 2. Tennant machine used for cleaning joints and grinding surface.

Sealer was removed from the joints by plowing with an improvised "foot" mounted on the front of a light tractor, followed by two or more passes of a Tennant machine adjacent to the joints (Fig. 2), supplemented by hand-operated spud bars. Experience had indicated that sand blasting is also effective for final cleaning of joints after use of the Tennant machine.

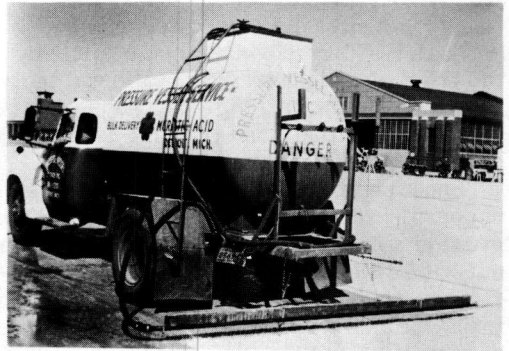
Figure 3. Tank truck used for distributing muriatic acid.

The commercial muriatic acid (27.9 percent HCl) was delivered to the job by tank truck which was equipped with a 12-ft spreader bar (Fig. 3). A force pump on the truck supplied pressure for distribution which was regulated by the forward speed of the truck to give an application of 1 gal of acid per 100 sq ft on the pavement surface which has been previously wetted. It should be noted that this is a minimum requirement. Felt recommends 1 gal of acid per 60 sq ft of pavement. As soon as all visible etching or foaming action ceased, the pavement was scrubbed with a mechanical broom and flushed with water until it showed a neutral reaction to pH paper. Because the product of acid reaction forms a jell if left long on the concrete, it is important that the surface be cleaned by flushing and scrubbing as soon as the foaming action stops.

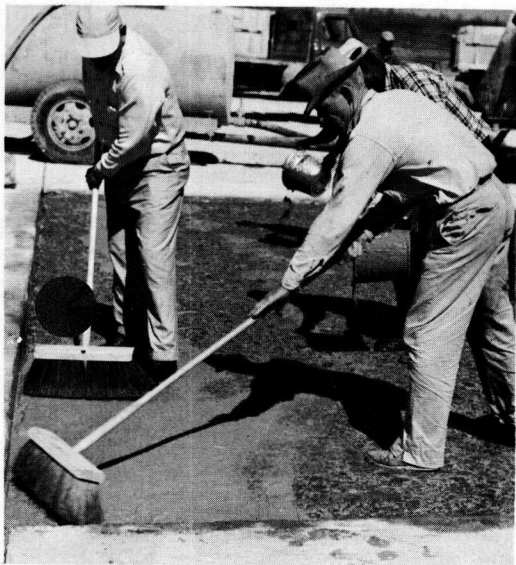
Figure 4. Spreading bonding grout.

Just ahead of placing concrete, a 1 to 1 sand-cement grout was applied to the old pavement surface (Fig. 4). The sand used in this mixture had been screened to remove the plus  $\frac{1}{8}$  particles. The grout was mixed to a heavy paint consistency in a paddle-type mixer, carried to the paving lane in buckets and scrubbed onto the damp but not wet surface with rattan stable brooms. A coating of about  $\frac{1}{16}$  in. was left on the surface. Any excess grout in transverse and longitudinal joints was redistributed with a warehouse broom. It should be mentioned that the pneumatic method of placing bonding grout has been successfully used. This method of application requires expert operation in order to control rebound and accumulation of the coarser sand particles along the form lines in a concentration likely to prevent bond. The lack of skilled operators and of proper pneumatic equipment dictated the use of hand methods of grout application on the Selfridge project.

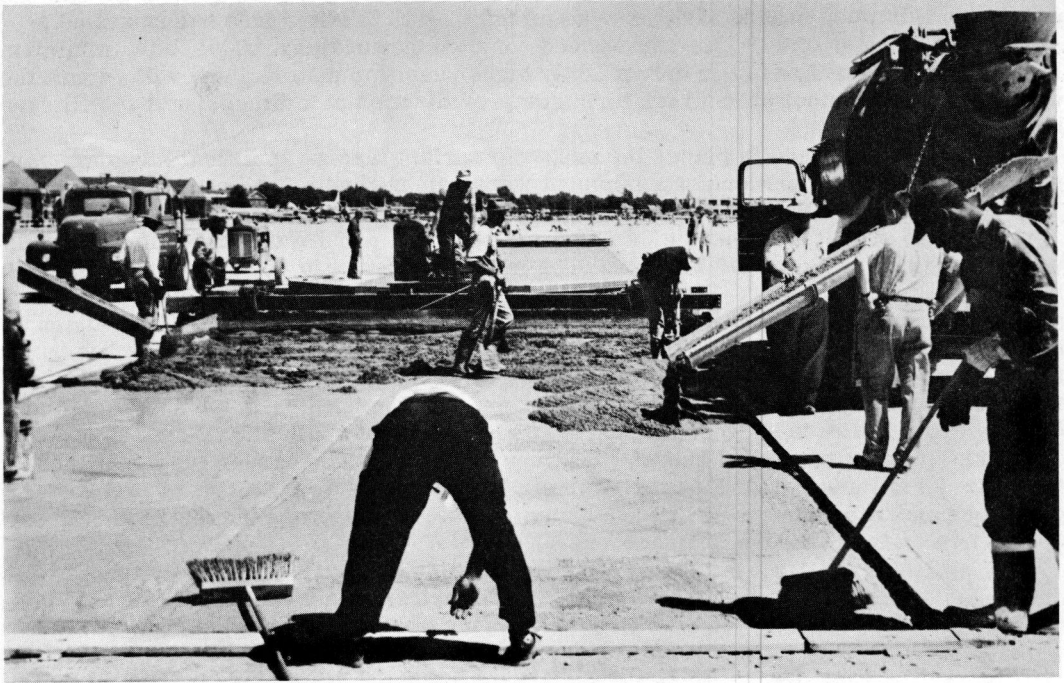
Figure 5. Concrete delivered to both sides of paving lane by transit mixers.

Ready-mix concrete was delivered to the site by transit mixers, two scheduled to arrive on the job and place concrete at the same time from each edge of the paving lane (Fig. 5). Each mixer carried 5 to 6 cu yd of concrete made from  $\frac{1}{2}$ -in. maximum size crushed dolomite, 60 percent by weight of natural sand and  $7\frac{1}{2}$  bags of portland cement per cu yd. Mixing water was proportioned to give a net water content of 5 to 5.1 gal per bag of cement and a slump of 4 to 5 in. which was necessary for discharging from the mixer and for placing and finishing the resurfacing concrete. Sufficient air-entraining agent was added at the batching plant to produce an air content of 7 to 8 percent.

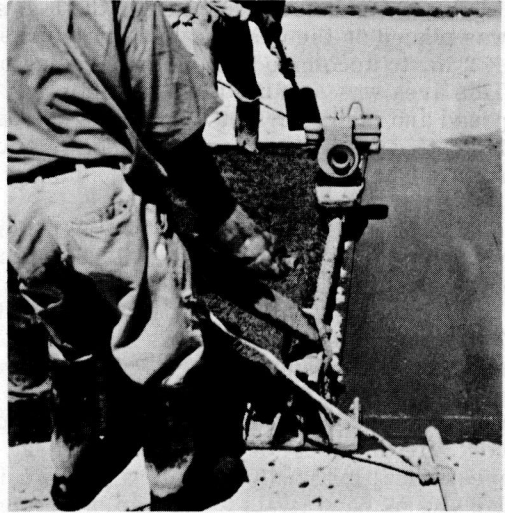
Figure 7. Hand-operated vibrating screed used at Standiford Field, Louisville,

The approximately 8,000 sq yd of bonded resurfacing was constructed using the techniques previously described. Defective surface material was removed from the old concrete by mechanical means and the prepared surface was etched with muriatic acid. Four-inch metal sidewalk forms were used on the 12½-ft paving lanes as the contractor elected to set forms to conform to the longitudinal joints in the old pavement. The concrete was struck off and consolidated by use of a hand-operated vibrating screed (Fig. 7).

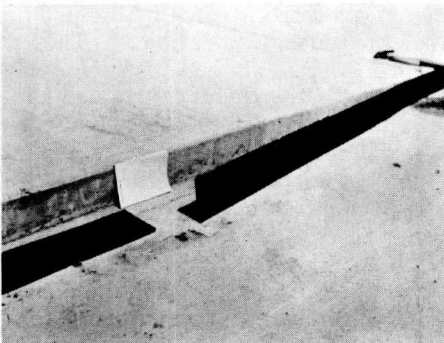
Figure 8. Full-depth joint inserts used in longitudinal construction joints at Standiford Field.

Longitudinal joints were formed by a full depth fiberboard insert which was tacked to slab edges prior to placement of the alternate fill-in lanes (Fig. 8). About 1 in. of the insert was later sawed out to form a reservoir for joint sealer. Expansion joints were formed over existing expansion joints by use of a nonextruding joint filler. Contraction joints were sawed at the joint locations in the old pavement.

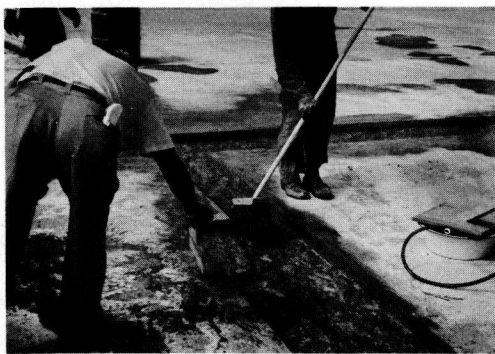
Figure 10. Prepared patch receiving acid treatment. Note improvised acid dispenser at right.

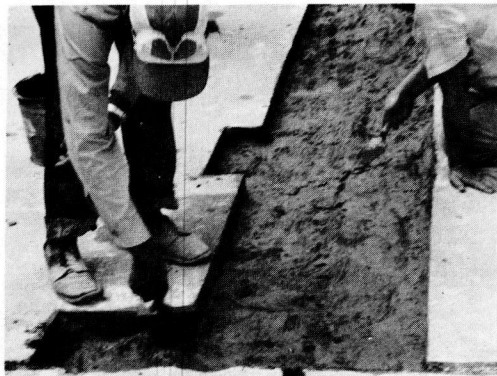
Figure 11. Applying bonding grout prior to placing patch.

Acid was removed from the excavations by first filling the depression with water then applying a high pressure jet to blow out the acid water and clean the surface. This was continued until a neutral reaction to litmus paper was obtained. A 1:1 sand-cement grout was brushed into the surface, including the vertical faces of saw cuts (Fig. 11).

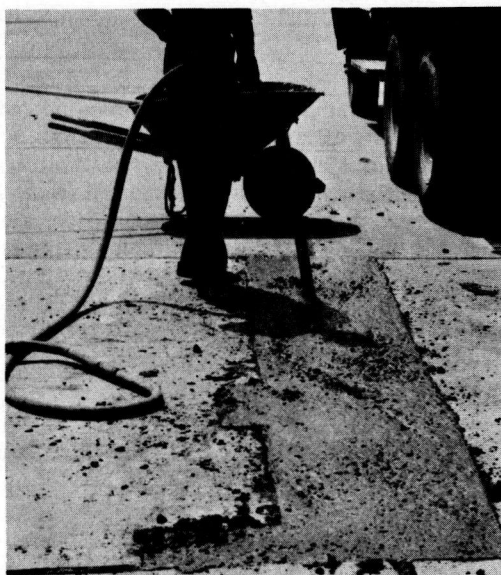
Figure 12. Hand vibrator used to consolidate concrete in patch.

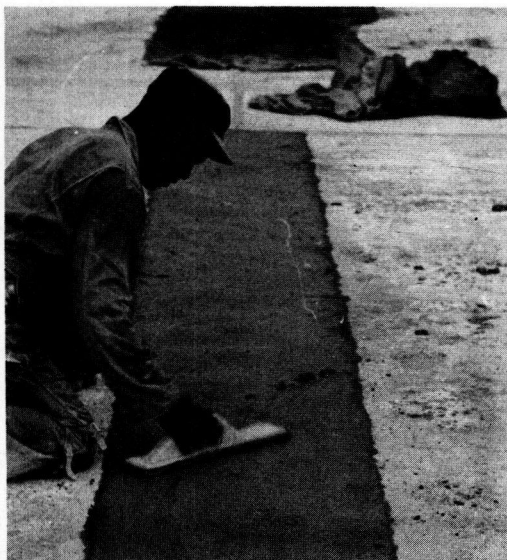
Figure 13. Finishing patch with hand float.

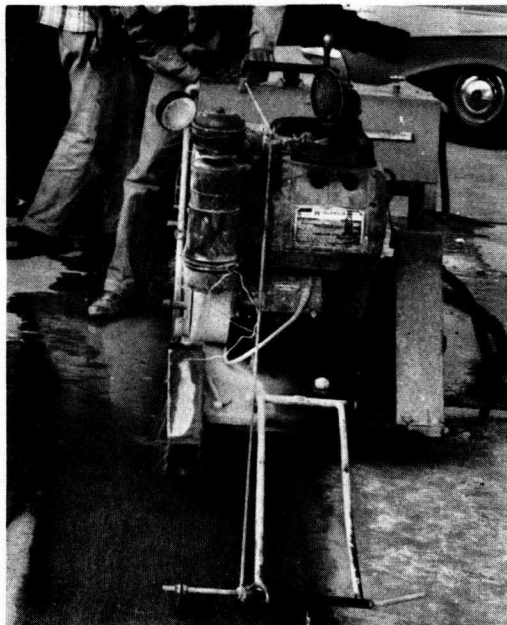
Figure 14. Sawing patch placed on both sides of joint.
