# ***Dynamic Full-Scale Tests of Median Barriers***

JOHN L. BEATON AND ROBERT N. FIELD, respectively, Supervising Highway Engineer, and Materials and Research Engineering Associate, Materials and Research Department, California Division of Highways, Sacramento

Full-scale dynamic tests were made of 15 proposed designs of traffic barriers for use in median areas. Of these, two proved to be worthy of trial installations.

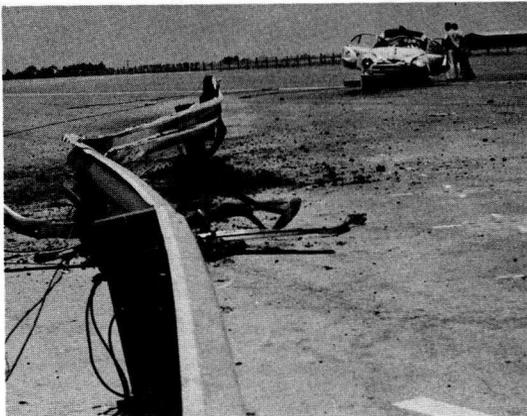
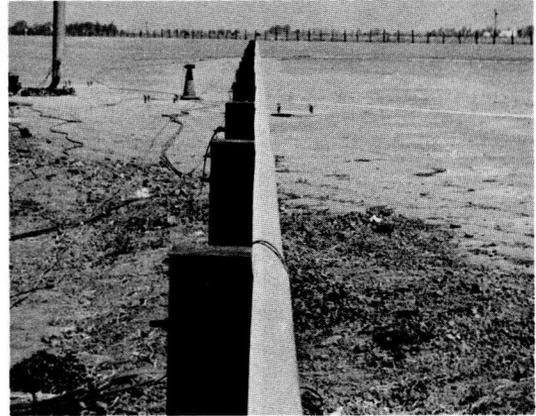
Figure 3. Test data information sheet

Tests No. 1 and 2 (Figs. 3 and 4) were typical highway guardrail installations. In neither of these tests did the car pass over the barrier; however, the collision with the spring-mounted, curved-beam type resulted in the test car rolling along the top of the rail. Indications were that the car could have bounced across as well as coming to rest on the rail. The curved beam (Fig. 4) tended to pocket the car during impact whereas the corrugated beam (Fig. 3) formed a smooth curve and reflected the test car away from the rail. The necessity for good beam strength in metal-beam guardrails was well illustrated by these two tests which coincide with the findings of others (4).

| BRACKET ..... | None | GUARDRAIL DAMAGE ..... | 3 Sections damaged beyond repair. | DATE ..... | 7-10-58 |
| POST ..... | 8x8 D.F. | POST DAMAGE ..... | 2 Posts damaged beyond repair. | VEHICLE ..... | Chev. 52 Sedan |
| LENGTH OF INSTALLATION... | 212.6' | VEHICLE DAMAGE ..... | Total loss | IMPACT ANGLE..... | 27° |
| GROUND CONDITION ..... | Dry | MAX. DYNAMIC DEFLECTION OF RAIL... | 48" | VEHICLE WEIGHT... | 3980 |

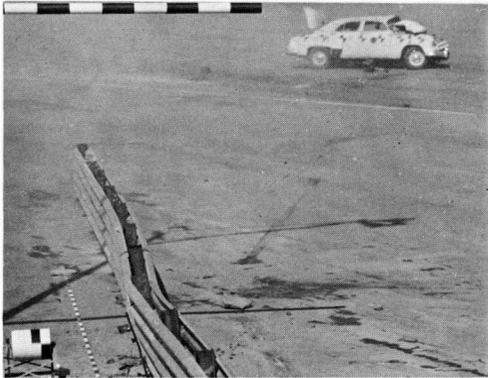
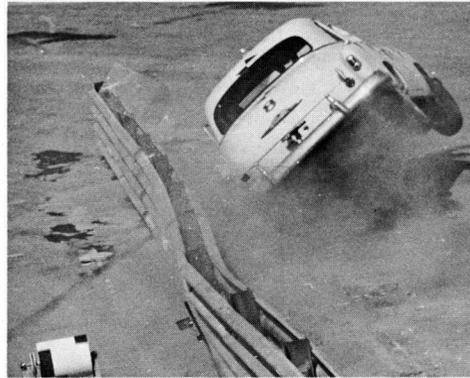
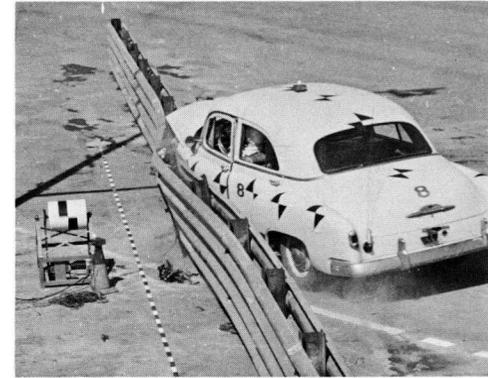
Figure 10. Test data information sheets.

Test No. 8 (Fig. 10) made use of a double corrugated-metal rail mounted at an over-all height of 34 in. on each side of the steel post system so as to solve the entrapment problem. It did, but at the same time imparted a corkscrew rolling action to the car which resulted in the car tumbling on down the roadway similar to the 25-in. mounting height. This test seemed to verify that when no provision is made to prevent the rail from being downed with the posts, no matter what the height, it will impart a rolling tendency to the vehicle. In other words, to prevent roll the car must go under the rail so that the reaction of the rail on the car is downward.

DUMMY INJURY ..... Severe head, shoulder & arm injuries.  
 Multiple lacerations & concussion.  
 GUARDRAIL DAMAGE ..... 2 Sections damaged beyond repair.  
 POST DAMAGE ..... All can be repaired.  
 5 Posts out of alignment.  
 VEHICLE DAMAGE ..... Total loss.  
 MAX. DYNAMIC DEFLECTION OF RAIL... 15"

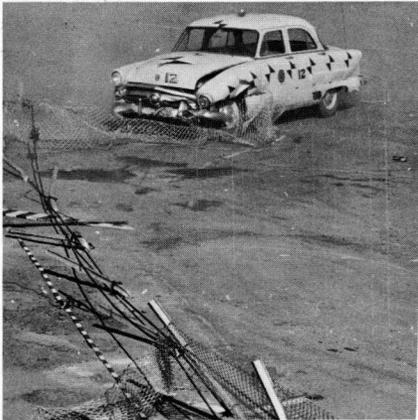
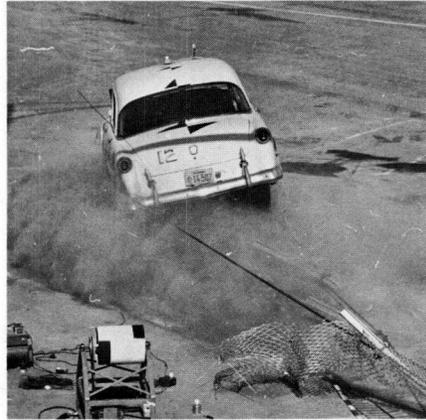
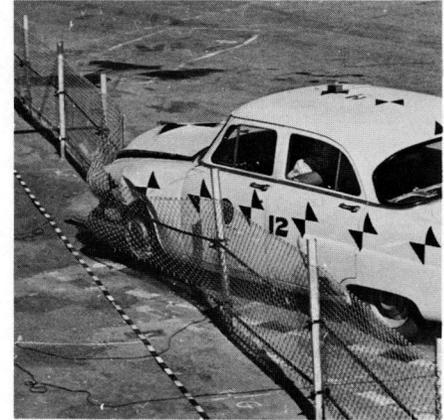
Figure 14. Test data information sheets.

DUMMY INJURY ..... Possible neck injuries & minor bruises.  
 GUARDRAIL DAMAGE ..... 50' of Fence knocked out. No damage  
 to Cable.  
 POST DAMAGE ..... 7 Posts damaged beyond repair.  
 6 Posts Bent.  
 VEHICLE DAMAGE ..... \$ 600.  
 MAX. DYNAMIC DEFLECTION OF RAIL .. 7' - 2"  
 VEHICLE DECELERATION (PEAK).... Long. 69 G ... Transv. 154 G  
 DUMMY DECELERATION (PEAK).... Long 7 G ... Transv. 9.5 G

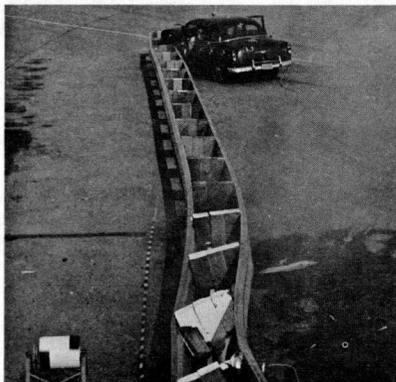
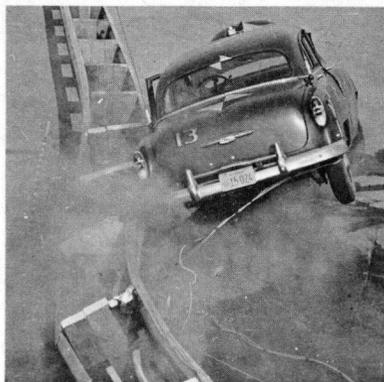
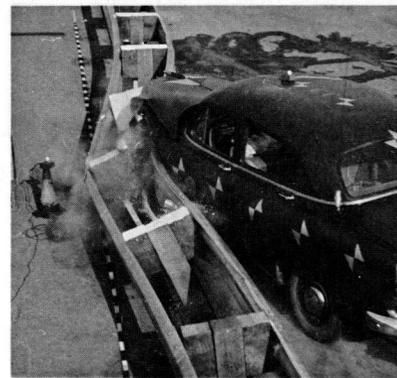
Figure 15. Test data information sheets.

The efficiency of the design used for Test No. 13 (Fig. 15) in lessening the chances of injury-producing impacts apparent in other tests on corrugated-beam guardrail mounted 30 in. above the ground is illustrated by the deceleration patterns shown in Figure 30. Note that the moderately high transverse Gs on the dummy occur when the vehicle is still in contact with the rail. It is apparent that the human body can sustain these moderate transverse Gs, taking the full load against the shoulder and arm, with less chance of critical injuries than the high longitudinal Gs which usually throw the occupant against the steering column and windshield.

blocked out guardrails used on the New Jersey Turnpike, led to the design shown in Figure 24. Here the rail is blocked out on timber posts and has a lower rail to prevent undercarriage entrapment. The 30-in. high blocked out design minimizes the rollover tendency of the car by allowing it to force under the metal guardrail, thus maintaining rail elevation, while the lower rail prevents the car from being trapped by the posts. Figures 15 and 22 show this design to be a success.

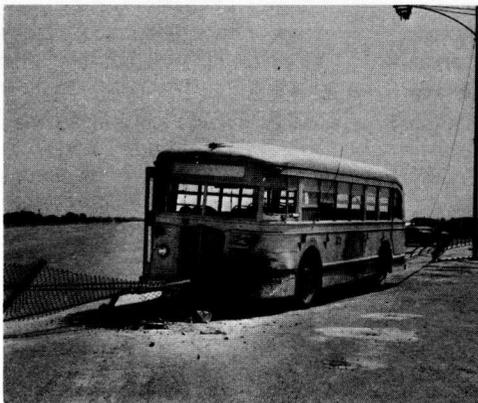
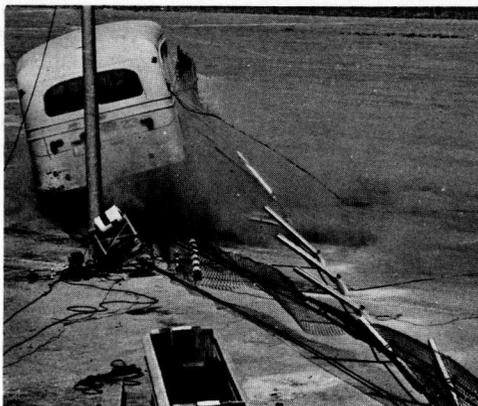
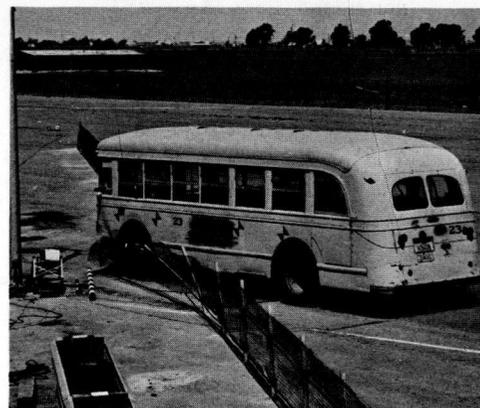
Figure 20. Test data information sheets.

Rigid barriers are represented in this series by only one test (Fig. 20), but this test was supplemented by information gained during dynamic tests of five bridge rails performed and reported in 1955 and two concrete bridge rails tested during this series. As shown by the test data sheet, this design failed during tests.

Indications from the results of Test No. 22 (Fig. 20) are that the design of this rail needs only a slight amount of stiffening to make it serve under heavy collisions. Previous tests on bridge rails indicate that a wall as low as 27 in. in height could be effective as long as it did not fail. The reflective action from a properly designed concrete wall, as indicated by previous tests conducted on bridge rails, shows that the offending vehicle will reflect from the concrete wall with an abrupt change in direction and with high decelerations caused by the extremely rapid reflection of the vehicle from the non-deflecting surface. There is good opportunity, however, for evasive action by following cars in that the reflection angle is normally flat and due to the damaged colliding wheel the car tends to curve back into the rail and come to rest against it. There is even less opportunity of evading stalled traffic ahead after collision than there is with the semi-rigid-type barrier.

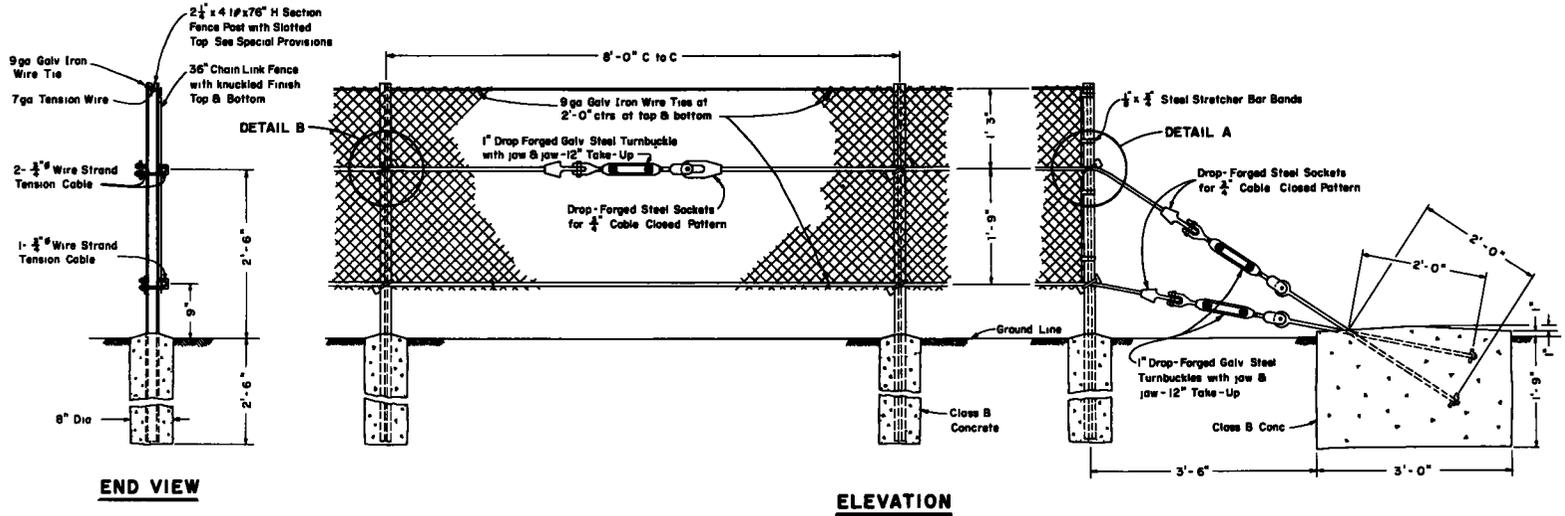
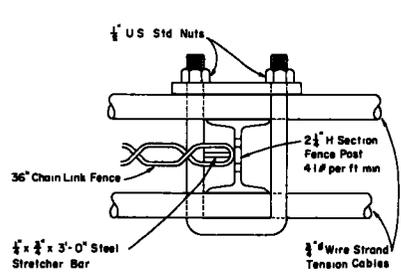
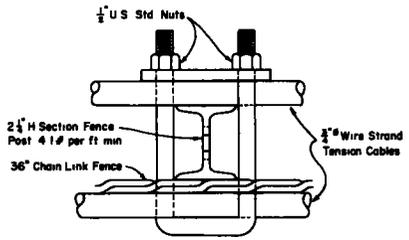
Figure 23. Cable-chain link barrier.

The combination cable-chain link barrier (Fig. 23) is over-all the most effective barrier but is limited to use in median strips where a deflection of about 8 ft can be tolerated. This barrier met all three requirements.

1. The cable-chain link barrier shown in Figure 23 be used as a barrier in medians where the width available will allow for at least 8-ft deflection of the barrier. It could be used in a median of lesser width depending on the degree of risk involved in allowing a momentary encroachment into the opposing roadway.
2. The blocked-out metal beam barrier shown in Figure 24 be used in narrow medians down to 3 ft when the space is insufficient for the cable-chain link barrier. By eliminating the metal beams and the wood block from one side of this design, it could be used where a definite barrier-type guardrail is needed, such as at bridge ends, tight curves, or other hazardous areas.

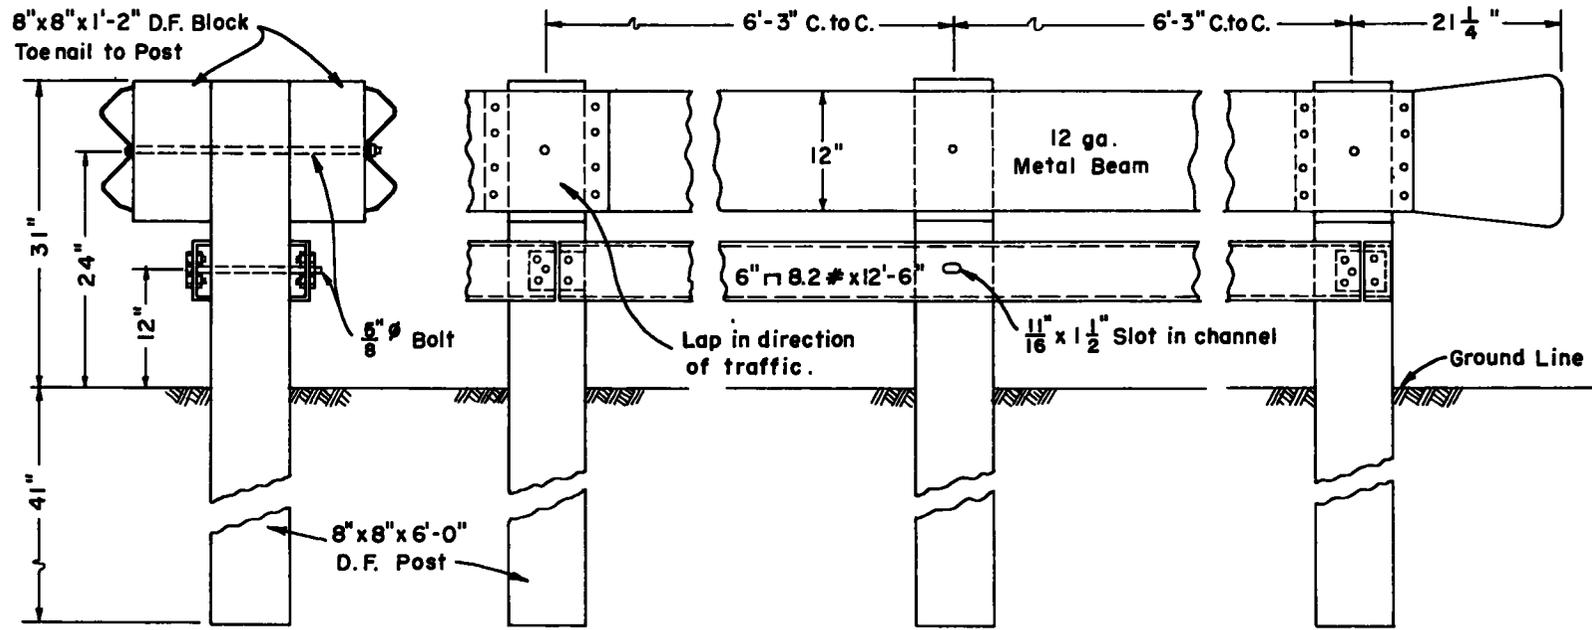
Figure 24. Blocked out metal beam barrier.

The blocked out metal beam barrier design shown in Figure 24 is the most effective for narrow medians and traffic conditions where deflections allowed by the cable-chain link type could not be tolerated. During the tests this barrier satisfied all three criteria to some degree.

The two designs shown in Figures 23 and 24 are recommended for use as traffic barriers between divided roadways subject to the following:
