Comparative Studies of Combinations of Treated and Untreated Bases and Subbases for Flexible Pavements

CHARLES W. JOHNSON, Materials and Testing Engineer, New Mexico State Highway Department

INSPECTION COMMENTS, F-051-1 (8)

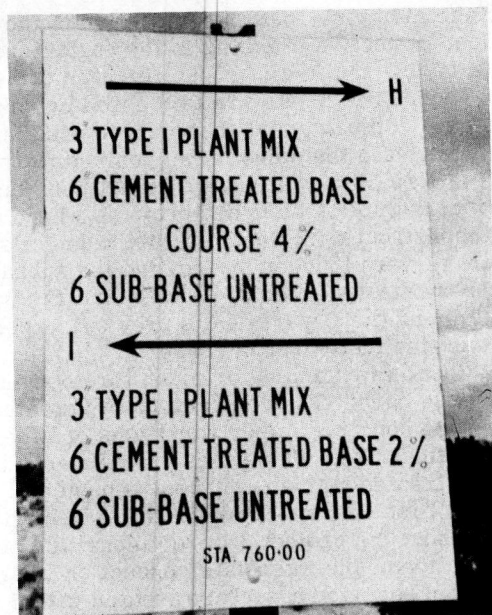
Figure 1. Information sign for Section H.

To assist inspection of this project there are signs at the beginning and end of each design change with information giving the stations and how each section is constructed (Fig. 1). There are nine experimental test sections designated by letters A, B, C, D, E, F, G, H, I. Section A is the control section and is typical of both right and left lanes throughout the project, excepting the comparative experimental group B through I. All the comparative sections were constructed on the northbound lane.
