Crack Control Joints in Bituminous Overlays On Rigid Pavements

JOHN O. WILSON, Engineer of Research and Development, Connecticut State Highway Department

This research study concerns a method of controlling reflection cracks in bituminous concrete overlays over the transverse joints of rigid pavements. The study was undertaken to determine whether sawing and sealing joints would extend the maintenance-free life of the overlay sufficiently to justify the additional cost.

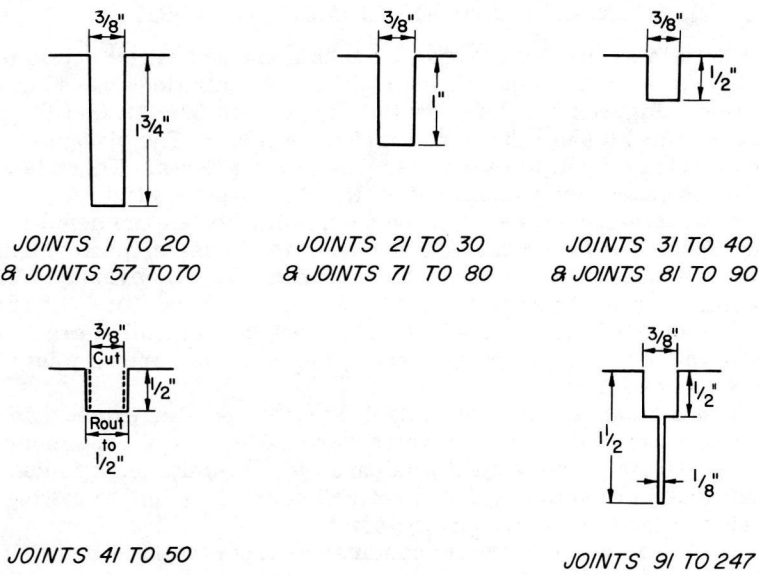
Figure 7. Experimental joint shapes.

as efficiently as the other shapes. Considerable variation in adhesive failure between replicate sections of the same joint shape raises the question of influences other than the joint shape. Figure 7 shows the system of replicate sections.
