HIGHWAY RESEARCH BOARD

Bulletin 322

*Repair of Concrete Pavements*

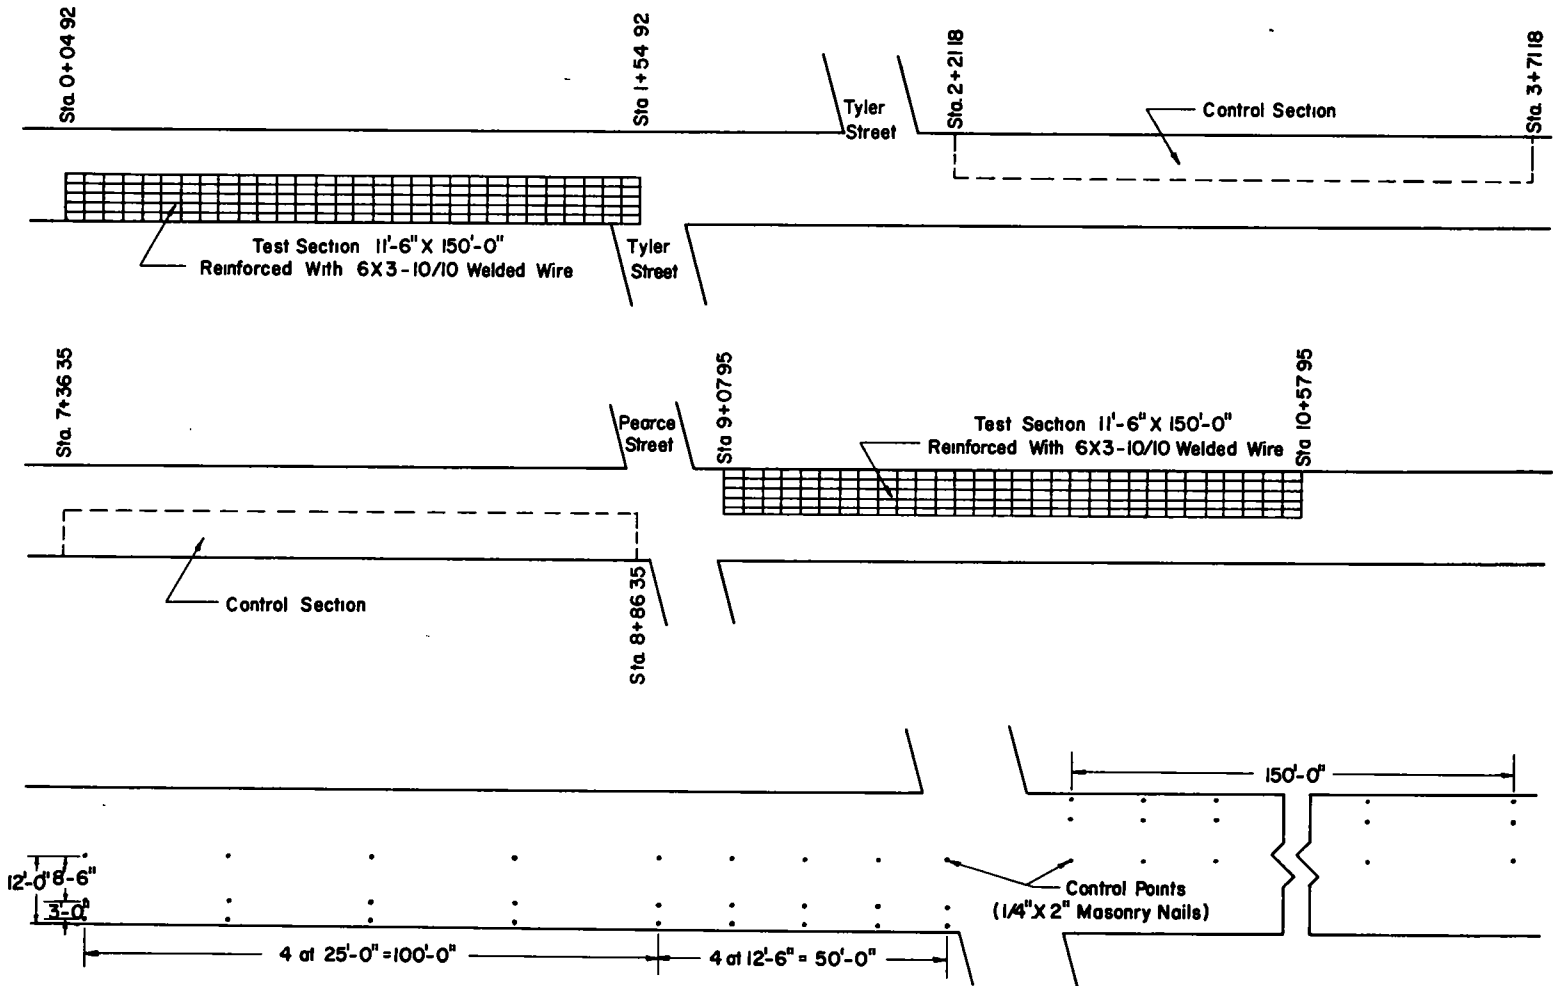
Figure 7. Plan view of test sections with typical layout of control points.

During the first 24 hours after construction, the pavement in the reinforced section at the Tyler Street intersection began to crack, leaving the fabric exposed along portions of the inside edge. A pattern of fine cracks, similar to the pattern of the fabric, was also noted in some areas. This was caused by the fabric having bulged under the surface course in areas, which resulted in a "springy" portion of pavement, and by the traffic creating excessive deflections. The greater part of the cracking, and all exposed wire was near the centerline where the longer edge of fabric had been placed during construction.

No indications of pavement cracking was found in the reinforced section at the Pearce Street intersection, but one small strand of wire was exposed.

Within one week after construction, cracking of the pavement was noticeable in both reinforced sections over the longer edge of the fabric. The pattern cracking in the "springy" areas at the Tyler Street intersection was more pronounced by this time and a probe into these areas revealed a void space between the surface course and the leveling course. This indicated that the fabric was not flat against the pavement and that the bridging effect of the fabric prevented the surface course from bonding to the leveling course.

The longer edge of fabric caused both reinforced sections to continue to crack and repairs were necessary in these sections one month after construction. The Tyler Street section required patching of the pavement where the wire was protruding and/or the surface course had shattered. At the Pearce Street section only sand sealing of cracks in the pavement was needed.

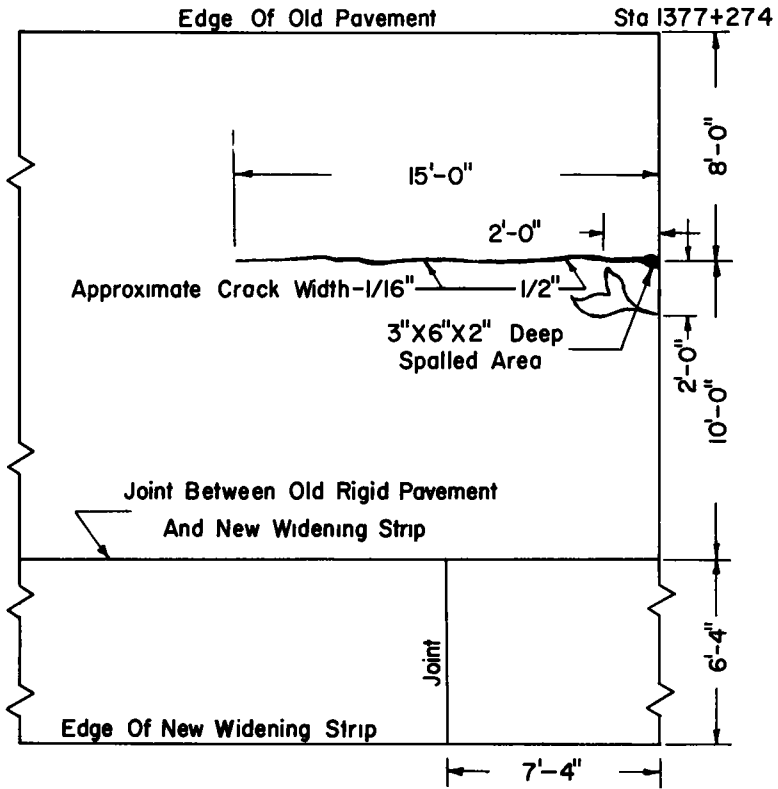
Figure 3. Plan view (upper) and photograph (lower) of typical section of pavement.

Before resurfacing, a detailed pavement condition survey was made of the existing concrete pavement and the new concrete widening strip in the two test sections. Included in this survey was the location and magnitude of all cracks, spalled area, joints, and patches. A photograph was also made of each slab included in this survey (Fig. 3).

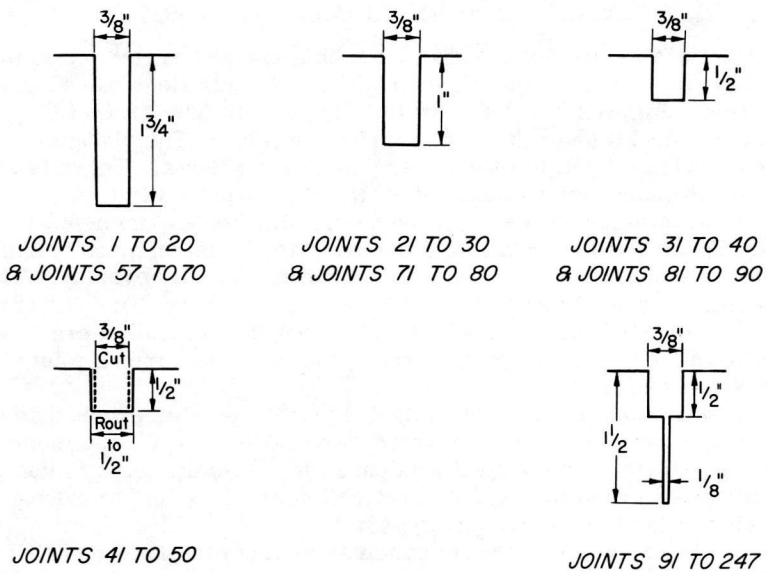
Figure 7. Experimental joint shapes.

as efficiently as the other shapes. Considerable variation in adhesive failure between replicate sections of the same joint shape raises the question of influences other than the joint shape. Figure 7 shows the system of replicate sections.

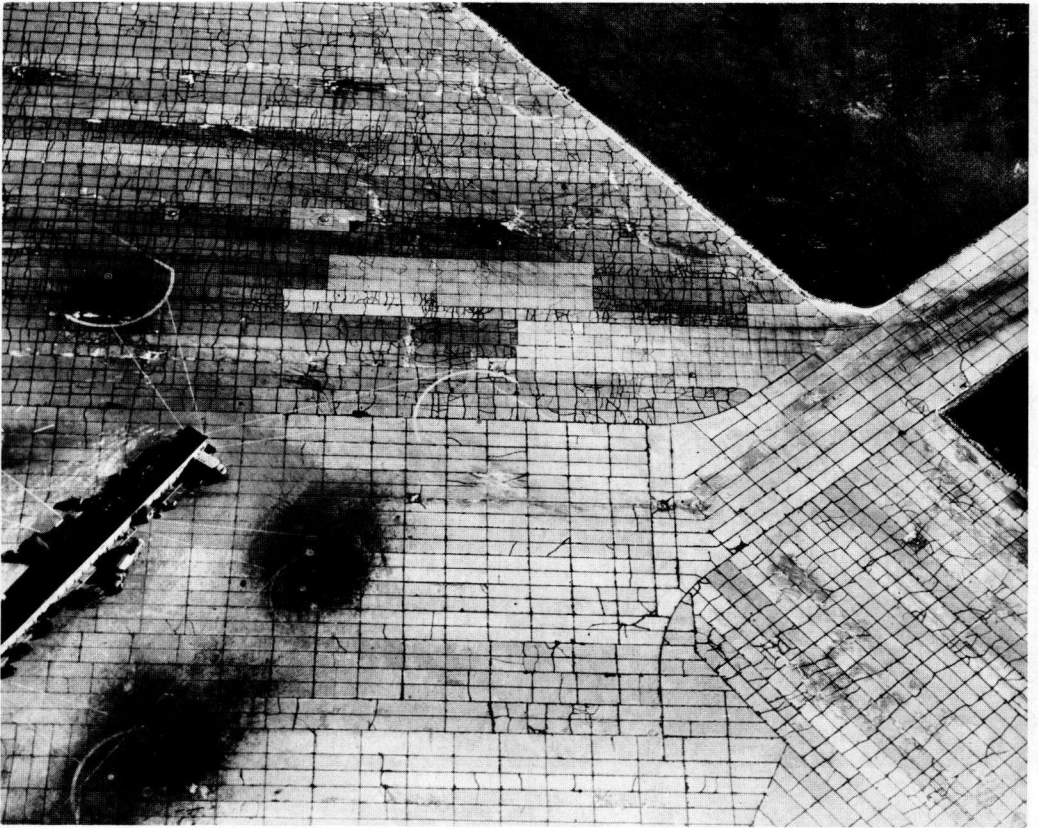
Figure 4.

One of the most interesting developments shown in Figure 3 is this pattern cracking developing along the edge of every fourth lane in the 1943 apron. The cause of this incipient cracking was traced to the fact that this section of the apron was poured in alternate 20-ft widths and the concrete mixer was permitted to travel on the recently completed slab while adjacent lanes were being poured. This weakness was also associated with the fact that the paving was done during the fall of the year, under unfavorable weather conditions. The concrete on which the mixer traveled had not been completely cured and its strength was not sufficient to carry the concentrated load of the mixer at the edge of the slab. As a result, these frequently accepted compromises in paving practice contributed more to the deterioration of this badly cracked pavement than any other factors in design or construction.

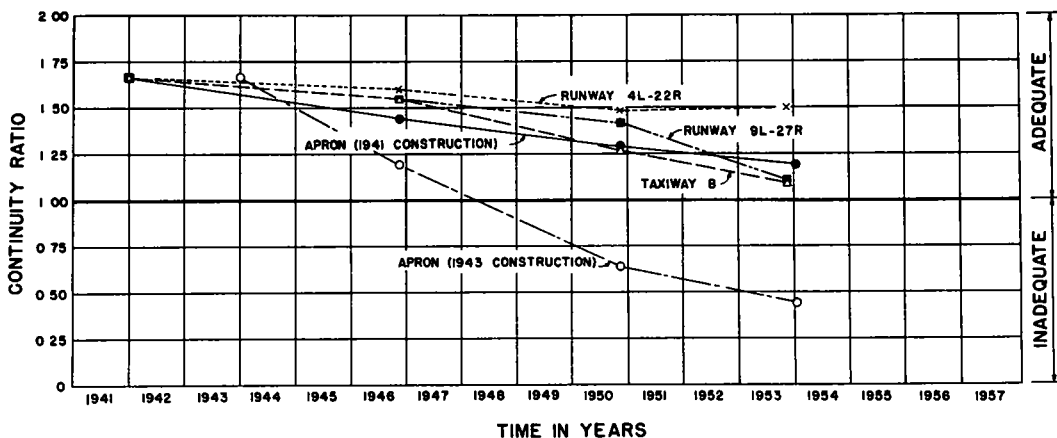
Figure 5.

Summarizing the results of the periodic pavement condition surveys, Figure 5 shows the change in continuity ratio of typical paved areas during the period from 1946 through 1954. Runway 4L-22R is one of the main diagonal runways of the 1941 construction, considered representative of the well-built pavement with excellent subgrade conditions and good construction control. By 1954, the continuity ratio had only been reduced from 1.67 to 1.50; this good performance can be considered as a basis for comparison with the other areas to be considered. Taxiway B and Runway 9L-27R, with continuity ratios reduced from 1.67 to approximately 1.10, were still in reasonably good condition, but these were areas of known subgrade deficiency due to the inclusion of unstable organic material in the subgrade during the grading operation. The 1941 apron, with a continuity ratio of 1.19, may be showing some influence of greater load repetition, but is still rated as satisfactory and representative of the better 1941 construction. This performance is in marked contrast to that of the 1943 apron, where the average continuity ratio has been reduced to 0.44, indicative of excessive cracking and loss of structural continuity.

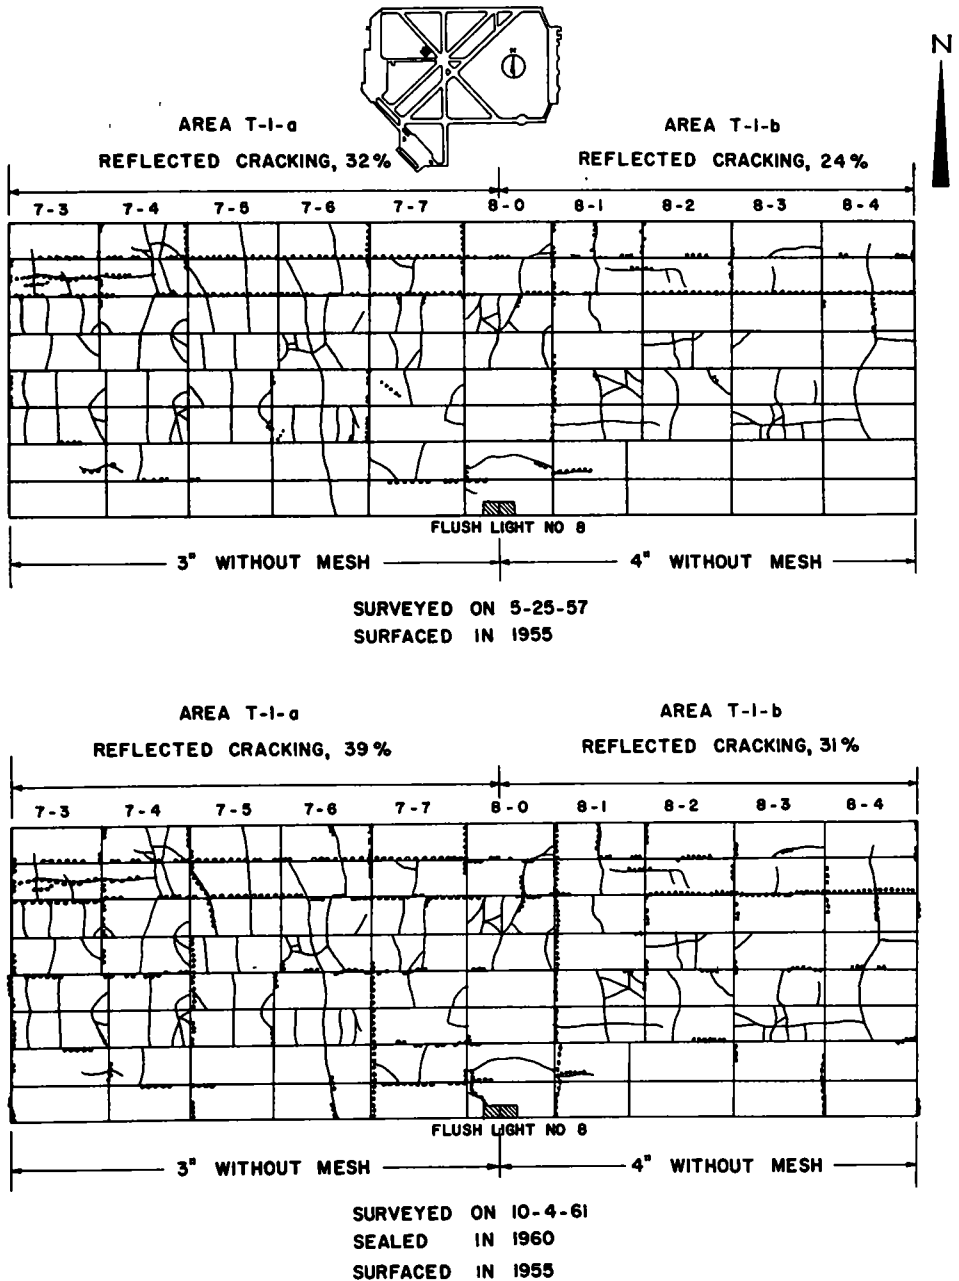
Figure 7.

Test Area 1, shown in Figure 7, is on the center taxiway and was intended to show the effect of varying the thickness of the bituminous surface from 3 in. in Area T-1-a to 4 in. in Area T-1-b, both without mesh or welded wire fabric. In the 1957 survey, shown at the top of the figure, the reflected cracking was 32 percent in partial Area a and 24 percent in partial Area b, with an 8 percent differential in favor of the greater thickness of bituminous surfacing. Also, a large percentage of the reflected cracking was at pavement joints, with very little of the slab cracking being reflected through the surface. The results of the 1961 survey, after the surface had been sealed in 1960, show a moderate increase in reflected cracking in both areas, with the same differential of 8 percent in favor of the greater thickness of bituminous surface. The pattern of reflected cracking in both surveys is closely comparable, with the same cracks showing up in 1960 that were observed in 1957 with some increase, which is mostly over pavement joints rather than the slab cracking pattern.
