HIGHWAY RESEARCH BOARD
Bulletin 52

***Performance of
Concrete Pavement on
Granular Subbase***

THIS STUDY covers a condition survey in Indiana of 328.5 mi. of rigid pavements constructed with granular bases.

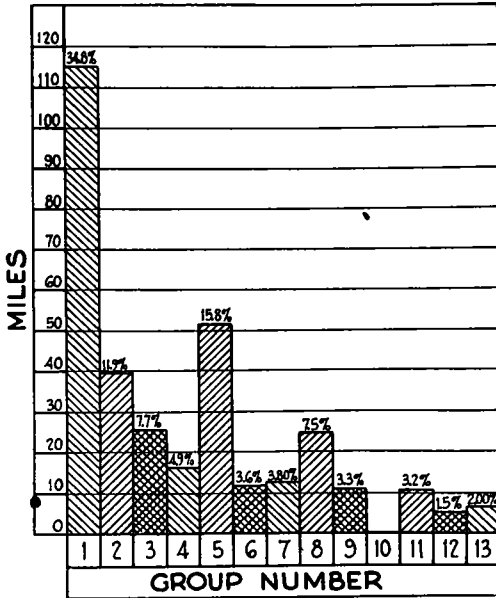
Figure 12. Mileage and percent of total mileage in each of groups No. 1 thru group 13 as shown in table No. 4

From this one will observe that of the 328.548 mi. treated, 114.220 mi., or 34.765 percent, have no defects and to date have given perfect performance, thereby meeting the requirements of Group 1; that Group 2 includes 39.039 mi., or 11.882 percent, which are perfect with the exception of having less than two first-stage blows per mi., and this mileage together with that in Group 1 amounts to 153.259 mi., of 46.647 percent of the total; that Group 3 includes 25.366 mi., or 7.721 percent, which are perfect with the exception of having from 2 to 20 first-stage blows per mi., and this together with the mileage in previous groups total 178.625 mi., or 54.368 percent of the total that are at least this good; that Group 4 includes 16.060 mi., or 4.888 percent, which have less than two defects per mi. in two or more classes, thus producing a total, when added to mileage of the previous groups, of 194.685 mi. or 59.256 percent, that Group 5 includes 51.800 mi. or 15.766 percent which have less than two defects per mile in one or more of the first five classes and from 2 to 20 in Class 6, and this together with the mileage in the first four groups give a total of 246.485 mi. or 75.022 percent having this performance or better; that Group 6 includes 11.941 mi., or 3.634 percent, which have less than two defects per mile in one or more of the first five classes, and between 20 and 30 in Class 6, thus producing a total of 258.426 mi., or 78.656 percent when the mileage of the first five groups are added; that Group 7 includes 12.496 mi., or 3.803 percent, which have between 2 and 10 defects per mi. in one or more of the first five classes and less than 30 in Class 6, and this together with the mileage in Groups 1 through 6 produce a total of 270.922 mi. or 82.459 percent that are of this caliber or better.

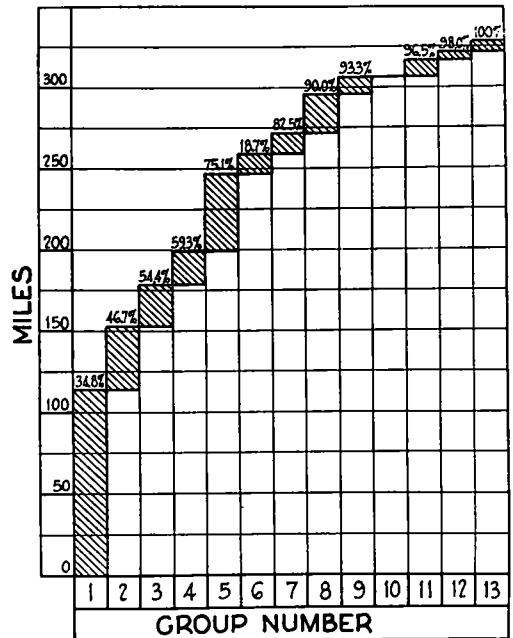
Figure 13. Accumulative mileage and accumulative percents of groups No. 1 thru group No. 13 as shown in table No. 4.

of the total. The last two columns show the accumulated totals progressively by groups and the accumulated percentages. In other words, by a single glance, one can see the total number of miles of pavement that is better than or meets the requirements of any particular group. Figures 12 and 13 show the totals in each group and the accumulated totals, graphically.

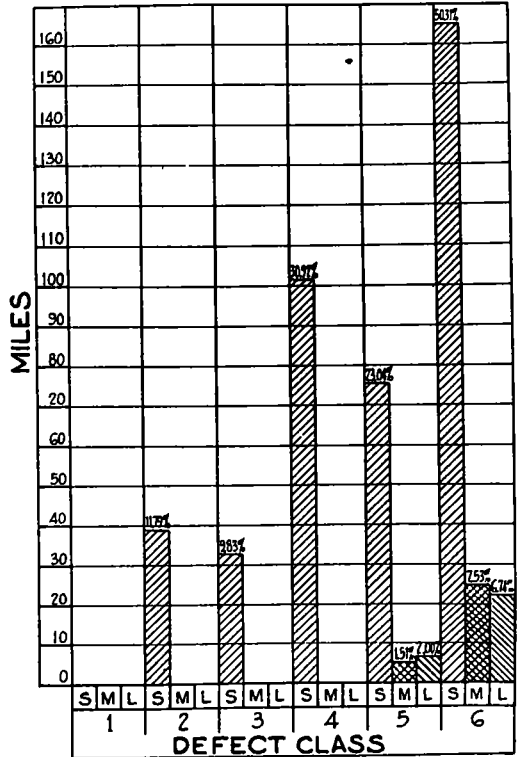
Figure 14. Summary of mileage and percents of total mileage in slight, moderate, or large categories for each of six classes of defects as shown in table No. 5.

ing, and inactive-edge pumping, the defects that are present are all in the "slight" category and the percentages of miles affected vary from 0 percent to 30.923 percent. Of the two least serious defects, there are 23.040 percent and 50.315 percent of the total mileage treated in the "slight" category, 1.518 percent and 7.530 percent in the "moderate" category, while 2.000 percent and 6.740 percent of the total are in the "large" category. In other words, where the most serious defects are involved, the amounts involved are slight; while in the least serious defects, the amounts increase.

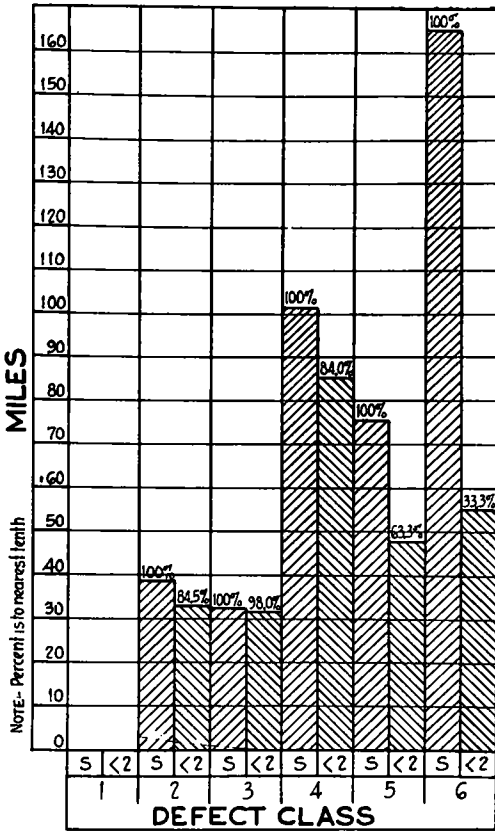
Figure 15. Six classes of slight-classified mileage compared with mileage in corresponding classes having less than two defects per mile as shown in tables No. 5 and No. 6.

defects per mi.; of 32.304 mi. of "slight" classified inactive-joint pumping, a total of 31.678 mi. have less than 2 defects per mi., which is 98.06 percent of the total for this classification; of 101.596 mi. of "slight" classified Inactive-Edge Pumping, a total of 85.344 mi. have less than 2 defects per mi., which is 84.0 percent of the total for this classification; of 75.697 mi. of "slight" classified second-stage blows, a total of 47.903 mi. have less than 2 defects per mi., which is 63.28 percent of the total for this classification; and of 165.308 mi. of "slight" classified first-stage blows, a total of 55.099 mi. have less than 2 defects per mi., which is 33.33 percent of the total for this classification. Figure 15 shows these comparisons graphically.
