**HIGHWAY RESEARCH BOARD**  
**Bulletin 87**

***Concrete Resurfacing of  
Concrete Pavement in Various  
Stages of Deterioration***

**PRESENTED AT THE  
Thirty-Third Annual Meeting  
January 12-15, 1954**

**DEPARTMENT OF MAINTENANCE**

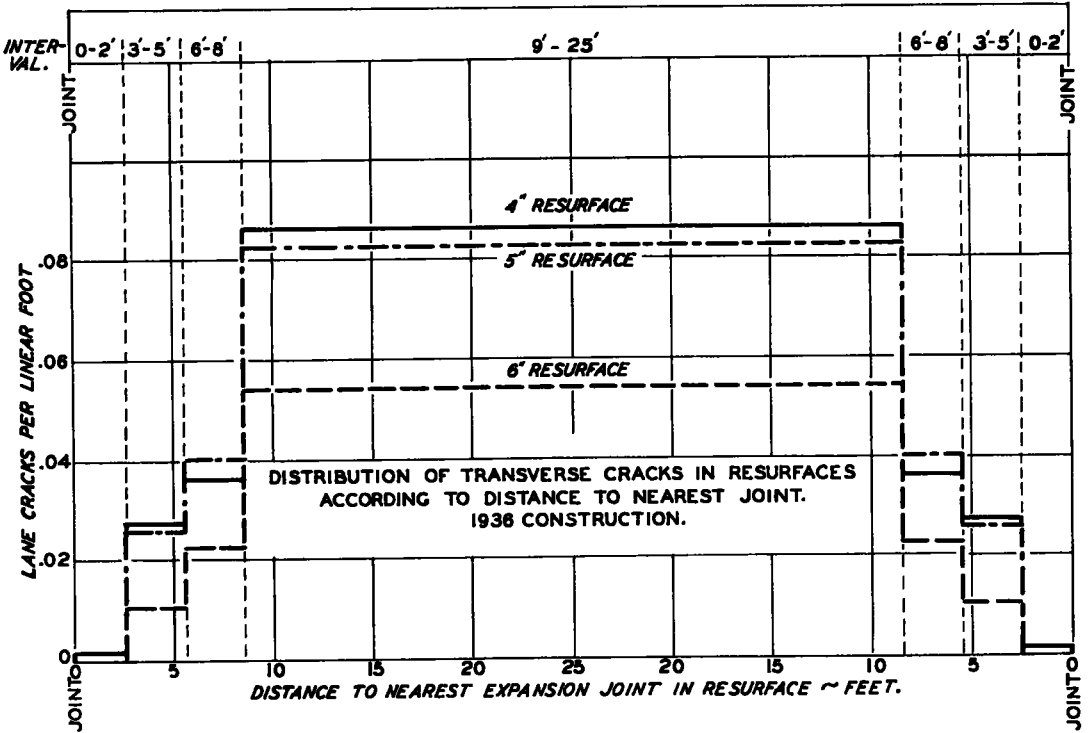
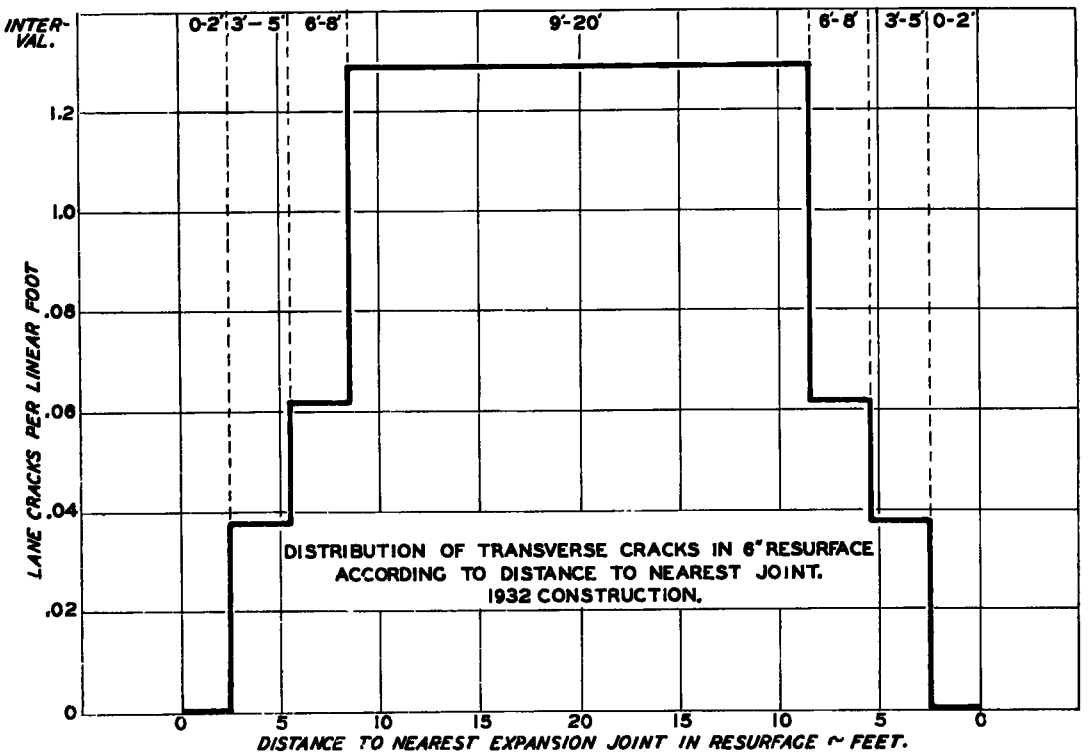
tances from the joints. Figures 6 and 7 show the same data in graphical form. The transverse cracks were tabulated into groups according to their distances from the nearest joint. The four intervals selected were 0 to 2 feet, 3 to 5 feet, 6 to 8 feet, and 9 feet or more from the joint. The cracking further than 9 feet from a joint was not further subdivided because previous studies indicated that, although cracking varied with the distance from a joint up to about 9 feet, beyond that point the intensity of cracking showed no trend relative to the proximity of the joint.

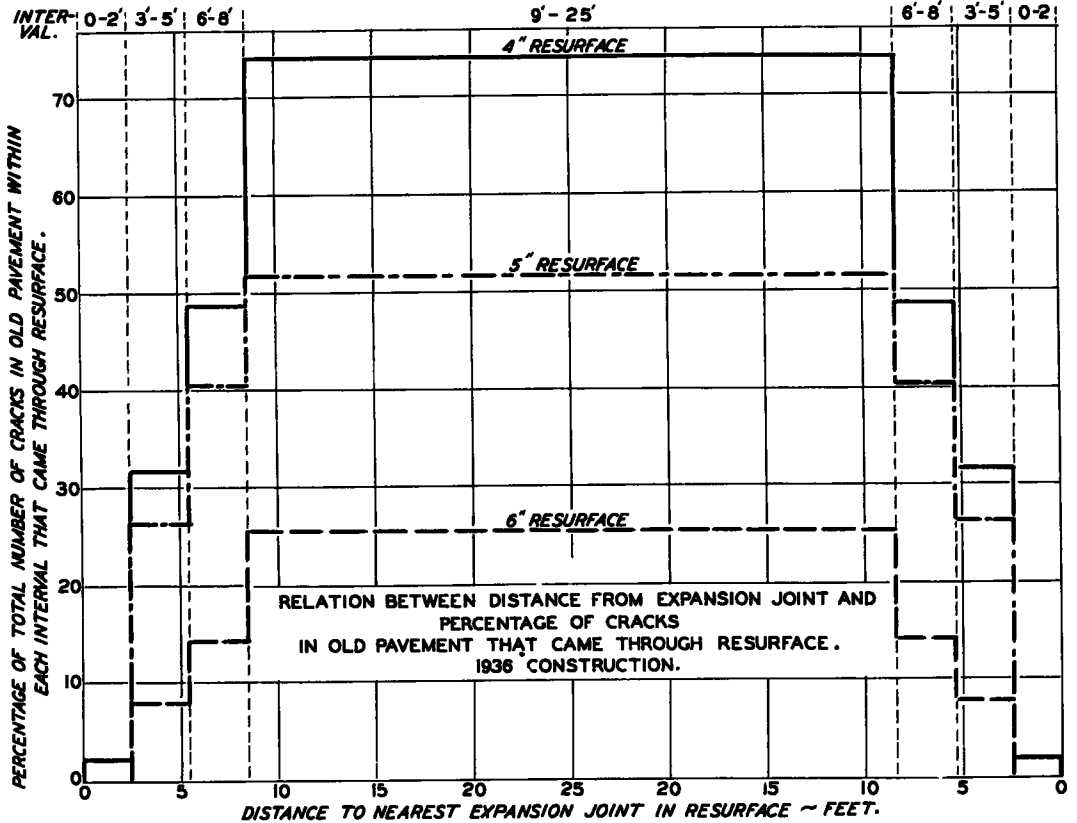
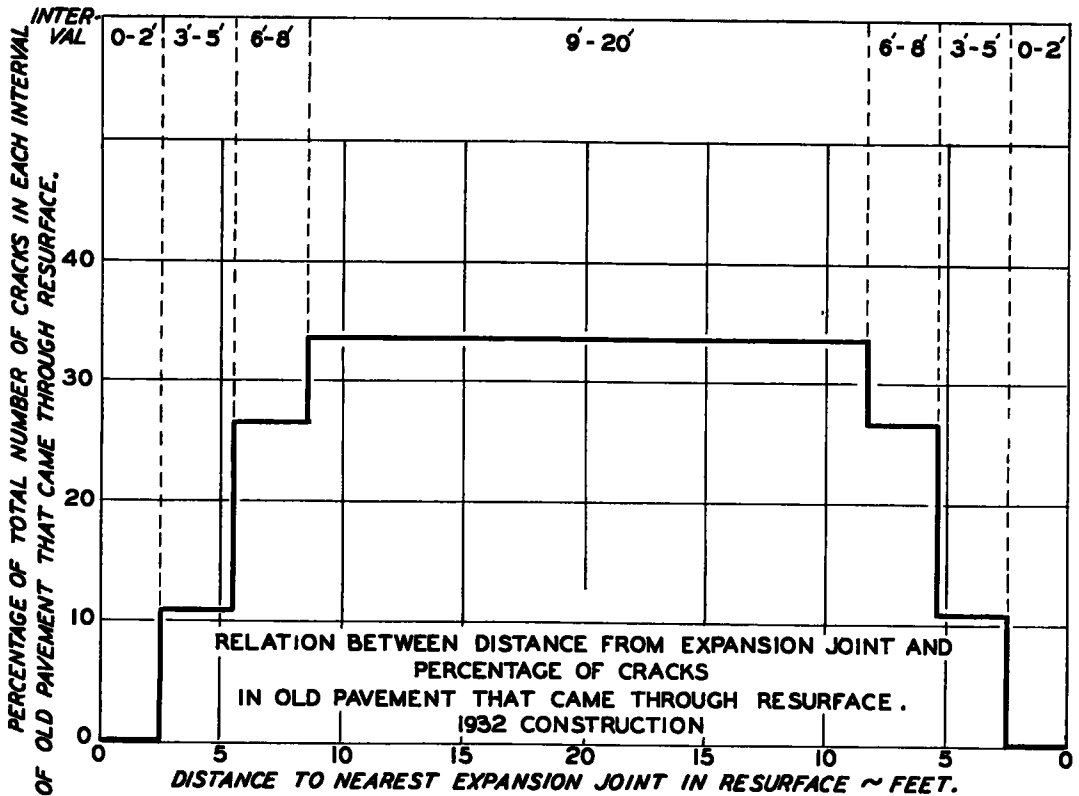
Figure 8 shows that in the 1936 construction, through the interior of the slabs where the joints theoretically had little

As shown graphically in Figure 9, the 6-inch resurface built in 1932 has a somewhat greater percentage of cracks coming through than the comparable thickness of 1936 construction. At least part of this difference might be attributed to the greater length of service of the 1932 construction.

From Figures 8 and 9 it can be seen that for any distance from the nearest joint, the percentage of cracks that came through is smaller as the resurfacing thickness increases. It is also evident that in all resurfaces the expansion joints had an effect in controlling the tendency for cracks in the old pavement to come through the resurfacing within a distance of 9 feet from joints. It should be kept in mind that joint spacings were uniform in each of these resurfaces and no attempt was made to locate joints over cracks in the old pavement. The results of this study indicate that design methods to provide for locating transverse joints over well-defined cracks by varying the joint spacing would be worth trying. Theoretical studies of this subject have been reported previously and a method is presented in Appendix B.
