CORRECTING PAVEMENT PUMPING BY MUD JACKING

Robert E. Frost
Research Engineer, Purdue University

U.S. HIGHWAY NO. 30

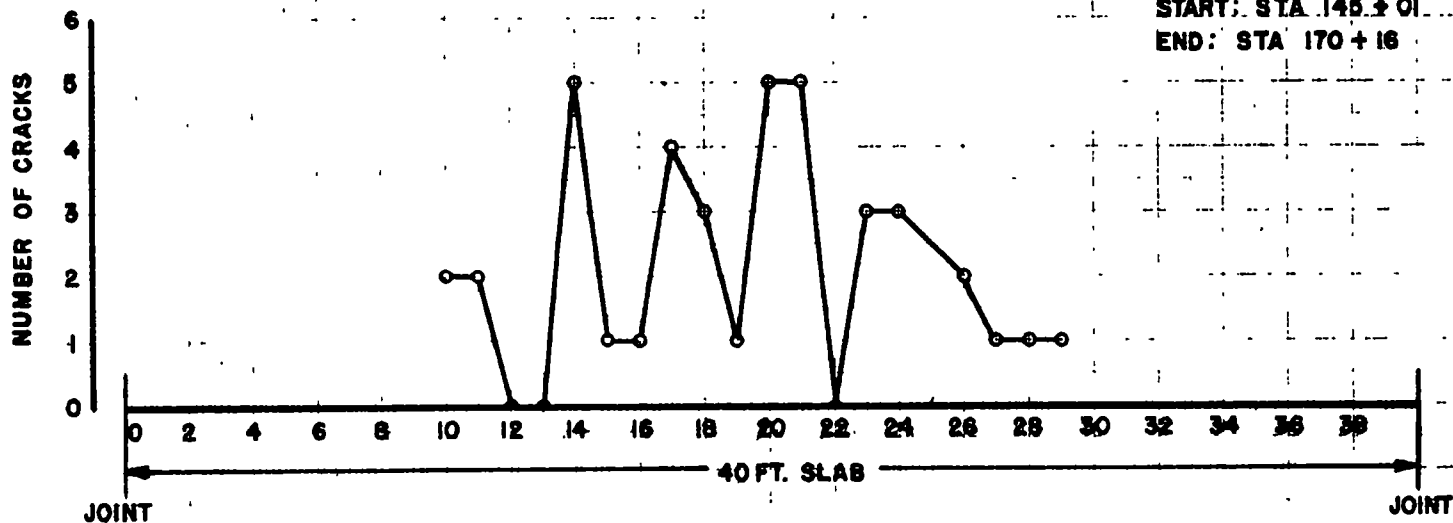
6" SAND SECTION
START: STA 145 + 01
END: STA 170 + 16

On the 6-in. sand-treatment section all of the cracks in the 40-ft. slabs occurred in the middle third of the slabs. Figure 23 shows the distribution of cracks in the slabs in the 6-in. sand section. There are only two cracks less than 13 ft. either side of a joint in fifty-nine, 40-ft. slabs of this section. Further, it was found that after seven years, 42 percent of the slabs had no cracks and 47 percent contained only one crack. Since this section receives the same traffic and rainfall, is of the same pavement design, and was constructed approximately at the same time as the two-mile section under observation, it is believed that the cracking distribution on this section can be taken as typical of a pavement placed on a firm, well-drained support. Assuming this to be the case, cracks occurring less than 13 ft. either side of a joint can be considered as the result of slab movement caused by pumping action and that cracks occurring in the middle third of a 40-ft. slab are the result of other causes.

NO. CONSTRUCTION SLABS = 4
NO. 40 FT. SLABS IN JOB = 59 = 100%
NO. 40 FT. SLABS WITH NO CRACKS = 25 = 42%
NO. 40 FT. SLABS WITH 1 CRACK = 28 = 47%
NO. 40 FT. SLABS WITH 2 CRACKS = 6 = 11%

FIGURE 23. DISTRIBUTION OF CRACKS IN 59 SLABS IN 6 INCH SAND SECTION

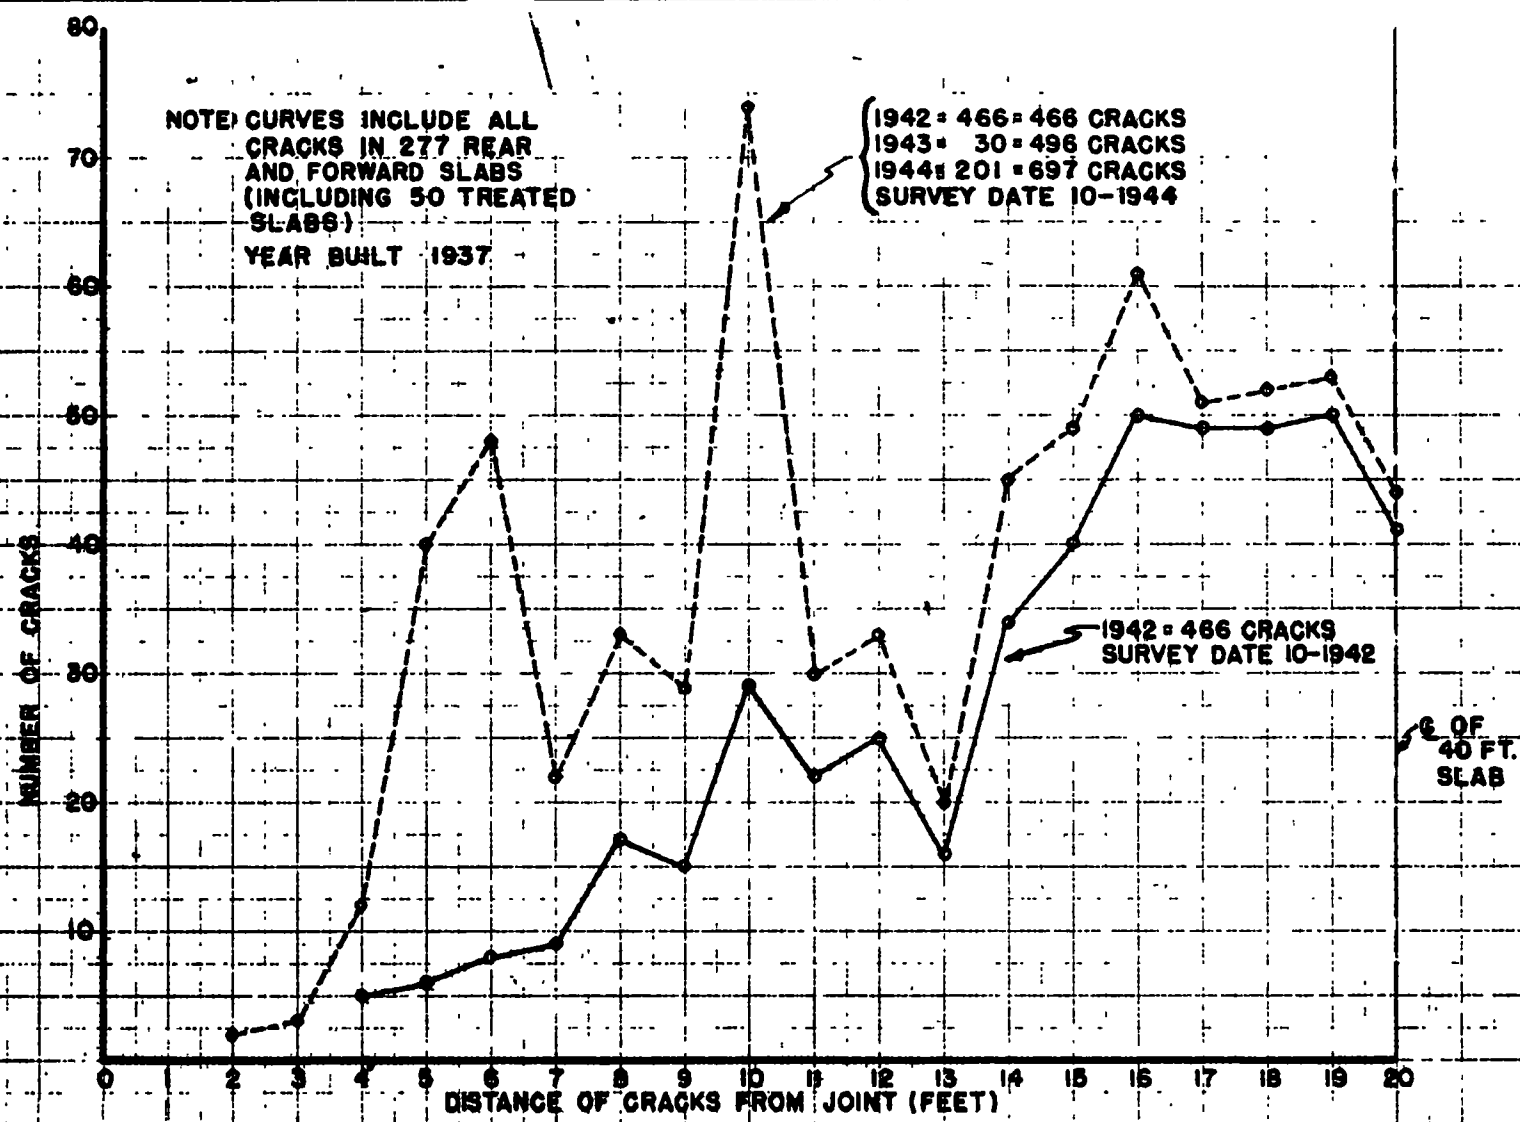
Figures 24 and 25 show the distribution of all cracks (both forward and rear slabs combined) with respect to any joint for both treated and untreated joints for the 1942 and 1944 surveys. Both curves show a decided drop in the number of cracks at 13 ft. in the distribution curves. It is interesting to note, by comparing the two curves in each figure, that the cracking less than 13 ft. from the joint was considerably more in 1944 than in 1942 and that cracking past 13 ft. from the joints remained fairly constant during the same two-year period. This observation confirms the statement that cracking up to 13 ft. from the joint must be directly influenced by slab movement initiated by pumping action, and that cracks past 13 ft. either side of the joint are not caused by any movement at the joint.

Additional study of Figs. 24 and 25 shows that the distribution of cracking less than 13 ft. in 1944 is bi-modal, ^c having a mode between 5 and 6 ft. and one at 10 ft. This perhaps shows that once a slab cracks about 10 ft. from the joint, a new and smaller slab, lighter in weight and able to move more freely, is formed. This, in turn, begins to break up usually at a point 5 or 6 ft. from the joint.

**FIGURE 25. DISTRIBUTION OF CRACKS IN ALL SLABS
1942 - 1944**

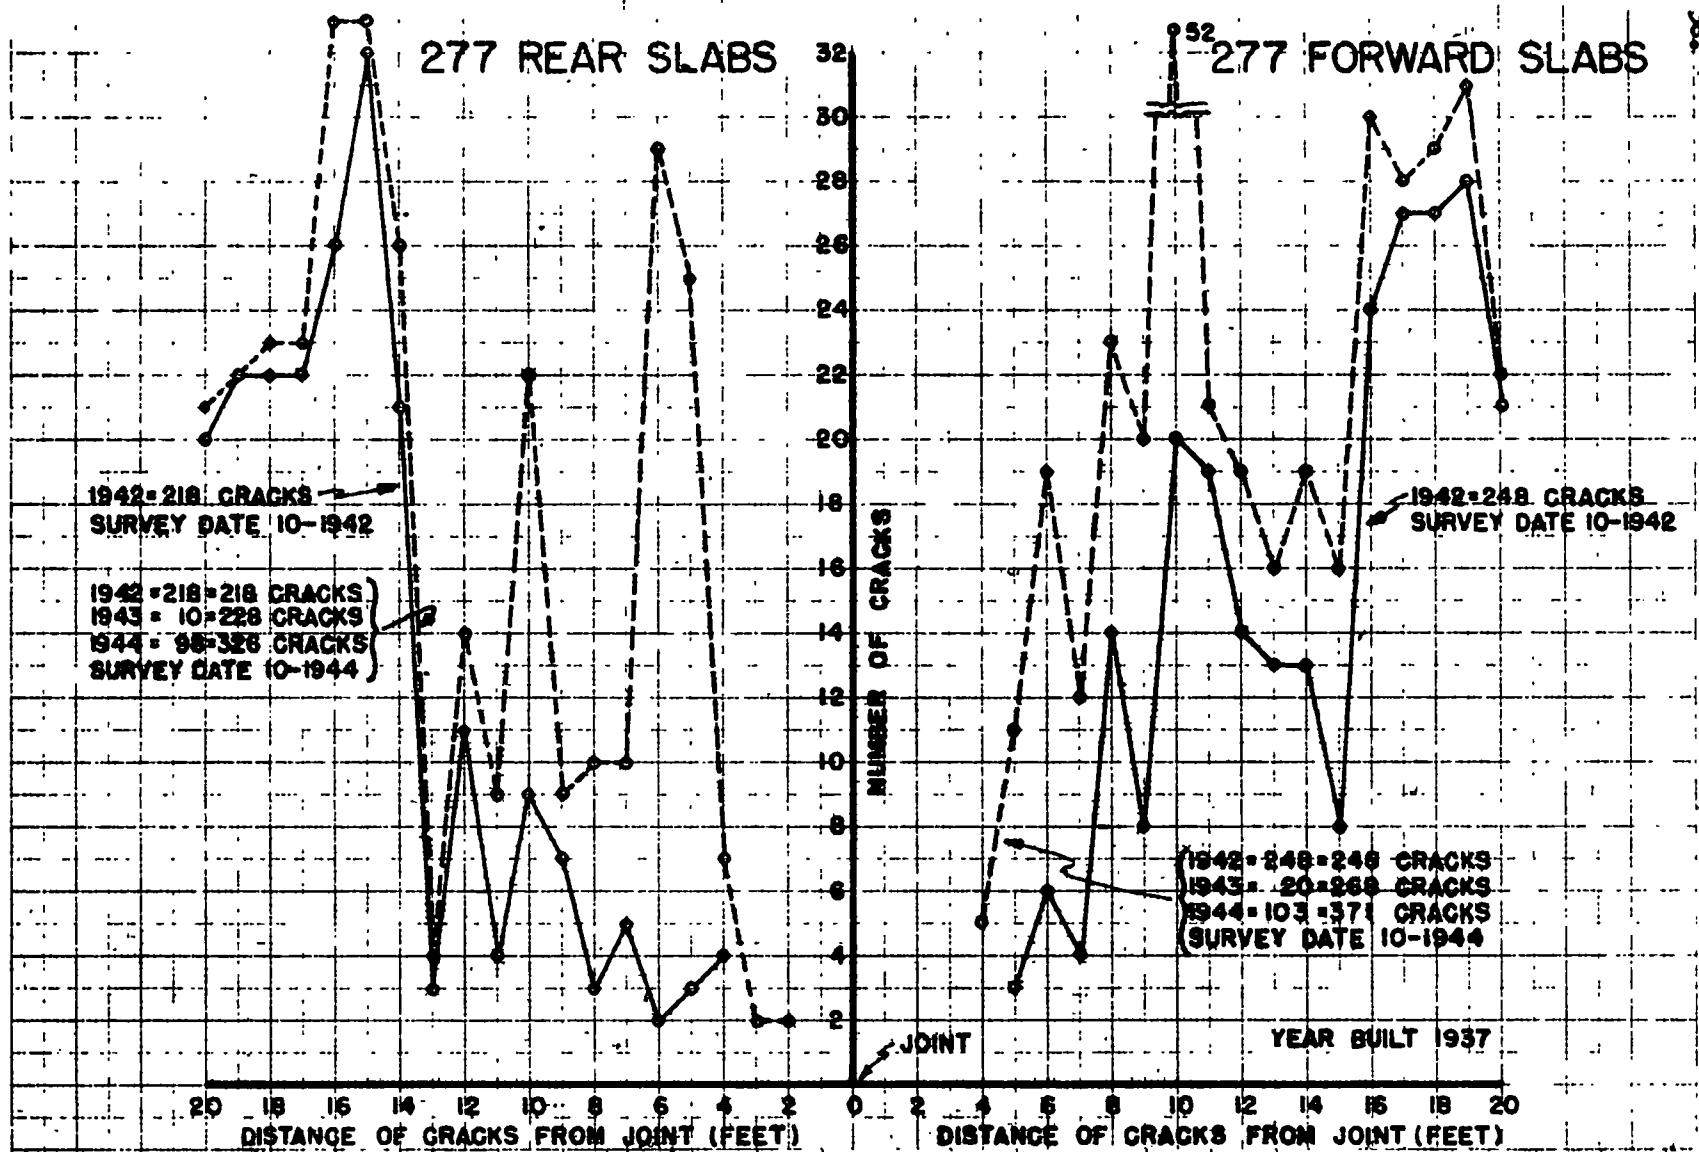
Since the curves shown in Figs. 24 and 25 are bi-modal, a second distribution was plotted in which cracking is divided into cracks occurring in forward and rear slab areas. This distribution is contained in Figs. 26 and 27. Study of Figs. 26 and 27 shows considerable difference in the cracking of the rear and forward slabs and that in 1942 cracking less than 15 ft. ahead of the joint was more severe than cracking less than 13 ft. to the rear of the joint. However, by 1944 cracking in the rear slabs had developed considerably in proportion to cracking on the forward slabs. The 1944 curve of the forward slab distribution of cracks contains modes at 6 and 10 ft. as compared to 5 and 10 ft. on the rear slabs. However, cracking at 5 ft. in the rear slabs was more severe than cracking at 5 ft. in the forward slabs in the 1944 survey; also, that cracking at 10 ft. on the forward slabs was more severe than at 10 ft. on the rear slabs in 1944.

FIGURE 27. DISTRIBUTION OF CRACKS IN ALL SLABS
1942 - 1944

an increase of 49.3 percent during the two-year period. Further, the number of new cracks occurring in the forward slabs was nearly equal to the number of new cracks occurring in rear slabs (of the entire 277 treated and untreated sections). However, study of Fig. 27 shows a remarkable difference between the position of new cracks in forward and rear slabs with respect to the joints.

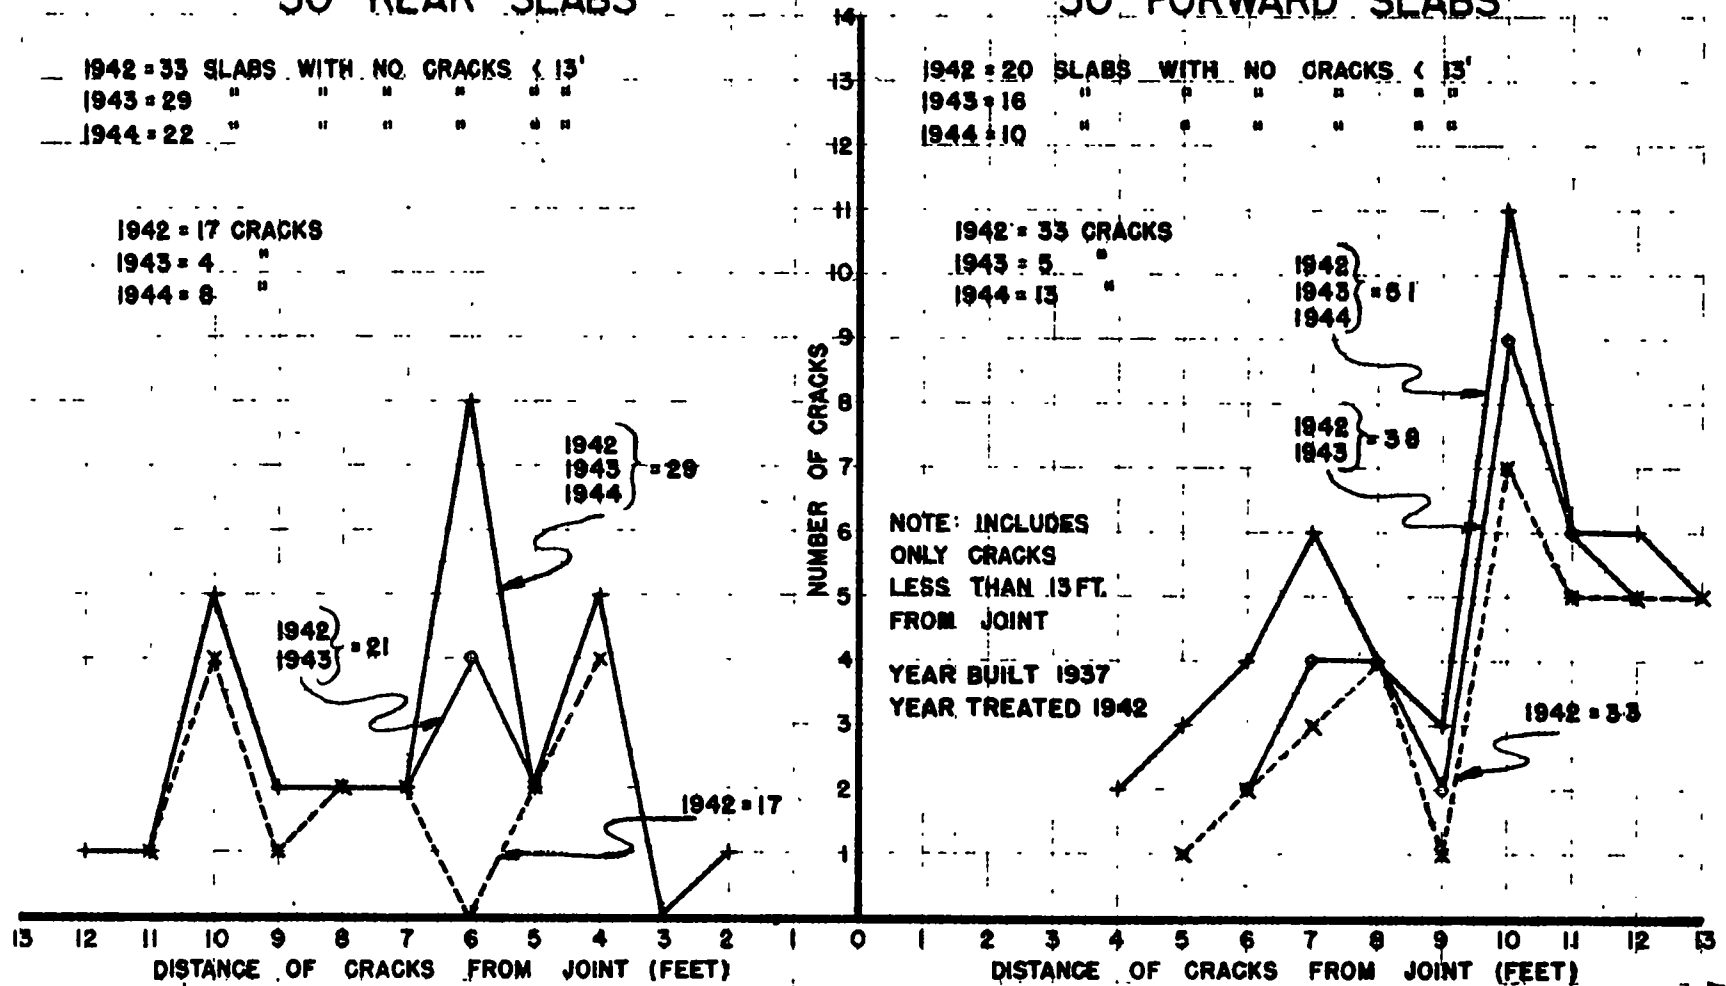
Figures 28, 29, and 30 are distribution curves of cracks less than 13 ft. from the joints of untreated slabs, treated slabs, and individual mixes for each of the three surveys. Further study of Figs. 28, 29 and 30 illustrate the effect of mud jacking on cracking. Assuming that all cracks less than 13 ft. either side of a joint are caused by pumping action, these data show that treatment by mud jacking has decreased considerably the expected number of cracks on both rear and forward slabs. Study of Fig. 28 shows that in 1942 there were 35 cracks in 227 untreated rear slabs and that by 1944 there were 114 cracks which is an increase of 226 per cent during the two-year period. This can be compared to the data contained in Fig. 29 which shows that in 1942 there were 17 cracks in 50 rear slabs, that were later treated, and that by 1944 there were 29 cracks, which is an increase of only 70.5 per cent. In other words, the expected cracking in untreated rear slabs should have been a 226 percent increase but treatment reduced this to a 70.5 percent increase. A similar study of forward slabs shows that the expected cracking was reduced from a 117 percent normal two-year increase to an increase of 51.5 percent for the treated slabs.

FIGURE 29. DISTRIBUTION OF CRACKS LESS THAN 13 FEET FROM EITHER END OF 50 TREATED SLABS

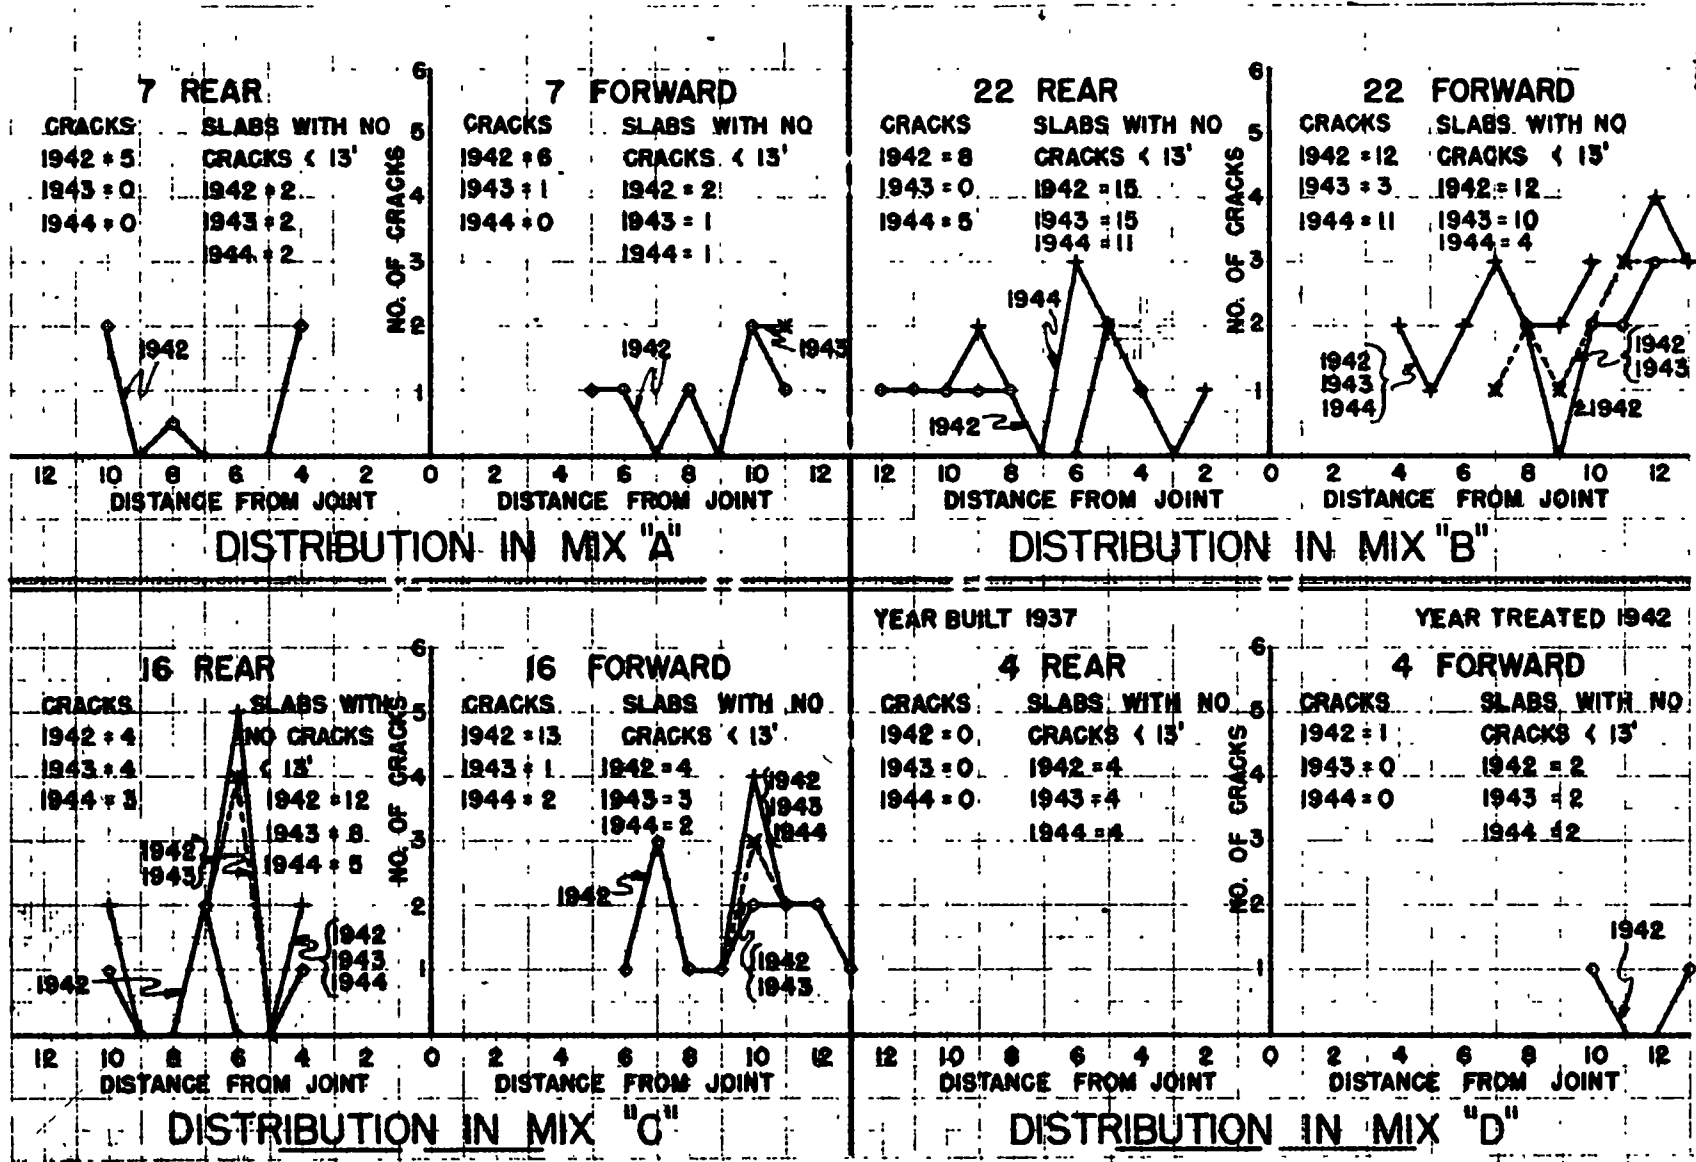
FIGURE 30. DISTRIBUTION OF CRACKS LESS THAN 13 FEET FROM THE JOINT BY MIXES

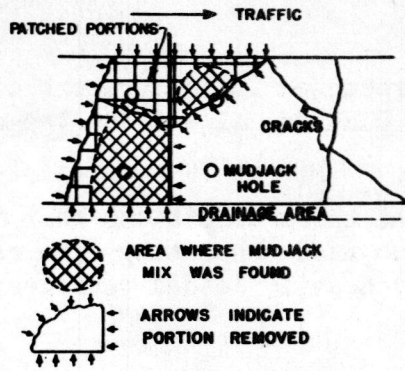
MIX "B" STATION 694+86

The mix under the slab varied in thickness and texture. The thickness varied from 0 to 2"; the thickest being farthest from the holes and the maximum under the holes. No trace of the mix was found in the inner rear portion of the section. The mix was laminated. Mud was found under the parts adjacent to the mix. The stone in the drain had clogged to the tile.
