THE PUMPING ACTION OF CONCRETE PAVEMENTS

MAINTENANCE OF JOINTS IN CONCRETE PAVEMENTS

THE PUMPING ACTION OF THE SLABS

Special Papers Presented  
for  
The Twenty-fourth Annual Meeting  
(Unassembled)

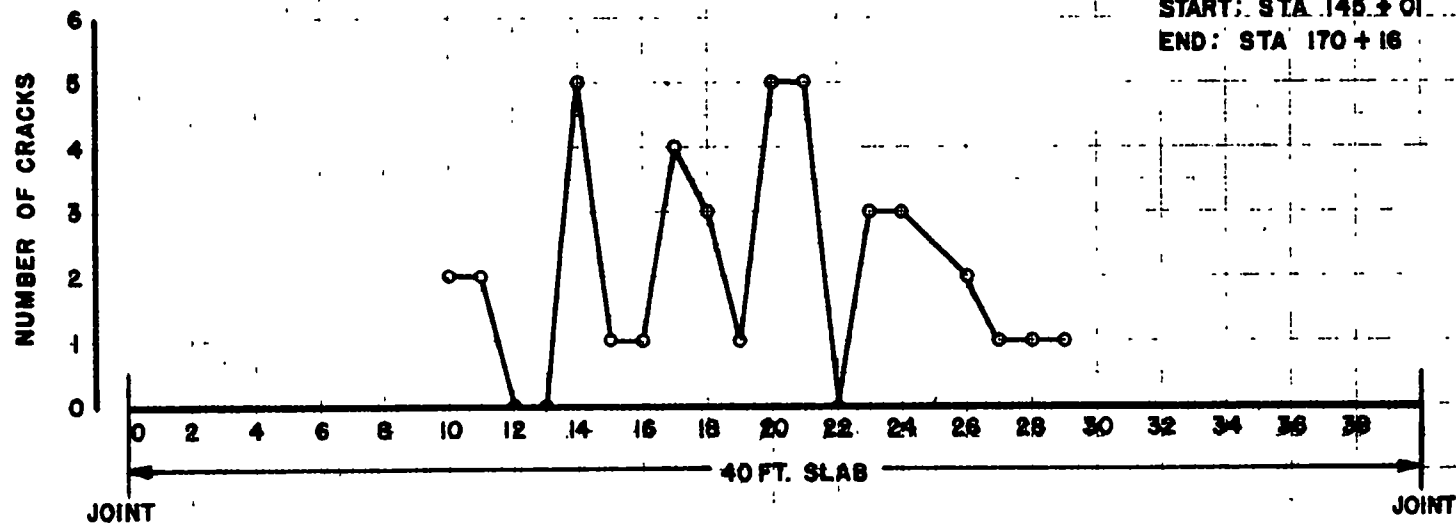
FIGURE 23. DISTRIBUTION OF CRACKS IN 59 SLABS IN  
6 INCH SAND SECTION

On the 6-in. sand-treatment section all of the cracks in the 40-ft. slabs occurred in the middle third of the slabs. Figure 23 shows the distribution of cracks in the slabs in the 6-in. sand section. There are only two cracks less than 13 ft. either side of a joint in fifty-nine, 40-ft. slabs of this section. Further, it was found that after seven years, 42 percent of the slabs had no cracks and 47 percent contained only one crack. Since this section receives the same traffic and rainfall, is of the same pavement design, and was constructed approximately at the same time as the two-mile section under observation, it is believed that the cracking distribution on this section can be taken as typical of a pavement placed on a firm, well-drained support. Assuming this to be the case, cracks occurring less than 13 ft. either side of a joint can be considered as the result of slab movement caused by pumping action and that cracks occurring in the middle third of a 40-ft. slab are the result of other causes.

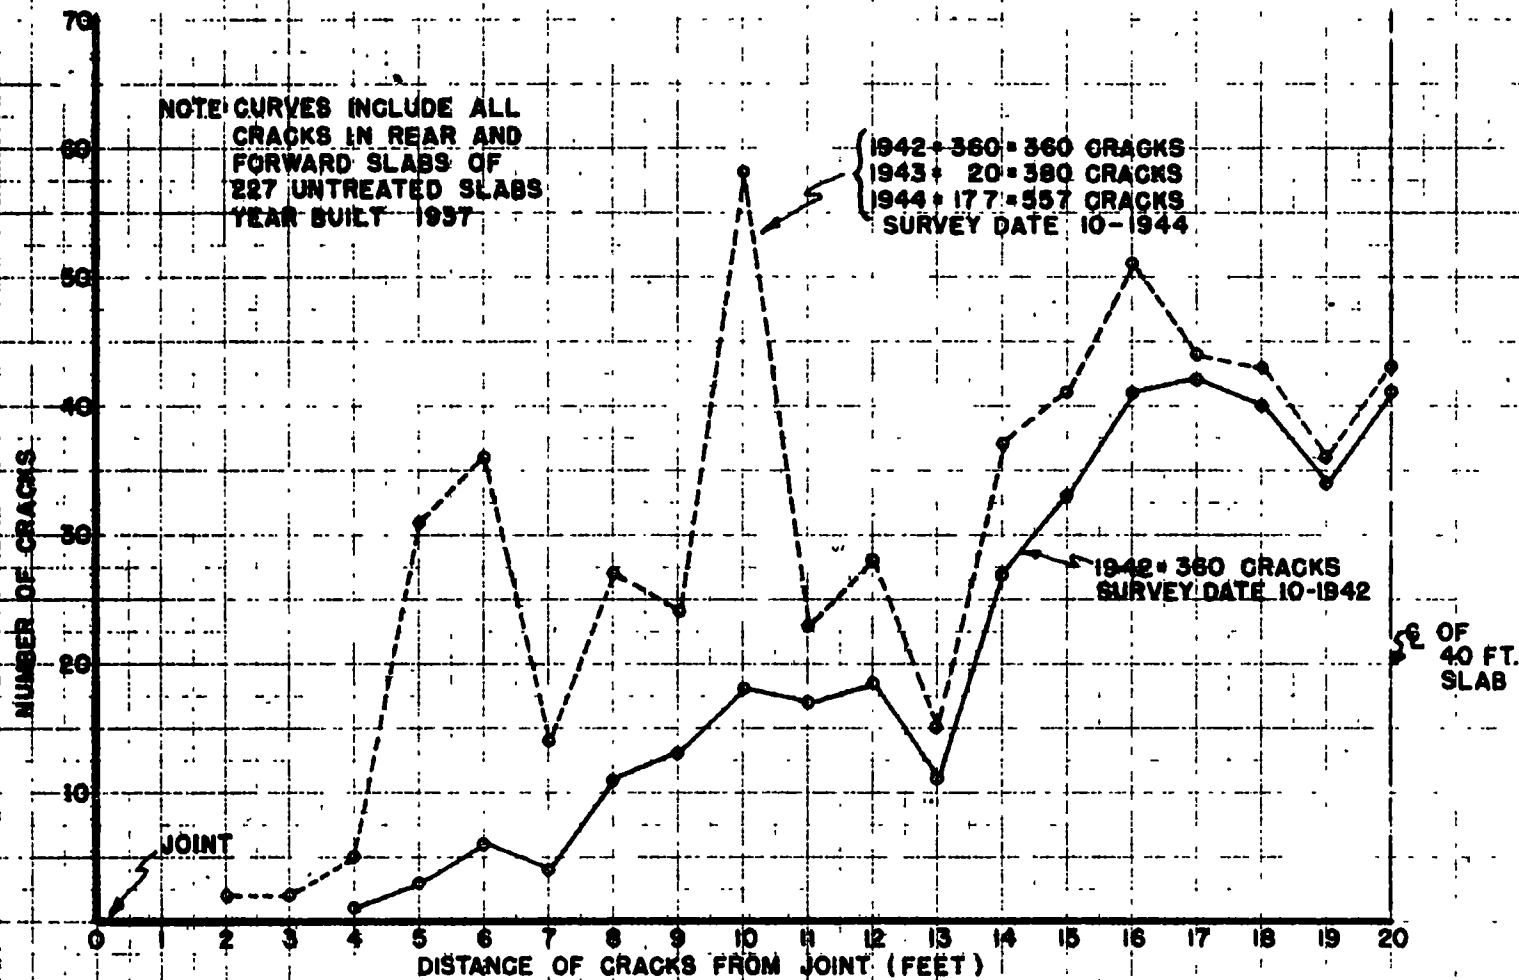
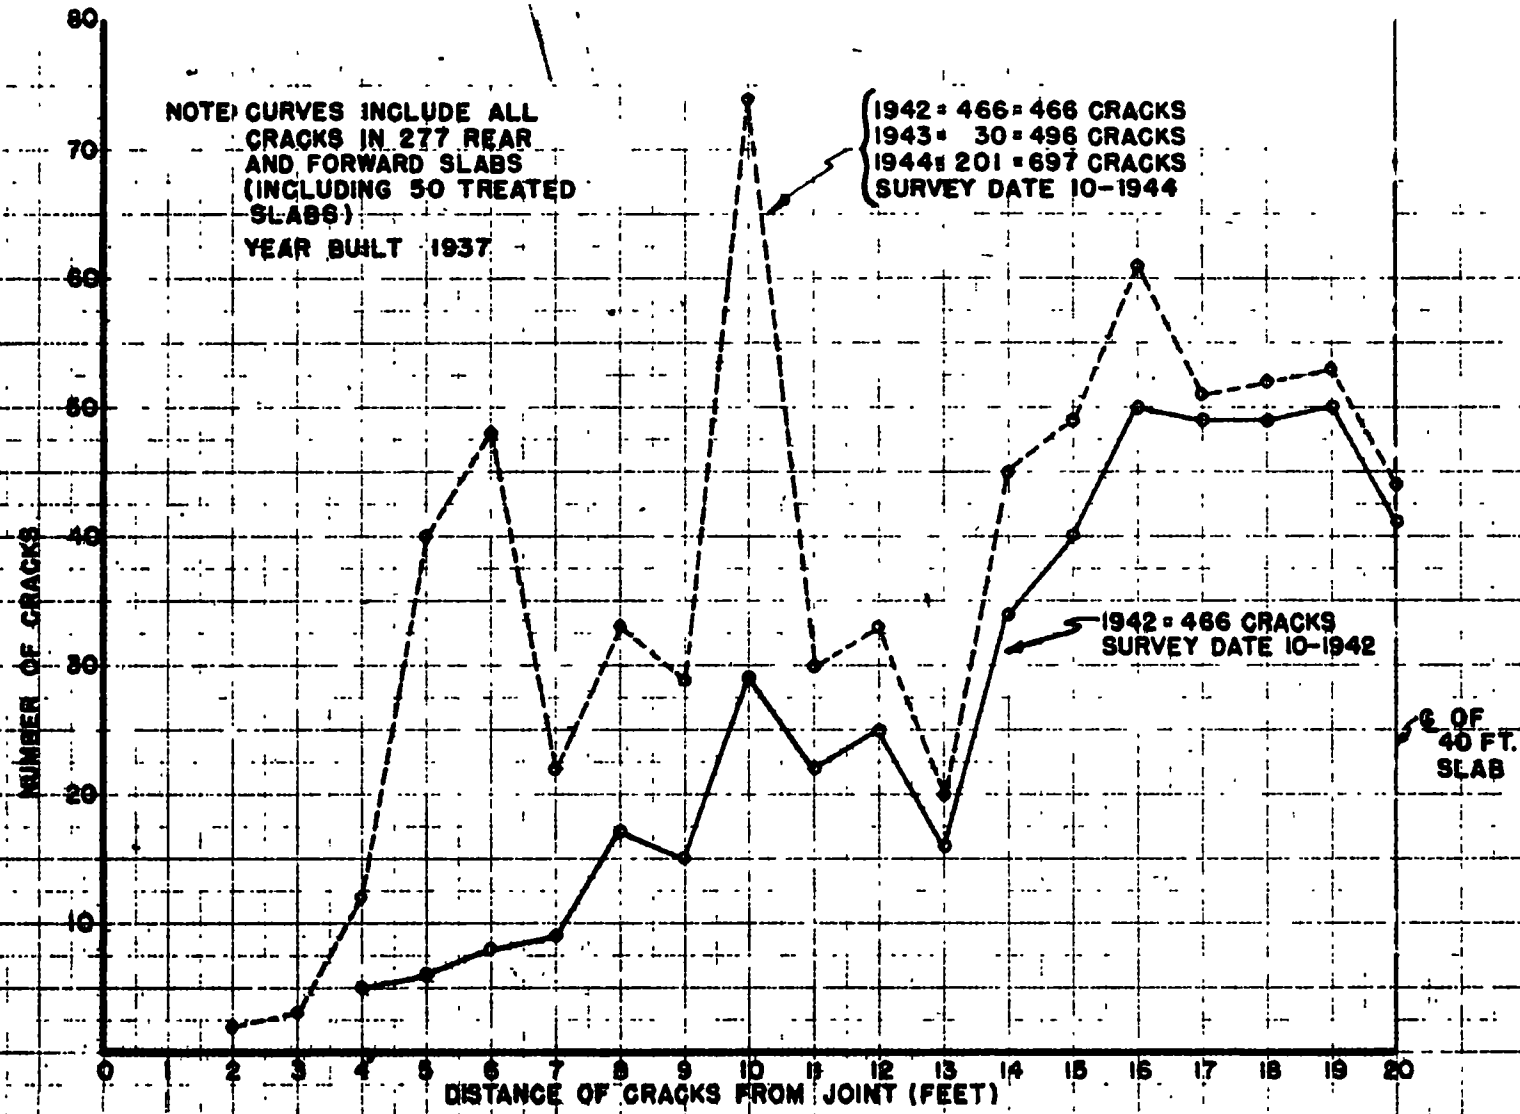
Figures 24 and 25 show the distribution of all cracks (both forward and rear slabs combined) with respect to any joint for both treated and untreated joints for the 1942 and 1944 surveys. Both curves show a decided drop in the number of cracks at 13 ft. in the distribution curves. It is interesting to note, by comparing the two curves in each figure, that the cracking less than 13 ft. from the joint was considerably more in 1944 than in 1942 and that cracking past 13 ft. from the joints remained fairly constant during the same two-year period. This observation confirms the statement that cracking up to 13 ft. from the joint must be directly influenced by slab movement initiated by pumping action, and that cracks past 13 ft. either side of the joint are not caused by any movement at the joint.

Additional study of Figs. 24 and 25 shows that the distribution of cracking less than 13 ft. in 1944 is bi-modal, <sup>c</sup> having a mode between 5 and 6 ft. and one at 10 ft. This perhaps shows that once a slab cracks about 10 ft. from the joint, a new and smaller slab, lighter in weight and able to move more freely, is formed. This, in turn, begins to break up usually at a point 5 or 6 ft. from the joint.

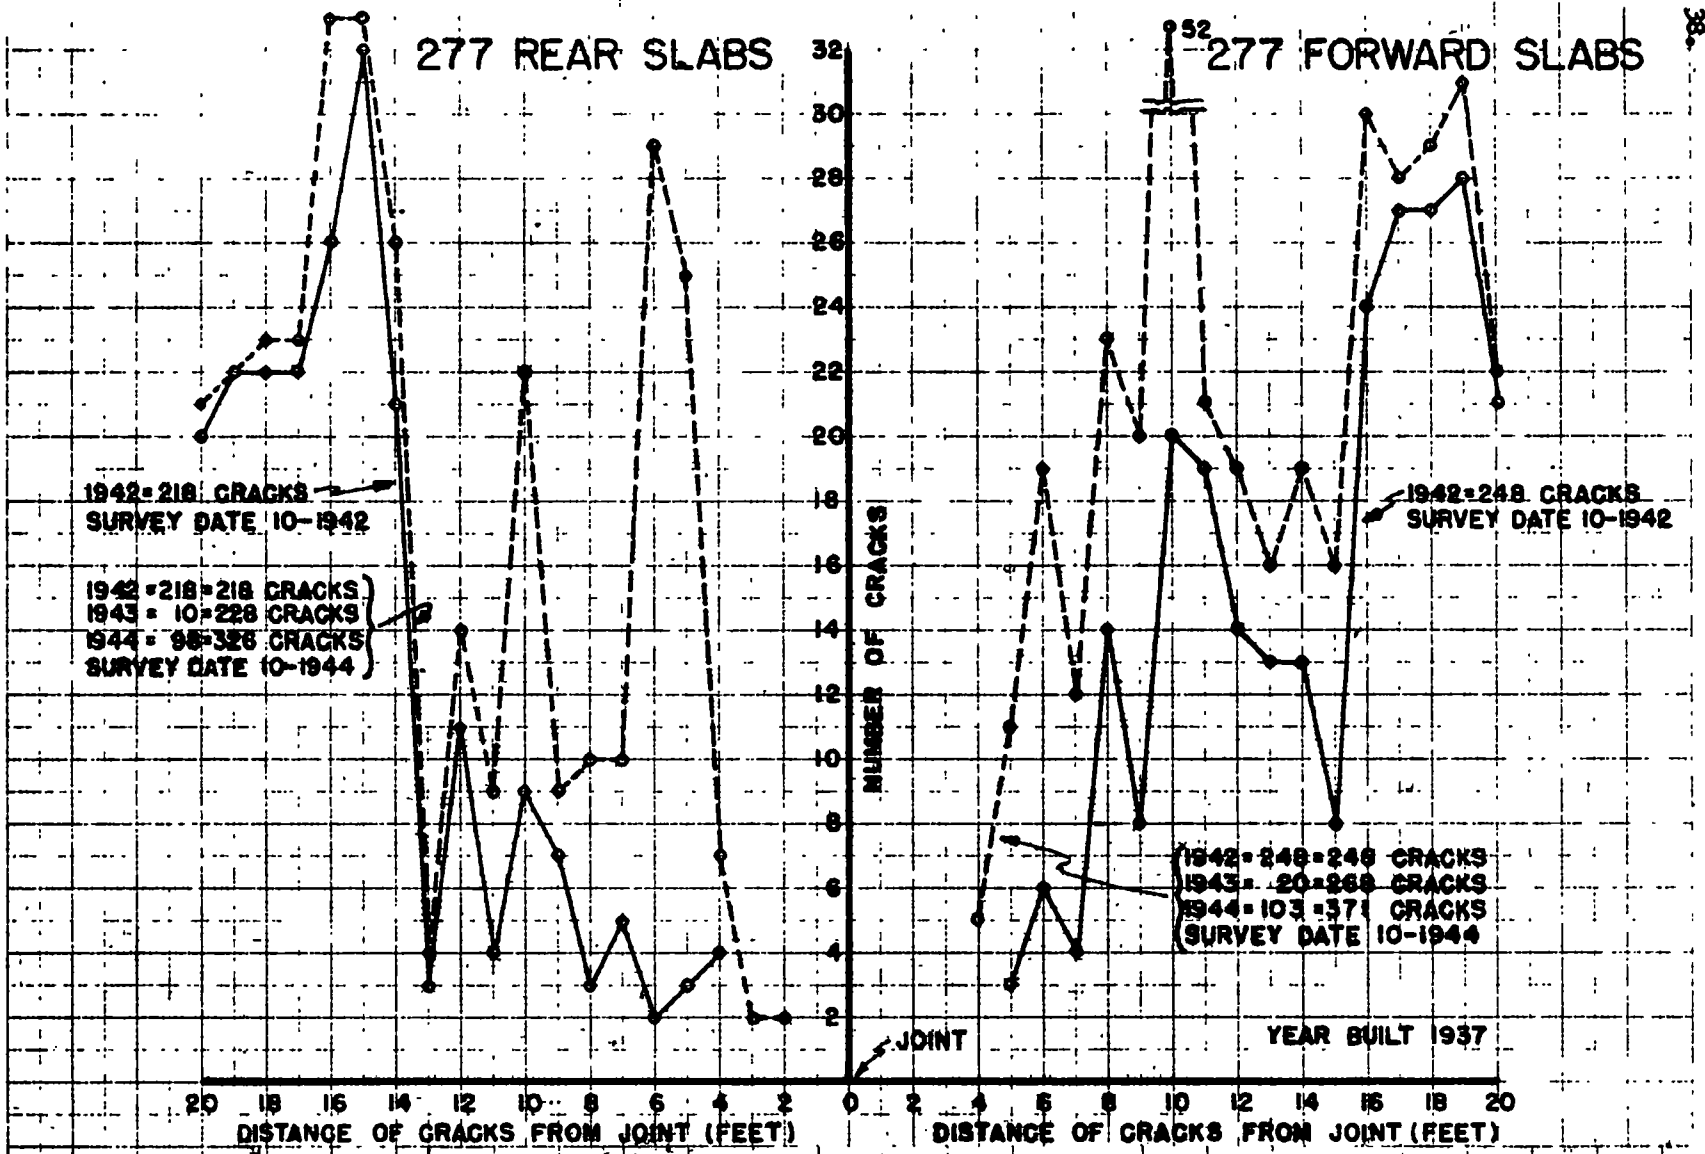
**FIGURE 27. DISTRIBUTION OF CRACKS IN ALL SLABS**  
**1942 - 1944**

an increase of 49.3 percent during the two-year period. Further, the number of new cracks occurring in the forward slabs was nearly equal to the number of new cracks occurring in rear slabs (of the entire 277 treated and untreated sections). However, study of Fig. 27 shows a remarkable difference between the position of new cracks in forward and rear slabs with respect to the joints.

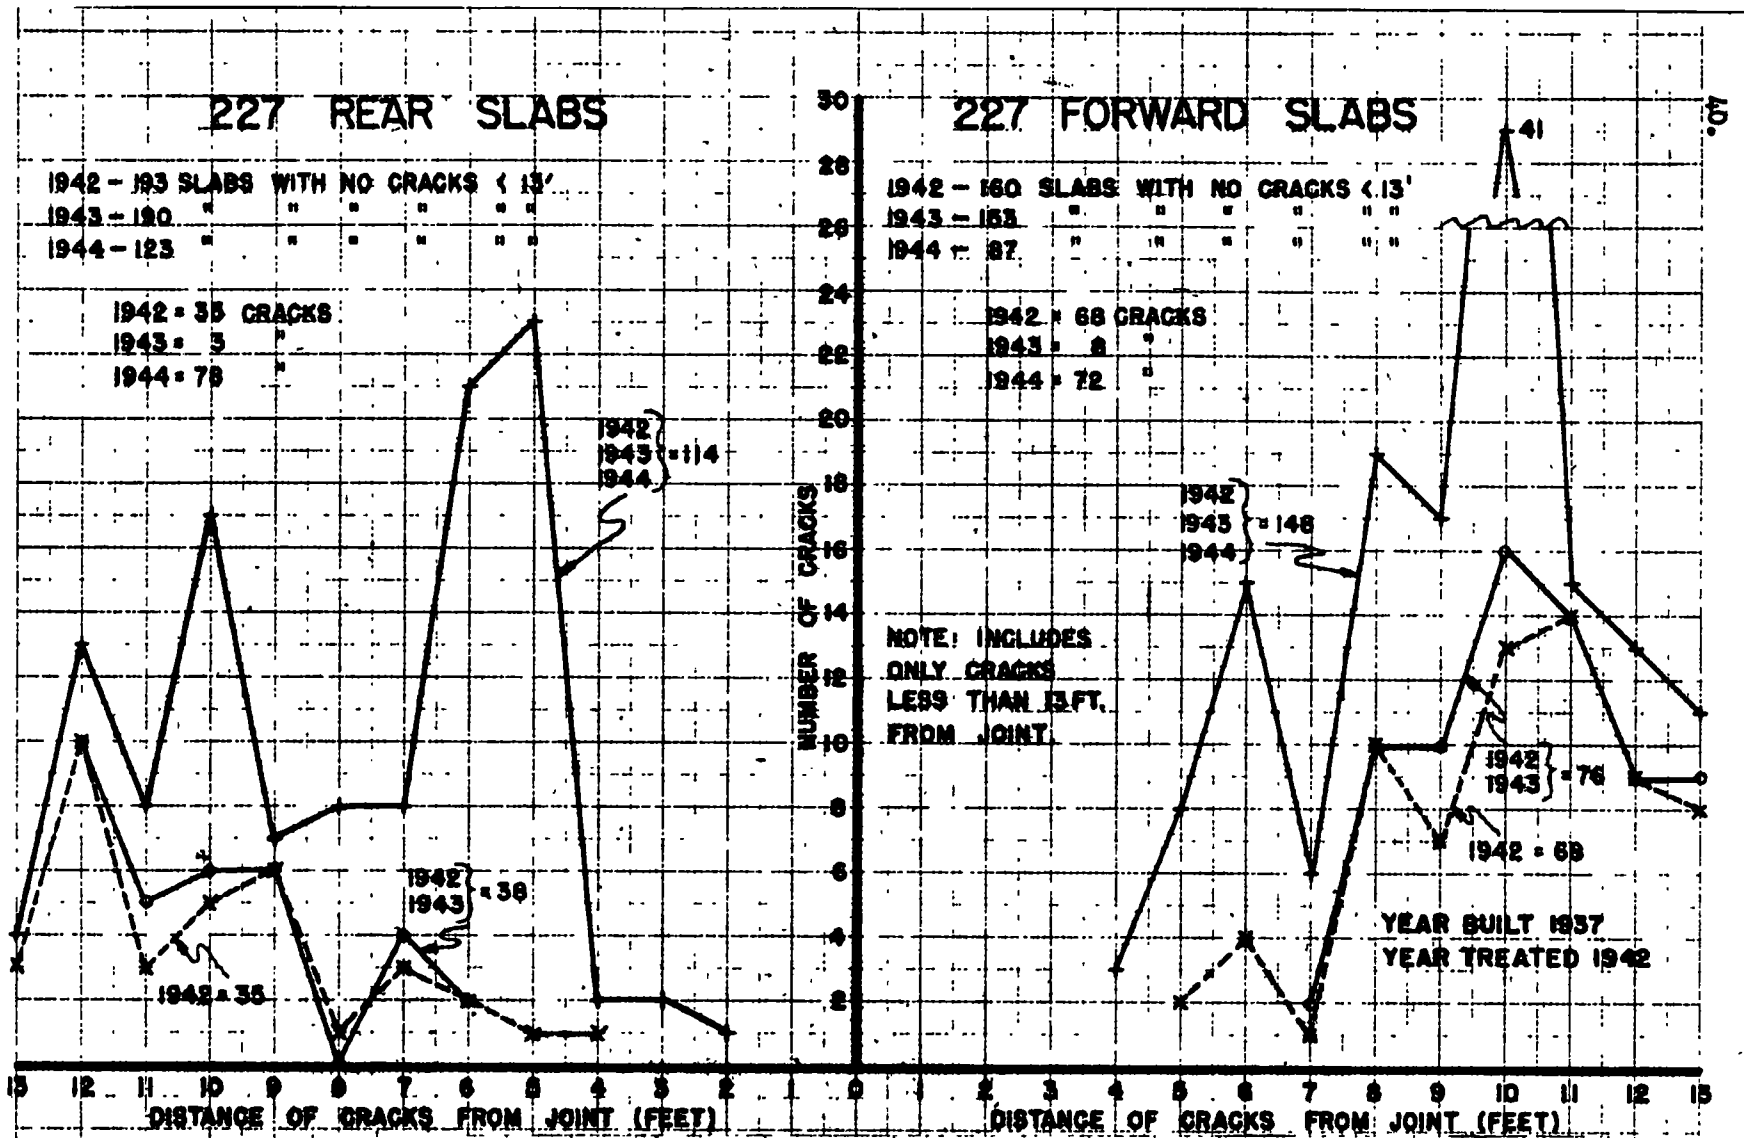
**FIGURE 28. DISTRIBUTION OF CRACKS LESS THAN 13 FEET FROM THE END JOINTS OF THE 227 UNTREATED SLABS**

Figures 28, 29, and 30 are distribution curves of cracks less than 13 ft. from the joints of untreated slabs, treated slabs, and individual mixes for each of the three surveys. Further study of Figs. 28, 29 and 30 illustrate the effect of mud jacking on cracking. Assuming that all cracks less than 13 ft. either side of a joint are caused by pumping action, these data show that treatment by mud jacking has decreased considerably the expected number of cracks on both rear and forward slabs. Study of Fig. 28 shows that in 1942 there were 35 cracks in 227 untreated rear slabs and that by 1944 there were 114 cracks which is an increase of 226 per cent during the two-year period. This can be compared to the data contained in Fig. 29 which shows that in 1942 there were 17 cracks in 50 rear slabs, that were later treated, and that by 1944 there were 29 cracks, which is an increase of only 70.5 per cent. In other words, the expected cracking in untreated rear slabs should have been a 226 percent increase but treatment reduced this to a 70.5 percent increase. A similar study of forward slabs shows that the expected cracking was reduced from a 117 percent normal two-year increase to an increase of 51.5 percent for the treated slabs.

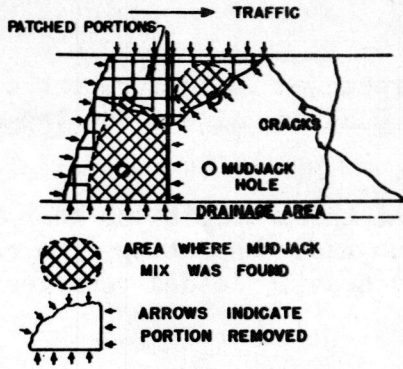
MIX "B" STATION 694+86

The mix under the slab varied in thickness and texture. The thickness varied from 0 to 2"; the thickest being farthest from the holes and the maximum under the holes. No trace of the mix was found in the inner rear portion of the section. The mix was laminated. Mud was found under the parts adjacent to the mix. The stone in the drain had clogged to the tile.

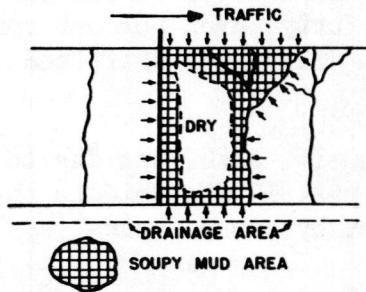
UNTREATED STATION 662+46

This slab was not treated. A zone of soupy mud was found directly under the cracks and the joint. The remainder of the subgrade-pavement contact area was fairly dry. The drain at this joint had also clogged to the tile.
