# HIGHWAY RESEARCH RECORD

Number 17

## *Stability of Rock Slopes*

5 Reports

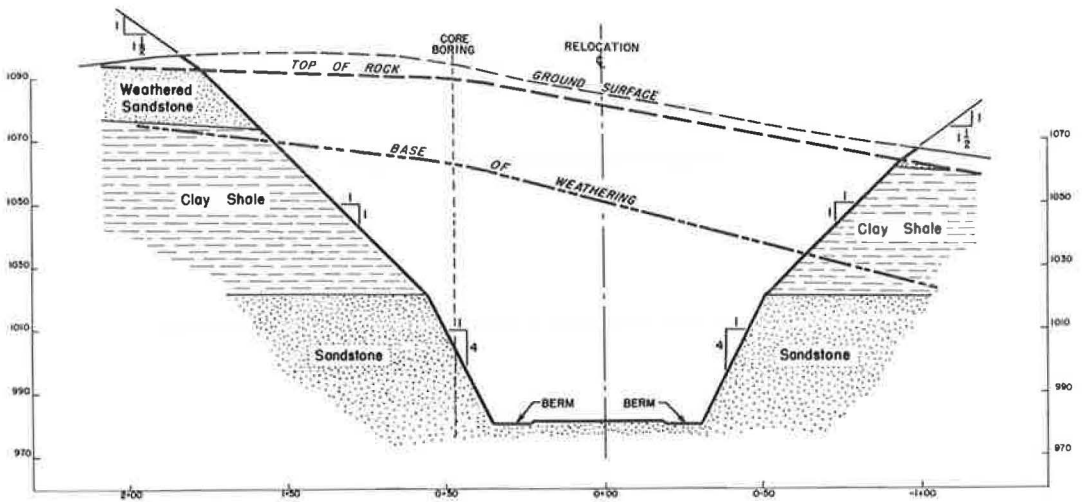
Figure 4. Through cut in rock.

Another example of material-controlled slopes is shown in Figure 4, which is a geologic section through a double-track railroad cut. Two rock types occur in the cut, both of which show weathered as well as unweathered zones. The basal rock is a sandstone which was cut on a slope of  $\frac{1}{4}$  to 1. The cap rock of the cut is likewise a sandstone but it is deeply weathered and therefore is cut on a flatter slope of 1 on 1. In between these two rocks is a clay shale, a very fine-grained but somewhat cemented rock, which requires a flat slope of 1 on 1 in both its weathered and unweathered expressions. The rock segments in this cut are random, unoriented, somewhat tabular, flat-lying shapes which are mainly stable with these cut slopes. Nevertheless, a narrow bench at track level was provided.

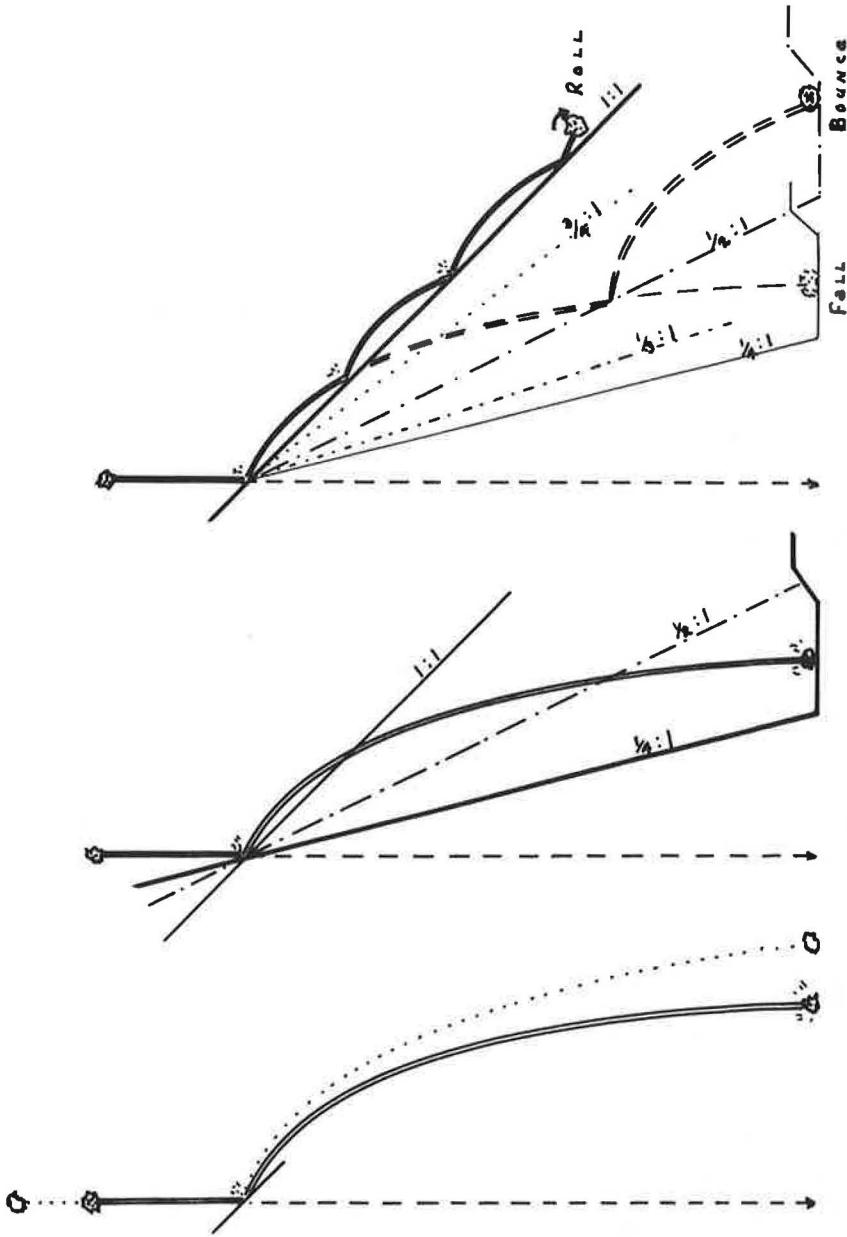
Figure 2. Path of rock trajectory superimposed on variable slopes.

relationship between the height of cliff and width of fallout area necessary to contain the material (Fig. 1). Figures 2 and 3 show that this relationship is in error. Present assigned values are arbitrary and unrealistic; hence, they are an unsafe solution. Another reason why the problem exists is that it is twofold in nature. Rockfall must take into consideration not only the minimum width of fallout zone determined by the frequency of stones making impact at a maximum distance from the base of the cliff, but also a means of stopping the stones after they have picked up angular velocity on impact. The latter feature particularly has not been emphasized enough.

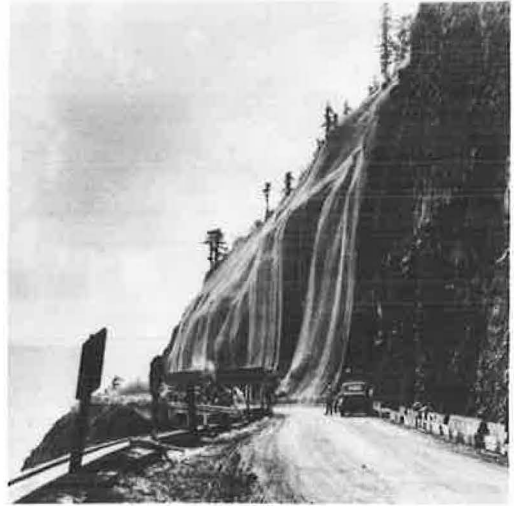
Figure 5. Wire netting, rockfall area on old construction.

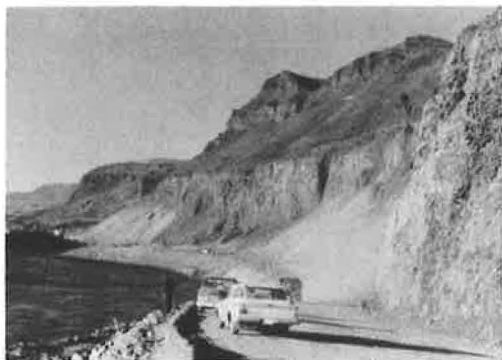
It is difficult to comprehend the magnitude of some talus slopes along mountain highways. It is still more difficult to realize that each of these stones has at some time fallen from the parent cliff and rolled to its present position, only to be buried by other rolling stones. If one lingers long with this concept, the ever-present danger of rolling stones becomes quite apparent (Fig. 8).

Figure 8. Double talus slope along Columbia River, Wash.; height of cliff in middle background = 400 ft.

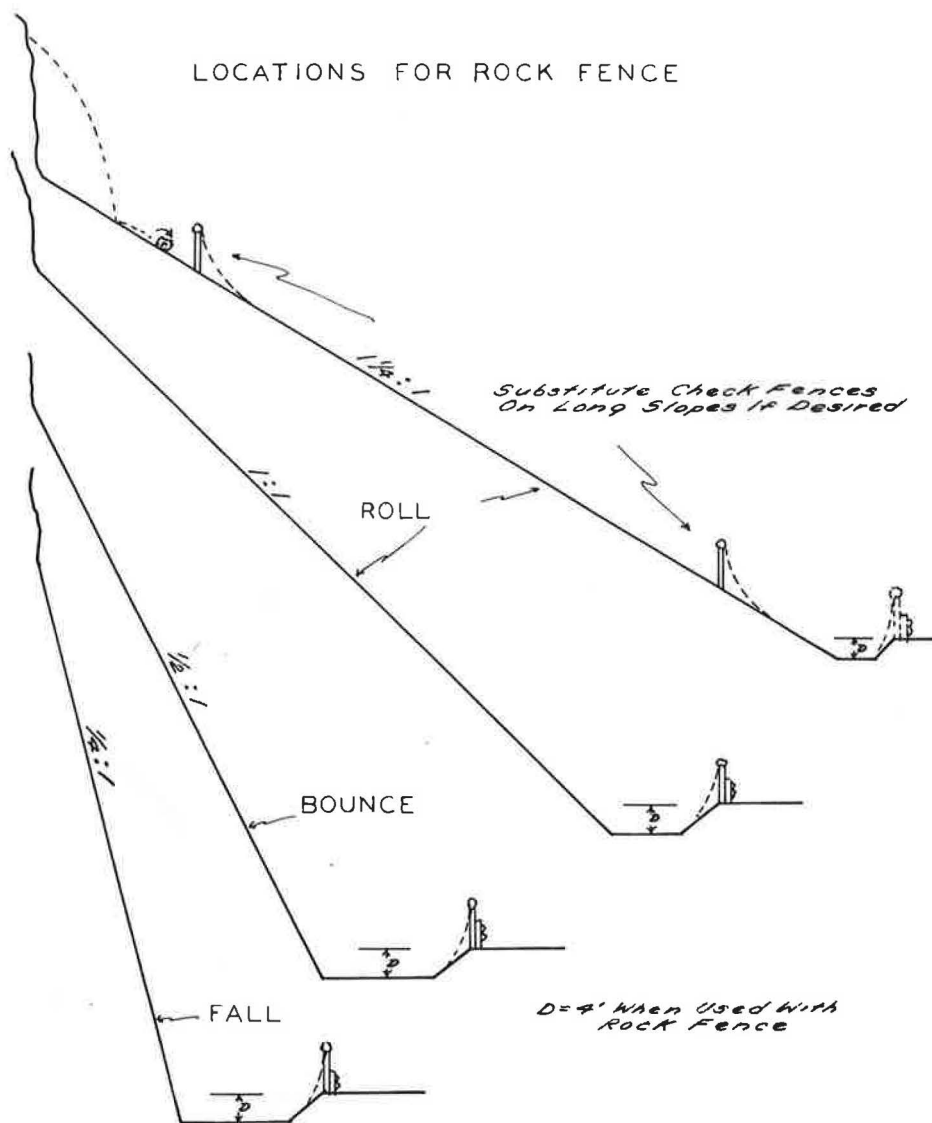
Figure 11. Position of installation of rock fence used either as check fence on slope or as protection on highway. Though ditch design for  $\frac{1}{4}:1$  and  $\frac{1}{2}:1$  for a 100-ft high slope is same, yet rock from  $\frac{1}{2}:1$  slope must cover a greater distance before encountering same fence.

The rock fence is designed to decelerate a rolling stone and to retard its angular velocity. Nearly all rocks stay very close to the talus surface while they roll. This characteristic permitted a chain link fence only 6 ft high to encounter all rolling stones. The fence is novel in that it is not mounted like an ordinary fence, but is suspended like a curtain from a cable. The cable, in turn, pulls on a compressive spring to absorb the shocks of the rocks. The spring that was used for the test was one taken from an old cable guardrail set-up. The cable is supported by fence posts every 50 ft to keep the top of the rock fence essentially in a horizontal line. The installation is mounted on the slope above the ditch line, or on the back side of guardrail posts on the shoulder of the road (Fig. 11).

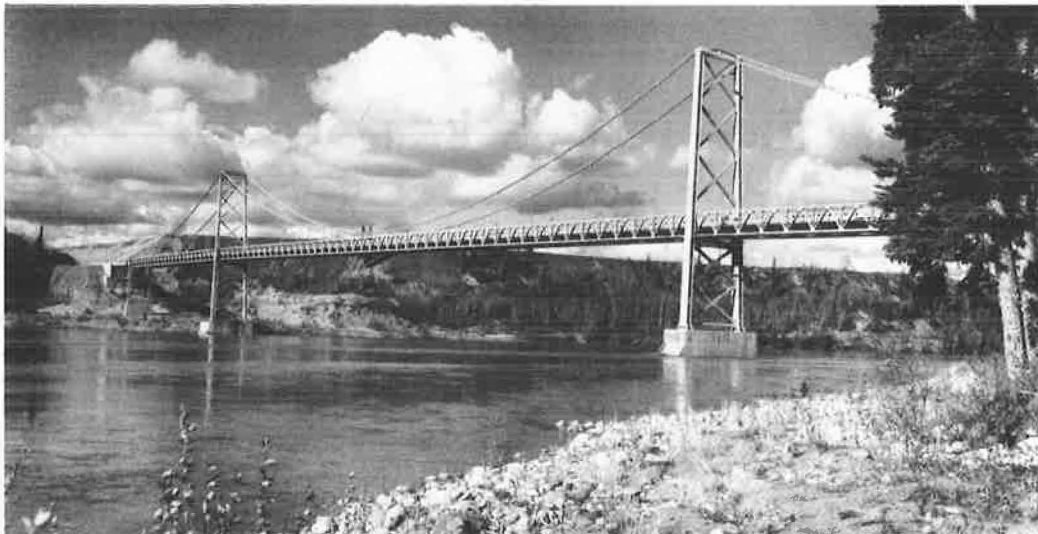
Figure 1. The Peace River highway bridge as originally constructed.

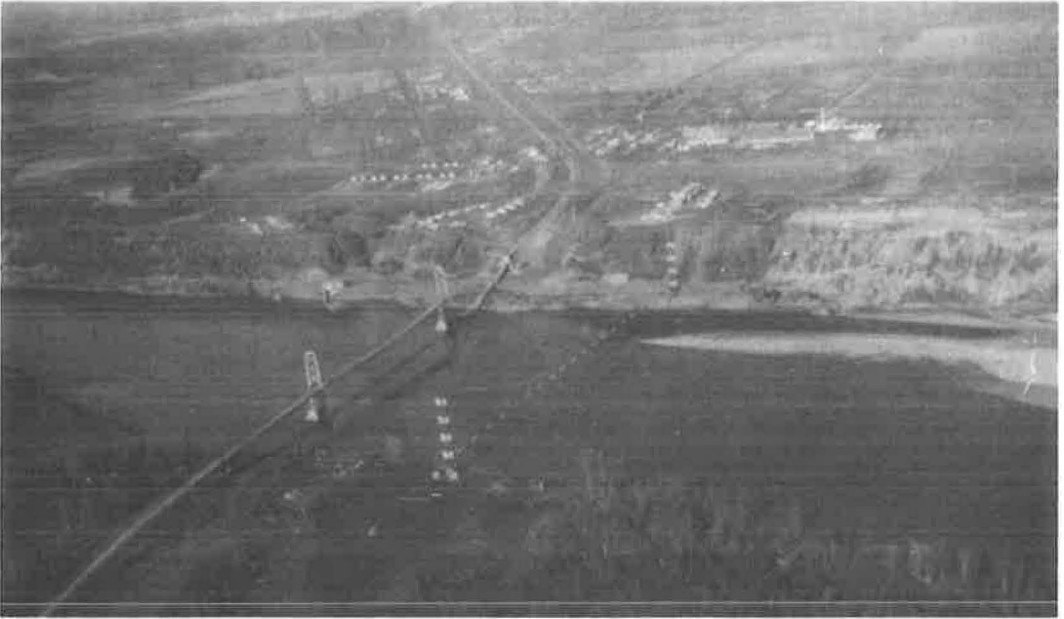
Figure 2. Gas processing plant and pipeline suspension bridge in relation to highway bridge.

The locations of the natural gas scrubbing plant pumphouse and pipeline suspension bridge in relation to the highway bridge are shown in Figure 2.
