Continuously-Reinforced Concrete Pavements in Pennsylvania—A Six-Year Progress Report

R. K. SHAFFER, and C. D. JENSEN, respectively, Research Coordinator and Director of Research, Materials Bureau, Pennsylvania Department of Highways

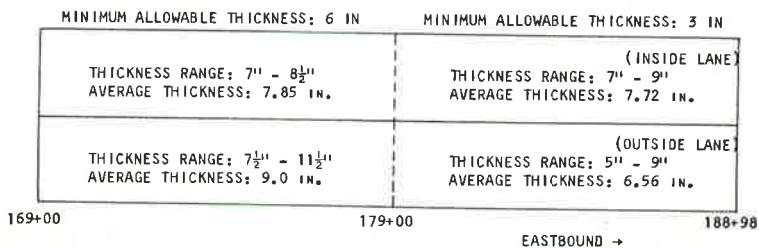
Figure 8. Thickness measurements of subbase.

The subbase thickness is quite variable and is in excess by a considerable amount from the minimum called for in the contract. The proposal called for 1,000 ft with a minimum subbase depth of 6 in. from station 169 + 00 to 179 + 00 and 1,000 ft with a minimum depth of 3 in. from station 179 + 00 to 189 + 00. The extensive irregularities in subbase depth as shown in Figure 8 could be expected to result in differential densification and nonuniformity, all of which is aggravated by traffic compaction.
