Moving Load Test on Experimental Prestressed Concrete Highway Slab

JOHN R. SMITH and RICHARD K. LIGHTHOLDER

Department of Civil Engineering, University of Pittsburgh

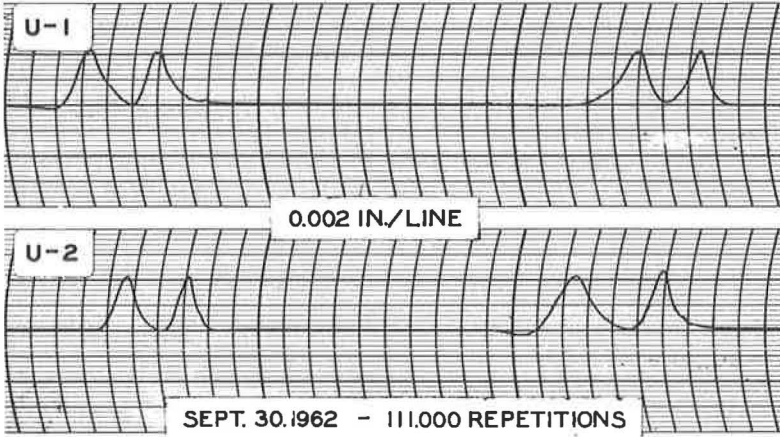
Figure 9. Typical deflections as recorded by oscillographs at U-1 and U-2.

The majority of the deflections were recorded from 4 to 5 P.M. The oscillographs shown in Figures 9 and 10 are typical for the deflections at points U-1, U-2, U-3, and L-3. The variation in the width of the peaks was caused by a variation in the velocity. This also accounts for the somewhat higher readings at the broad peaks because lower velocity would cause a greater deflection.

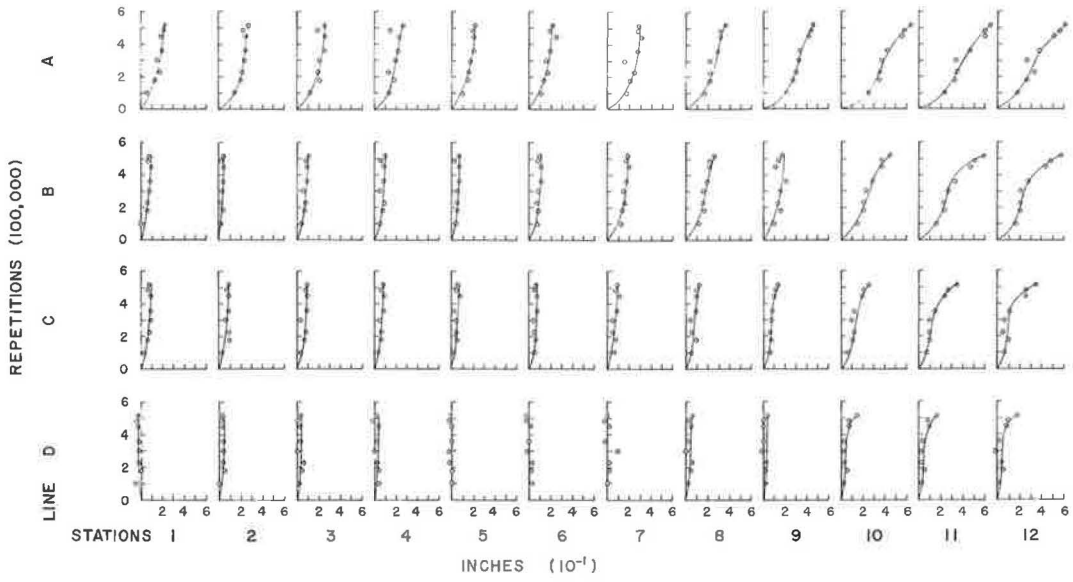
Figure 17. Change in elevations.

Figure 17 shows the graphs for each point at which a record of the elevations was made. The graphs were plotted with repetitions on the ordinates and deflections on the abscissas; the effects of the pumping from Station 8, just to the west of the expansion joint, to Station 12 can be seen.

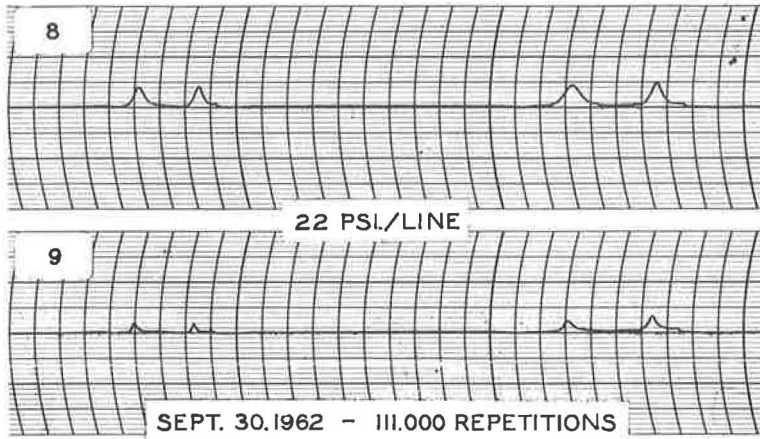
Figure 18. Oscillographs for transverse gages 8 and 9.

Most of the strain readings were recorded from 5 to 6 P.M. The transverse stresses are of questionable value because of the longitudinal cracks that developed through the strain gage stations. Typical oscillographs for the transverse stresses are shown in Figure 18. The maximum readings from these charts were plotted against repetitions to develop the graphs in Figure 19. The maximum transverse stress recorded was 105 psi at gage 8. This was based on an elastic modulus of 4,400,000 psi.

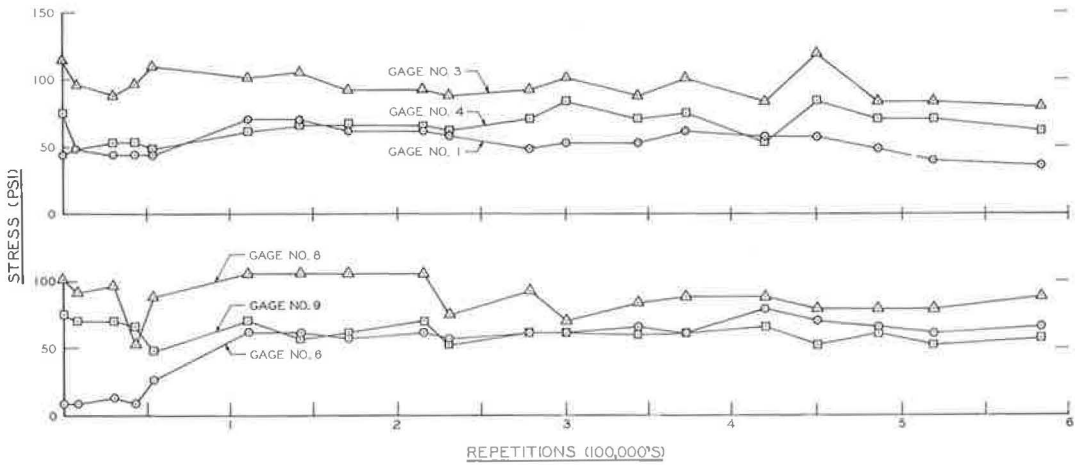
Figure 19. Transverse stresses.

During the test the downward movement of the slab west of the joint increased to 0.25 in. at the loaded edge. In spite of this, the stresses shown in Figures 19 and 21 and the moving load deflections shown in Figure 11 were nearly constant for the pavement. The longitudinal stresses were well below the cracking stress and an investigation of the loaded edge of the slab revealed no transverse cracks.

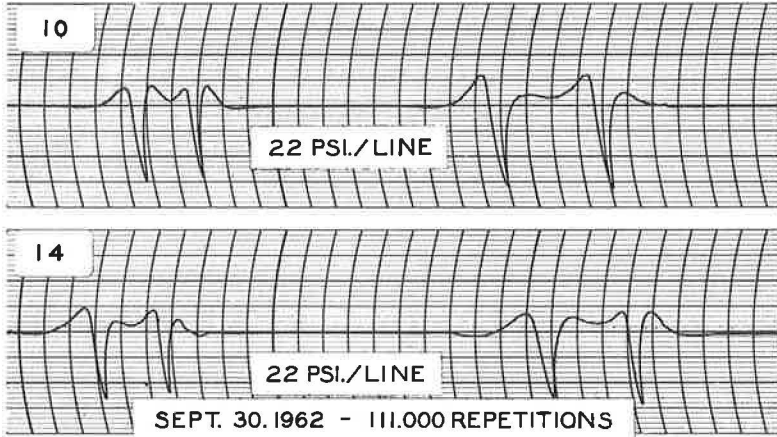
Figure 20. Oscillographs for longitudinal gages 10 and 14.

The oscillographs shown in Figure 20 for gages 10 and 14 are typical for the longitudinal gages. Figure 21 shows the maximum stresses recorded for the longitudinal gages. Gages 2 and 7 were located 6 ft from the edge of the slab and recorded a maximum tensile stress of 70 psi and a maximum compressive stress of 190 psi. The longitudinal gages along the edge of the slab show a maximum tension of 125 psi for gage 14 located 5 ft west of the edge of the sleeper slab and a maximum compression of 350 psi for gage 15 located at the west edge of the sleeper slab.
