Evaluation of Welded-Wire Fabric in Bituminous Concrete Resurfacing

W. EMMITT CHASTAIN, SR., and R. H. MITCHELL

Respectively, Engineer of Research and Development and Research Engineer, Illinois Division of Highways

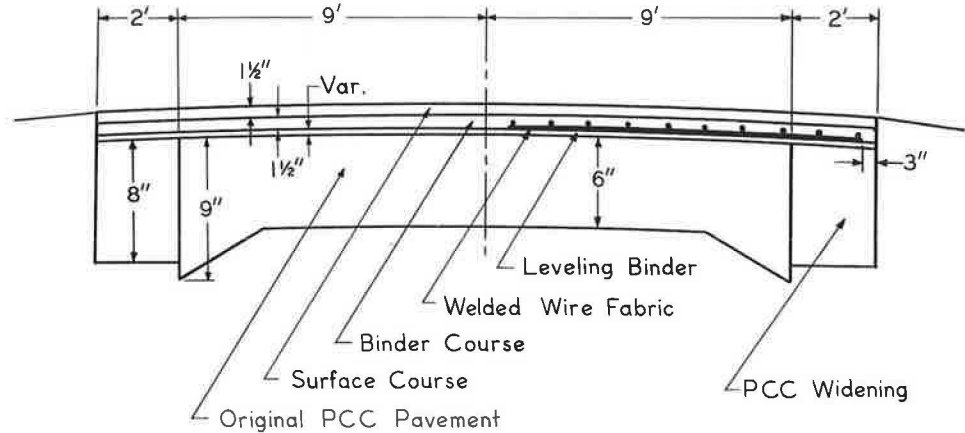
Figure 3. Typical cross-section.

The 1958 rehabilitation consisted of widening the existing pavement to 22 ft by a 2-ft width of 8-in. thick portland cement concrete along each edge, and resurfacing the entire width with a 3-in. thickness of bituminous concrete, Illinois subclass I-11. A typical cross-section of the rehabilitated pavement structure is shown in Figure 3.

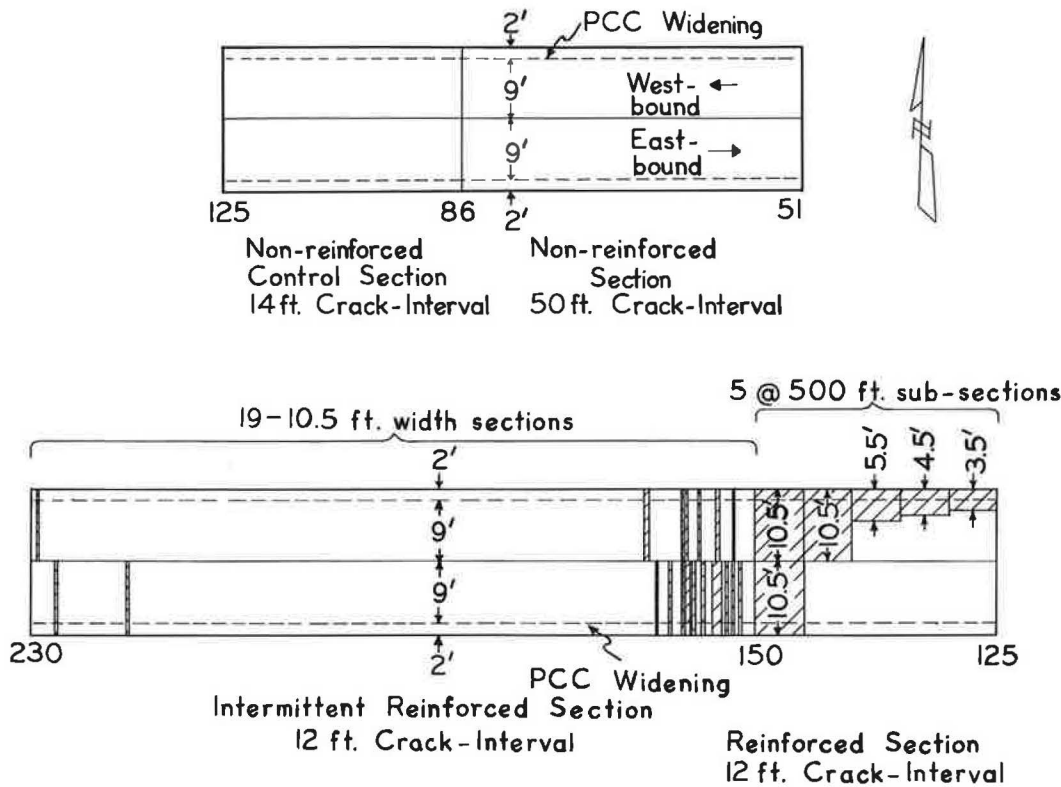
Figure 4. Details of project layout.

The two sections with no fabric installation included a 3,500-ft length in which the interval between transverse cracks in the existing pavement averaged about 50 ft, and a 3,900-ft section in which this interval was about 13 ft. The latter section was selected as the control for the analysis of transverse reflection cracking because its average crack interval was the same as that in the sections containing the fabric. Details of the project layout are shown in Figure 4.

The condition survey of the old portland cement concrete pavement before resurfacing revealed numerous wide transverse cracks and associated spalling and faulting. There were two general transverse crack intervals, one at nearly 50 ft, between Stations 51 and 86, and the other at approximately 10 to 15 ft, between Stations 86 and 230 (Fig. 4). No reason was found for the wide difference in crack interval between the two locations.
