# A 10-Year Report on Performance of Bonded Concrete Resurfacings

ROY W. GILLETTE, Manager, Personnel Training, Portland Cement Association

Approximately 15 small and large bonded concrete overlay projects constructed over the past 10 years on both highway and airfield pavements are described. Because techniques of constructing these projects have been amply covered previously, only performance of the overlays under ordinary usage is considered.

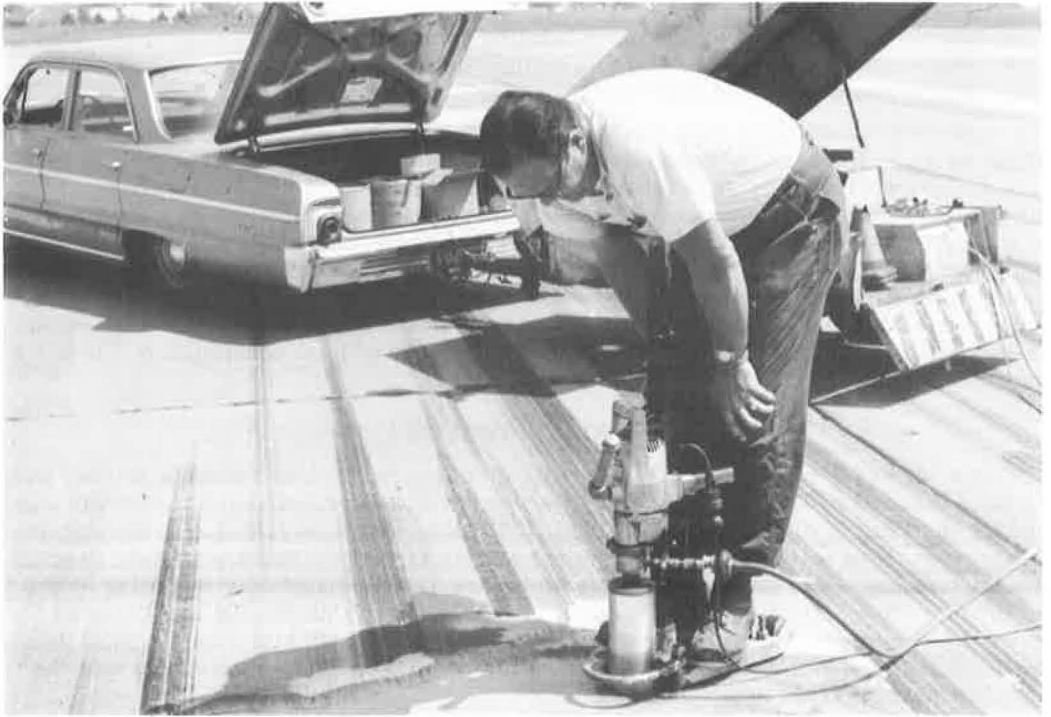
Figure 1. Coring operations.

In addition to the visual survey and the random soundings, two 4-in. diameter cores were taken (Fig. 1) from each project where it was possible to do so. In addition, several 2-in. diameter cores were taken at random to verify the existence of bond wherever a solid area was indicated by sounding.

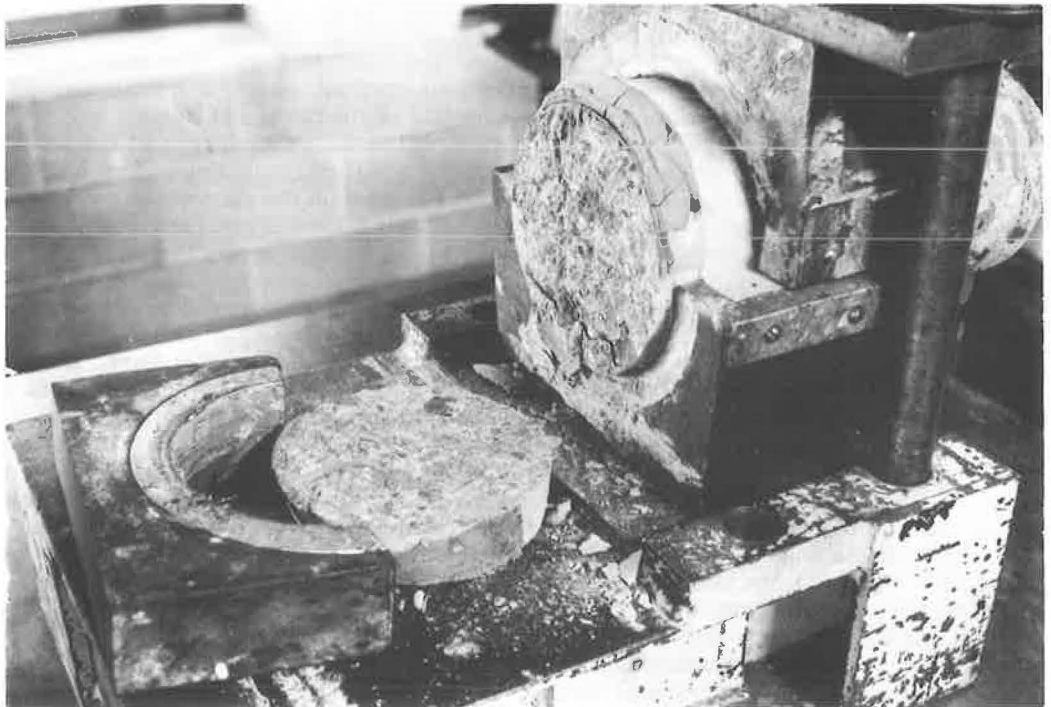
Figure 2. Laboratory jig for shearing cores.

The 4-in. diameter cores were taken to the Portland Cement Association's Research and Development Laboratories where they were placed in a special jig and sheared at the bond interface (Fig. 2). All cores fractured in the old base concrete indicating an excellent bond (Figs. 3 and 4, Table 5). The 2-in. cores indicated a satisfactory bond although they were not sheared in the laboratory. Several 4-in. cores were taken in unbonded areas to try to determine the reason for the loss of bond.
