HIGHWAY RESEARCH RECORD

Number 136

Studded
Tires

7 Reports

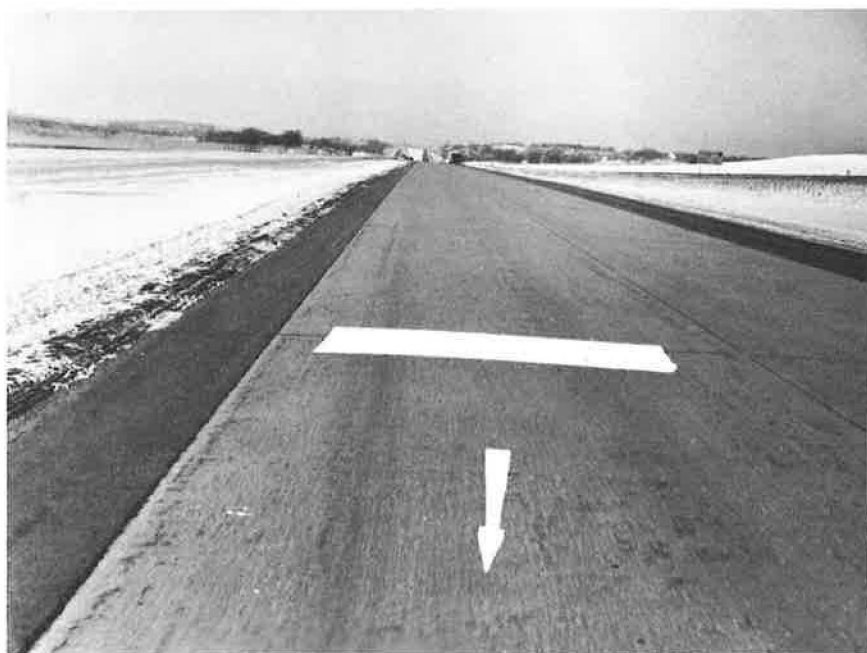
Figure 3. Location of normal stopping and starting tests on concrete.

Normal Stops.—The location of the test section where normal stops were made on the concrete pavement is shown in Figure 3. The white bar in the picture indicates the location of a hypothetical stop sign. The vehicle approached this section at 30 mph, traveling in the direction indicated by the arrow and braked to a complete stop at the white bar. The surface condition of the concrete pavement after 210 normal stops is shown in Figure 4. There was little or no apparent difference in the surface condition of the pavement in the wheelpath (area to the left of pencil in Fig. 4) and the untested concrete pavement (area to the right of pencil). The dark spots evident on the pavement surface in this picture are oxidized residues from snow plow blades. There was no visible change in the condition of the concrete surface after 310 normal stops.

Normal Starts.—After the vehicle had completed a normal stop at the location shown in Figure 3, a normal start was made. The condition of the pavement surface after 310 normal starts was similar to that of the section where the normal stops were made. Although the studs left visible short, scratch-like marks on the concrete in both test sections, there was no apparent abrasive loss of the concrete surface.

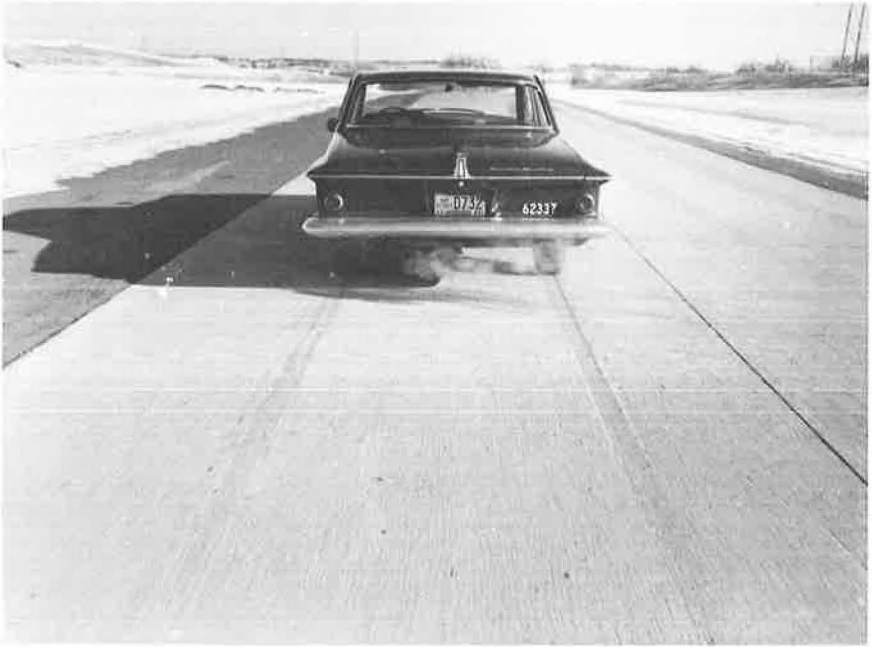
Panic Stops.—At the beginning of this study, panic stops were made from speeds of 10, 20, 30 and 50 mph. Figure 5 shows the concrete surface after a single panic stop from 30 mph at a location where no other tests had been made. The skid marks and the scratches left by the studs are visible in the foreground.

Figure 5. Concrete surface after single panic stop.

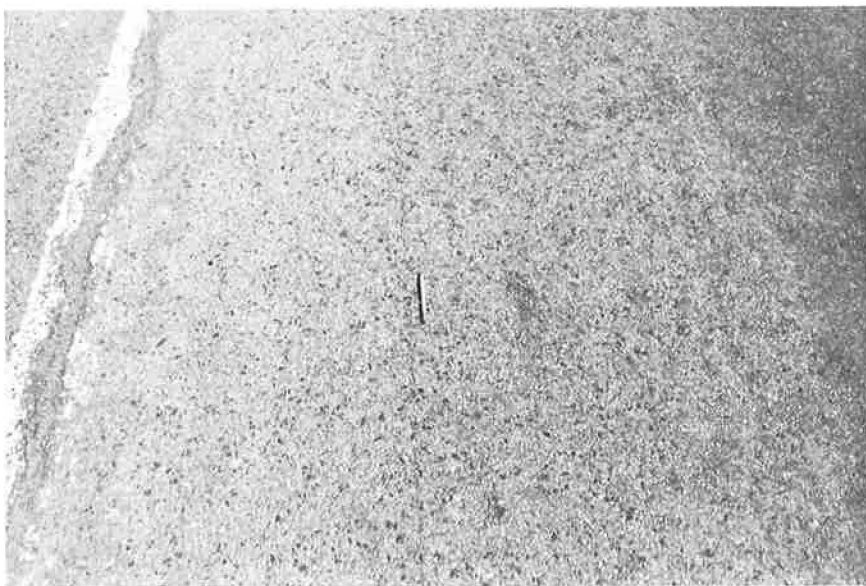
Figure 15. Condition of bituminous surface at typical intersection.

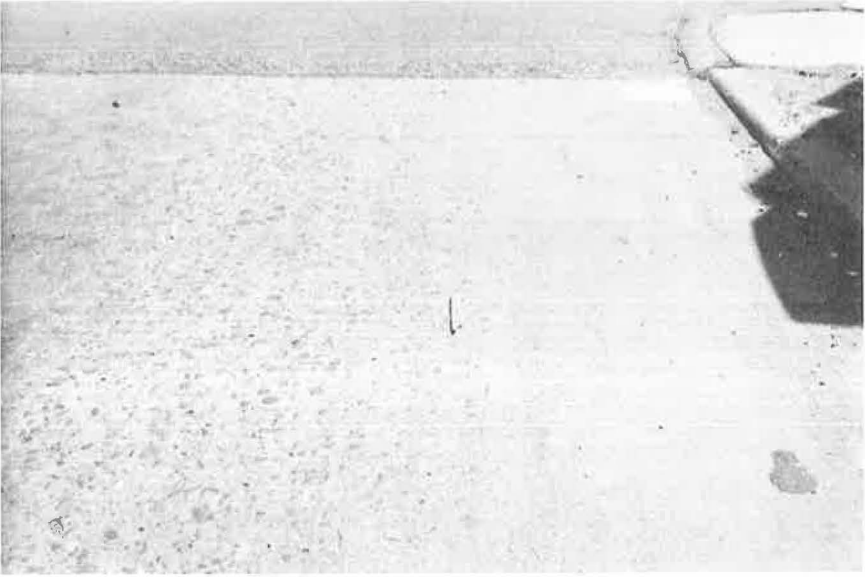
Figure 16. Condition of concrete surface at a high volume intersection.

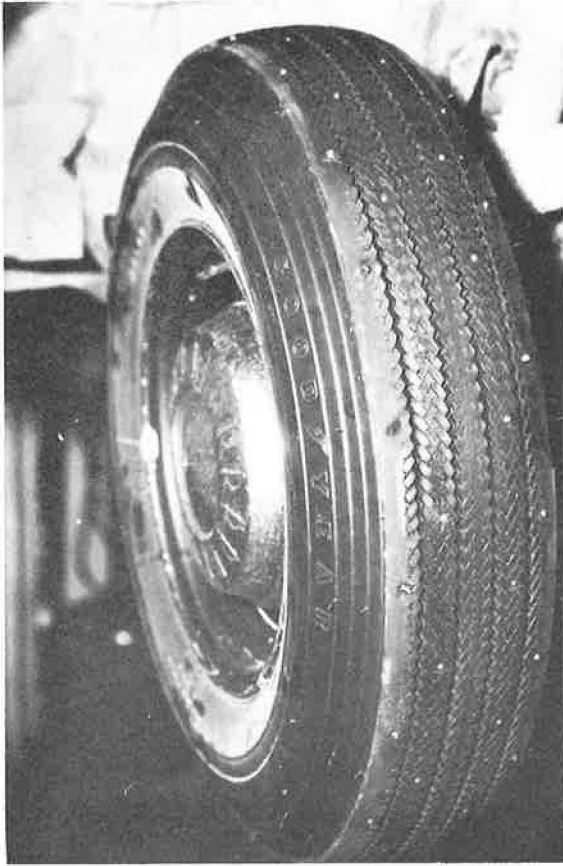
Figure 20. Condition of steel encasement type studs after 21 series of stops and starts.

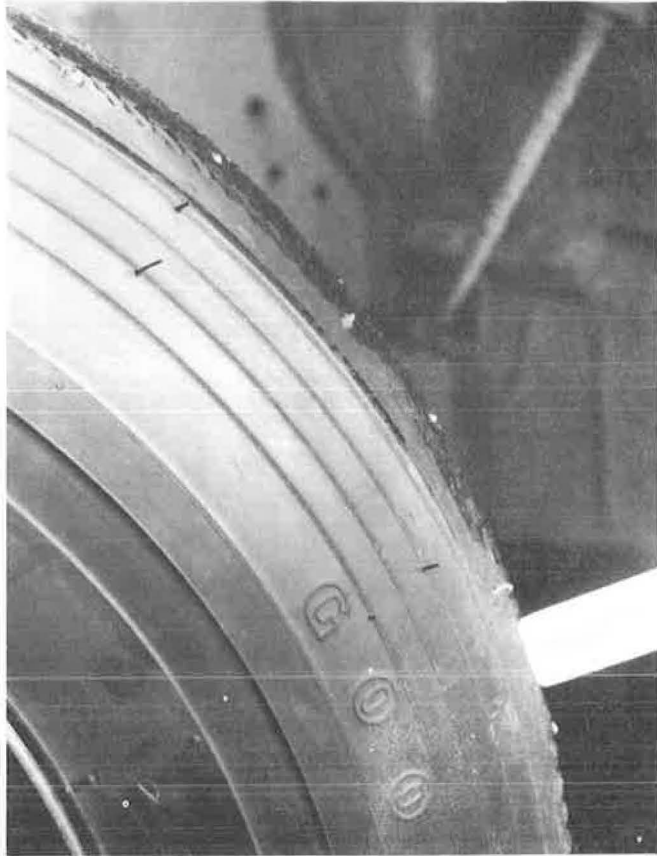
Figure 21. Wear on front tires after 21 series of stops and starts (400 mi total travel).

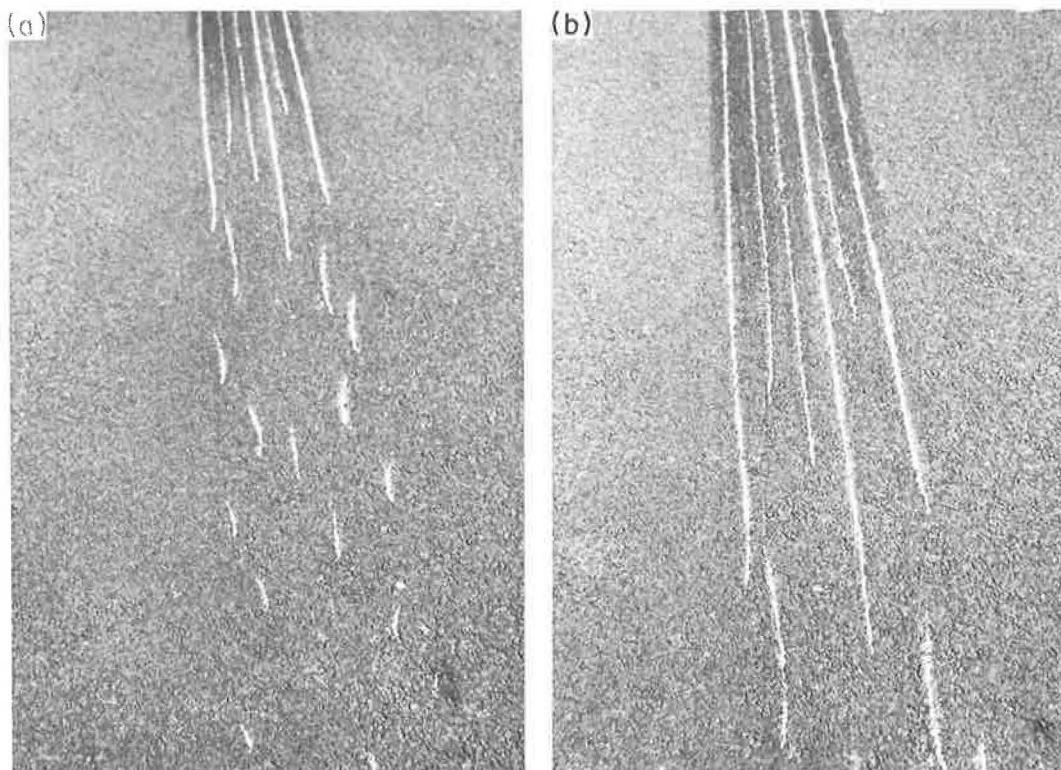
the studs did not decrease skid resistance on clear pavement was that as the tire stopped rotating, six studs were in contact with the pavement, and this number was not sufficient to lift the tread from the pavement, as evidenced by the amount of black rubber marks in the upper portion of Figures 5a and 5b.

Figure 5. Skid marks on bituminous pavement.

sliding studs. When the trailer brakes were first applied and the wheel had not yet stopped rotating, different studs skidded and each one made a short scratch on the surface (Fig. 5). However, when the wheel locked, 6 studs were in contact with the pavement and the scratches became continuous and uniform in depth (less than $\frac{1}{16}$ in.) on the bituminous pavements (Fig. 5). On concrete surfaces the scratches were very shallow and barely visible (Fig. 6). No aggregate particles were dislodged from the pavement surfaces.

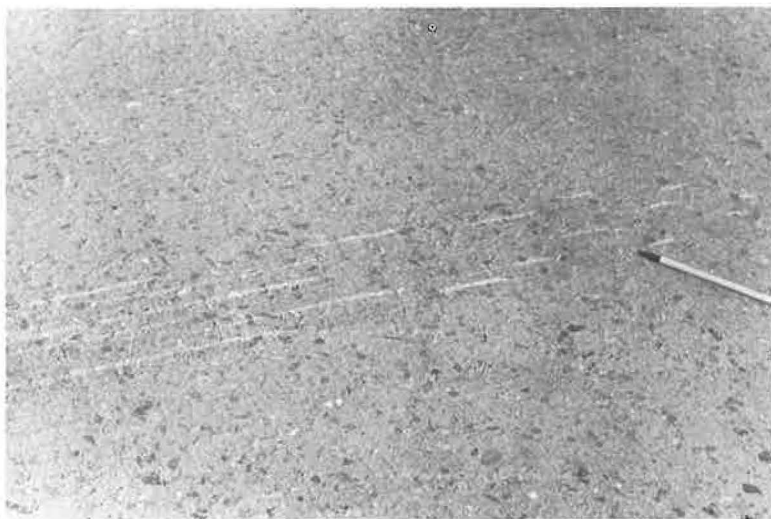
Figure 6. Skid marks on concrete pavement.

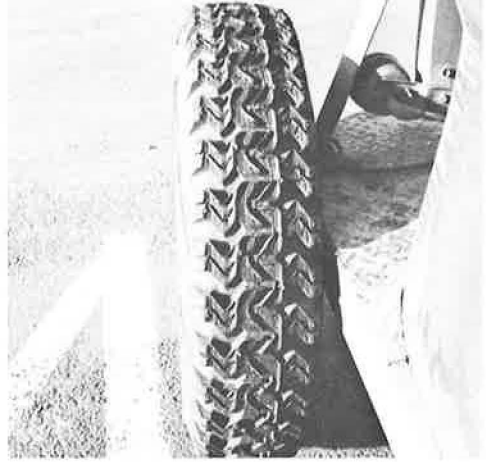
Figure 2. Tire similar to Figure 1, after 21st test spin; tread 50 percent gone; one stud lost.

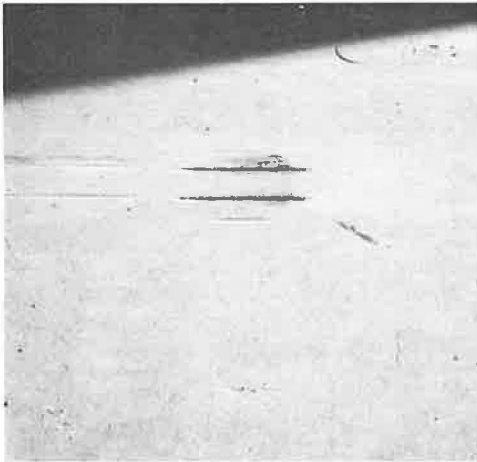
Figure 3. Test no. 3 (portland cement concrete): stud scour 6.8×0.12 in. deep.

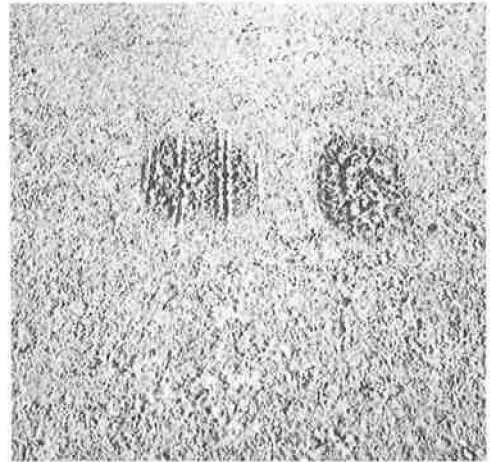
Figure 4. Test nos. 4 and 4a: stud scour, left, 7.0×0.20 in. deep; plain snow tire, right, scoured maximum depth of 0.20 in. on oil mat (Goodrich snow tire pattern has narrower width).

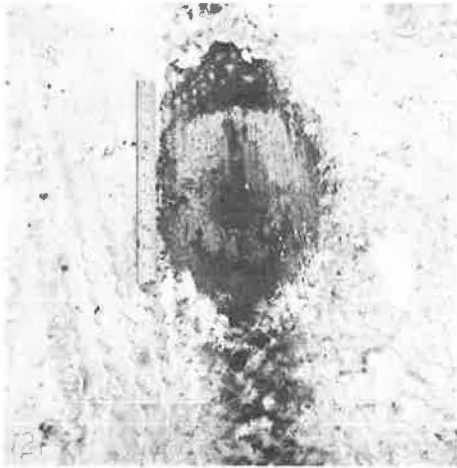
Figure 5. Test no. 7 (chain on old portland cement concrete): maximum depth of scour, 0.06 in.

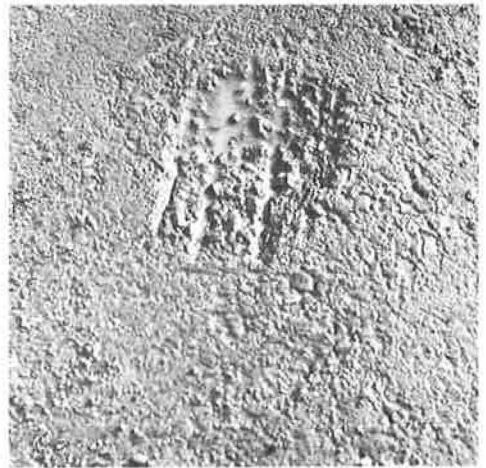
Figure 6. Test no. 12 (two runs of studded tire side-by-side, on new asphaltic-concrete shoulder): scour, 9.0 x 0.64 in. deep; breakout of intervening pavement.

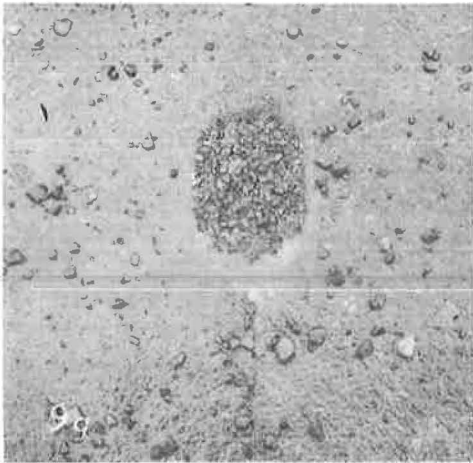
Figure 7. Test no. 13 (OK Rubber Co. "extra traction" tread without studs on new asphaltic-concrete shoulder): maximum depth of scour, 0.23 in.

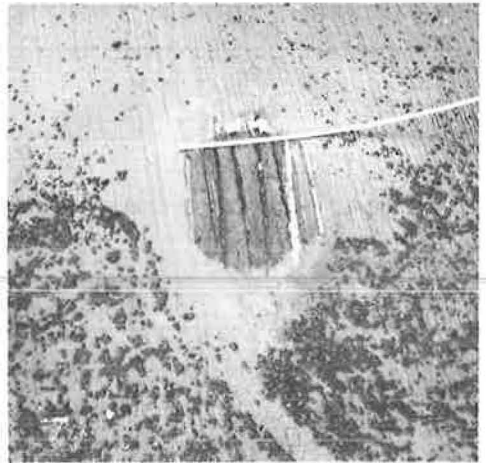
Figure 8. Test no. 15 (two runs of studded tire side-by-side on new portland cement concrete): maximum depth of scour 0.32 in., very little breakout of material between studs.

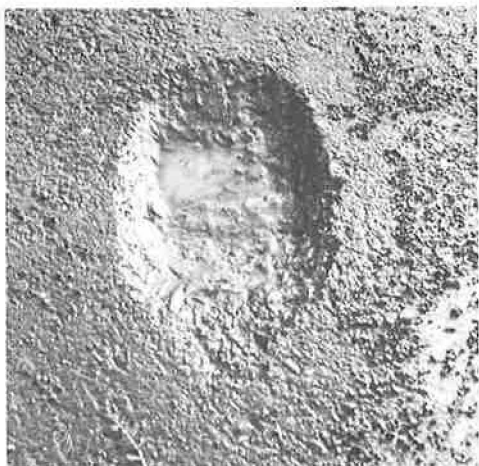
Figure 9. Test no. 17 (chain on new asphaltic-concrete shoulder): maximum depth of scour 1.5 in.

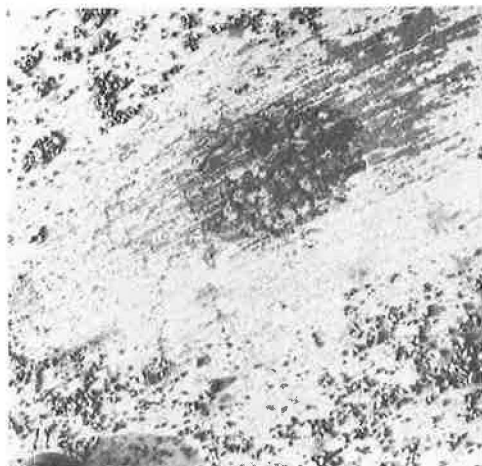
Figure 10. Test no. 18 (plain snow tire on new portland cement concrete): depth of scour, 0.06 in.

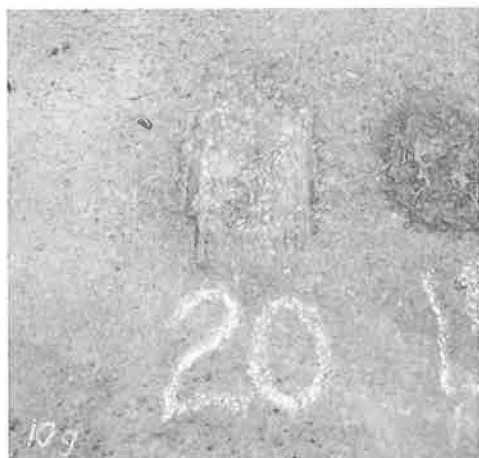
Figure 11. Test no. 19 (right edge, plain snow tire on oil mat): scour depth, 0.23 in. Test no. 20 (center, chain): scour depth, 0.48 in.

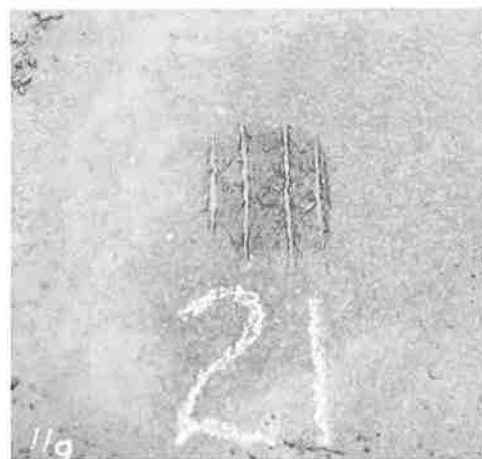
Figure 12. Test no. 21 (studded tire on oil mat): depth of stud scour, 0.40 in.

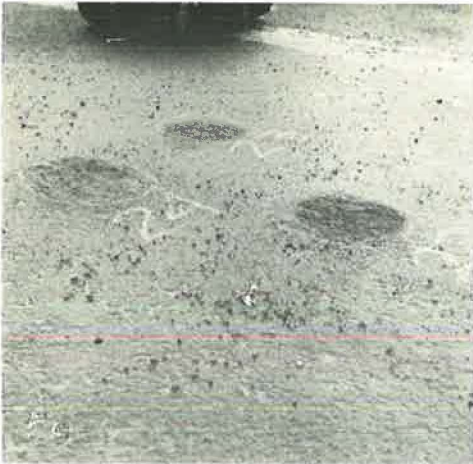
Figure 13. Test nos. 22, 23, 24 (asphaltic-concrete pavement): stud scour depth 0.15 in. (no. 22), plain snow tire scour depth, 0.14 in., maximum; chain scour depth, 0.50 in., maximum (no. 24).

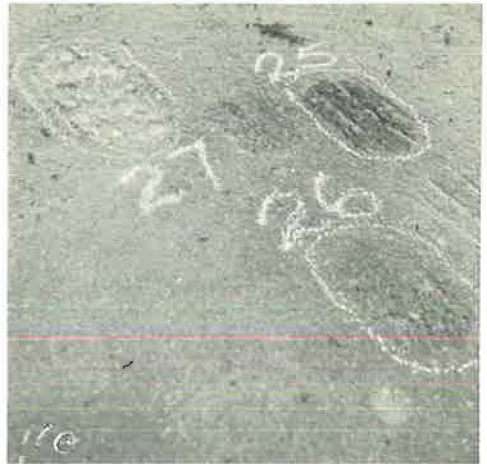
Figure 14. Test nos. 25 (stud), 26 (plain), and 27 (chain). Scour depths: stud, 0.25 in.; plain, 0.14 in.; chain, 0.38 in. (asphaltic-concrete pavement).

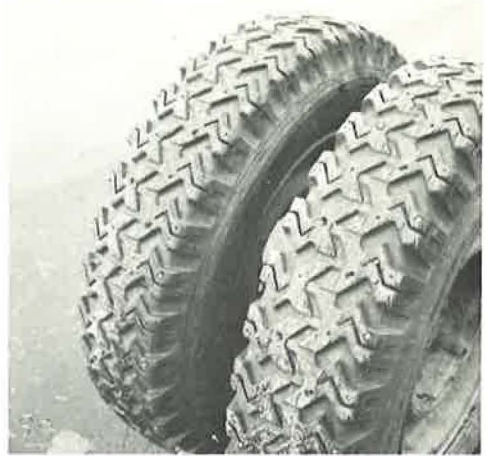
Figure 16. Initial studded tires after removal at 2,940 trips (27 hr): rear tire, left; front tire, right.

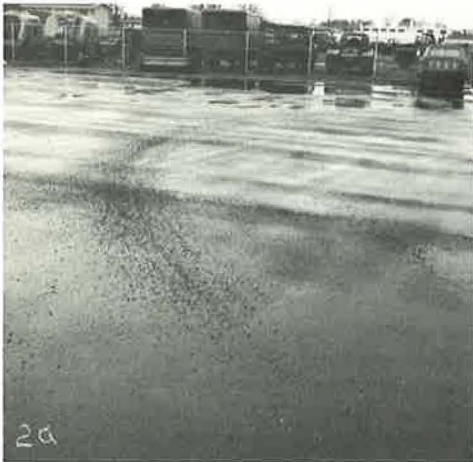
Figure 17. Curve right 4 hr after beginning test (400 trips); studded tires on left.

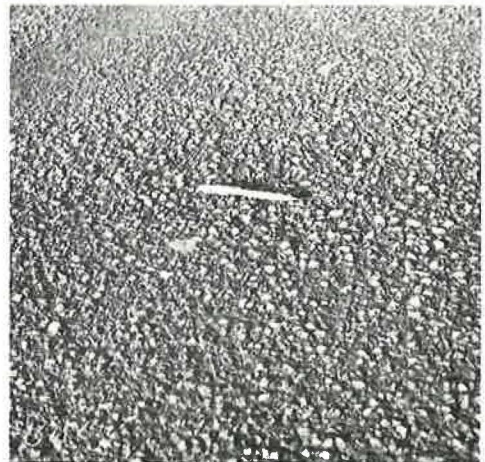
Figure 18. Left track at middle of curve right at 46 hr (5,330 trips).

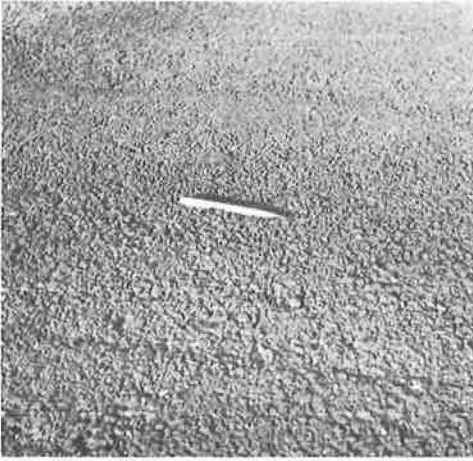
Figure 19. Right track at middle of curve right at 46 hr (5,330 trips).

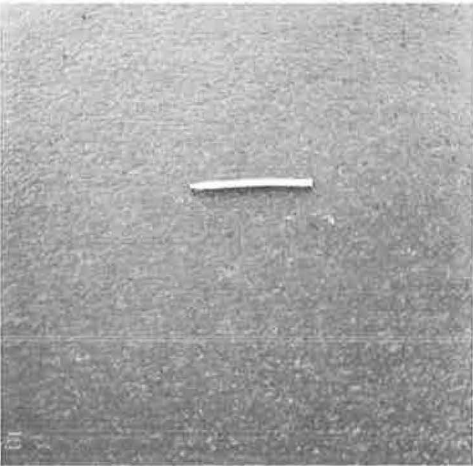
Figure 21. Left track of curve left at 4 hr (400 trips).

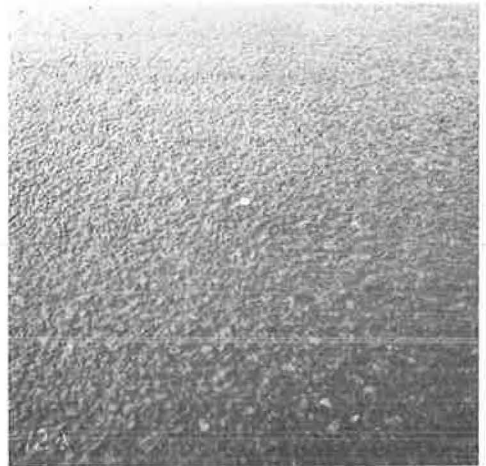
Figure 22. Left track of curve left at 29 hr (3,190 trips).

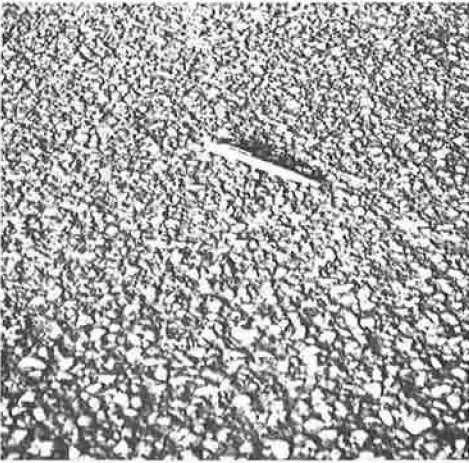
Figure 23. Left track of curve left at 46 hr (5,330 trips).

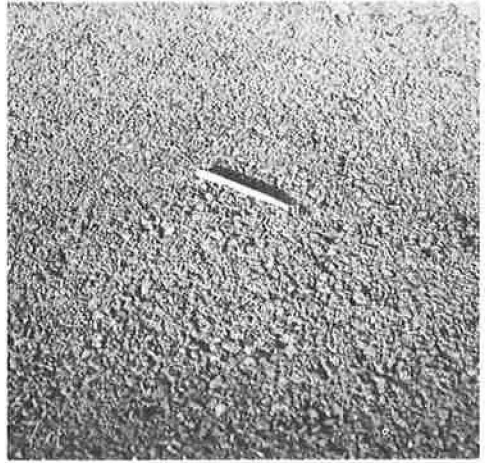
Figure 24. Right track of curve left at 46 hr (5,330 trips).

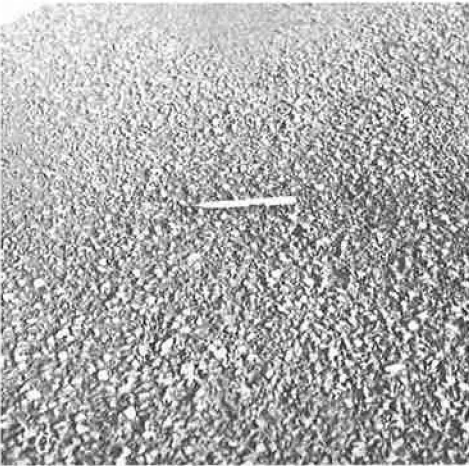
Figure 25. Left wheel tracks at cross-over at 46 hr (5,330 trips).

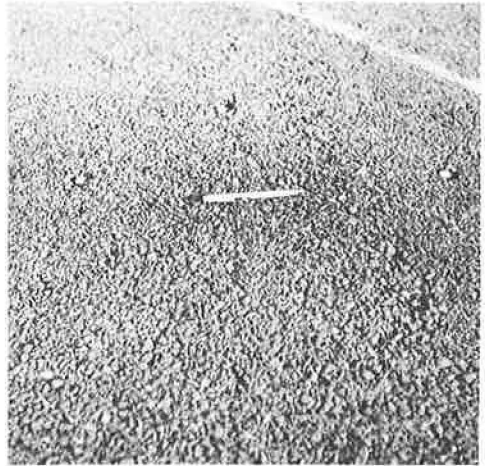
Figure 26. Right wheel tracks at cross-over at 46 hr (5,330 trips).

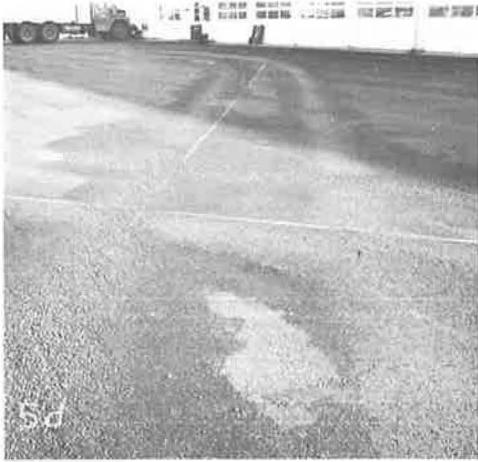
Figure 27. Cross-over area at 46 hr (5,330 trips).

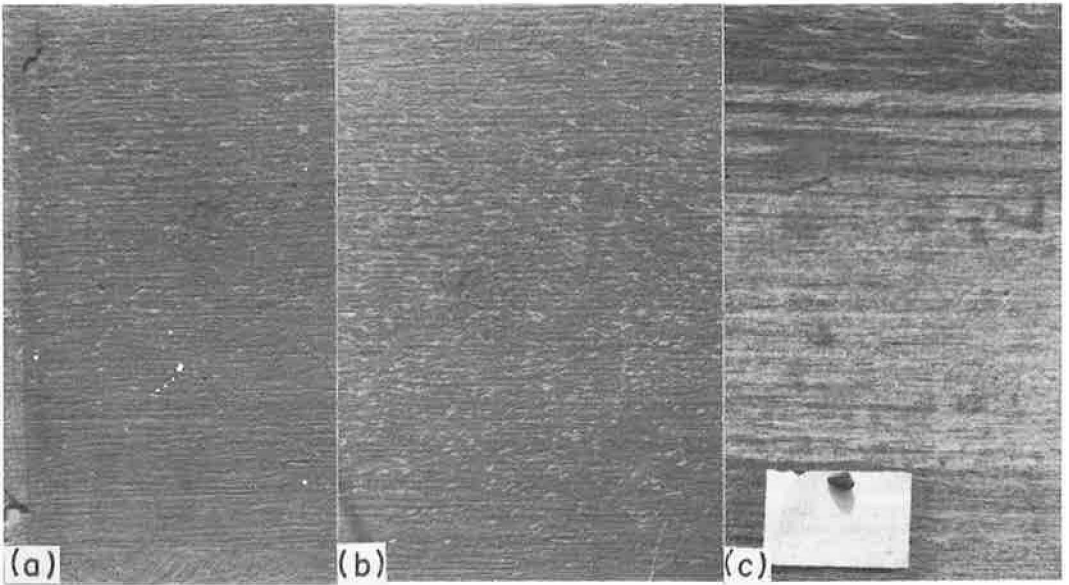
Figure 5. Portland cement concrete pavement surface after (a) 25 normal starts, (b) 125 normal starts, and (c) 175 normal starts plus 75 rapid starts.

Figure 5 shows the portland cement concrete pavement surface after 25 normal starts, after 125 normal starts, and after 175 normal starts followed by 75 rapid starts. The bright scratches crossing the burlap drag marks in the view taken after 25 applications are striations in the pavement surface made by the tire studs. After 125 applications of normal starts the stud marks were more numerous and the burlap drag marks were beginning to disappear. The abrasion of the pavement surface was much greater under rapid-start testing. Abrasion by the studded tires after 250 applications (175 normal starts plus 75 rapid starts) extended completely through the original surface in the center of the wheelpath, and a new surface was exposed (Fig. 5).

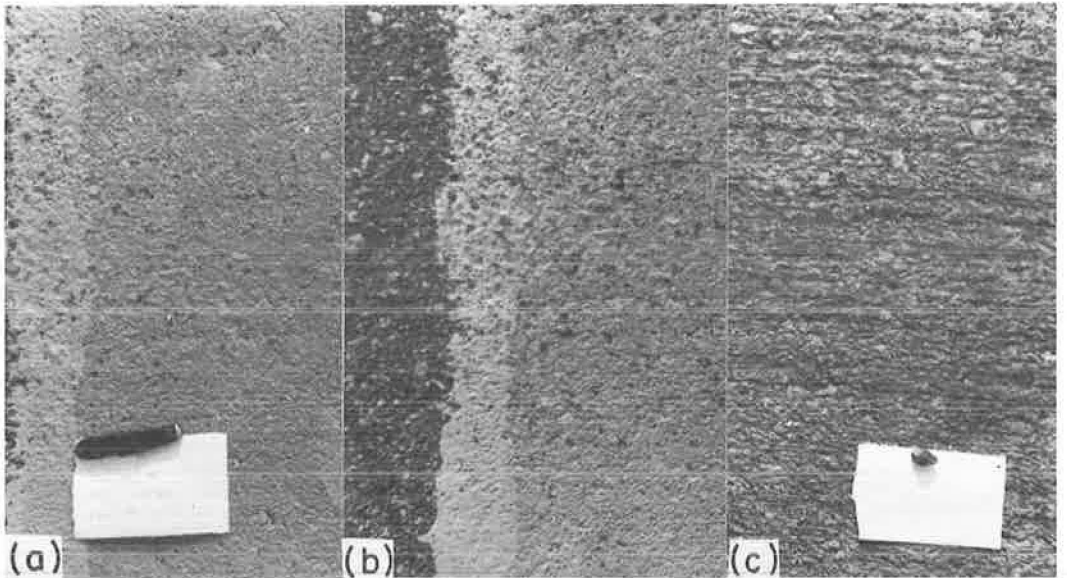
Figure 6. Bituminous-concrete pavement surface after (a) 25 normal starts, (b) 125 normal starts, and (c) 175 normal starts plus 75 rapid starts.

The condition of the bituminous-concrete surface at various stages during the starting tests is shown in Figure 6. The dark line to the left in Figures 6a and 6b indicates the limits of the painted area in the test sections. The effects of studded tires in starting on the bituminous-concrete surface were about the same as those on the portland cement concrete surface. The dark specks in Figures 6a and 6b are gouges in the pavement surface made by the metal studs. Figure 6c shows the surface after 250 applications (175 normal starts followed by 75 rapid starts). The paint was completely removed and the pavement surface markedly abraded.

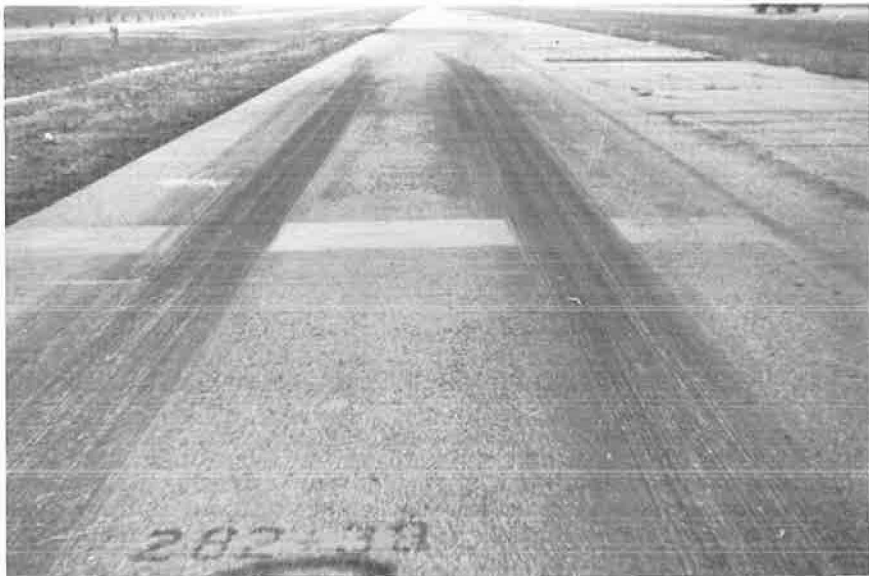
Figure 9. Bituminous-concrete surface after application of 175 normal stops followed by 25 emergency stops.

On the stopping test section of the bituminous-concrete pavement the paint mark was completely obliterated in the wheelpaths and abrasion of the surface was evident after 175 normal stops followed by 25 emergency stops (Fig. 9).

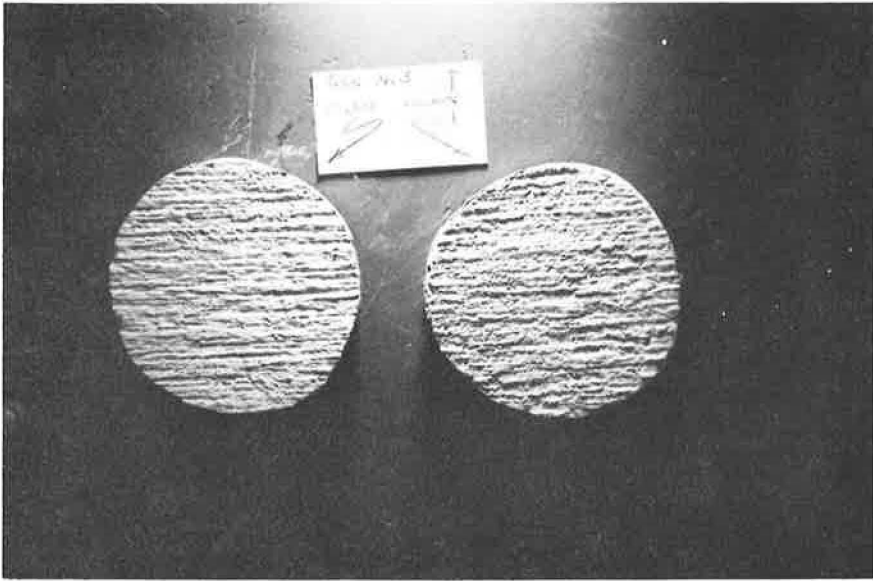
Figure 10. Plaster-of-paris casts of surface of portland cement concrete pavement before testing (left) and after 200 stop applications (right).

Comparisons of plaster-of-paris casts of the pavement surface made before testing and after the application of 175 normal stops followed by 25 emergency stops are shown in Figures 10 and 11.

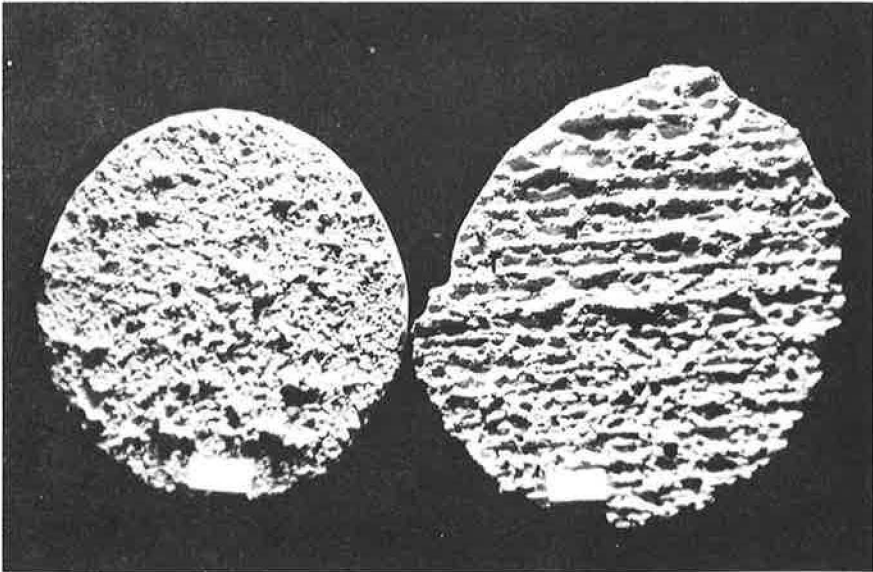
Figure 11. Plaster-of-paris casts of the surface of bituminous-concrete pavement before testing (left) and after 200 stop applications (right).

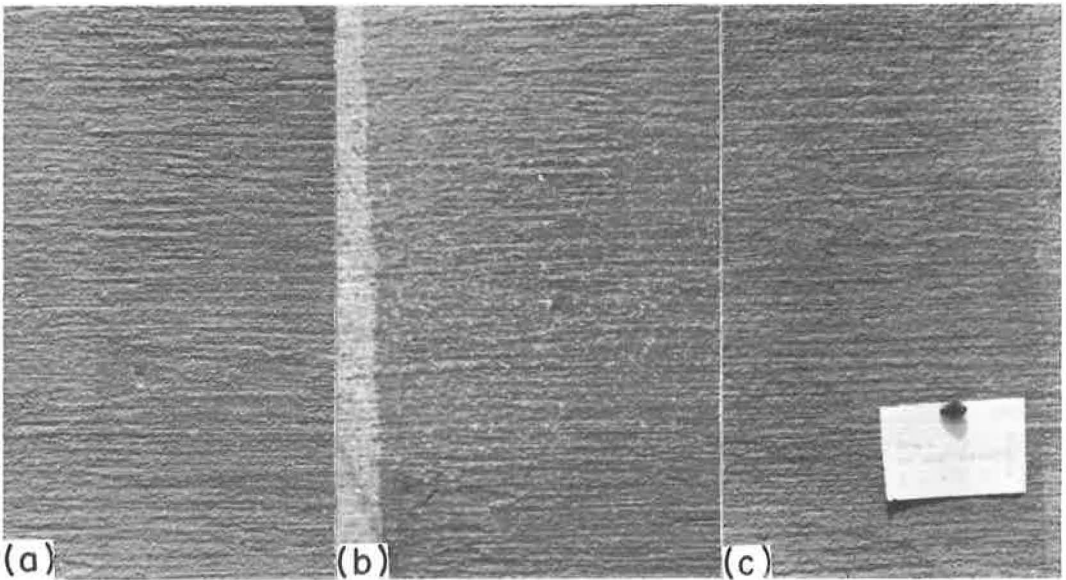
Figure 12. Portland cement concrete surface after constant-speed testing: (a) 25 applications, (b) 125 applications, and (c) 250 applications.

One test section of portland cement concrete pavement and one of bituminous-concrete pavement were used for testing studded tires with the vehicle operating at a constant 25-mph speed; 250 applications of the vehicle were made on each section (Figs. 12 and 13). Abrasion in this series of tests was indicated only as small pock marks, which appear as white dots (Fig. 12) and as black specks (Fig. 13). Abrasion of the pavement surfaces during constant-speed testing was very minor, although the marks in the wheelpaths were clearly visible at the end of testing.

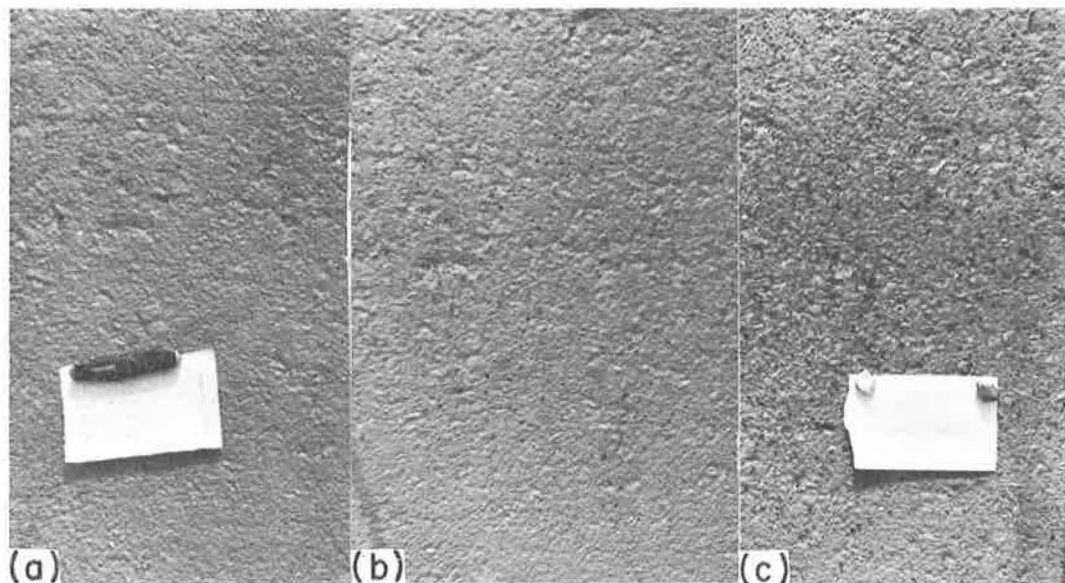
Figure 13. Bituminous concrete surface after constant-speed testing: (a) 25 applications, (b) 125 applications, and (c) 250 applications.

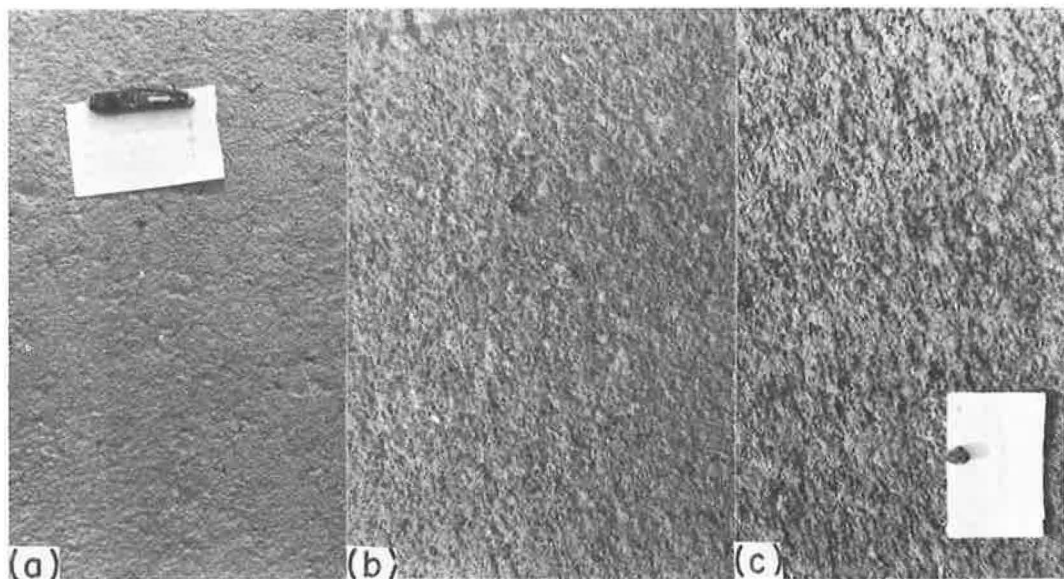
The abrasive effects of turning on a bituminous concrete surface appeared to be intermediate between those occurring under constant-speed driving and those occurring under starting and stopping. Turning produced stud marks or striations in the pavement surface that were almost normal to the direction of travel because of the twisting effect as the vehicle turned. Figure 14 shows the bituminous-concrete surface after 25, 125, and 250 applications. The test pavement has a 20-ft radius along the inside edge, which is similar to the turning radius at many intersections.

Figure 14. Turning tests on bituminous concrete surfaces after (a) 25 applications, (c) 125 applications, and (c) 250 applications.

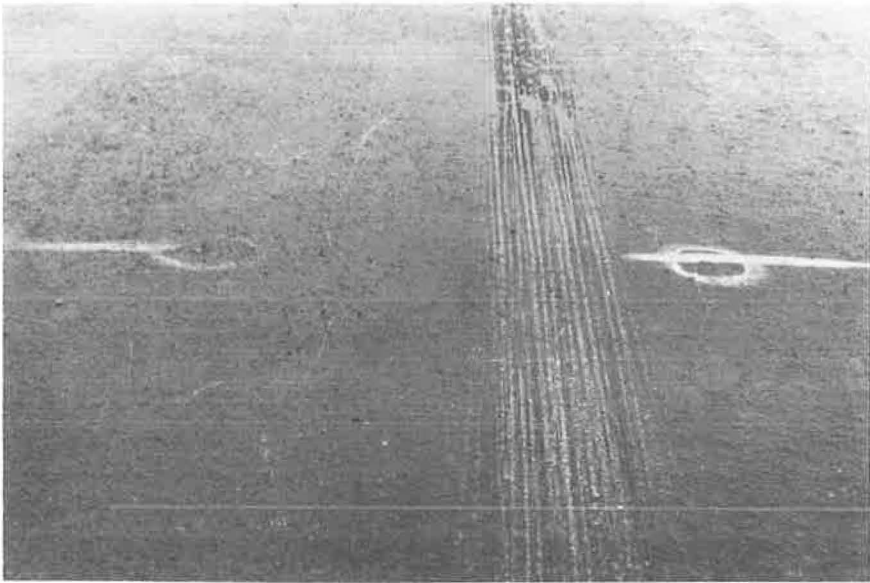
A series of 25 rapid starts followed by 25 emergency stops was applied to the subclass A-3 bituminous-treated surface of the township road that parallels loop 1. The studded tires caused deep abrasion of the A-3 treatment (Figs. 15 and 16). Figure 15 shows the pavement surface after completion of the testing; Figure 16 shows the plaster-of-paris casts made before and after testing, with the severity of grooving indicated by the left-hand cast.

Figure 15. Subclass A-3 surface treatment after completion of testing.

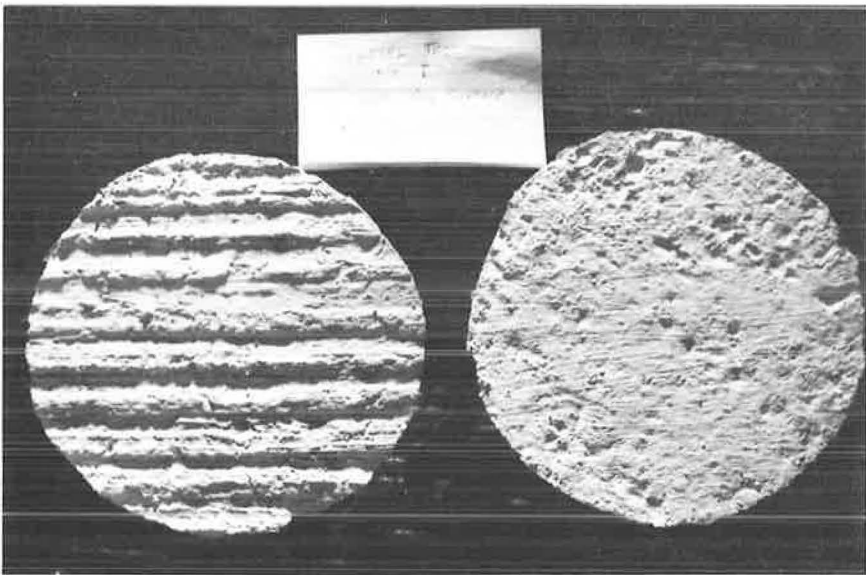
Figure 16. Plaster-of-paris casts of A-3 surface treatment before testing (right) and after completion of testing (left).

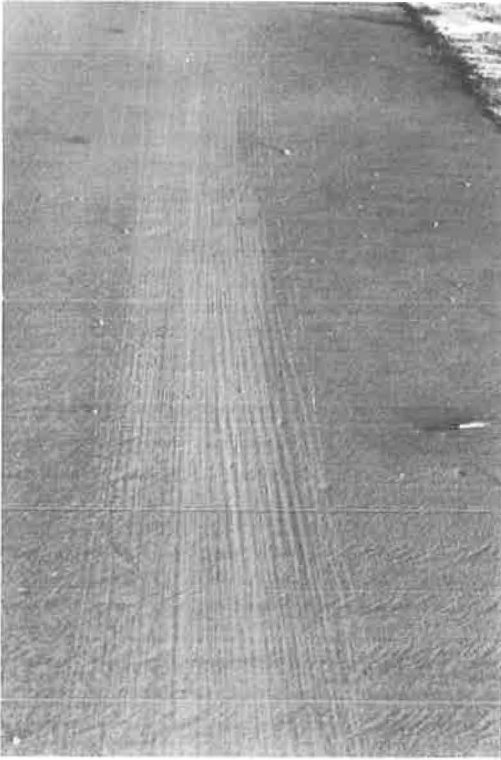
Dry Portland Cement Concrete Surface, Studded Tires.—Abrasion of the pavement in this special test (Figs. 17 and 18) appeared similar to that resulting from the original starting and stopping tests.

Figure 17. Special test no. 1 on portland cement concrete; pavement surface after completion of tests.

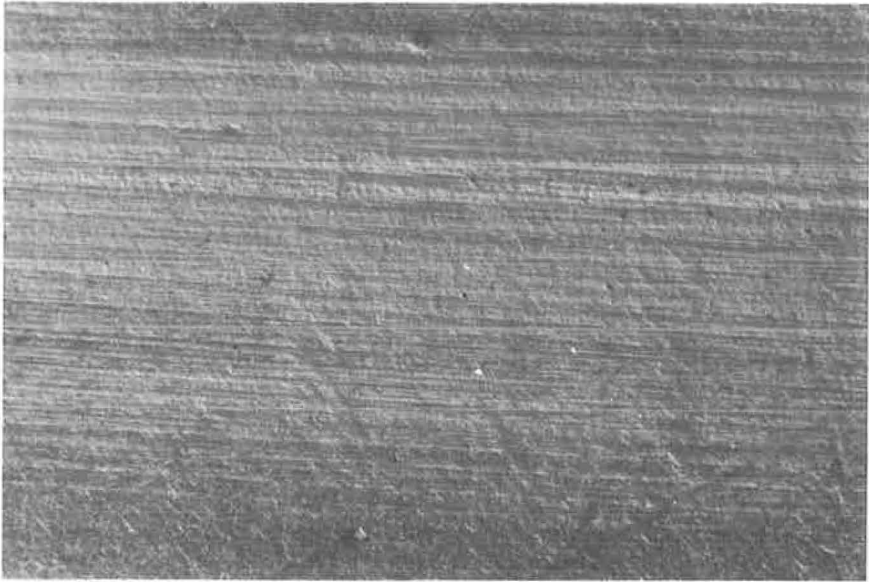
Figure 18. Special test no. 1; pavement surface after completion of tests.

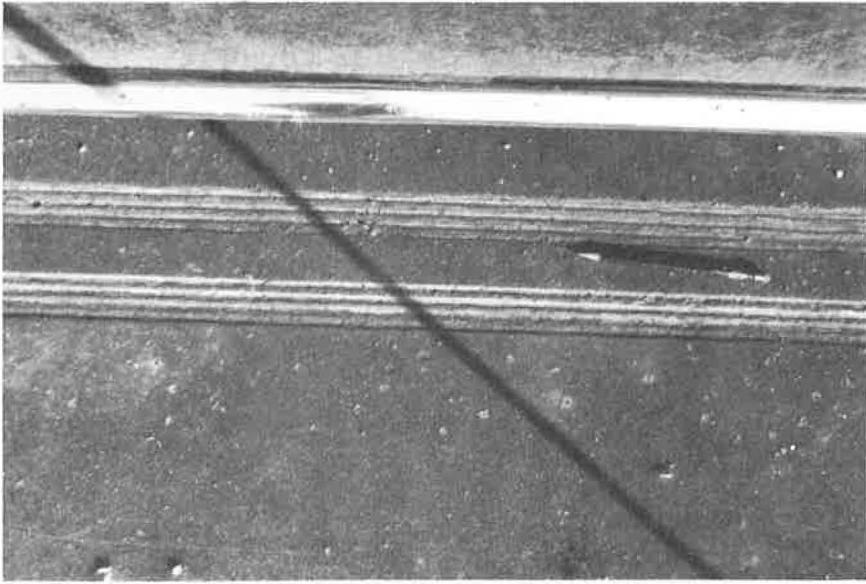
Icy Portland Cement Concrete Surface, Studded Tires.—Water was poured over the surface of the pavement and allowed to freeze solid (Figs. 19 and 20). For the initial beam measurements the ice was chipped away under each dial. After three applications of rapid starts, two sets of grooves had been cut through the ice into the pavement surface by the studs (Fig. 19). The same type of grooving was evident at all test sections where serious damage occurred as a result of spinning the wheels during rapid starts. During this test, the initial grooves appeared quickly and the studs tended to slip into the grooves on successive passes, widening the grooves and rounding off the ridges between the grooves. Grooving did not appear to be increased in intensity as a result of the ice on the surface. After 25 applications of rapid starts, all of the ice had been removed from the wheelpaths and pronounced grooves had been made in the pavement surface (Fig. 20). Chips on the surface are ice fragments chipped out of the wheelpath.

Figure 19. Special test no. 2; icy portland cement concrete surface after three applications of rapid starts.

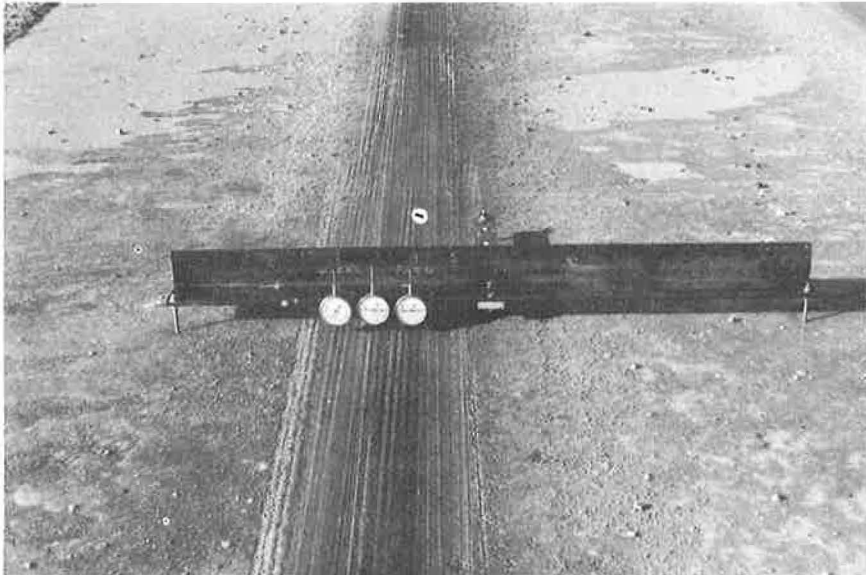
Figure 20. Special test no. 2, surface after completion of tests.

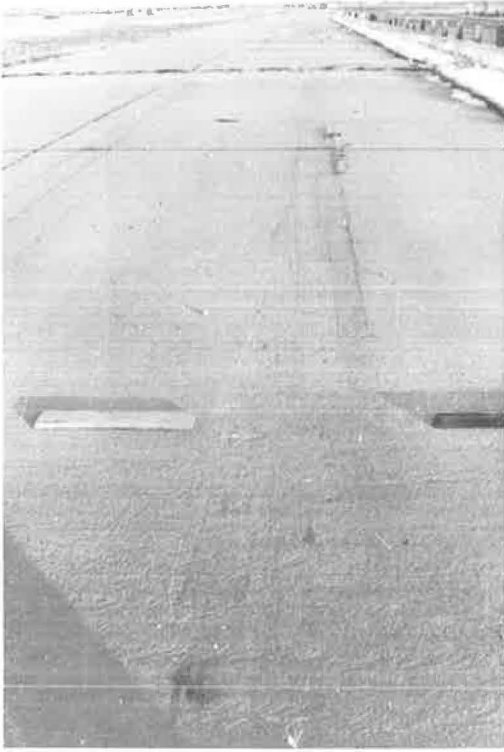
Dry Portland Cement Concrete Surface, Regular Tires.—This study was conducted as a control test using regular tires. On completion of testing, there was no evidence of the test except for the black rubber marks caused by spinning and sliding the tires (Fig. 21).

Figure 21. Special test no. 3 on dry portland cement concrete pavement with regular tires, after completion of test.

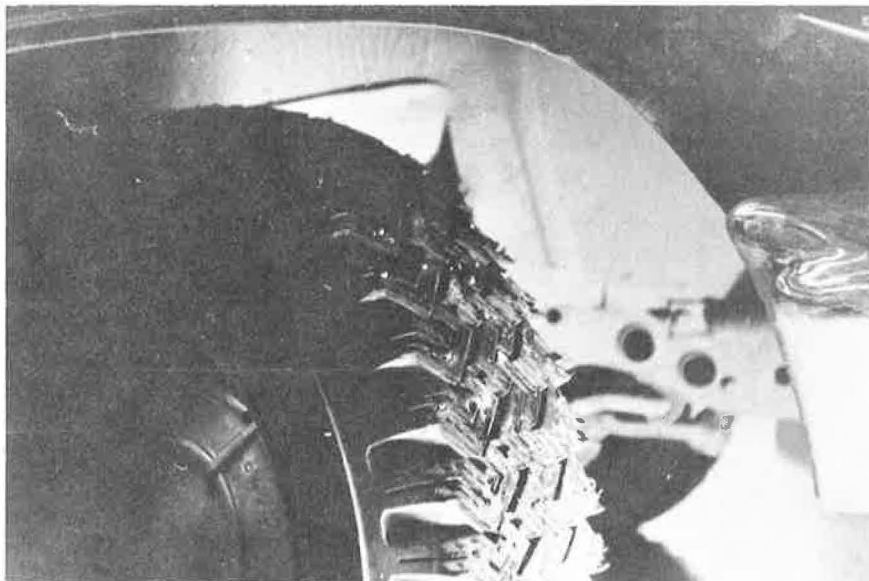
Available information on studded winter tires indicates that the tires are designed so that the rate of wear of the rubber tread and of the tungsten carbide studs would be the same. Under the conditions of these tests, however, the tire treads wore at a faster rate than the tungsten carbide studs. Measurements of the protrusion of the studs from the surface of the tread taken before and after the tests indicated that the average protrusion had increased by $\frac{3}{64}$ in. for both brands of tires. The average protrusion of the studs from the tread surface for the Goodyear tires was $\frac{3}{32}$ in. before testing and $\frac{9}{64}$ in. at the completion of testing. For the Allstate tires, the studs were flush with the tread surface before testing and protruded $\frac{3}{64}$ in. from the tread after testing. One of the Goodyear tires showing protrusion of the studs at the completion of the tests is shown in Figure 22.

Figure 22. Goodyear tire showing protrusion of tungsten carbide studs at completion of testing.

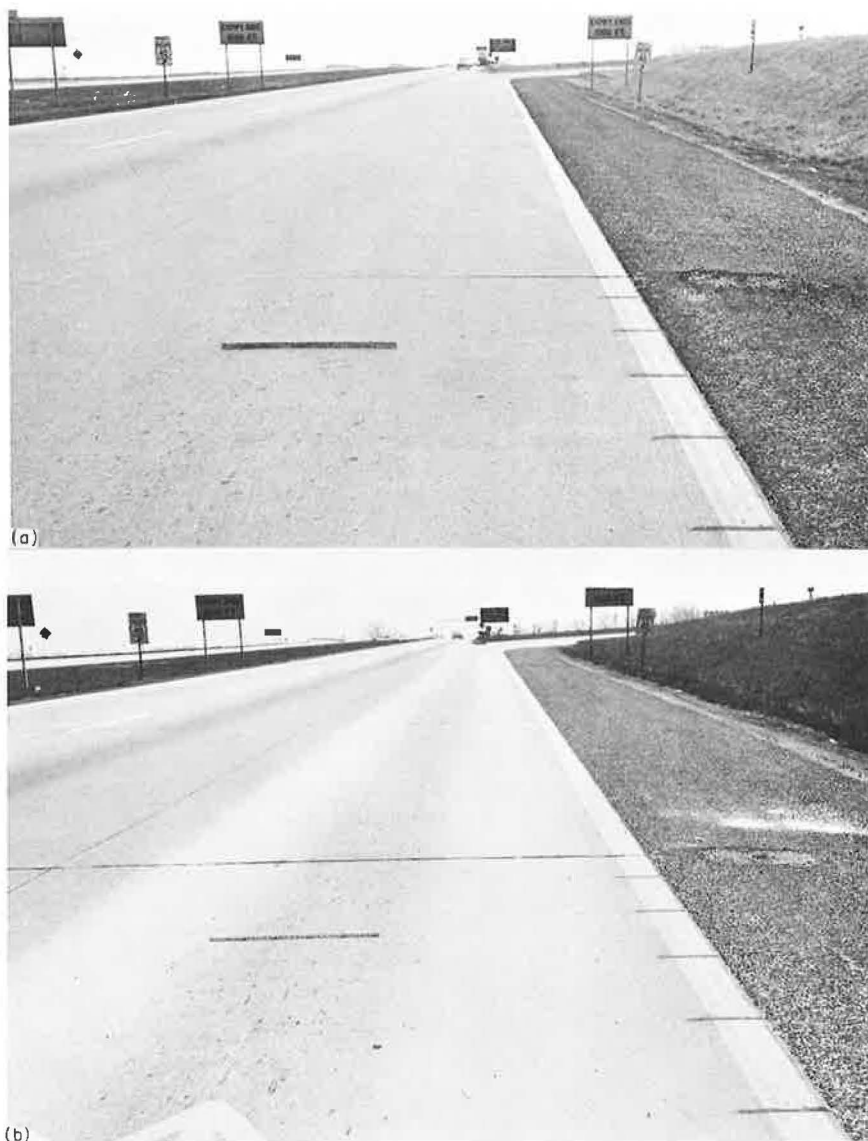
Figure 11. Truck test loop, rigid pavement (a) before test and (b) after test, Md. 7 and Baltimore Beltway.

Effect of the studs on the pavement surfaces was apparent after the first day of test circuits. Initially, the wear was more easily noticed on the rigid pavement surfaces.

Figure 11 shows the condition of the rigid pavement surface at beginning and end of the test for the Baltimore Beltway ramp subjected to truck test circuits. Figure 12 shows the flexible pavement along Md. 7 at the beginning and end of the same truck test.
