HIGHWAY RESEARCH RECORD

Number 136

Studded
Tires

7 Reports

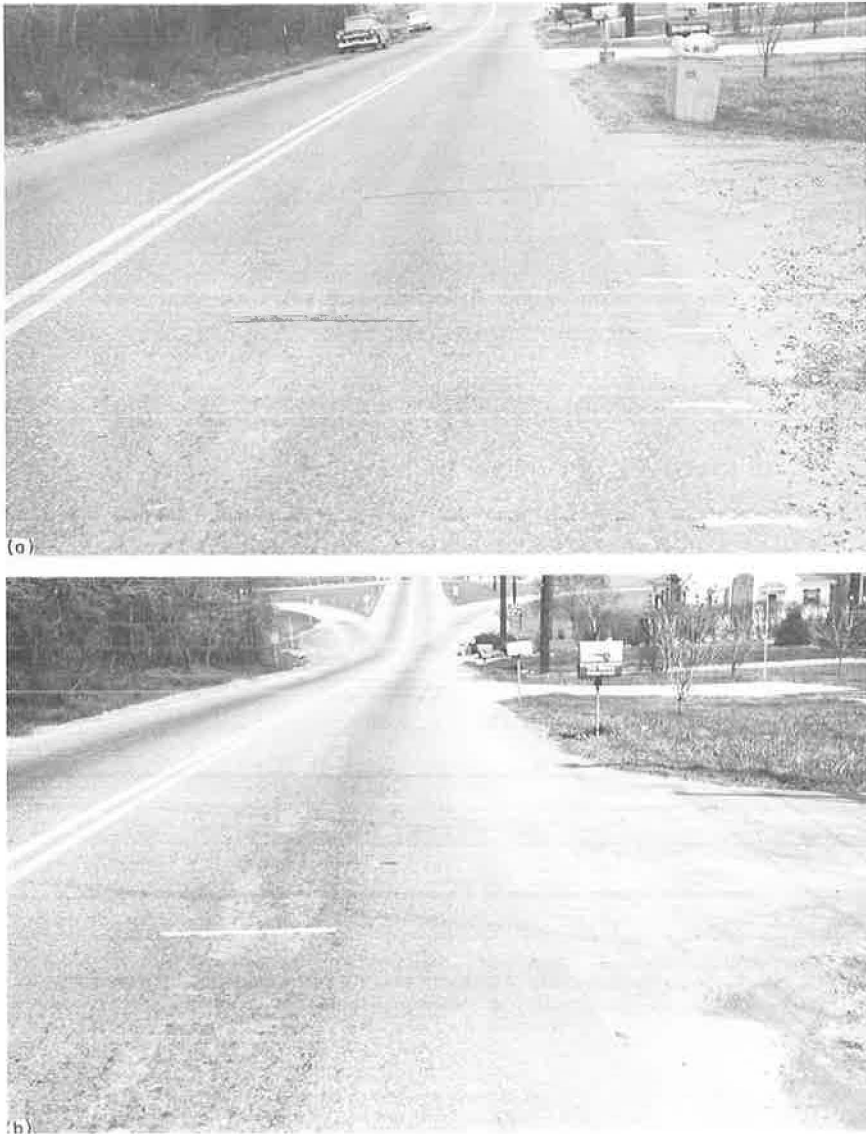
Figure 12. Truck test loop, flexible pavement (a) before test and (b) after test, Md. 7 and Baltimore Beltway.

Figure 11 shows the condition of the rigid pavement surface at beginning and end of the test for the Baltimore Beltway ramp subjected to truck test circuits. Figure 12 shows the flexible pavement along Md. 7 at the beginning and end of the same truck test.

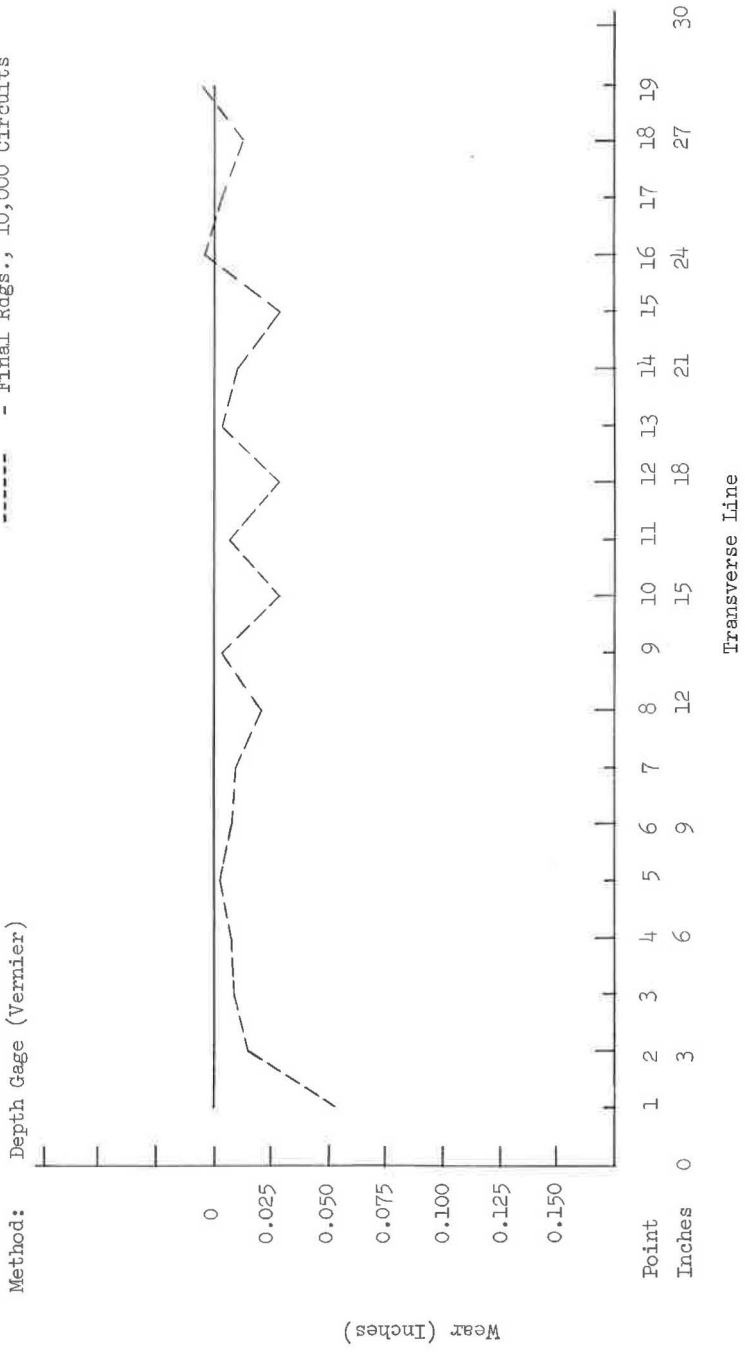
Figure 13. Passenger cars, transverse profile, US 50, site 3R, line 1b.

For the passenger car loop the wear at each significant transverse line at the end of test was plotted (Fig. 13). In the case of the truck loop, where wear was greater, the graphs show the wear at about midpoint as well as at the completion of the field test (Fig. 14). Figure 15 shows the rate of wear which occurred to the pavement surface at one of the points in Figure 14.
