Design Features of an 18.5-Foot Diameter Culvert Installation in Montana and Data on Subsequent Failure

ALBERT N. KRAFT and HAROLD L. EAGLE, Morrison-Maierle, Inc.,
Helena, Montana

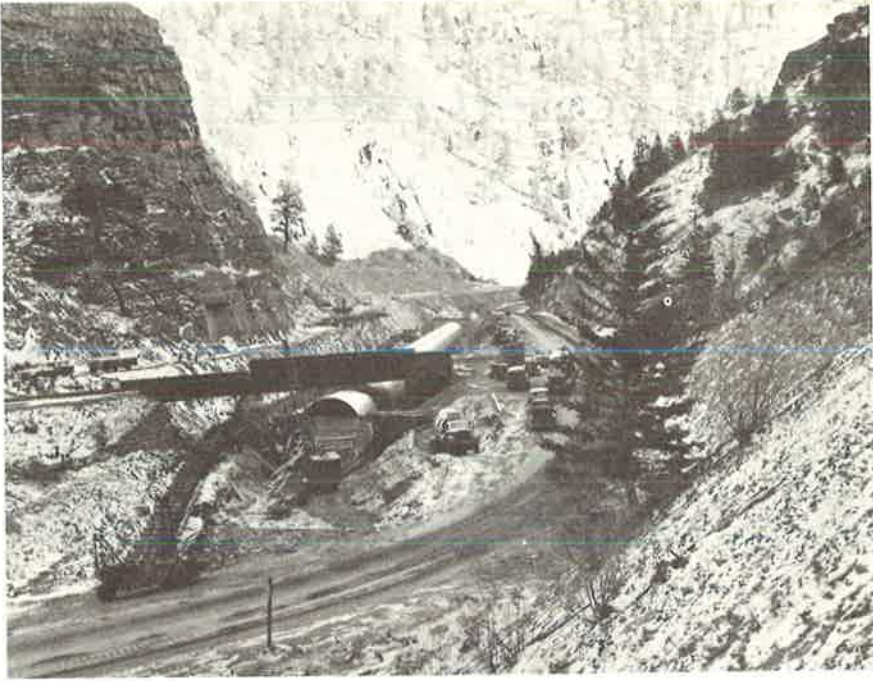
Figure 2. Outlet end of culvert during construction.

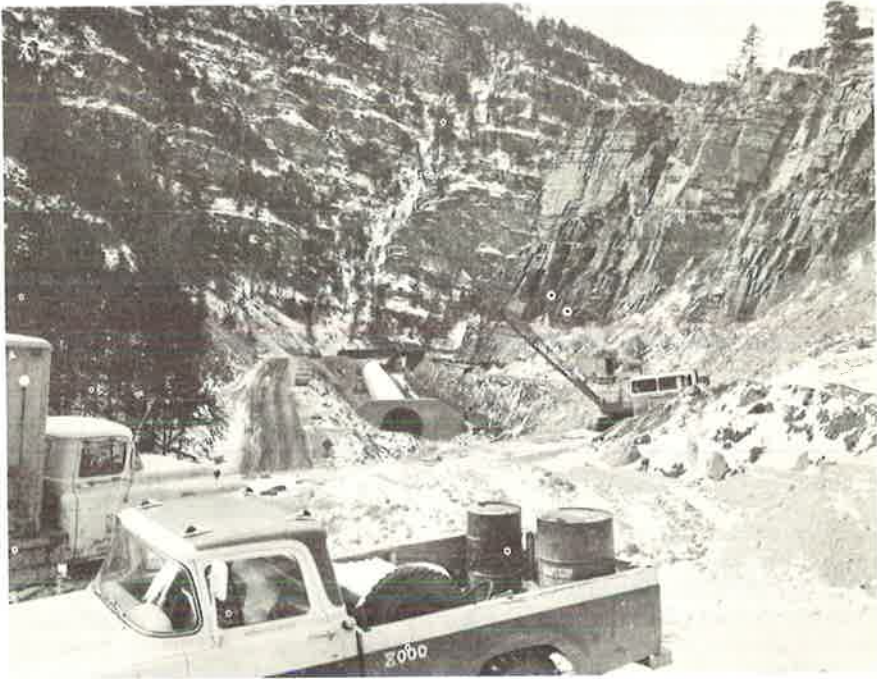
A reinforced concrete inlet headwall completely surrounding the pipe was used at right angles to the end of the pipe (Fig. 3). A 12-in. radius rounding of the inlet edges formed into the concrete was used to increase the capacity characteristic of the inlet. A reinforced concrete headwall was also used at the outlet, but it does not completely encircle the pipe. The top of it is 14 ft above the bottom of the pipe. It is tied into a concrete apron with a flat bottom and sloping sides which extend 15 ft beyond the end of the pipe. This structure provides protection to the abutments of a railroad bridge under which the pipe passes, and will prevent scour at the culvert outlet. Heavy riprap extends for another 63 ft beyond the apron where a concrete sill 32 ft long extending across the stream is located. The top of the concrete sill and the pipe outlet invert are at the same elevation, while the concrete and riprap aprons between the two are both 2 ft lower in elevation. This provides a pool and more resistance to scour at the outlet of the culvert.

Figure 3. Inlet end of culvert during construction.

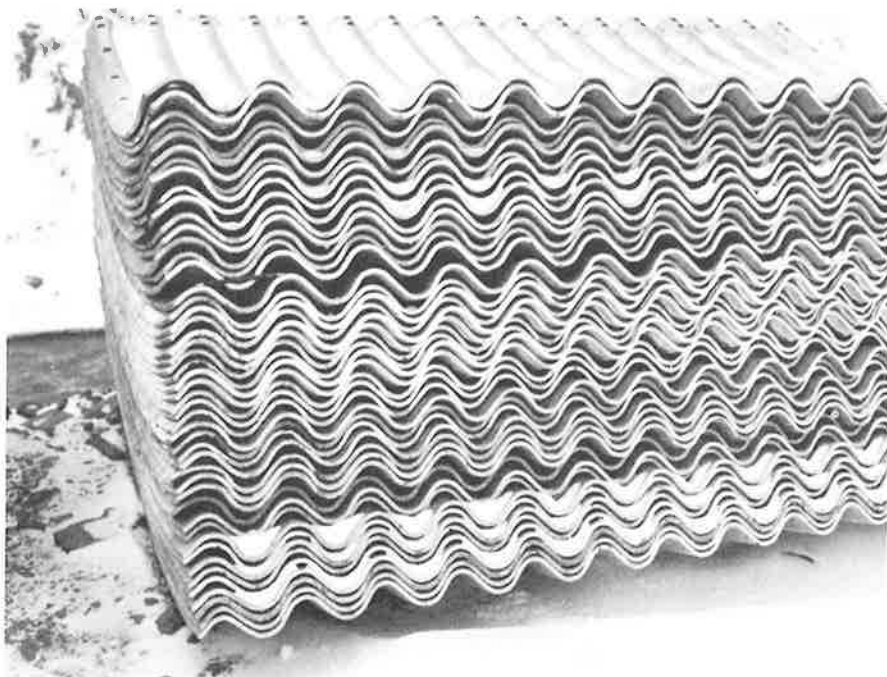
Figure 4. Edge view of pile of $\frac{3}{8}$ -in. plates.

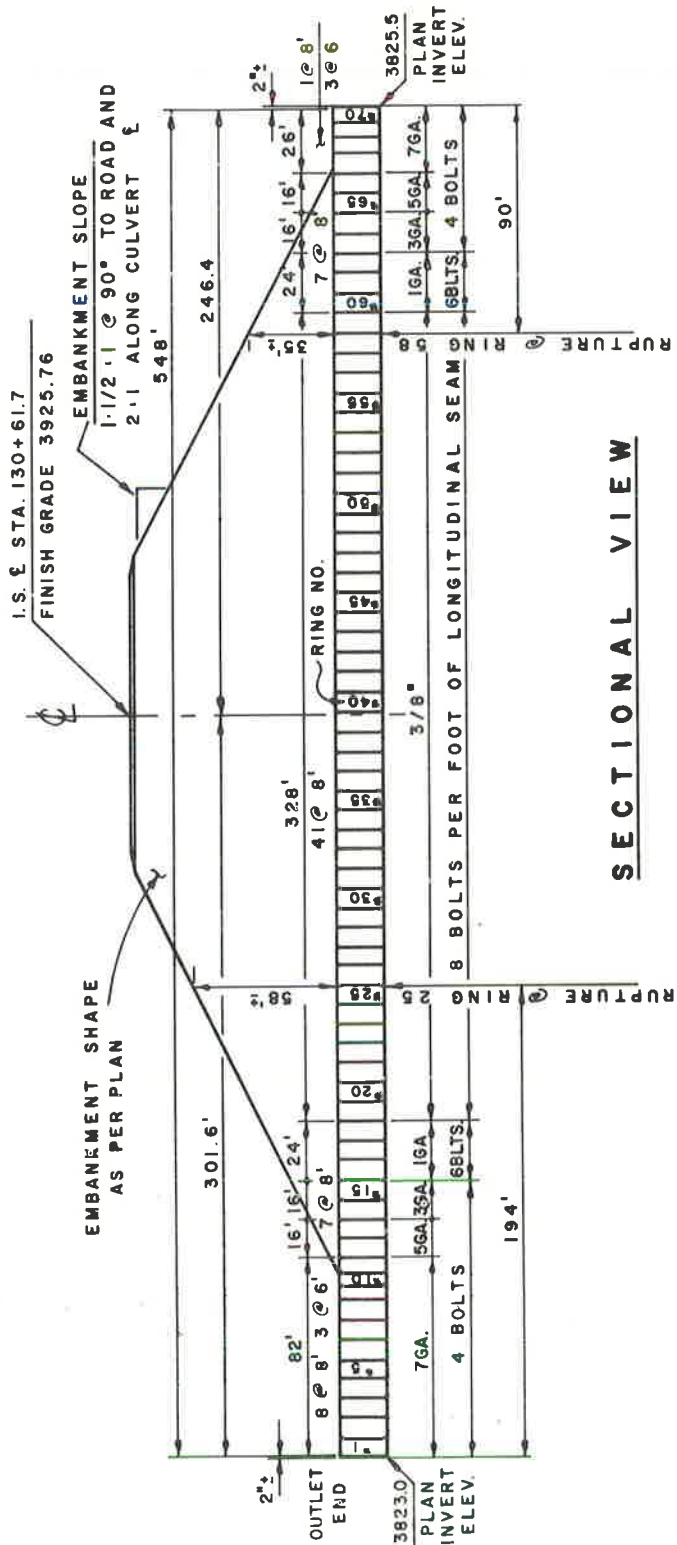
Figure 5. Section through culvert showing plate and bolting requirements.

The culvert plates were stepped down from $\frac{3}{8}$ -in. plates to 1 gage to 3 gage to 5 gage and to 7 gage in thickness at the ends of the pipe where the fill height was less, in order to reduce material cost (Fig. 5). Except for the central portion of the pipe where $\frac{3}{8}$ -in. plate was used, 1-gage plate was used throughout the pipe in the invert to provide more erosion resistance than would be supplied by the lighter gages of pipe. The bolts used for all except the $\frac{3}{8}$ -in. plates were $\frac{3}{4}$ -in. ASTM A 325 bolts.

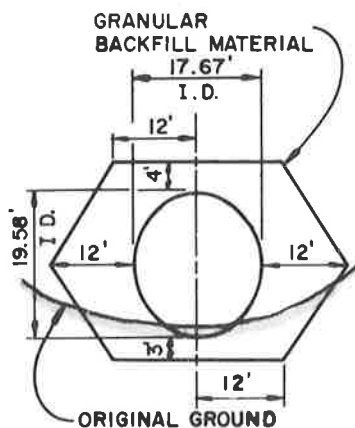
The special provisions stated that the pipe would not be strutted. It was considered unnecessary and undesirable and was not done during construction. An envelope of granular backfill material was called for to extend from 3 ft under, to 4 ft over the pipe and 12 ft wide on each side of the pipe (Fig. 6). The standard Montana Highway Department specification for backfill material was used, which consists of a granular material usually used for structure and culvert foundations and backfill. This allows a 4-in. maximum size gravel with at least 50 percent passing a No. 4 screen, or a sand, or a combination of sand and gravel. Ninety-five percent of maximum density was required for backfill material ranging from 100 to 120 lb per cu ft.

Figure 6. Section of envelope of select material that encased pipe.
