# HIGHWAY RESEARCH RECORD

Pipe Culverts

# Design Features of an 18.5-Foot Diameter Culvert Installation in Montana and Data on Subsequent Failure

# Research on Bolt Failures in Wolf Creek Structural Plate Pipe

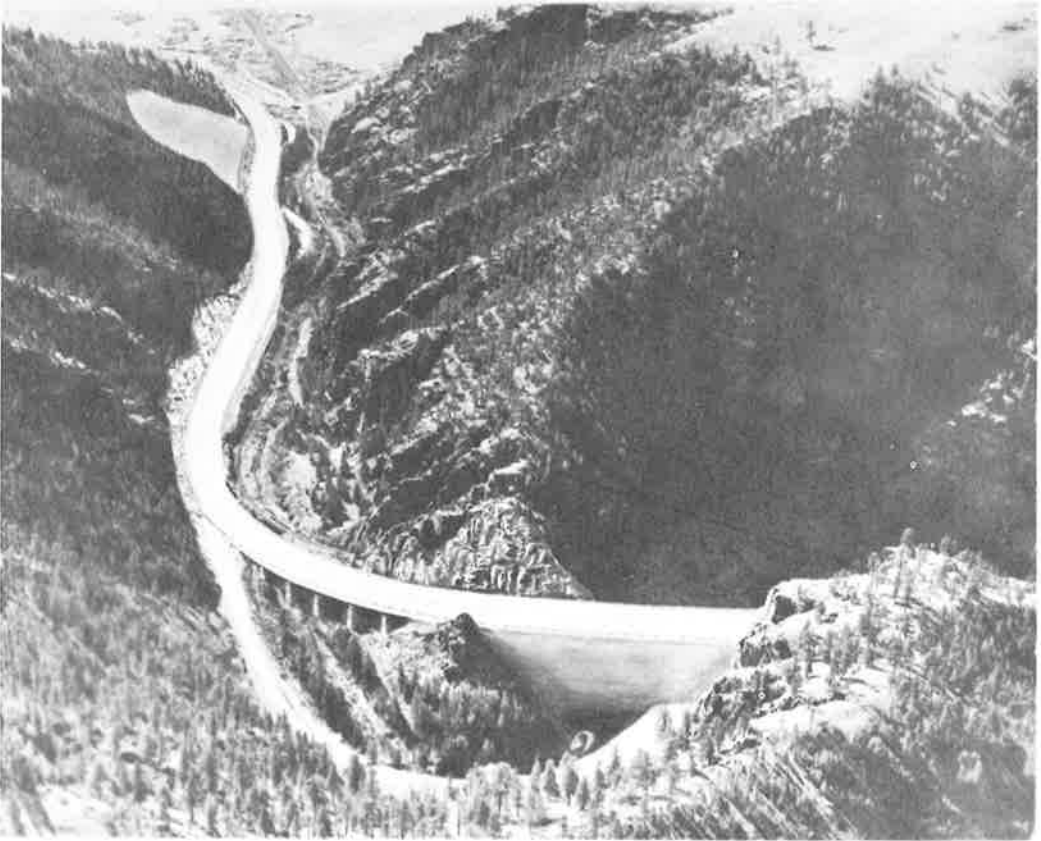
Figure 1. Sketch of completed Interstate—note culvert.

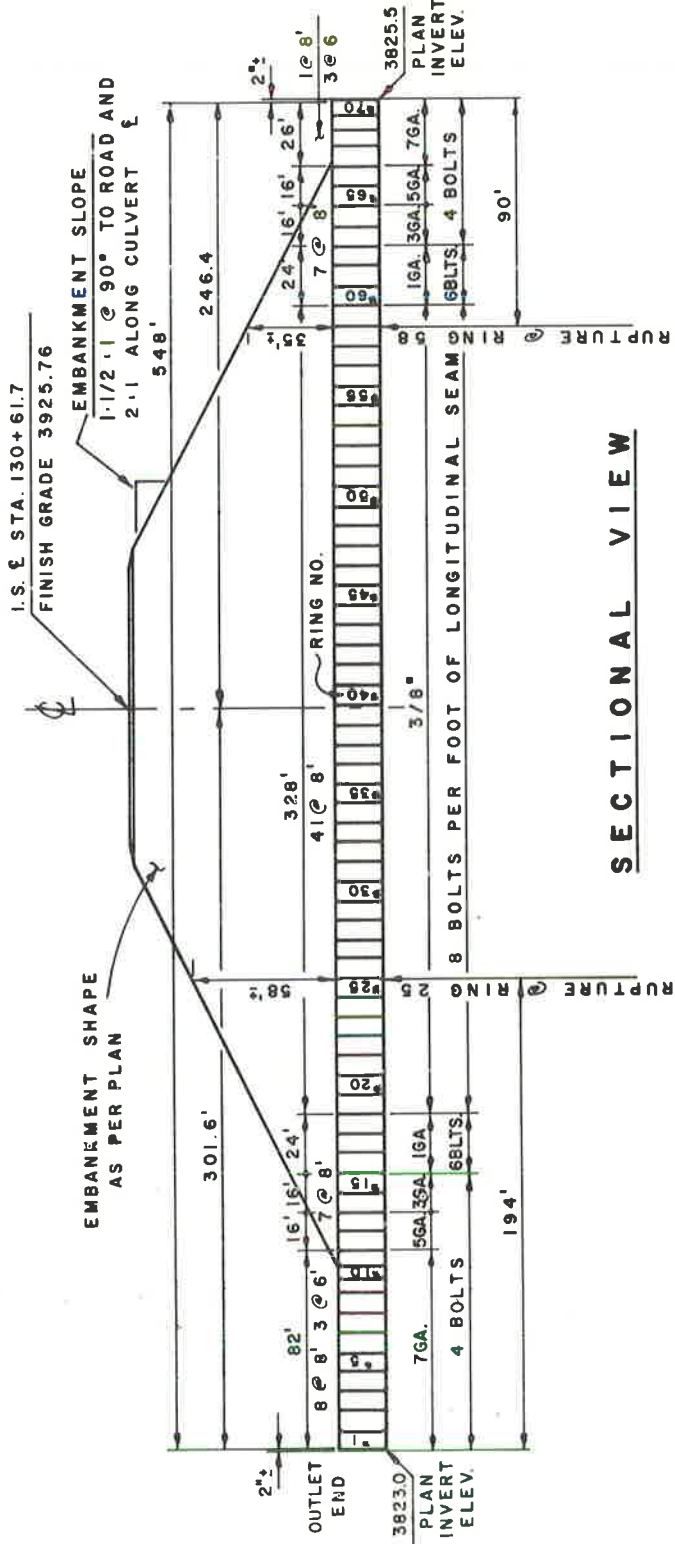
Figure 5. Section through culvert showing plate and bolting requirements.

The culvert plates were stepped down from  $\frac{3}{8}$ -in. plates to 1 gage to 3 gage to 5 gage and to 7 gage in thickness at the ends of the pipe where the fill height was less, in order to reduce material cost (Fig. 5). Except for the central portion of the pipe where  $\frac{3}{8}$ -in. plate was used, 1-gage plate was used throughout the pipe in the invert to provide more erosion resistance than would be supplied by the lighter gages of pipe. The bolts used for all except the  $\frac{3}{8}$ -in. plates were  $\frac{3}{4}$ -in. ASTM A 325 bolts.

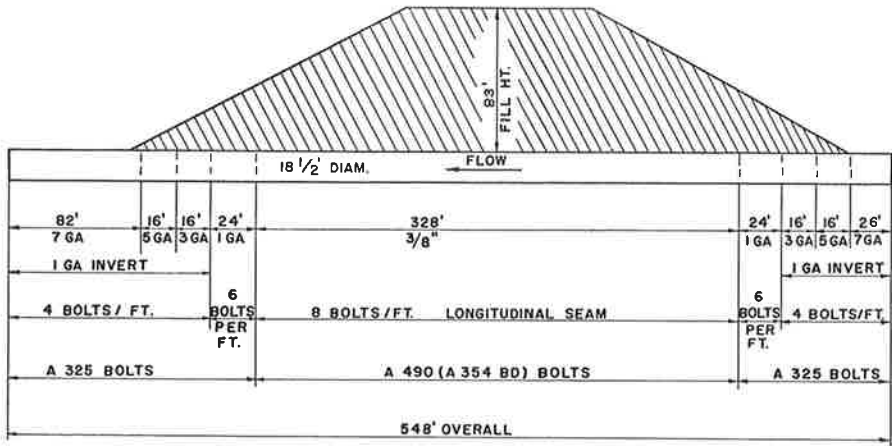
This culvert structure is 548 ft long under a maximum rock fill height of 83 ft. In the center portion, where fill loads are greatest,  $\frac{3}{8}$ -in. thick plates are used with  $\frac{3}{4}$ -in. ASTM A 490<sup>1</sup> high strength bolts. Near the ends lighter gage plates are used with ASTM A 325 bolts (Fig. 1).

Figure 1. Wolf Creek structural plate pipe.

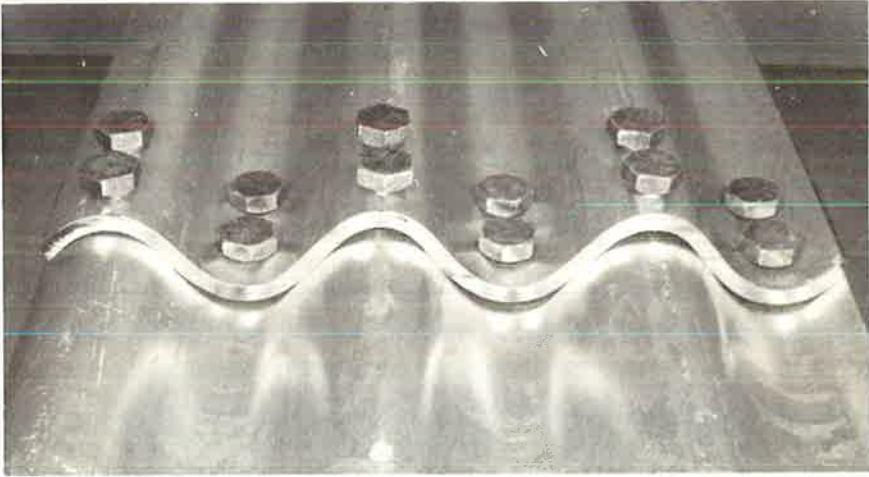
Figure 5. Fit between  $\frac{3}{8}$ -in. plates with bolts torqued to 200 ft-lb.

When structural plate sections are connected by the single lap joint, the corrugations do not nest in intimate contact. Inherent gaps between plates at crests and valleys of the corrugations will depend on the plate thickness. The greater the thickness, the greater the gap distance. Figure 5 illustrates the gaps present in  $\frac{3}{8}$ -in. thick plate

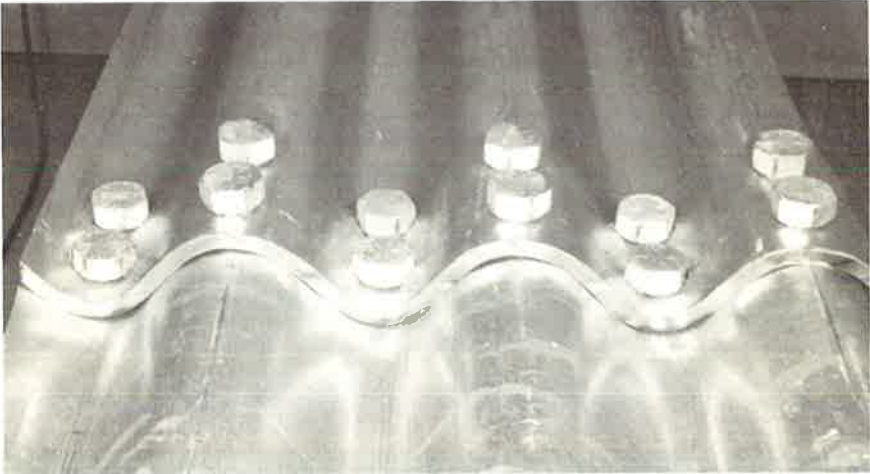
Figure 6. Fit between  $\frac{3}{8}$ -in. plates with bolts torqued to 910 ft-lb.

with the bolts tightened to 200 ft-lb torque. A torque of approximately 800 ft-lb was required to essentially close the gaps in 6-in. wide joints. In a wide plate joint complete yielding of the cross section would be required to close the gaps. Figure 6 shows the fit between plates with A 490 bolts tightened to 910 ft-lb.

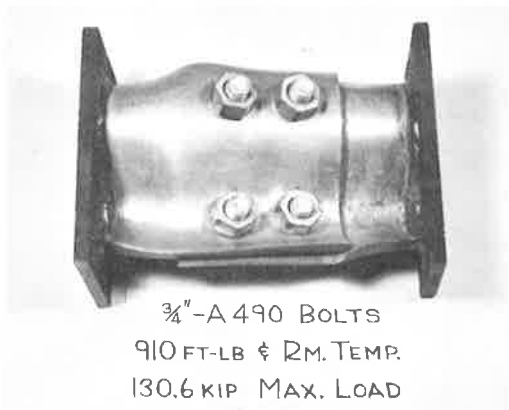
All A 490 bolted joint compression specimens failed by plastic buckling and yielding of the plate material away from the bolted lap (Fig. 9). In some tests at reduced temperatures the "Multi-Plate" material cracked under high local stresses between the bolt holes (Fig. 10). A 325 bolted specimens failed in either of two modes—plate failure (Fig. 10) or bolt shear (Fig. 11).

Figure 9. Typical plate failure.

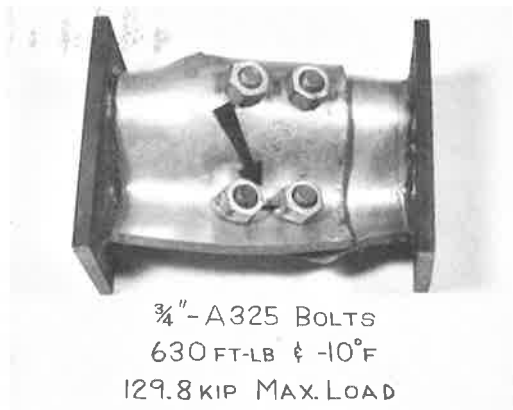
Figure 10. Typical plate failure with crack in plate between bolt holes in lower row.

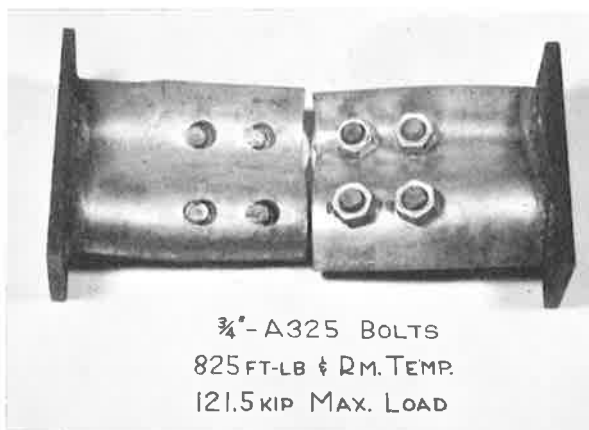
No bolt shear failures were obtained in the laboratory tests on A 490 bolts. However, in the Wolf Creek pipe all broken bolts were A 490 bolts and none of the A 325 bolts failed. Several characteristics of the A 325 laboratory shear rupture surfaces worth noting are: (a) flowed metal across the bolt ruptures (Fig. 11) was plainly evident; (b) the rupture surface was consistently 10 to 15 deg from the perpendicular cross section of the bolts; and (c) threads of the bolt indented in the plate under bearing pressure. None of these effects were noticeable in the Wolf Creek failure, indicating that bolt shear was not the primary cause of the field failure.

Figure 11. Typical bolt shear failure of A 325 bolts.

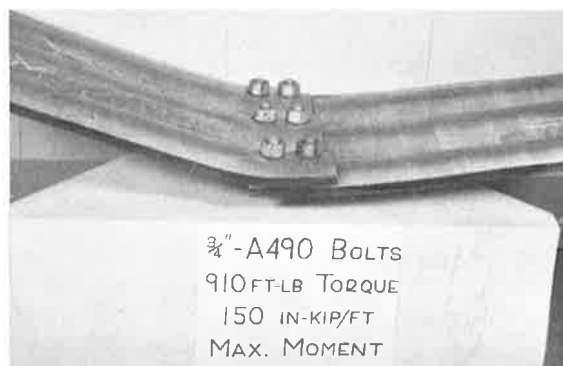
Figure 13. Typical beam test specimen after testing showing plastic bending failure of plate material.

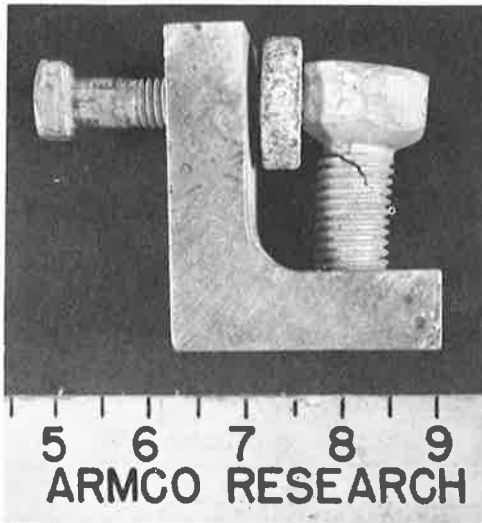
Exploratory tests were made to determine the hydrogen-stress cracking susceptibility of the A 325 bolts at R<sub>C</sub> 30 hardness and the A 490 bolts at R<sub>C</sub> 38 hardness. Bolts were loaded as short cantilever beams in bending by using the fixture shown in Figure 14. A small magnesium disk was used as the anode. This was done in an attempt to produce failures—if they would occur—in a reasonable length of time. It took 2 to 8 months in the field. This was too long for a lab test. The high hardness (R<sub>C</sub> 38) bolt assembly shown in Figure 14 was placed in a 3 to 4 percent salt solution and cracked as seen overnight. In a similar test a softer (R<sub>C</sub> 30) bolt did not crack after 92 hr.

Figure 14. Preliminary test fixture used to determine hydrogen embrittlement cracking susceptibility of "Multi-Plate" bolts.

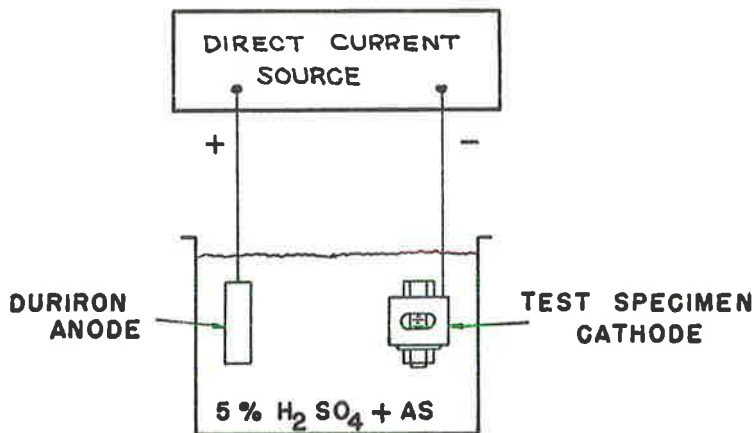
Figure 17. Hydrogen test method.

machined and polished to a depth slightly below the normal root diameter. This groove controlled the location of the hydrogen induced crack (Fig. 16). Bolts were tightened in the test block to desired tensile stresses by using the calibrated torque-tension relationship discussed later. The assembly was coated with wax leaving an exposed portion of the groove for hydrogen entry at each window opening in the test block. Specimens were placed in a 5 percent sulfuric acid solution containing approximately 0.05 percent sodium arsenite. A direct current of 1.5 to 2.5 amperes was maintained between the specimen and a Duriron bar anode (Fig. 17). At 15-min intervals the specimens were removed and examined under magnification for cracks (Table 5).

Following the preliminary tests, hydrogen-stress cracking experiments were made under more controlled conditions, with different levels of sustained tensile stress on A 490 bolts. To determine the effect of hardness, a group of A 490 bolts was heat-treated to approximately  $R_C$  25. An annular groove was

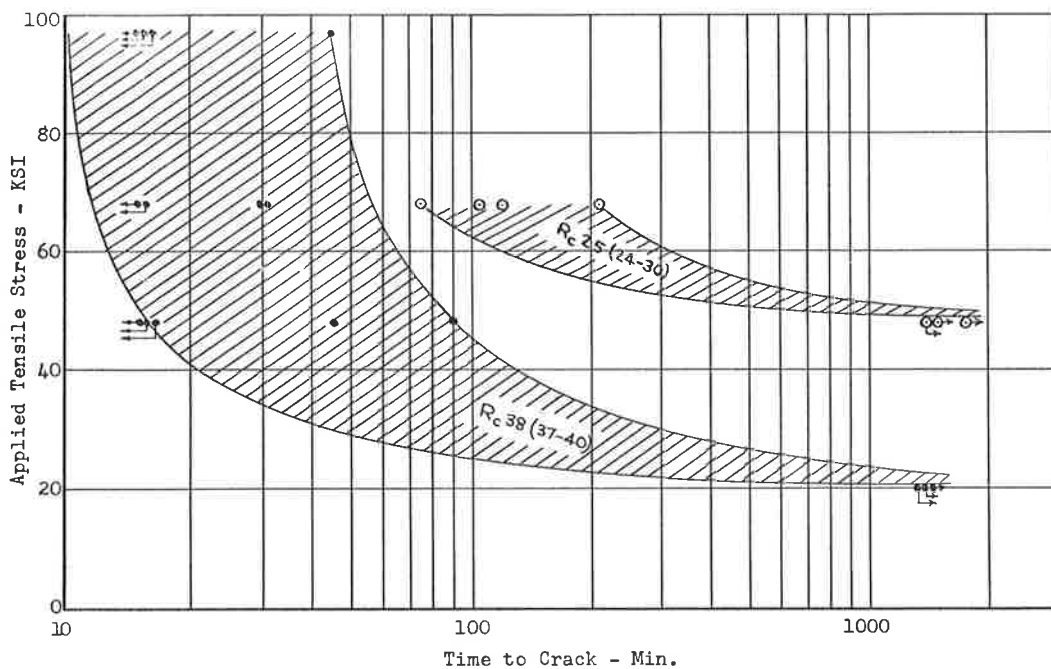
Figure 18. Hydrogen-stress cracking experiments.

Time-to-fracture or first crack is used as a measure of hydrogen embrittlement susceptibility. Figure 18 shows time to crack and applied stress for both hardness levels. These data are in reasonable agreement with other investigations (5).

conditions expected in the field would, of course, be much less severe. The time factor associated with hydrogen-stress cracking in the field would be much greater.

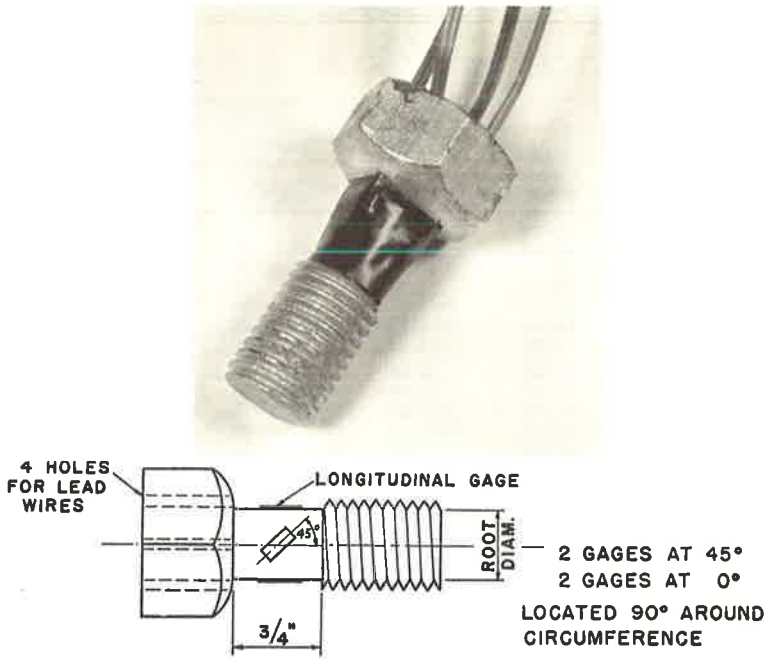
Figure 19. Strain gage instrumented bolts.

For this investigation it was desirable to ascertain the tensile and torsional shear stresses in the structural plate bolts as related to applied torque. Stresses were determined from strain gage instrumented bolts (Fig. 19). From this gage arrangement it is possible to determine tensile and torsional stresses for elastic conditions. Formulas for computing tensile stresses and torsional shear stresses are given in the Appendix.

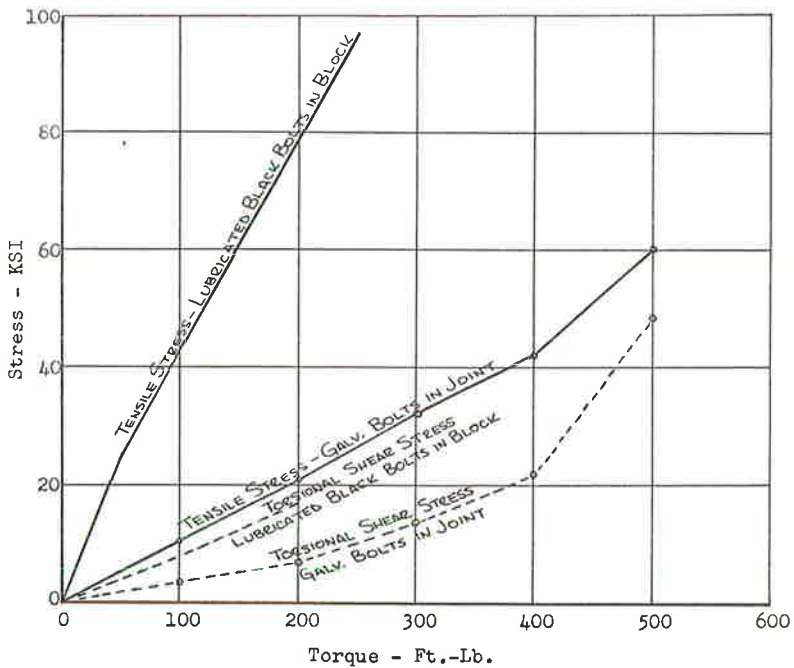
Figure 20. Comparison of bolt stresses vs torque.

One series of tests was made on instrumented bolts in the galvanized condition tightened in a galvanized structural plate joint. The stress-torque relationship is shown in Figure 20. Note that the torsional shear stress begins to increase significantly for applied torques above approximately 400 ft-lb. For increasing values of torque, torsional shear stress increases due to increasing friction developed by: (a) galling of the zinc at the thread contact surfaces, and (b) wedging action of the spherical seated nut into the hole in the plate.

The black bolts with lubricated threads and hardened nuts tightened in the "solid" block are stressed predominately in tension, while the torque applied to galvanized nuts and bolts in a galvanized structural plate joint results in high torsional shear stresses (Fig. 20).

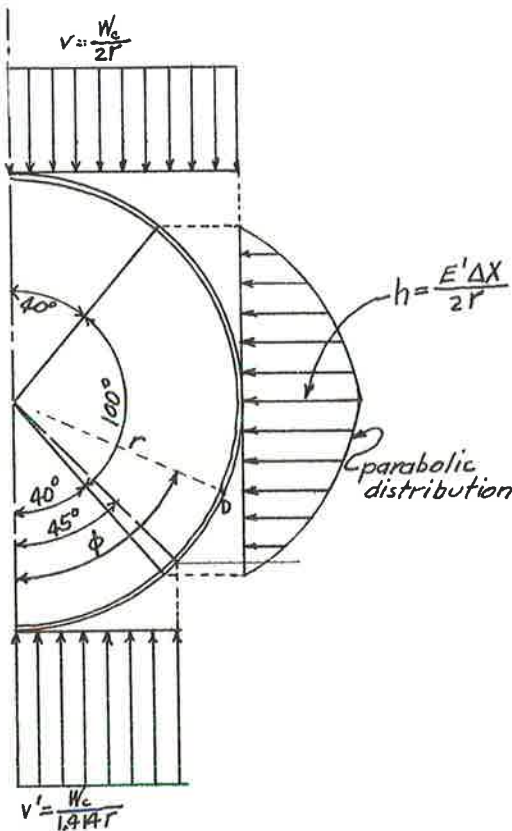
Figure 1. Assumed load system on Wolf Creek culvert.

A graphical representation of this load system is shown in Figure 1. Further assumptions are:

- $H = 83 \text{ ft}, B_c = 18.6 \text{ ft}, \frac{H}{B_c} = 4.47$
- $r = 9.3 \text{ ft} = 111.6 \text{ in.}$
- $w = 130 \text{ pcf}$
- $p = 0.9$
- $r_{sd} = 0, r_{sd}P = 0, C_c = 4.47$
- $\Delta X = 20 \text{ in.}$
- $E = 30,000,000 \text{ psi}$
- $I = 0.226 \text{ in.}^4/\text{in.}, EI = 6,780,000 \text{ in.}^4$
- $D_1 = 1.0$
- $K = 0.096$

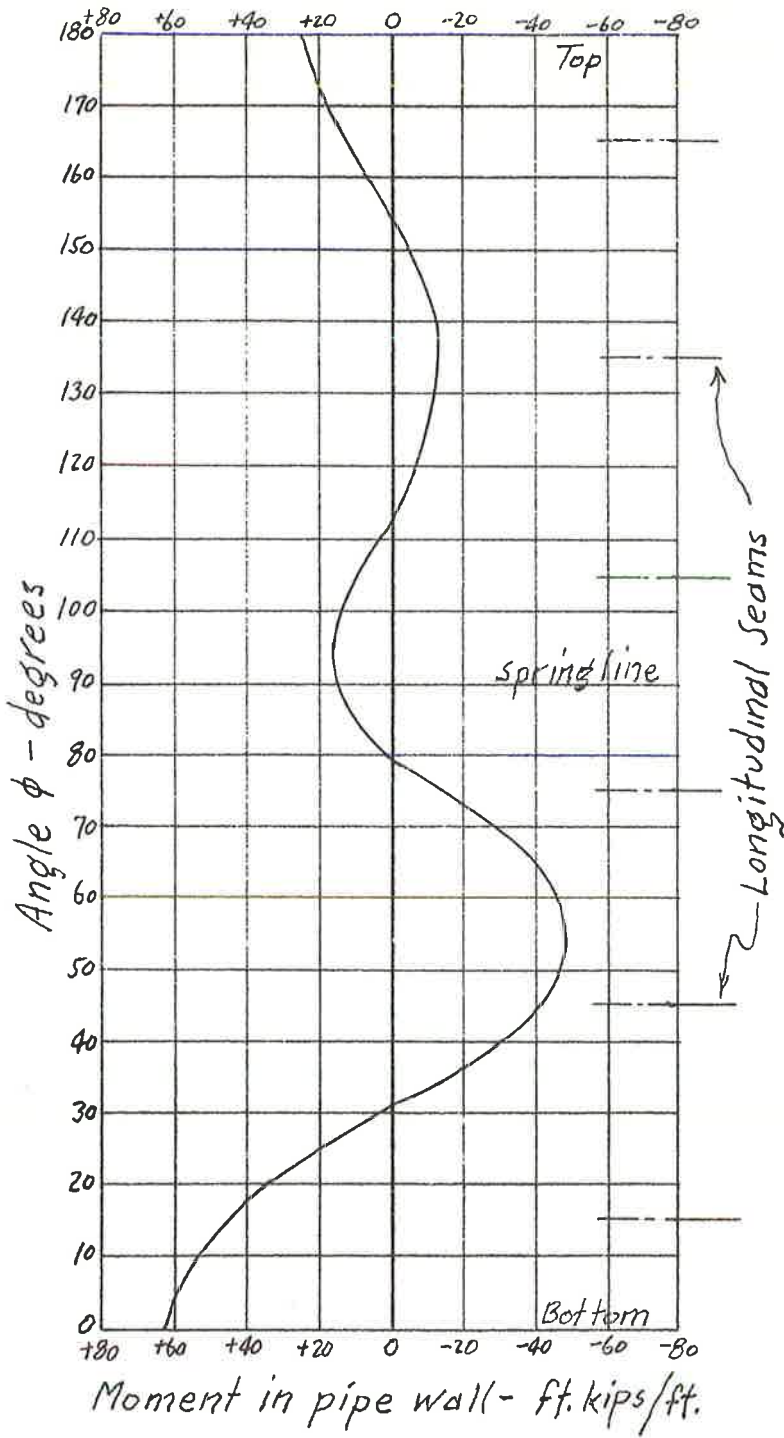
Figure 2. Moment diagram—Wolf Creek culvert.

Evaluation and combination of these equations yield the moment diagram shown in Figure 2, and the tangential thrust diagram of Figure 3. The maximum moment in the pipe wall is 63 ft-kips per foot at the bottom. The moment at the longitudinal seam near the lower quarter point ( $\phi = 45^\circ$ ) is approximately 40 ft-kips. A section through the seam is shown in Figure 4. Since the seam must transmit moment from one plate to another, we may determine the tension in the bolts by writing moments about the point of rotation of the seam and setting this equation equal to the moment in the wall.

A difficulty arises in trying to identify the fulcrum or point of rotation, and present knowledge does not permit a rational selection of the actual point. However, it is at least possible that rotation might occur about the inner row of bolts, and since the rows were only 2 in. apart, the tension in the outer row would be  $40 \div 0.167 = 240$  kips per ft. Since there are 4 bolts per ft in the outer row, the tensile stress in each bolt is 60 kips. ASTM A 354BD bolts,  $\frac{3}{4}$ -in. diameter, have a minimum specified ultimate strength of 50.1 kips. Therefore it is probable that failure of the structure began by tensile failure of the bolts in the lower quarter point seams. Since the calculated stress in the bolts is greater than the minimum specified strength, the factor of safety is less than unity. This suggests that failure probably occurred at some height of fill less than the maximum of 83 ft above the culvert.

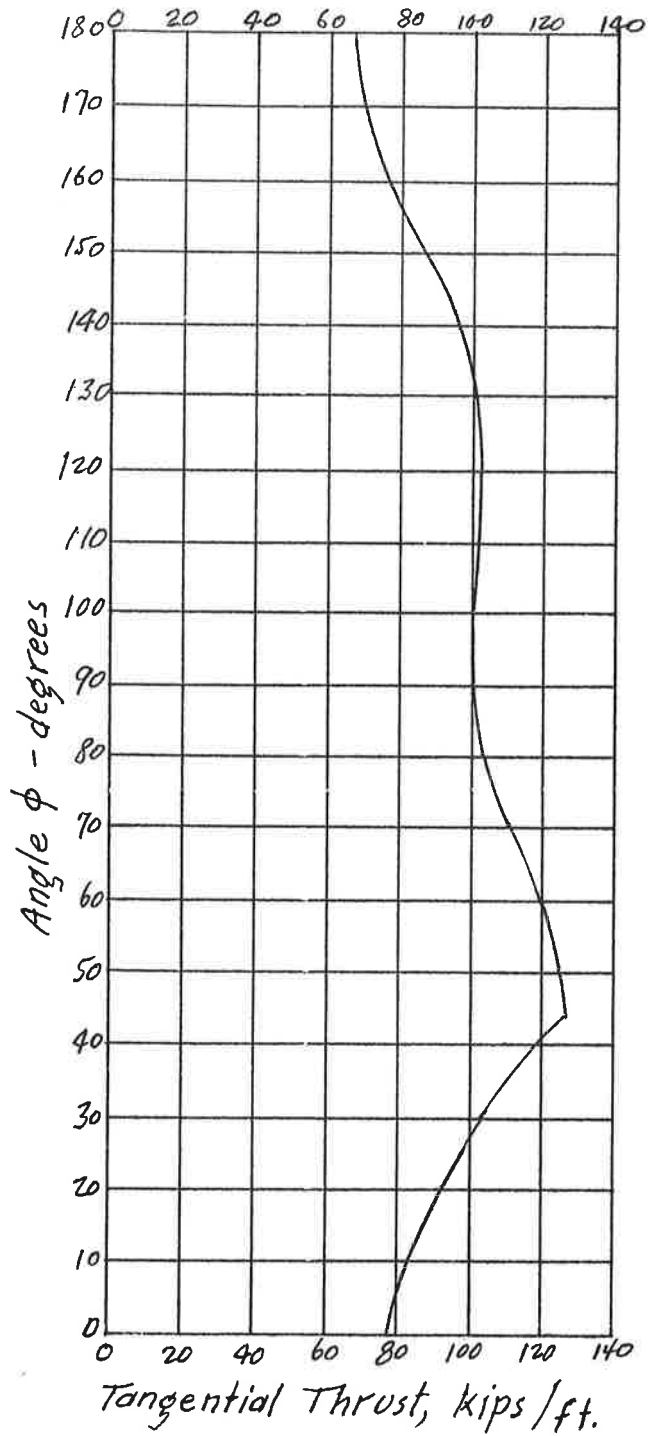
Figure 3. Thrust diagram—Wolf Creek culvert.

This failure hypothesis ignores the possibility that shear stress in the bolts may have contributed to the initial failure. The tangential thrust at the seam in question is approximately 125 kips per ft of pipe, or 15.6 kips per bolt. It is possible that the initial torque to which the bolts were subjected during construction may have created enough

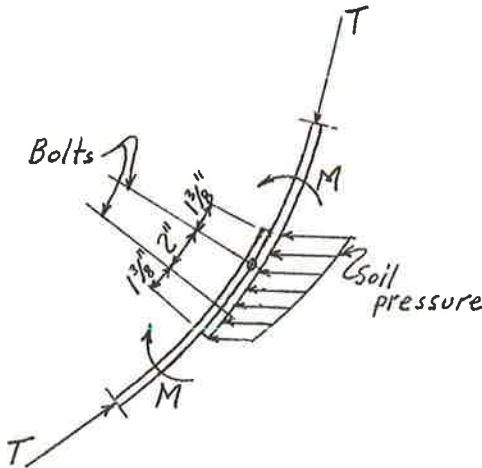
Figure 4. Forces on bolted seam—Wolf Creek culvert.

frictional resistance between the plates to carry this amount of thrust without stressing the bolts in shear. However, as bending moment developed, this frictional resistance would be relieved by the prying action of the moment. The magnitude of this relief is not readily determinable. If this transfer of shearing resistance from friction between the plates to shear stress in the bolts occurred, the composite effect of shear and tension in the bolts would have entered into the bolt failure phenomenon. Some recent research at the University of Illinois (1) has contributed materially to understanding of the failure of high strength bolts under composite stress conditions.

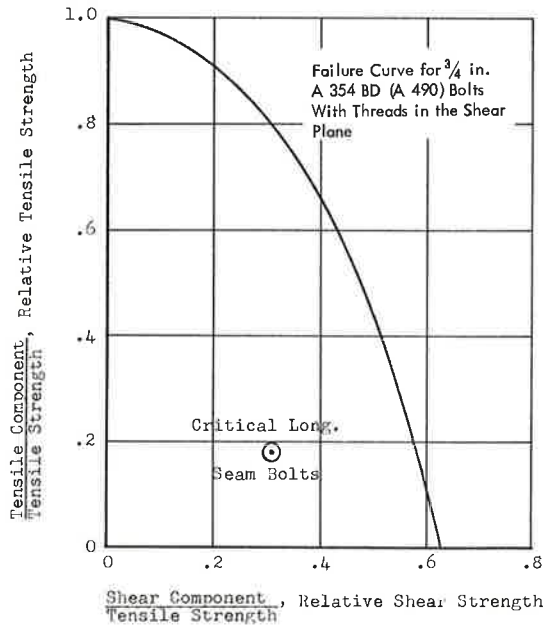
Figure 2. Comparison of critical longitudinal seam bolts and interaction failure curve from Illinois tests (Fig. 4 of Ref. 5).

The combination of 9,200 lb maximum possible direct tension and Spangler's value of 15,600-lb shear can be compared to the results obtained by Chesson et al. (5). Figure 2 shows the combined load state for the structural plate bolts as related to an interaction curve from tests on  $\frac{3}{4}$ -in. A 354 BD (A 490) bolts with threads in the shear plane. A factor of safety against failure of approximately 1.7 exists.

It is recognized that the ring compression method predicts that installed culvert pipe performance can be based on pipe wall thrusts. Some bending moment does exist in the pipe wall, but a history of properly backfilled installations has shown that the ring compression method is a successful design approach. Spangler's method of analysis for computing bending moments apparently can sometimes result in values which cannot be resisted by the pipe wall. In the case of the Wolf Creek structure, such computed moments lead to a false hypothesis of the bolt failures.
