HIGHWAY RESEARCH RECORD

Number 146

Pavement and Bridge
Maintenance

A New Patching Material for Pavement Failures

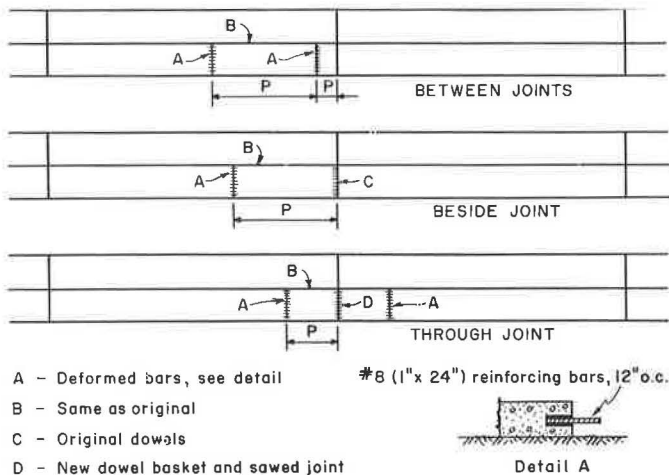
Figure 2. Ten-foot pavement repair.

During the construction of the turnpike, it was decided that a minimum of 10 ft would be replaced when, because of some construction fault, it became necessary to replace a portion of the pavement. This policy was carried out in replacing defective pavement during the construction phase at several locations. An inspection of these patches showed no failures, and in fact, they were all in excellent condition. Following a study of these areas, we decided to continue using the minimum length of 10 ft for pavement repair (Fig. 2).

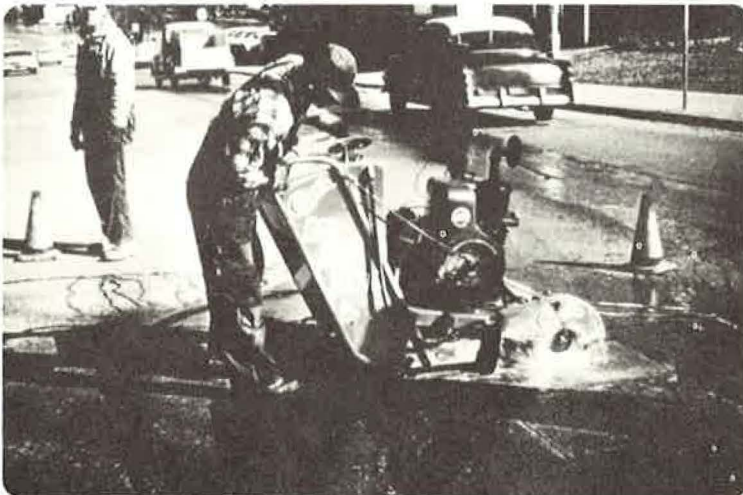
Figure 3. Sawing of pavement to cut reinforcing steel.

After the size of the repair area has been determined, the pavement is sawed to a depth of approximately 6 in., to cut the reinforcing steel (Fig. 3). A cut is made on both ends of the repair area and approximately 2 in. in from, and parallel to, the centerline. A cut is made approximately 8 in. in from, and parallel to, one of the end cuts. The remaining cuts are made in such a manner as to result in pieces of approximately 2- by 3-ft.

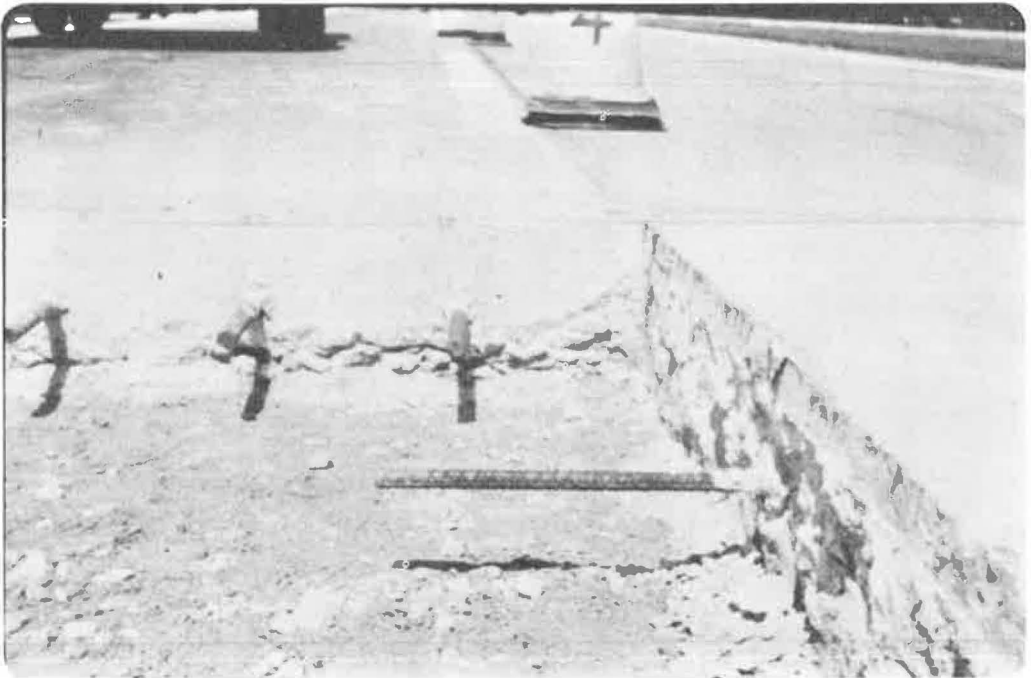
Figure 9. Replacement of joint, using steel bars to provide the working joint.

row, to insure a minimum of subbase disturbance (Fig. 8). When all the old material is removed, $1\frac{1}{2}$ -in. holes are drilled on 12-in. centers, 12 in. deep, into the vertical faces of the adjacent pavement at the transverse joints. In instances where the repair is an internal one (not at a contraction joint) No. 8 (1-in.) deformed bars are used for load transfer. Some locations involve the replacement of a joint where, for the most part, the full pavement width is replaced. The joint is replaced, using smooth, hot-rolled, steel bars $1\frac{1}{8}$ in. in diameter to provide the working joint (Fig. 9). One and one-half inch holes are drilled 12 in. deep on 30-in. centers on the longitudinal joint. Where the repair is full pavement width, a standard hook bolt key joint is used (Fig. 10).

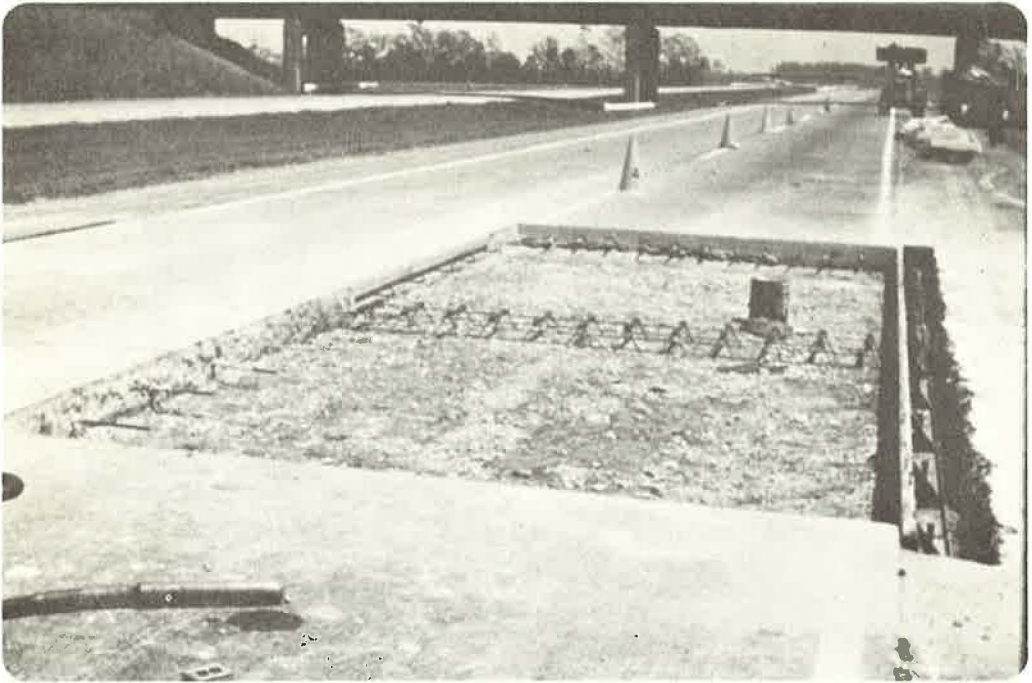
Figure 10. Standard hook bolt key joint.

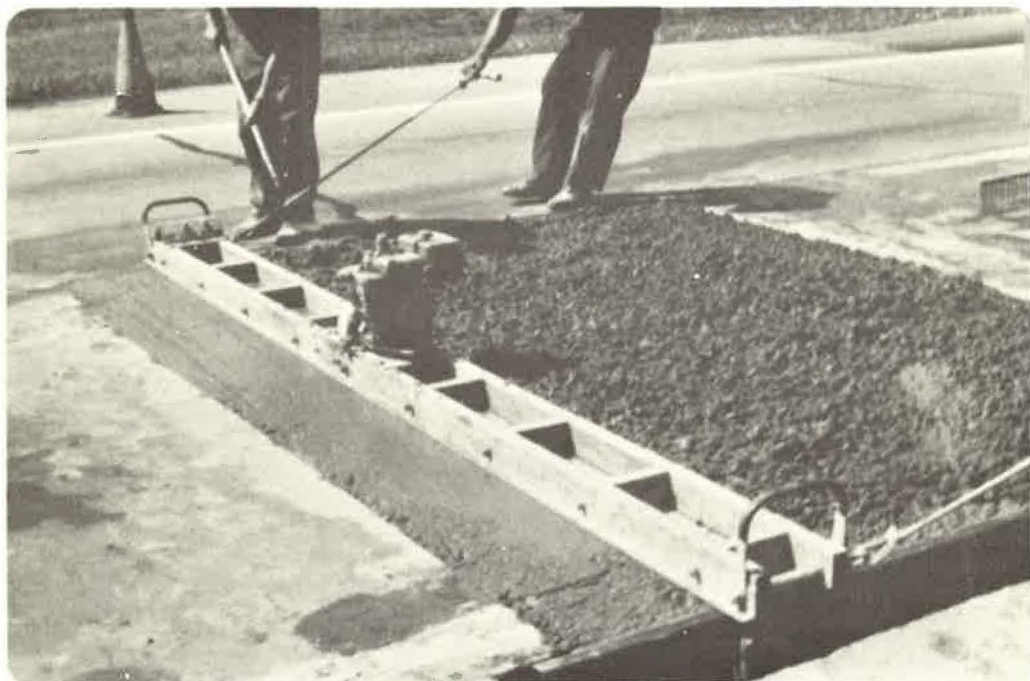
Figure 14. Addition of remaining concrete after placement of steel mesh.

dation around the dowel bars. The steel mesh is placed and the remaining concrete added (Fig. 14). A vibrating screed is used to strike off the concrete, and several passes with the vibrator are usually sufficient. Hand work is kept to a minimum; generally, only a float and a straightedge are required to finish the surface. Burlap is used to texture the surface.

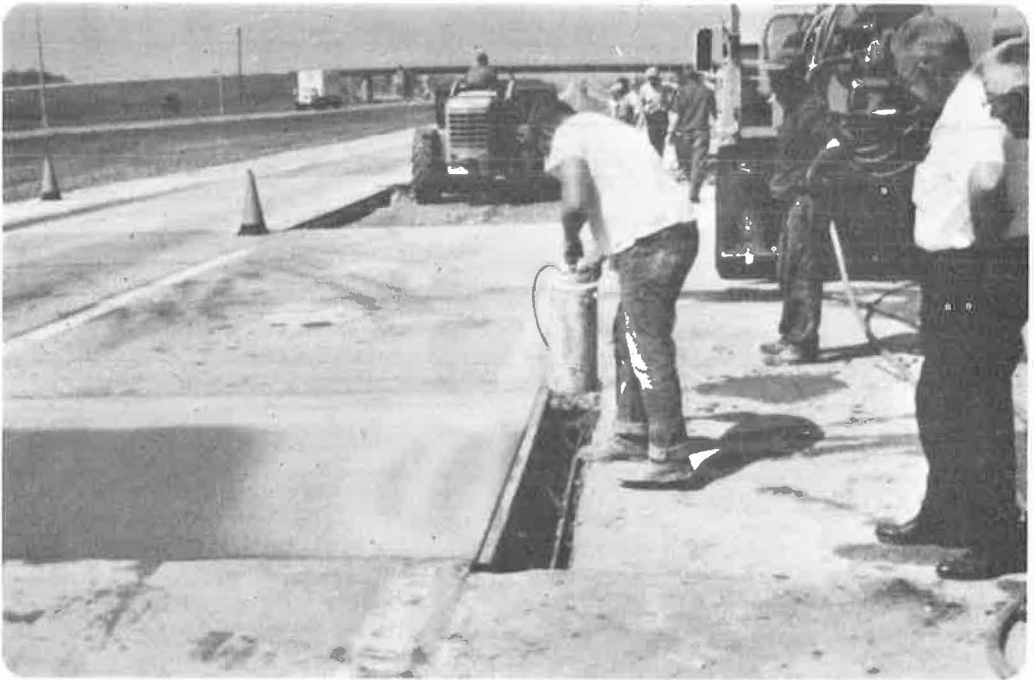
Figure 15. Spraying of white-pigmented compound on concrete.

Immediately on completion of the finishing operation a white-pigmented compound is sprayed on (Fig. 15). The forms are usually removed after 24 hr. A trench drain is installed from the trench excavated for the forms to the adjacent shoulder and the form trench is back-filled and surfaced. Each maintenance division is equipped with a beam breaker. When the beams cast at the repair area indicate 500-lb flexural strength, the pavement is reopened to traffic.

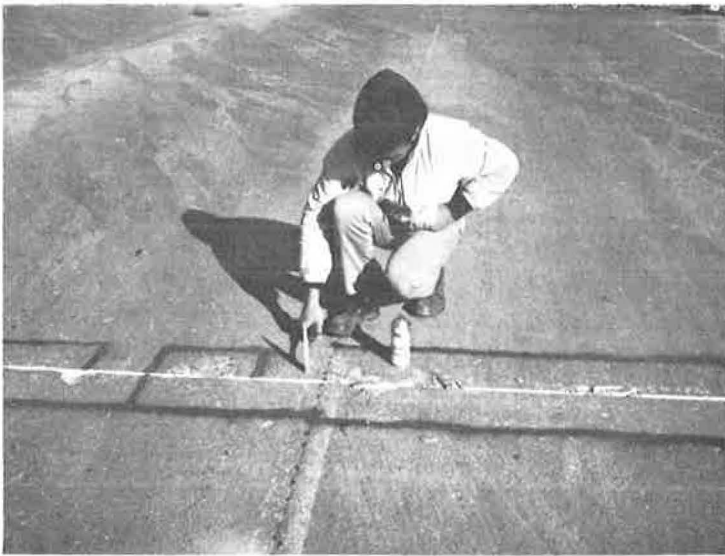
Figure 4. Painting outline of unsound concrete.

In August 1964, a contract was let for this restoration work at a contract price of \$41,700.00. The engineer's estimate of the cost of the work was \$28,000.00. After awarding contract, the first step in the work was to locate and outline all unsound, or loose concrete in the area of each joint. The loose portions of concrete were easily detected by a hollow sound when rapped with a hammer. The outline of each area was then painted (Fig. 4) on the pavement. The joints were then sawed to the dimensions required for the preformed neoprene seal. A 1-in. deep saw cut was made following the painted outline of the spalled areas.

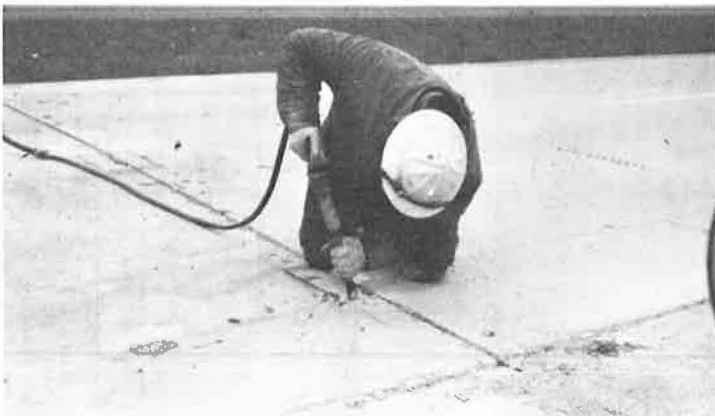
Figure 5. Using a small chipping hammer in small, shallow areas.

All unsound or loose concrete within each saw cut area was removed to a minimum depth of 1 in. Jack hammers were used to remove this concrete in the larger areas. A small chipping hammer was used in the small, shallow areas (Fig. 5). The resulting

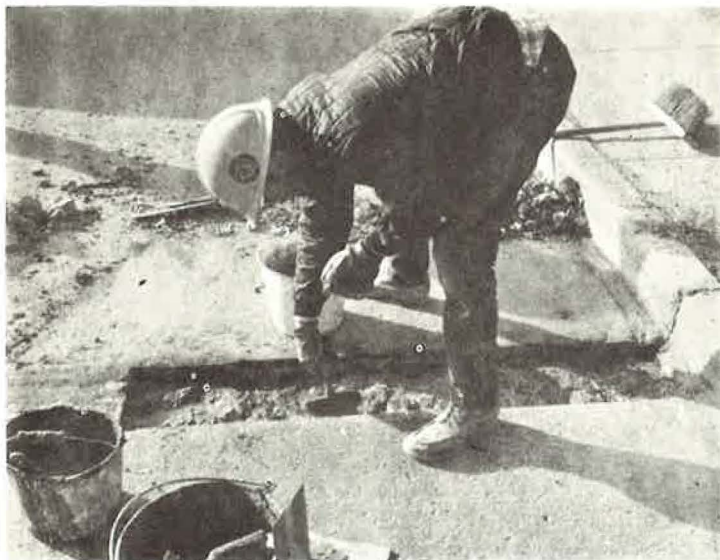
Figure 6. Applying brush coat of epoxy adhesive.

A coat of epoxy adhesive was carefully brushed onto each face of the exposed area (Fig. 6). Then each depression was filled with mortar. The mortar was tamped into place. The surface was troweled and a light dusting of portland cement applied so that the surface color blended with the surrounding pavement. Before placing a patch, a wooden form was placed in the joint to form a wall of the joint (Fig. 7). The forms were not removed for 72 hours or more until the patches cured enough to allow traffic over them.

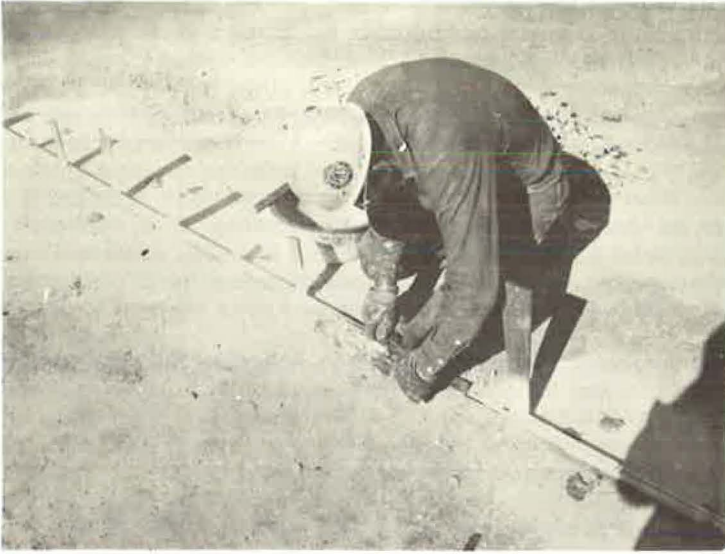
Figure 7. Placing wooden form.

one percent of the cement was added to the mortar as an accelerator. Three-day compressive strengths of this mortar exceeded 3,000 psi. Prior to placing these patches, forms were placed in the line of the joint to form the joint wall. The patch area was painted with a portland cement grout, consisting of 1 part cement to 1 part sand. The grout was applied with a stiff brush to be sure it was scrubbed into every indentation of the area. The patching mortar was then tamped into the patch (Fig. 8), finished to blend in with the surrounding pavement surface, and sprayed with a white, liquid curing agent. All forms were removed in 72 hours after the patch was placed. The area was then opened to traffic.
