EVALUATION OF TIMBER WEAK-POST GUARDRAIL SYSTEMS

Maurice E. Bronstad, Southwest Research Institute; and Robert B. Burket, Ohio Department of Highways

Six full-scale vehicle crash tests were conducted on guardrail systems to evaluate the effectiveness of substituting timber posts for the standard 315.7 steel posts specified in a current guardrail standard. Results of the tests indicate that timber is a suitable post material for the "weak-post" concept. Although there was some difficulty in determining the proper rail attachment to the post, solutions to the problem are suggested in this report. Basically, the timber post design calls for a 12-gage flexural beam mounted on 6- by 7-in. or $5\frac{1}{2}$ -in. diameter pine posts spaced at 12.5-ft centers. A $\frac{1}{4}$ -in. diameter steel bolt and a pipe insert provide proper attachment of rail to post. The sixth test of the series provided an evaluation of the effectiveness of a continuous installation composed of the new timber weak-post system and the department's strong-post system. The test results indicated that the transition design between the two systems was satisfactory, but design changes could improve performance.

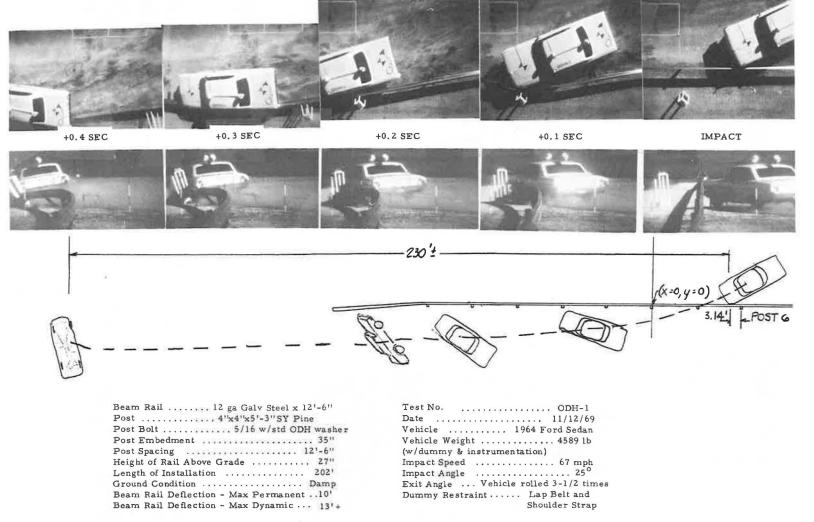
Figure 9. Summary of results, test ODH-1.

All posts in the installation were broken near ground level (Appendix, Figs. 8 and 9). Failure of the upstream posts clearly indicated the lack of sufficient post strength. Because of the extended contact with the system, the vehicle engaged the downstream terminal treatment, which indicated there was insufficient installation length for a general performance test.

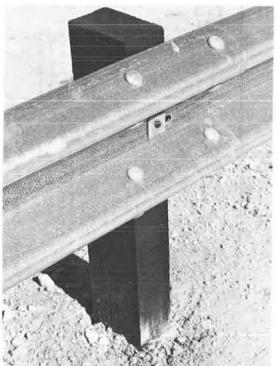
(b) Typical post

Based on the results of the first test, 4- by 6-in. posts were installed for the test and an additional 50 ft was added to the length of the test installation. The test vehicle impacted the installation with a speed of 62 mph and an angle of 25.3 deg (Appendix, Figs. 10 and 11). Although loss of rail height after impact permitted the vehicle to straddle the rail (Fig. 1), the vehicle was contained by the system and redirected. The vehicle was launched, but remained upright and was braked to a stop with moderate vehicle damage. Peak vertical and lateral dummy accelerations were +3 and -3 g respectively. Peak vehicle accelerations were -2.8 g and -2.4 g in the lateral and longitudinal directions respectively. As in test ODH-1, the $\frac{5}{16}$ -in. diameter post bolts did not shear. Rail separation from the post was accomplished by forcing the rear washer through the post material.

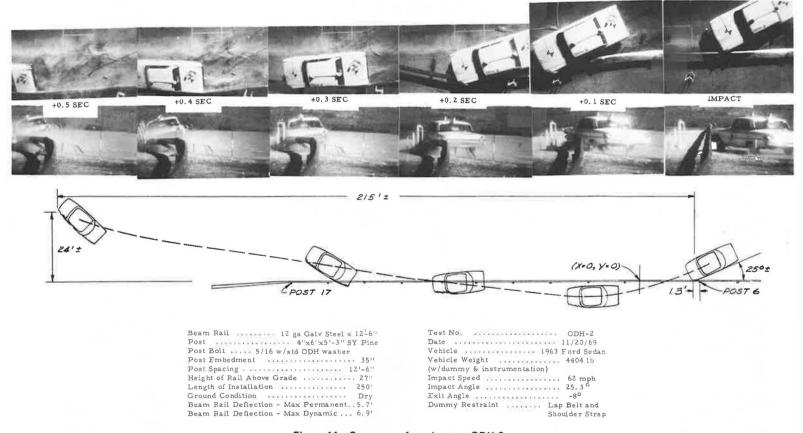
Figure 11. Summary of results, test ODH-2.

Lack of sufficient post strength and failure of the post bolts to shear on impact were considered primary causes of these undesirable results.

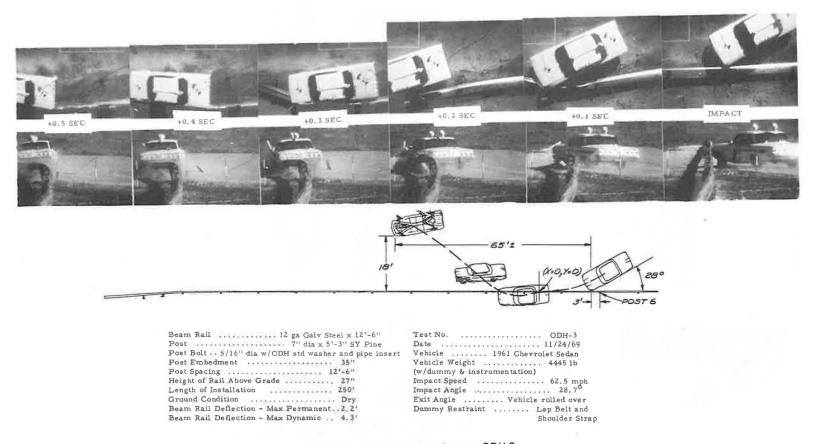
Figure 13. Summary of results, test ODH-3.

Test ODH-3 impact conditions were 62.5 mph at a 28.7-deg angle (Appendix, Figs. 12 and 13). The vehicle was initially redirected, but pocketing occurred about 30 ft from impact, and the vehicle rolled over and remained inverted (Fig. 2). Vehicle ac-

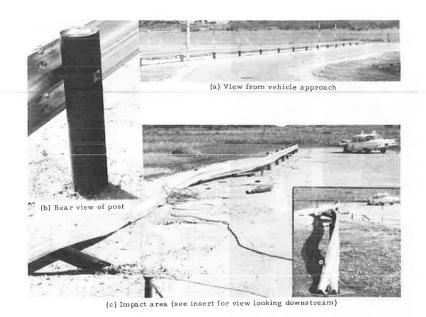
Figure 14. Scenes from test ODH-4.

A 6-in. diameter post was selected for test ODH-4; all other details (including pipe inserts) were the same as for test ODH-3. The vehicle impacted the rail with a speed of 63.1 mph and an angle of 28.3 deg (Appendix, Figs. 14 and 15). The vehicle was contained and redirected by the system, but loss of rail height again occurred due to lack of bolt shear. As the rail dropped, the vehicle rolled about 15 deg but remained upright throughout; the vehicle did not straddle the rail (Fig. 3). Vehicle accelerations

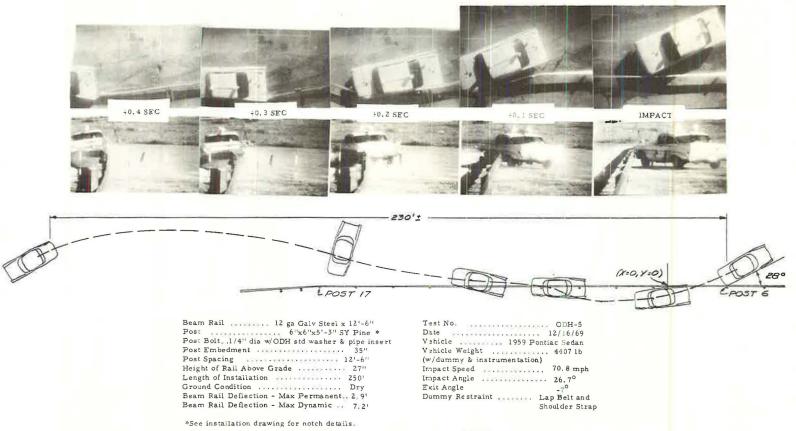
Figure 17. Summary of results, test ODH-5.

A $\frac{1}{4}$ -in. diameter bolt was substituted for the previously used $\frac{5}{16}$ -in. diameter bolt. A close-fit pipe insert was selected for compatibility with the new bolt size. Because the 6-in. diameter posts from test ODH-4 were considered to be somewhat overstrength, a 6- by 6-in. post with $\frac{1}{2}$ -in. notches on upstream and downstream edges 2 in. above grade was selected. The vehicle impacted with a speed of 70.8 mph and an angle of 26.7 deg (Appendix, Figs. 16 and 17). Redirection of the vehicle was good, and the rail remained at an effective height throughout the test (Fig. 4). The elusive bolt shear phenomenon was attained; however, it was not confined to impact area, as all but one of the bolts sheared. Maximum vehicle accelerations were -4.6 g laterally and -3 g longitudinally. A maximum of 8.8 g laterally was recorded from the dummy; seatbelt and shoulder-harness loads reached maximum values of 1,000 and 800 lb respect respectively.

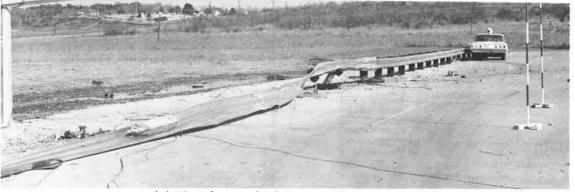
(c) View from vehicle approach after test

pocket near this exit point was evident, but the vehicle ranged only about 14 ft off the rail line before the brakes were applied and a subsequent second impact with the rail system occurred (Fig. 5). Maximum vehicle accelerations from film data were -3.2 g laterally and -4.3 g longitudinally. Dummy accelerations reached maximum value of -3.0 g longitudinally, -7.5 g laterally, and -6.5 g vertically. A maximum of 1,200 lb was recorded from the right seat-belt load cell. The $\frac{1}{4}$ -in. diameter bolt shear was again extensive and the effect of the notch was negated by post failure occurring below the notch line.
