DYNAMIC TESTS OF AN ENERGY-ABSORBING BARRIER EMPLOYING STEEL DRUMS

Eric F. Nordlin, James H. Woodstrom, and Robert N. Doty,
California Division of Highways

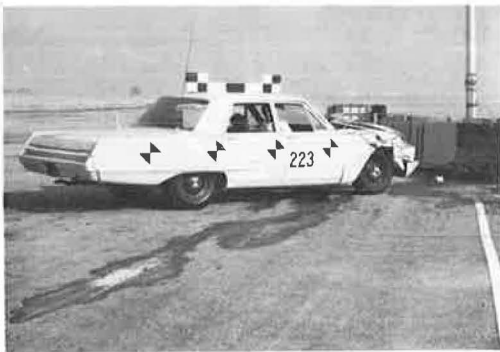
Figure 14.

Vehicle damage consisted of a crimp in the roof on the passenger side, extensive hood deformation, slight displacement of the left-front quarter panel, and 3.6 in. of energy-absorbing steering column collapse (Figs. 14 and 15). There was a slash high on the cheek of the dummy driver, and the windshield was broken in front of the dummy passenger. The dummy passenger was badly cut on the tip of the bridge of his nose, over his right eye and on his forehead, and on the right side of his face and cheek. (The removal of this dummy's lower legs before the crash may have contributed to some excessive movement of his upper body during the collision.)

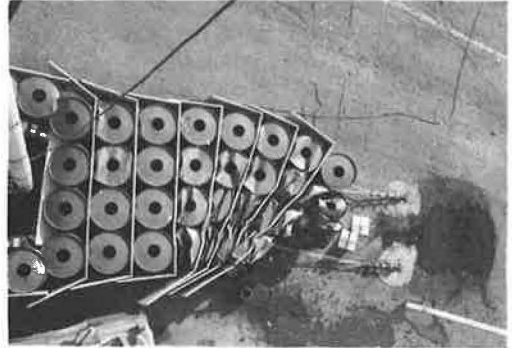
Figure 16.

All but two drums were damaged. The left-front and the right-rear plywood fender panels were the only ones damaged. It appeared that the impact force was transmitted somewhat diagonally from the left-front to the right-rear portion of the barrier (Fig. 16). The left-front portion of the barrier was crushed much more than the right-front side. The film record shows the drums crushing one row at a time in successive order with the exception of the back row, which was deformed soon after impact. This was very similar to the dynamic barrier compression sequence observed during test 221.

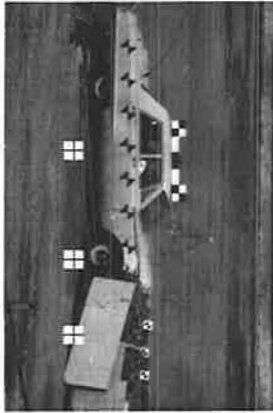
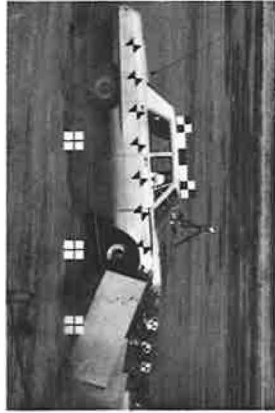
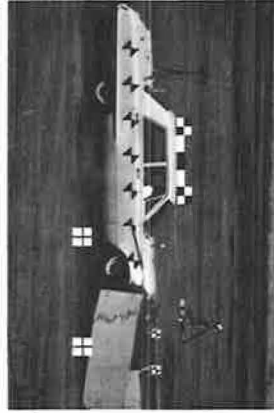
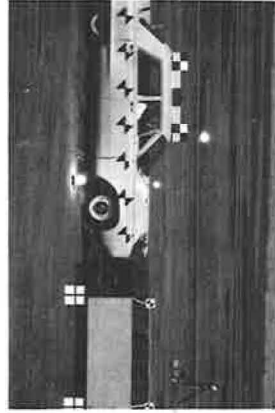
Figure 20.

All the drums in the barrier were deformed (Figs. 7 and 8). The cables were slack but undamaged. The plywood fender panels were badly cracked and splintered but remained attached to the barrier as it was deformed around the nose of the bridge approach guardrail. The drums crushed one row at a time, in successive order, as had been assumed in the design procedure. Figure 20 in the Appendix shows additional test data.

Barrier Depth	19.6 Ft.	Test No.	221
No. of Drums	41	Date	9-11-69
Permanent Displacement of Barrier Nose	10.7 Ft.	Vehicle	1968 Dodge
Deceleration Distance-Passenger Compartment	16.5 Ft.	Vehicle Weight	4690 Lbs. ²
Maximum Vehicular Deformation	16.5 In.	(W/Dummy and Instrumentation)	
Steering Column Collapse ¹	3.4 In.	Impact Velocity	64.2 MPH
Passenger Compartment Deceleration	10.3 G's	Impact Angle	Head-On
(Highest 50 ms avg.)		Dummy Restraint	Lap Belt
Vehicle Average Deceleration-Calculated	8.4 G's

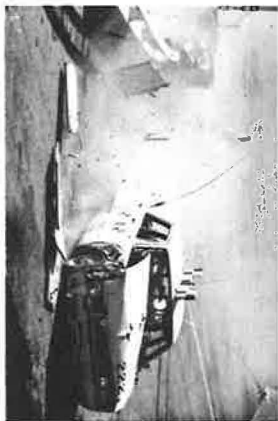
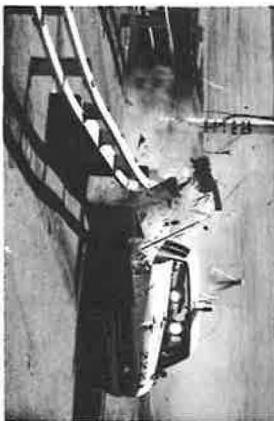
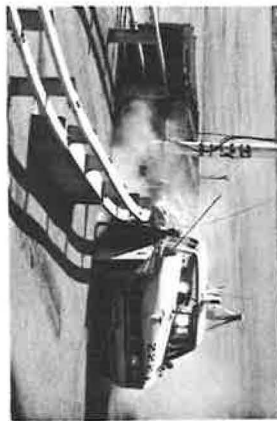
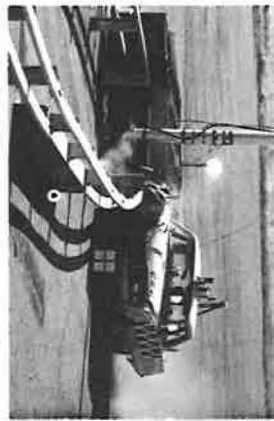
Figure 21.

Vehicle damage included severe crushing of the right-front quarter panel, jamming of the right-front door, scars on the right doors and right-rear panel, and displacement of the radiator to the point of touching one fan blade (Fig. 12). Figure 21 in the Appendix shows additional test data.

Barrier Depth	19.6 Ft.	Test No.	222
No. of Drums	41	Date	11-21-69
Permanent Displacement of Barrier Nose	None	Vehicle	1968 Dodge
Deceleration Distance-Passenger Compartment	Redirected	Vehicle Weight	4760 Lbs.
Maximum Vehicular Deformation	27 In.	(W/Dummy and Instrumentation)	
Steering Column Collapse ¹	None	Impact Velocity	59.8 MPH
Passenger Compartment Deceleration	6.6 G's Long.	Impact Angle	11° (Side)
(Highest 50 ms avg.)	5.3 G's Lat.	Dummy Restraint	Lap Belt
Vehicle Average Deceleration-Calculated	-

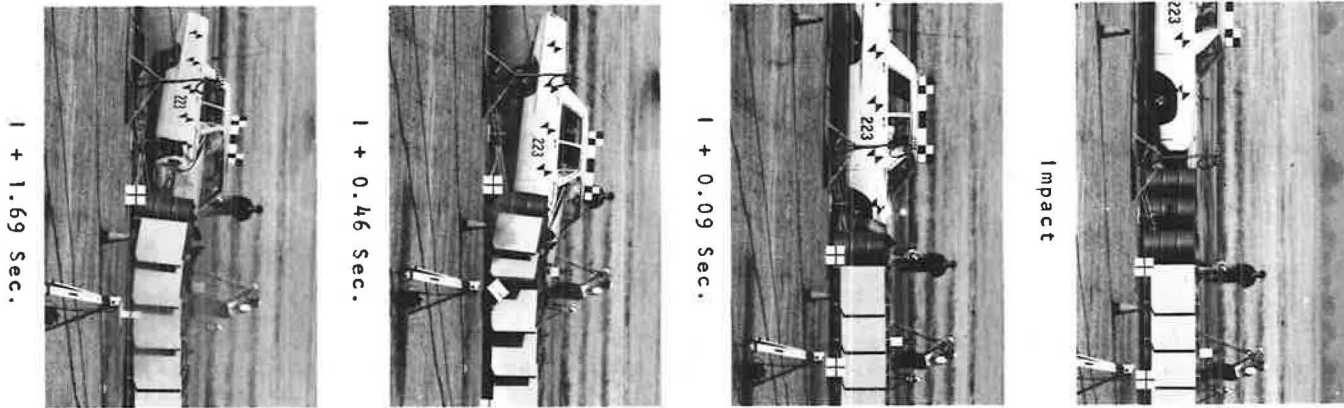
Figure 22.

The movies showed the car being ejected outward from the barrier due to the elastic energy stored within the barrier. The clockwise rotation of the car was probably caused by a moment couple consisting of the vehicular momentum, acting through the vehicle center of gravity, and this elastic energy, acting through the centroid of the vehicle-barrier contact interface. Figure 22 of the Appendix shows additional test data.

Barrier Depth	19.6 Ft.	Test No.	223
No. of Drums	41	Date	12-5-69
Permanent Displacement of Barrier Nose	5.5 Ft.	Vehicle	1968 Dodge
Deceleration Distance-Passenger Compartment	13.2 Ft.	Vehicle Weight	4740 Lbs. ³
Maximum Vehicular Deformation	14.5 In.	(W/Dummy and Instrumentation)	
Steering Column Collapse ¹	3.6 In.	Impact Velocity	53.6 MPH
Passenger Compartment Deceleration (Highest 50 ms avg.)	10.9 G's Long.	Impact Angle	9° (Nose)
Vehicle Average Deceleration-Calculated	7.2 G's ²	Dummy Restraint	Lap Belt
