BREAKAWAY OVERHEAD SIGN BRIDGES, CRASH TESTING

D. L. Ivey, R. M. Olson, C. E. Buth, and T. J. Hirsch,
Texas Transportation Institute, Texas A&M University; and
D. L. Hawkins, Texas Highway Department

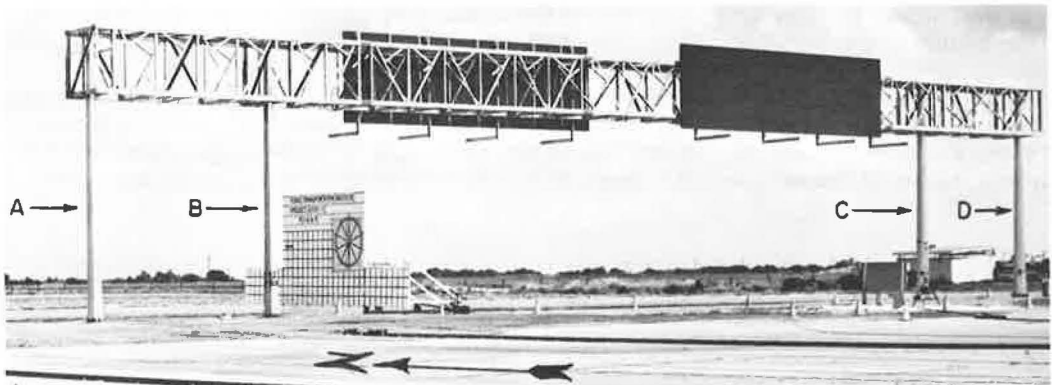
Figure 1. Prototype overhead sign bridge. Supports designated A, B, C, and D.

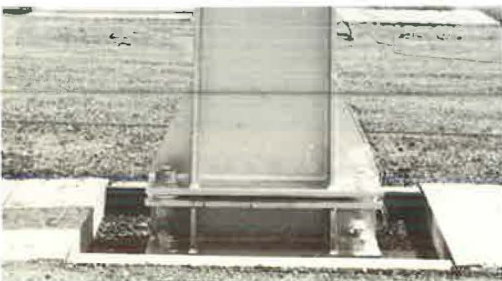
and lower base plates and that the base bolts be tightened to 200 lb-ft (Fig. 2). Preliminary calculations and analysis of the record films led to the conclusion that the bolt keeper plate and base-bolt torque do not affect the vehicle-support behavior. These conditions (28-gage bolt keeper plate and 200 lb-ft base-bolt torque) were established for the remainder of the regular crash test series.

Figure 2. Details of breakaway base connection.

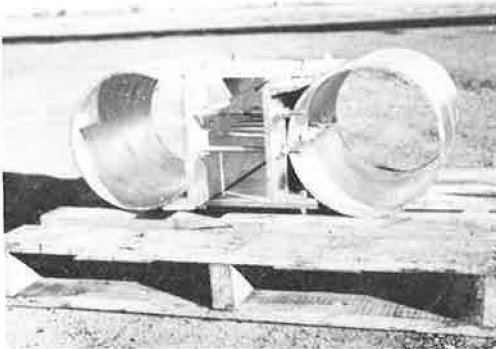
To provide the required distribution and dissipation a steel-tube load distributor was designed which could be placed to protect the lower chord members of the truss. Static laboratory and field tests were run to verify the function of these distributors before crash tests were conducted. A close-up of the load distributor before it was placed on the truss is shown in Figure 5, and typical installations on the truss are shown in Figures 6 and 7. Selection of the channel sections was made (a) to provide adequate load distribution to the truss, and (b) to provide a flat bearing surface for the cylindrical tubes during impact loading. The design of the connection provided both conditions, as can be seen in Figure 8. No damage to the lower chord occurred

Figure 5. Load distributor (steel tubing with 3/8-in. wall thickness, 12 3/4-in. outside diameter, and 17 in. long).

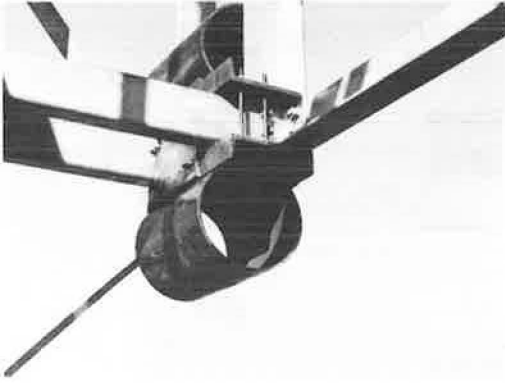
Figure 6. Load distributor bolted in place on lower truss chord at support A.

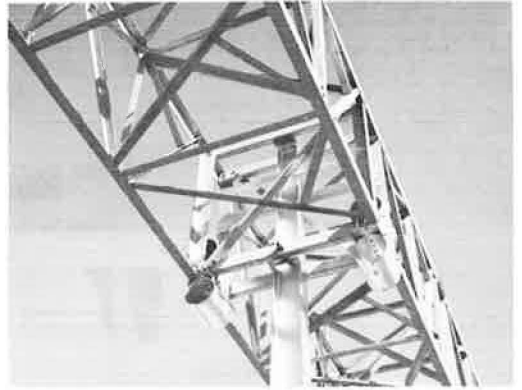
Figure 7. Load distributors at support B before Test B.

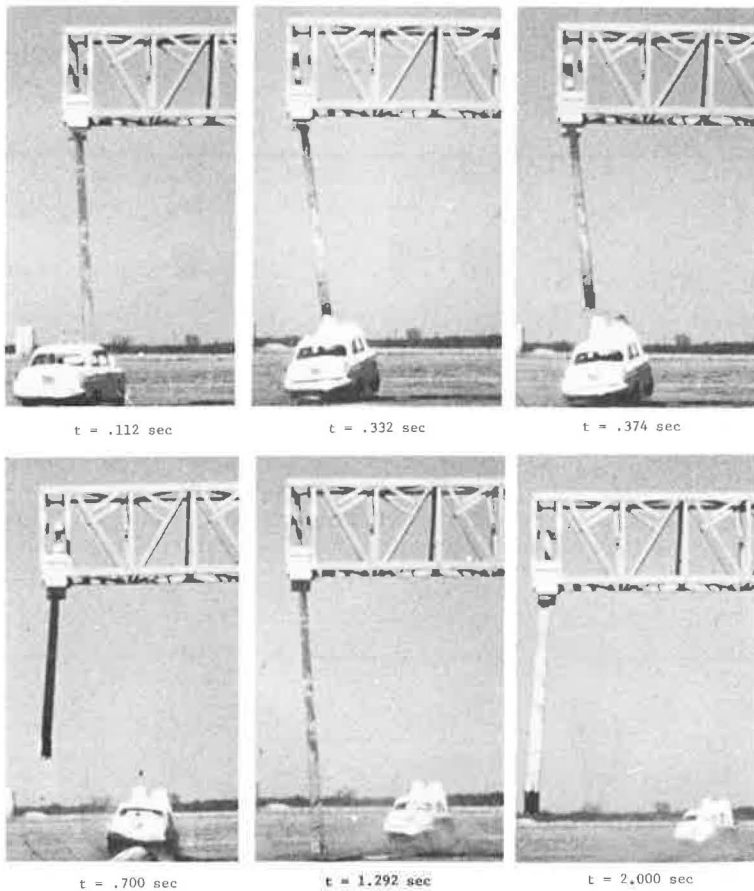
The truss twisted through 8 deg and the upper connection bolts at support B were fractured. Upper connection bolts at sup-

Figure 20. Sequential photographs of Test F.

ports C and D were removed, examined, and found to be undamaged. The structure remained erect and in good condition.

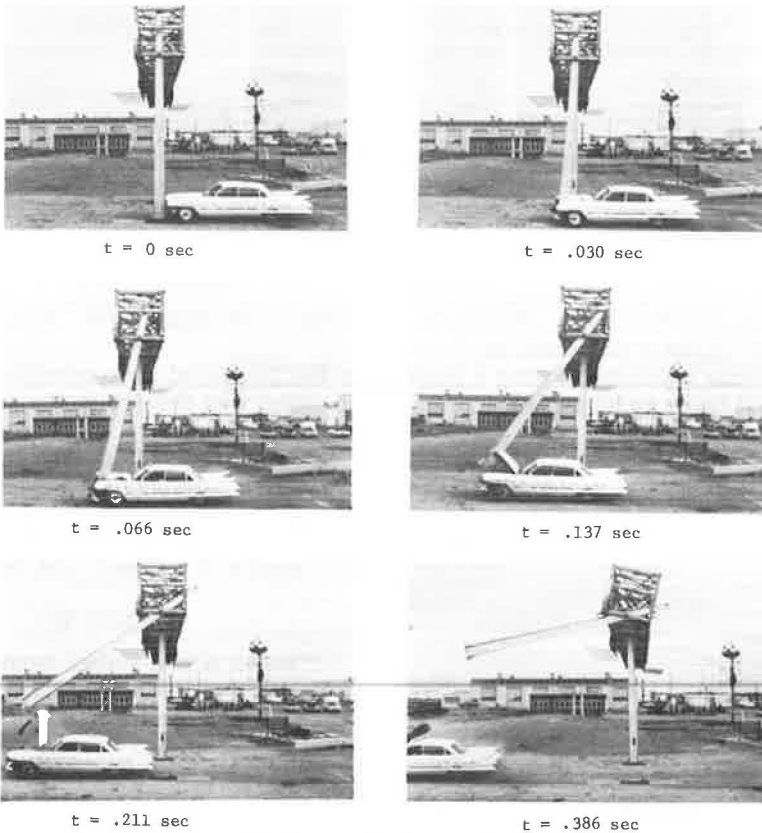
Figure 24. Sequential photographs of Test H.

This final crash test was conducted on January 28, 1971. A 5,170-lb Cadillac struck column B at 72.0 mph and was slowed 11.2 mph by the impact. The sequence of events in the collision incident are shown in Figure 24, and damage to the car is shown in Figure 25. The average and peak decelerations are given in Table 1. The maximum post penetration was 2.6 ft.
