AN EVALUATION OF THE IMPACT RESPONSE OF VARIOUS MOTORIST-AID CALL SYSTEMS

J. E. Martinez and D. E. Hairston, Texas Transportation Institute,
Texas A&M University

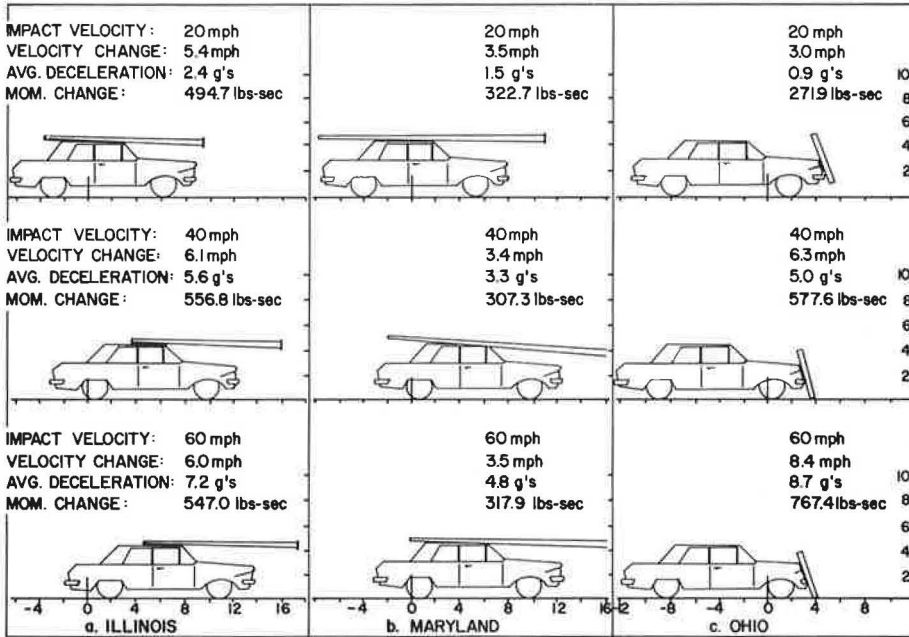
Figure 7. Parameter study results for 2,000-lb vehicle.

The Illinois assembly study revealed that the point of secondary impact by the post on the roof of the vehicle tends to move toward the rear windshield area as the speed and weight of the vehicle are increased. For the lighter vehicles, the tendency is for the post to strike somewhat further toward the front of the vehicle. However, it should be noted that the crash test demonstrated that the post did not exhibit planar motion because a rotation about its longitudinal axis took place. If this occurs in all cases, the simulation would normally predict shorter secondary impact times and a secondary impact point that is closer to the front of the vehicle. Thus, for this assembly, it appears that unless the assembly strikes the rear windshield of the vehicle, the secondary impact will not create a hazardous situation.

Figures 7b and 8b indicate that the Maryland call-box assembly behaves similarly to the Illinois assembly (Figs. 7a and 8a). The point of secondary impact by the post on the top of the vehicle tends to move toward the rear windshield area as the speed of the heavier vehicle is increased and strikes above the front windshield area for most light-weight vehicles traveling at low and medium speeds. Thus, it appears that, for the vehicles and speeds considered, a collision with a Maryland call-box assembly does not create a hazardous situation. However, due regard must be given to the possibility of component parts of the assembly becoming detached during the collision and striking the windshield of the vehicle.

Two systems, one of which included the properties of the call box, were considered for the Ohio call-box configuration; this simulated the condition observed in the crash test. The two systems behaved in a very similar manner for all the cases considered. As shown in Figures 7c and 8c, the call-box system rides the vehicle front end, rotates slightly toward the vehicle, and then drops to the ground in front of the vehicle. The system that contains the effects of the mass of the call box shows a stronger tendency to rotate toward the vehicle; however, because of the geometric and inertia properties of the assembly, it does not appear that the trajectory would be appreciably changed under actual field conditions. Thus, based on the parameter study and observation of the crash test, it appears that a hazardous situation is not created unless component

parts of this assembly become detached during the collision and strike the windshield area of the vehicle.

It is recommended that the component parts of the call-box assemblies be adequately secured so that they will not become detached during a collision. In particular, the attachments of the call box to the support post and the hinges of the call-box door should be strengthened.
