FAULTING OF PORTLAND CEMENT CONCRETE PAVEMENTS

D. L. Spellman, J. H. Woodstrom, and B. F. Neal, California Division of Highways

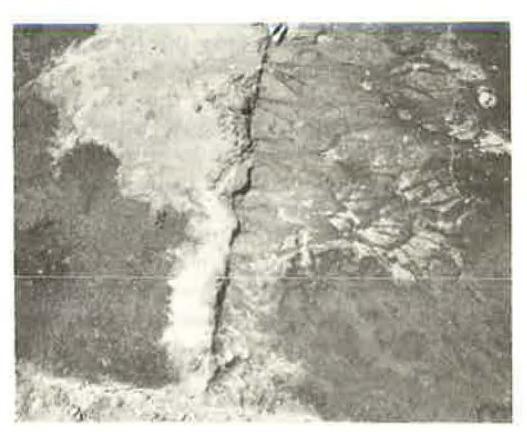
Although base settlement has long been suspected as a cause of faulting, there was no evidence found during the field investigation of any such settlement. (All pavements opened had cement-treated bases.) There was, however, positive evidence of erosion of the base surface under the leave slab. The evidence was in the form of rivulets caused by water movement, which might result in some lack of uniform support but would not allow the slab to be depressed (Fig. 6). The top portion of the CTB at many locations has been found to be loosely cemented and readily erodible. Although drying of the surface before curing may be responsible for part of the problem, much is felt to be due to the trimming operation used to conform to grading tolerances. Because a high base will result in thin pavement, for which a contractor is penalized, and a low base results in the use of excessive concrete, considerable effort is exerted in obtaining the proper grade. Trimming is usually done about an hour or more after original placement. The surface material, once loosened, is never fully rebonded and so does not form a monolithic erosion-resistant base.

Figure 6. Channels indicating water movement on CTB surface.
