DETERIORATION OF 249 BRIDGE DECKS

R. E. Carrier and P. D. Cady, Pennsylvania State University, University Park

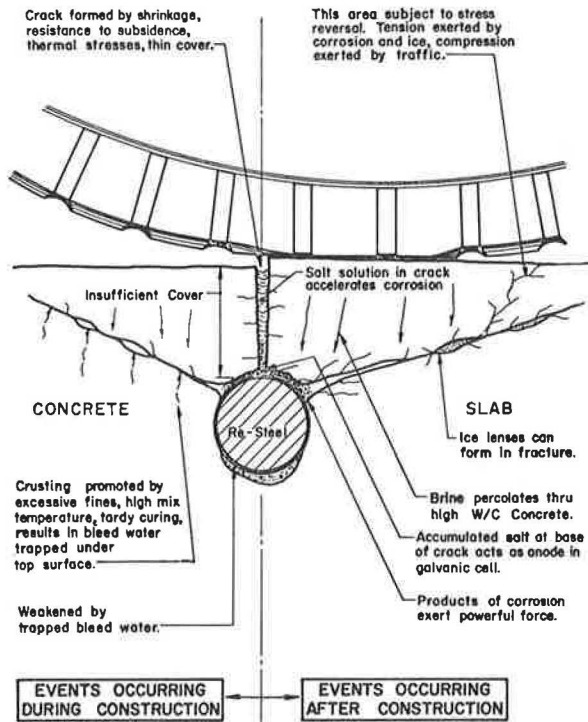
Figure 1. Spalling phenomena (5).

The two most important mechanisms of deterioration of concrete bridge decks have been postulated and are generally accepted. These include deterioration by freezing and thawing (6) and spalling caused by corrosion of reinforcing steel (9). Spalling is probably the single most serious form of deterioration from the standpoint of repair cost. It is necessarily preceded by the occurrence of a fracture plane or plane of separation that forms approximately parallel to the traffic surface usually at about the level of the top reinforcing steel. The various phenomena involved in spalling are shown in Figure 1. Note the importance of cracking.

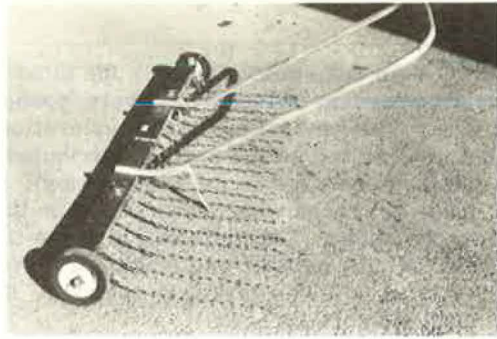
Figure 2. Chain drag device.

No special equipment was required for the deck surveys other than the aforementioned pachometer and a unique chain drag device used to detect fracture planes (Fig. 2). Although fractured areas are incipient spalls, they are usually not discernible at the road surface even upon close inspection. The chain drag device comprises a timber member with 2-ft lengths of ordinary snow-tire chains attached at 4-in. intervals along the member. As the device is traversed over a fracture plane on the deck, the chains produce a hollow sound. Tape recordings of several of these soundings were quite distinct. When a fracture plane was encountered, it was delineated, and its area and depth to reinforcing steel were measured (Fig. 3).

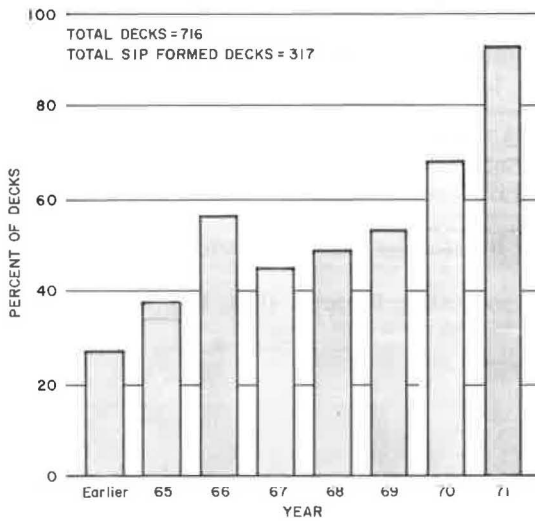
Figure 10. Distribution of SIP-formed decks in New York.

The New York study includes most decks built in the state during the 7-year period, 1965 to 1971—about one-half with SIP forms (Fig. 10).

The New York experience appears at first glance to supply the additional statistical evidence. Yet the lower crack intensity in SIP-formed decks in New York also can be explained by factors other than forming method. As shown in Figure 10, SIP-formed decks in New York, as a group, are younger than those formed by conventional methods. This fact, combined with the strong age-dependence of transverse cracks (Fig. 11), supplies an alternate explanation for the higher crack intensity associated with conventionally formed decks; i.e., conventionally formed decks are cracked more intensely because more are older. Unfortunately (for this purpose) the objectives of the New York survey were primarily descriptive, and the information at hand does not permit a more exhaustive study of causal factors, which might resolve this question. The Pennsylvania study, of course, was confined to decks of the same approximate age and does not suffer from this dilemma.

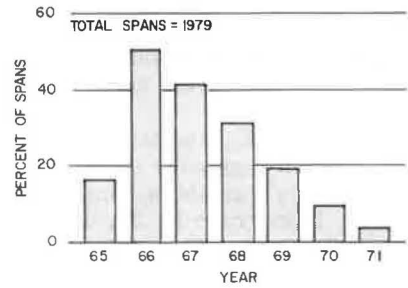
Figure 11. Frequency of transverse cracking by year of construction.

Regarding mechanisms, the authors (1) have speculated that the lesser crack intensity associated with the use of SIP forms could result from slower water loss in the fresh concrete with more gradual shrinkage or increased stiffness of the deck due to composite action. If this water-loss hypothesis is true, then cracking associated with forming method probably occurs early in deck life when drying (and shrinkage) is more rapid and strength not fully developed. However, this seems contrary to the implication of Figure 11, and to the findings of other investigators of bridge deck cracking (12), that the occurrence of transverse cracks is age-dependent. Resolution of this matter may rest on the question of whether transverse cracks resulting from such causes really become more frequent with deck age or develop early and just become more apparent with age.
