NATIONAL COOPERATIVE
HIGHWAY RESEARCH PROGRAM REPORT

336

**DISTORTION-INDUCED FATIGUE
CRACKING
IN STEEL BRIDGES**

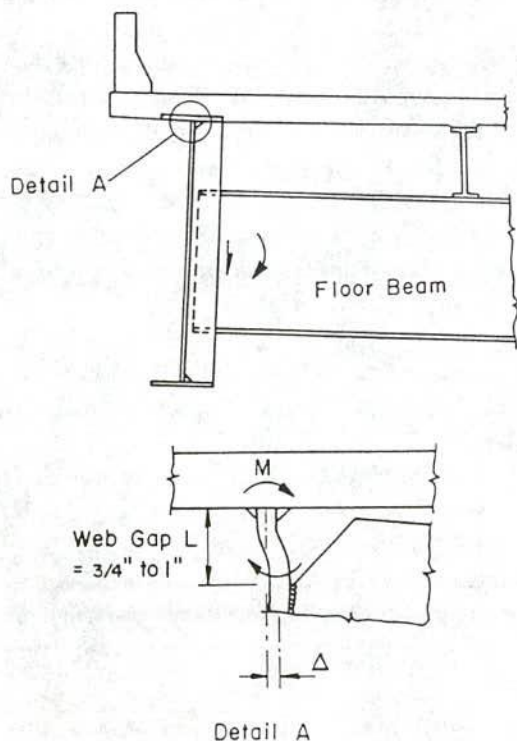
Figure 1. Schematic of distortion in web gap at end of floorbeam transverse connection plate.

Conditions which resulted in web gap cracks have often developed because of the desire to avoid welding transverse stiffeners that serve as connection plates to the tension flanges. Figure 1 shows a schematic of a condition that exists in floorbeam-girder bridges. Figure 2 shows typical cracks observed at a floorbeam web gap.

Extensive cracking has developed in web plates at the ends of floor beam connection plates. Studies indicate the cracking to be the direct result of cyclic, secondary bending stresses that are generated through relative out-of-plane movements. These displacements, although often less than only 0.005 in. (0.13 mm), concentrate in gaps between the floor beam connection plate and the girder tension flange, as illustrated in Figures 1 and 2.

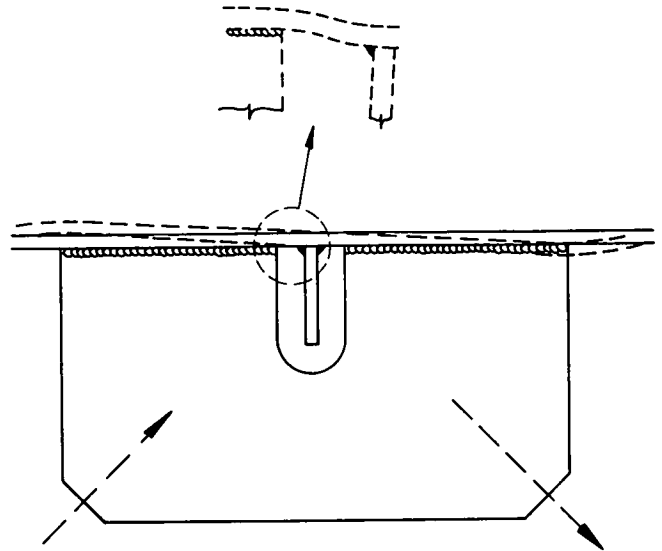
Figure 3. Schematic of distortion in web gap at lateral gusset plate.

Regardless of interaction with main members, lateral gusset plate attachments result in a detail with low fatigue resistance. The welded connection accommodates the small out-of-plane displacements necessary to induce relatively high stress ranges in web gaps. These displacements, often on the order of only 0.004 in. (0.1 mm), are accommodated within the segment of web plate bounded by the transverse stiffener weld toe and the inside of the gusset plate edge as illustrated in Figure 3. The out-of-plane deflections generate, in the unstiffened gaps, secondary bending stresses that are often sufficient to initiate cracking at weld toes. These secondary stresses are not calculated in normal rating procedures nor are they accounted for in the current design process. Thus, fatigue provisions have not been applied to this type of cracking.

The longitudinal web gaps, present in most gusset plate connections for lateral bracing, typically range from 0.25 in. to 4 in. (6.4 to 101.6 mm) in length. Details which include the smaller gaps increase the risk of cracking at the intersection of the transverse stiffener weld and the longitudinal gusset plate weld. Restraint due to large shrinkage strains along these welds elevates the local stresses within the smaller gaps. Further problems may arise from lack of fusion or slag inclusions that may exist at such intersections. Larger gaps are more flexible and can better accommodate out-of-plane displacements. The magnitude of distortion-induced fatigue cracking is directly related to the length of web plate over which the distortions must be absorbed.

With damage accumulating for each stress excursion above the detail's fatigue limit, a crack may initiate at the toe of a weld after only a brief period in service. The initial crack will grow perpendicular to the largest cyclic stresses. At longitudinal web gaps, the greatest restraint is provided by the boundaries at the ends of the web plate adjacent to the stiffener weld and the inner edge of the gusset plate as was shown in Figure 3. This restraint generates large secondary stresses. Consequently, gusset plate web gaps must undergo the simultaneous effects of primary, in-plane bending stresses and secondary, out-of-plane displacement-induced stresses. Thus, the horizontal gaps are very susceptible to fatigue crack growth and pose a serious threat

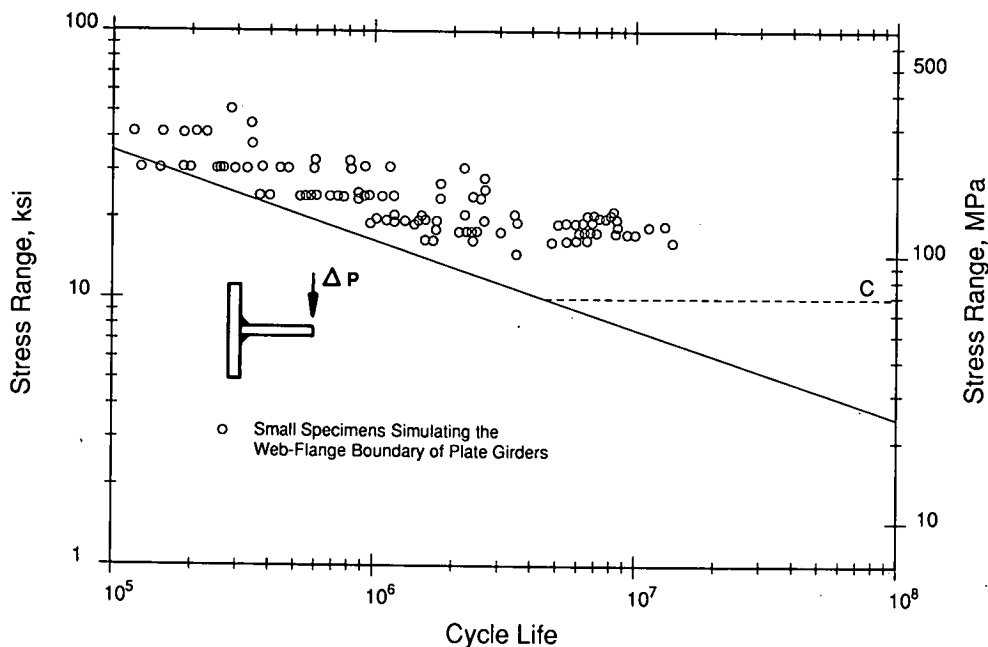
Figure 16. Fatigue test results from small simulated plate bending tests.

The only other experimental data were tests made on small specimens to simulate the flange-web boundary of plate girders (11, 12). These experiments were used to assess the potential for fatigue cracking from pumping of the plate girder web. Figure 16 shows the results of these experiments in the form of the classical S-N curve.

These tests on small T-type specimens simulating the web-flange connection indicated that out-of-plane web bending stresses provided a fatigue resistance compatible with Category C.

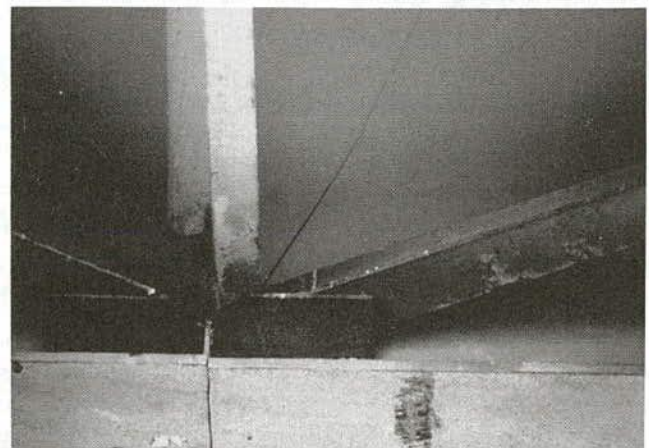
Figure 18. View showing two gusset plates welded only to the web.

The gusset plates may be welded, bolted, or cut free of the transverse stiffener in addition to being welded at the web. Figure 18 shows the case of two separate plates welded only to the web. Within the gap bounded by the transverse stiffener weld toe and the inside of the gusset plate edge, the out-of-plane displacement is accommodated by the short length of the web plate. The resulting out-of-plane cyclic bending stresses have caused crack development and growth. The web gap is less than $\frac{1}{4}$ in. (6.4 mm) in length, and the displacement is sufficient to generate large stresses.

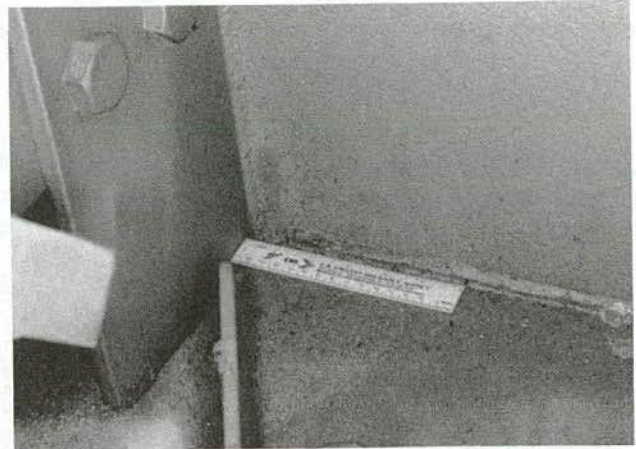
Figure 19. View showing gusset plate framing around floor beam connection plate, I-79 Bridge #2682. (Source: Ref. 19)

Cracking at the lateral gusset plate gaps developed in I-79 Bridge #2682 over Big Sandy Creek in West Virginia (19). The twin roadway is supported by two main steel girders with four stringers resting on 10-ft (3.1 m) long floor beams. The continuous girders have three spans: 120 ft, 130 ft, and 120 ft (36.6, 39.6, 36.6 m). The lateral bracing is bolted to a gusset plate which is welded to the girder web, but not to the floor beam connection plate. The gusset plate detail is shown in Figure 19. The web gaps vary from $\frac{1}{4}$ in. to 1 in. (6.4 to 25.4 mm) in length. The prevailing condition has resulted in the formation of vertical cracks along the outside (facia) transverse stiffener weld toes.

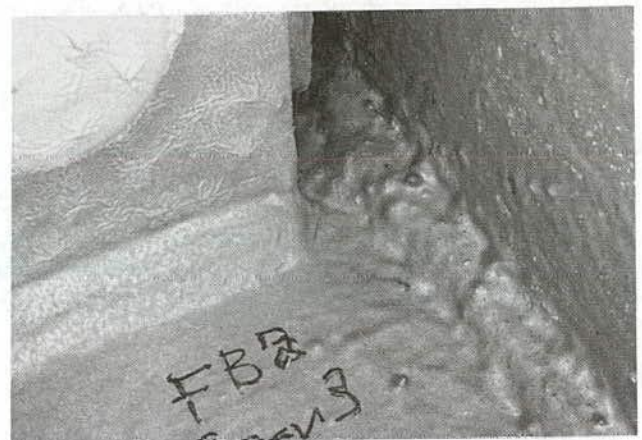
Figure 20. Lateral gusset plate detail, Canoe Creek Bridge. (Source: Ref. 13).

Similar cracking was investigated on the Canoe Creek Bridge in Clarion County, Pennsylvania (13). Figure 20 shows the gusset plate detail which resulted in $1\frac{1}{2}$ -in. (38 mm) web gaps between the transverse connection plate and the weld bars on the girder web. High-strength bolts were used to attach the gusset plates to the welded connection plates.

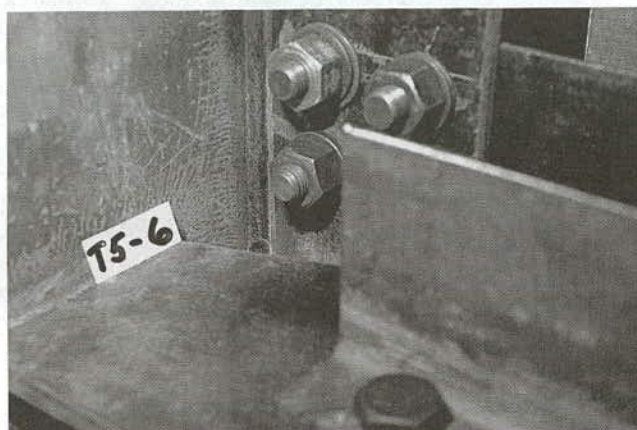
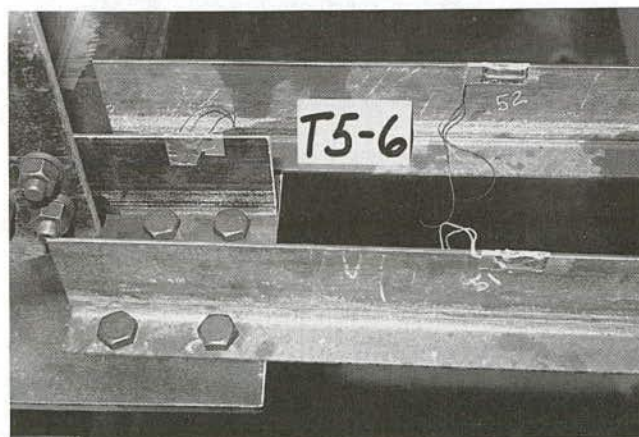
Figure 27. Top photograph shows web gap detail for T5-6 (Type B) with 3-in. (76 mm) gap; bottom photograph is an overview of Detail T5-6.

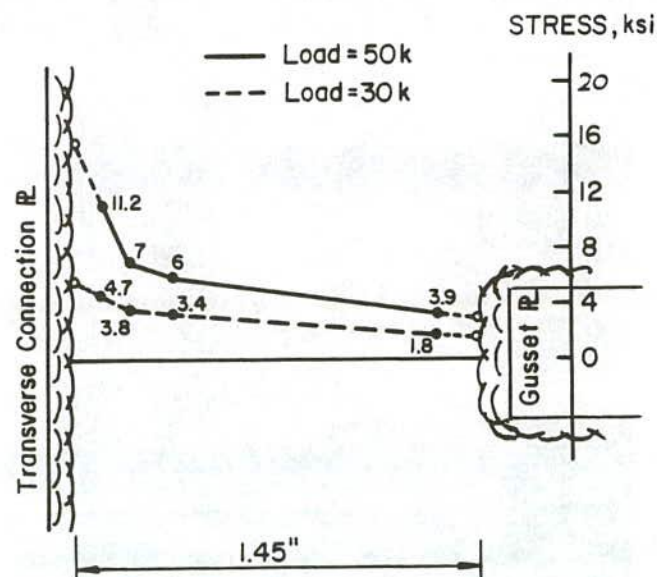
Each web gap region was gaged to establish the strain gradient and magnitude. Figure 28 shows the stress gradient observed at Detail T5-1 which was subjected to a 15-ksi (103.5 MPa) stress

Figure 28. Stress gradient for Detail T5-1 (Type A), east web gap.

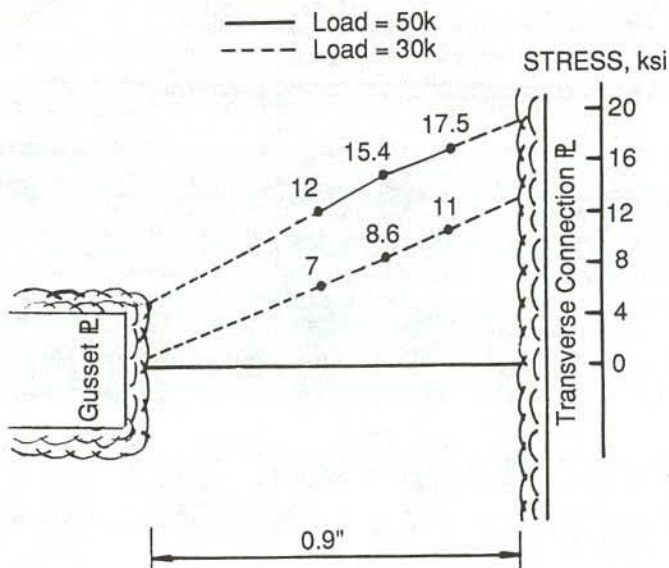
Figure 29. Stress gradient for Detail T5-5 (Type B), west web gap.

lengths between weld toes. Only one of the Type B, bolted attachment details developed fatigue cracks (Detail T5-5). As can be seen in Table 3, Detail T5-8 was subjected to 20×10^6 cycles at 15.5 ksi (107 MPa) without detectable cracking. Detail T5-5 with a stress range of 19.5 ksi (134.6 MPa) was observed to have a small crack after 5×10^6 cycles. Both of the Type B details experienced stress gradients similar in shape to the Type A detail. Figure 29 shows the stress gradient for T5-5 which developed a fatigue crack. Figure 30 shows the small fatigue crack that was first detected after 5×10^6 cycles. A history of each gusset detail crack development and retrofit condition is provided in Appendix A.

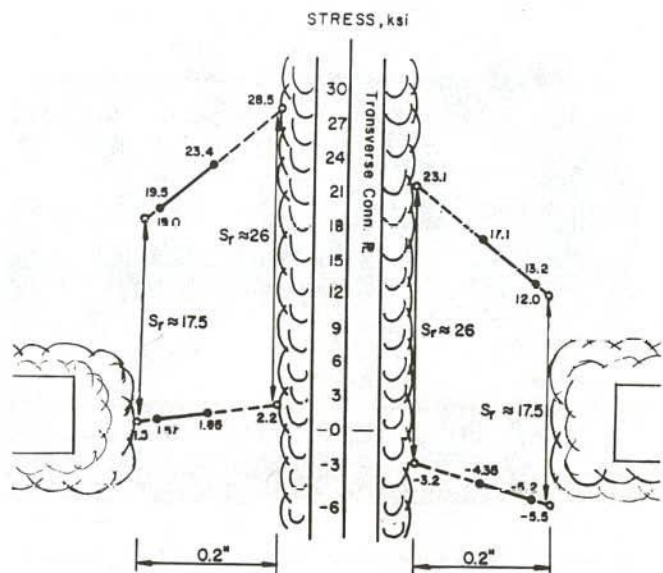
Figure 32. Stress gradients for Detail T5-10 (Type C).

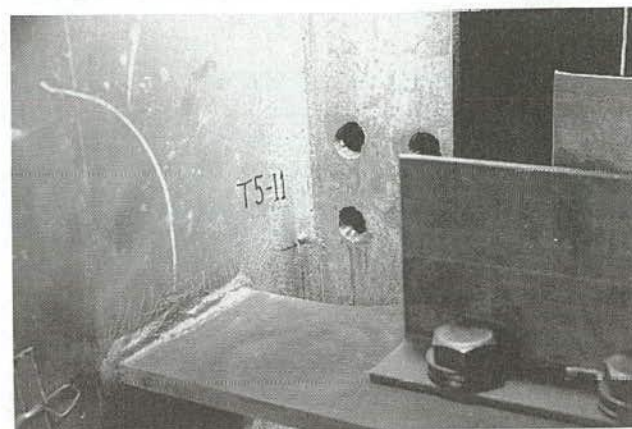
of 2.4-in. (61 mm) and 2.6-in. (66 mm) length and can be seen in Figure 34.

Figure 34. Detail T5-11 (Type C) with 3-in. web gap.

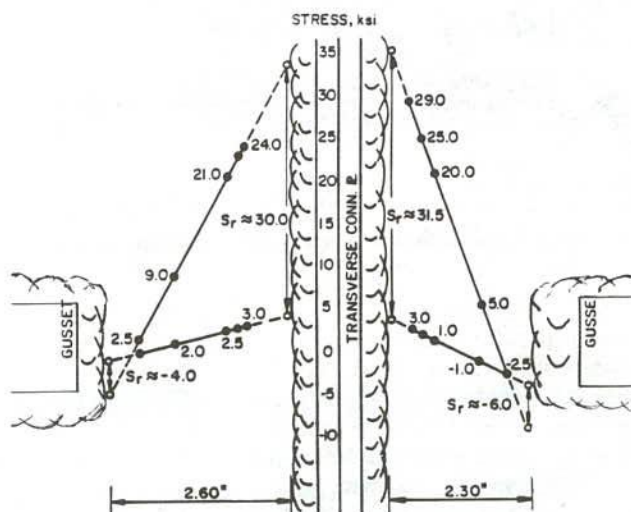
A plot of the measured stress gradients across the gaps of Detail T5-12 is shown in Figure 35. Stress ranges of 30 to 31.5 ksi (207 to 217 MPa) developed along the vertical connection plate weld toe within the horizontal gaps. The measured gradients extrapolated to compressive stress ranges of 4 to 6 ksi (27.6 to 41.4 MPa) at the toe of the gusset weld for these gaps. The measured stresses indicated the development of double-curvature within unrestrained web plate gap.

Figure 35. Stress gradients for Detail T5-12 (Type C).

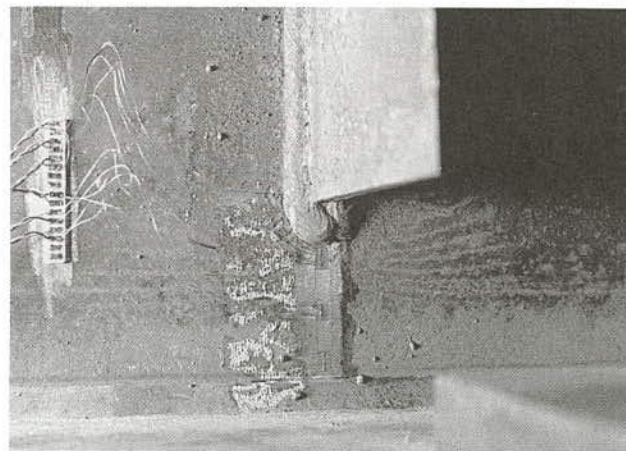
The out-of-plane bending stress in the web gap region was determined from strain gages installed in the gap, as illustrated in Figure 43. Strain gages were mounted on each side of the web plate.

Figure 43. Photograph shows strain gages installed in web gap between transverse connection plate and web-flange weld.

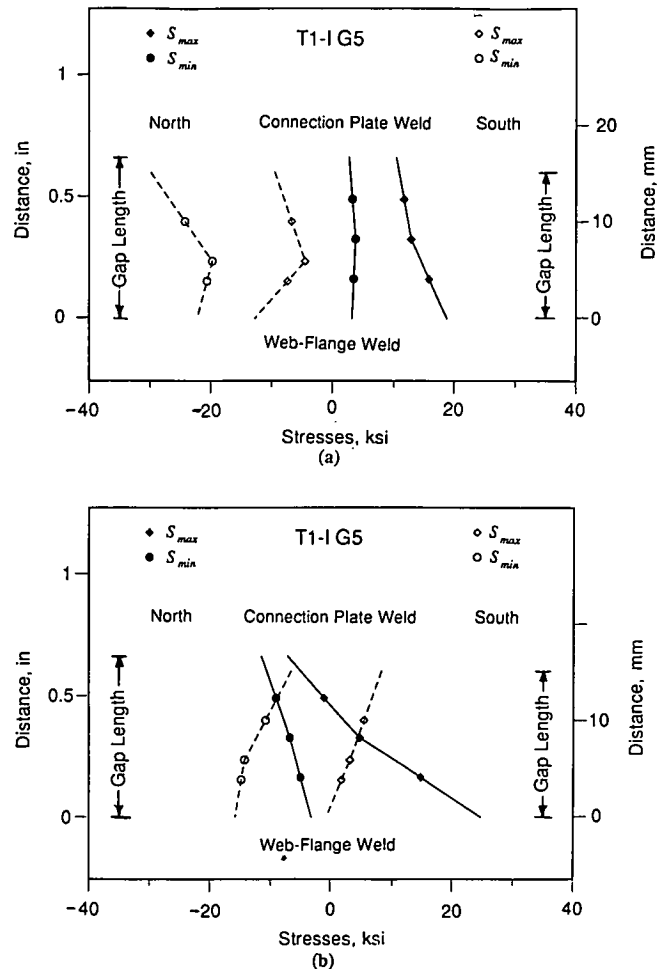
Figure 47. Stress gradients at transverse connection plate detail T1-I G5 (1½-in. gap) before and after cracking at end of connection plate: (a) prior to cracking; (b) after 10.7×10^6 cycles and visible cracking.

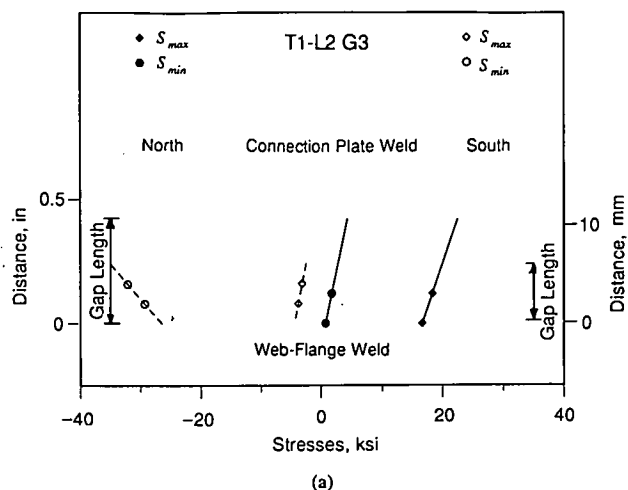
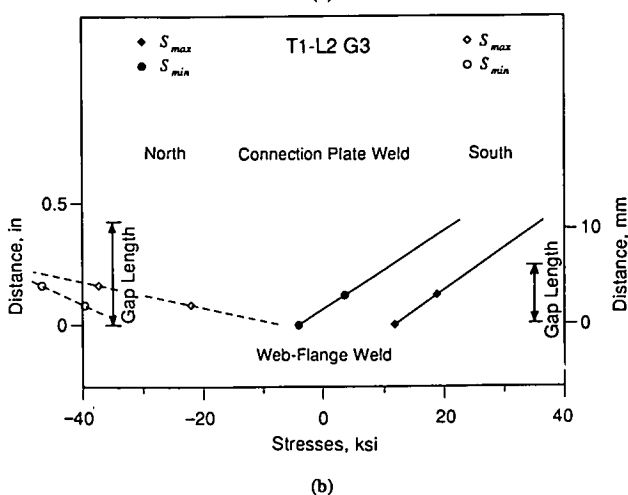
Figure 48. Stress gradients at transverse connection plate detail T1-L2 G3 ($1\frac{1}{2}$ -in. gap) before and after cracking at end of connection plate: (a) at start of test; (b) after cracking and 1.8×10^6 cycles.

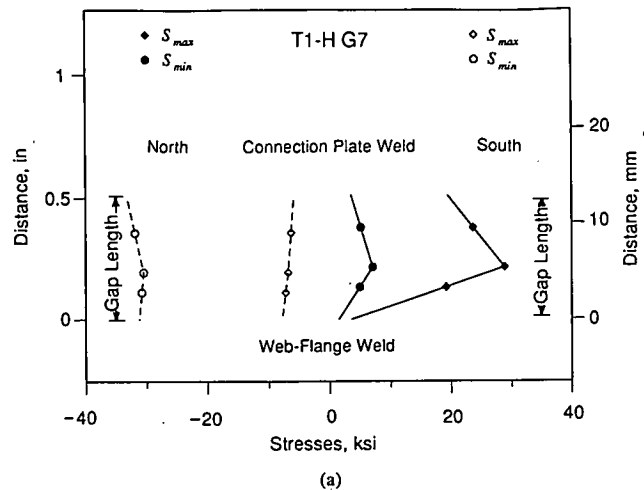
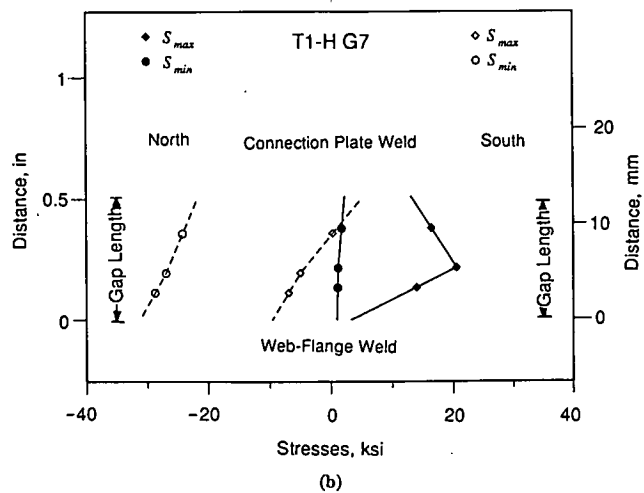
Figure 49. Stress gradients at transverse connection plate detail T1-H G7 ($1\frac{1}{2}$ -in. gap) before and after cracking at end of connection plate: (a) at start of test; (b) after cracking at 0.71×10^6 cycles.

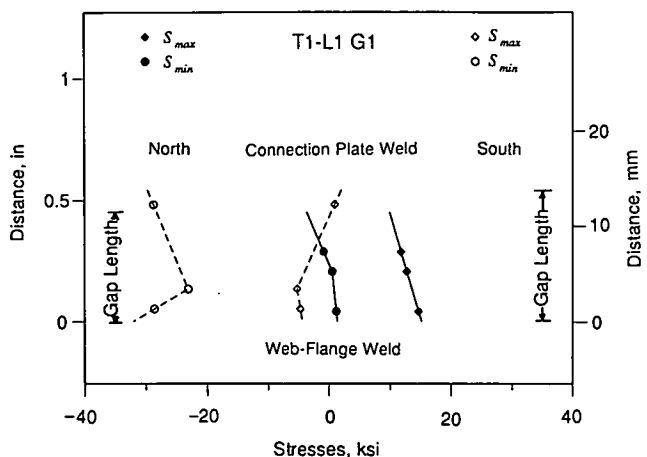
Figure 50. Distortion stresses at transverse connection plate detail T1-L1 G1 ($1\frac{1}{2}$ -in gap) which had no detectable crack growth in web gap.

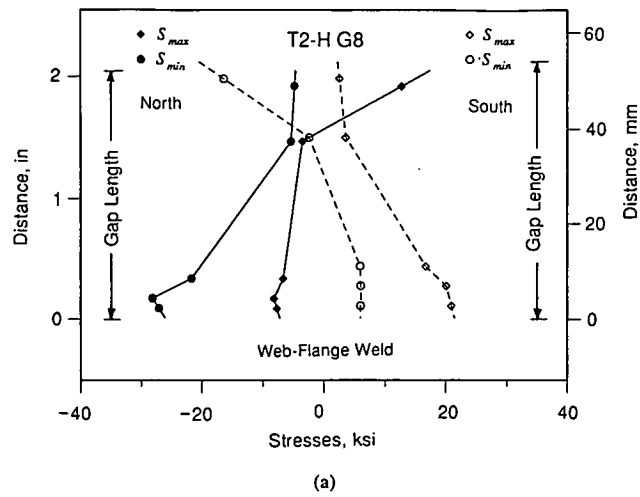
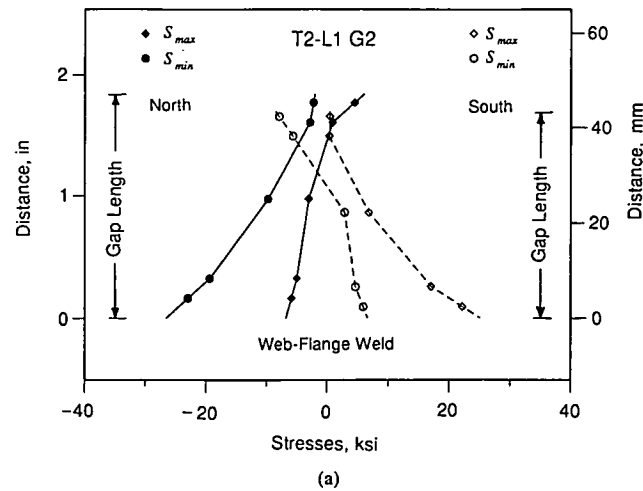
Figure 51. Stress gradients at transverse connection plate detail T2-H G8 (3-in. gap) before and after cracking at end of connection plate: (a) prior to cracking; (b) after 0.52×10^6 cycles and visible cracking.

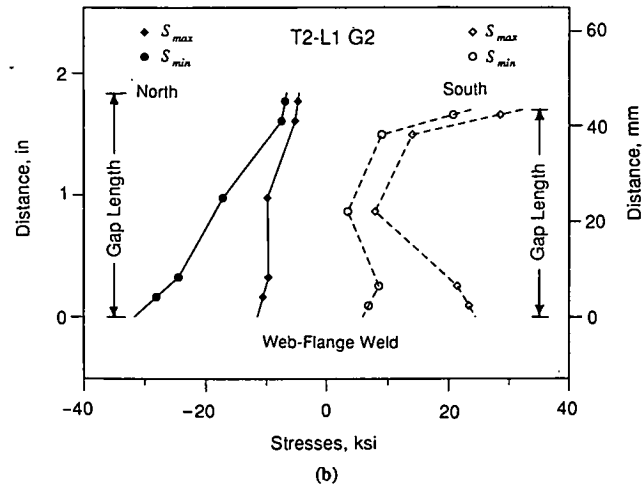
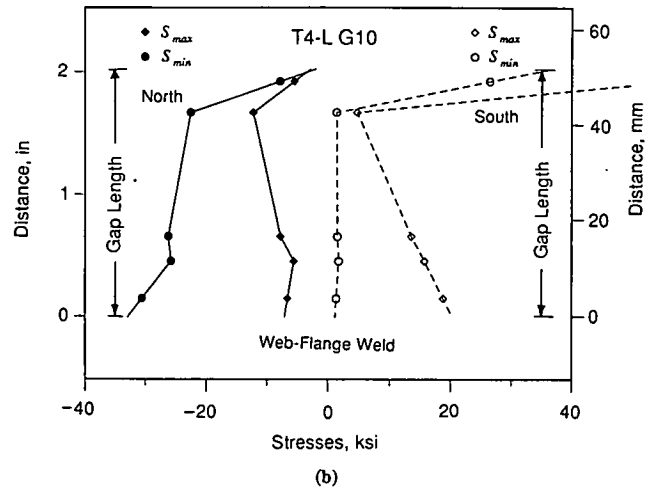
Figure 53. Stress gradients at transverse connection plate detail T4-L G10 (3-in. gap) before and after cracking at end of connection plate: (a) at start of test; (b) after 3.3×10^6 cycles and visible cracking.

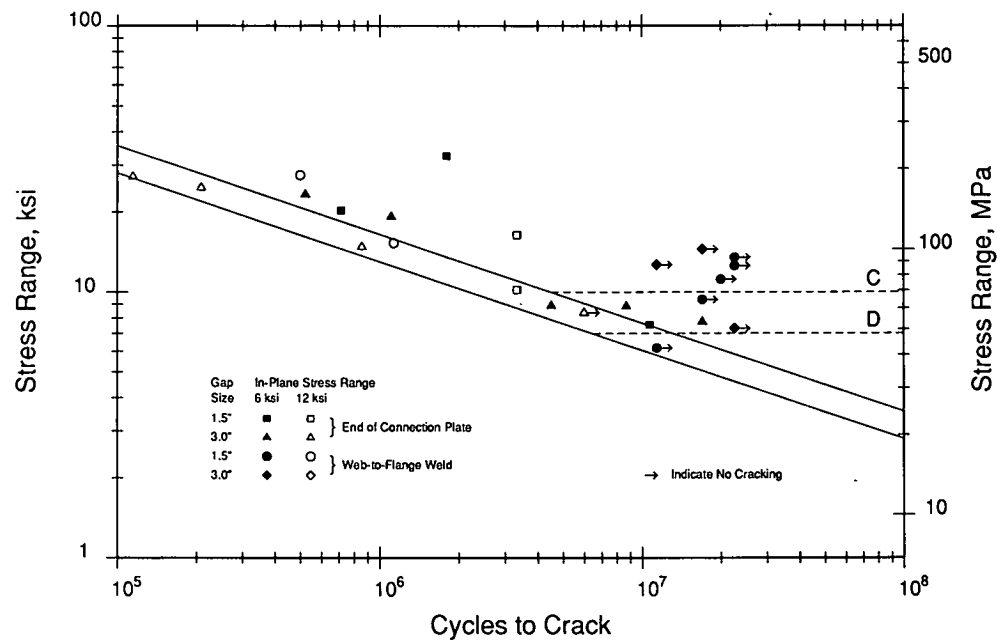
the fatigue resistance provided by Categories C and D of the AASHTO specifications in Figures 54 and 55. Crack detection provided a lower bound fatigue life corresponding to the Category D fatigue resistance curve as shown in Figure 54. This is consistent with other fatigue test data where fatigue cracks are generally observed at about 75 percent of their fatigue resistance. When the results were compared for cycles at the time of first retrofit, the fatigue strength generally exceeded Category C.

Figure 54. Cycles at which cracks were first detected at transverse connection plate details.

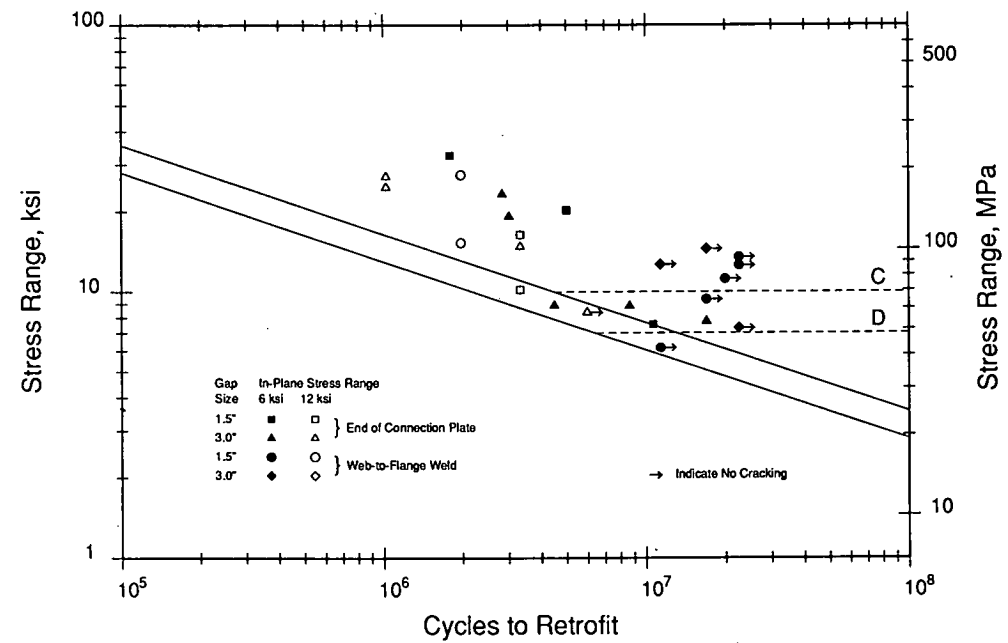
The results plotted in Figure 55 show the fatigue life at the first retrofit (usually by drilling holes), at which time the crack was through the web thickness and several inches long. At this stage of crack extension the fatigue life was comparable to other details used to define the AASHTO fatigue resistance curves. The four details that developed cracks below Category C fatigue limit were not retrofitted even though small cracks were detected. These details were subjected to an additional 10 to 17 million cycles of stress range. The cracks extended between 1 and 2 in. (25 to 50 mm) during these additional cycles. Hence,

Figure 55. Comparison of cycle life at time details were retrofitted at transverse connection plate details.
