Repair and Rehabilitation of Bridge Components Containing Epoxy-Coated Reinforcement

**National Cooperative Highway Research Program
Transportation Research Board
National Research Council**

**Ali Akbar Sohangpurwala
CONCORR, Inc.
Sterling, Virginia**

August 2002

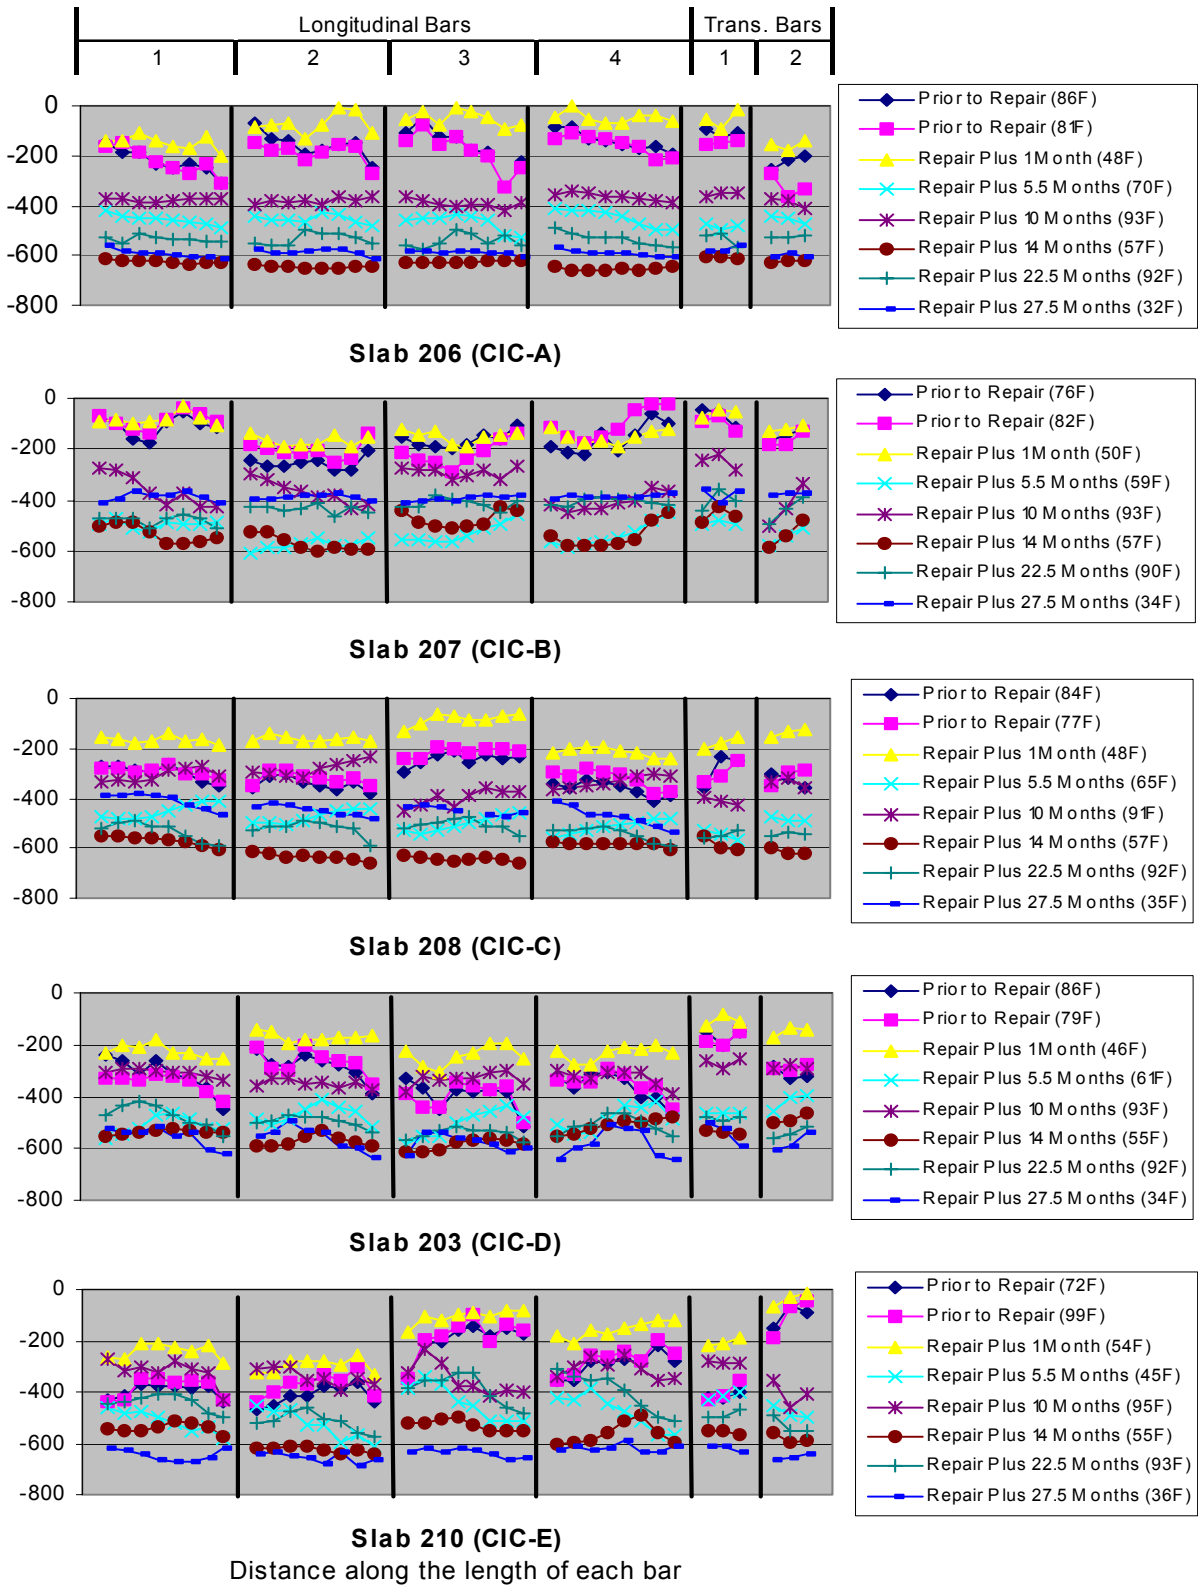
Figure C-18: Plots of Half-cell potential vs. time

Figures C-18 present plots of half-cell potential measurements along individual top ECR's in each slab versus exposure time. These plots show that one month after repairs the potentials of all top ECR's shifted in the positive direction (i.e. became more passive). An exception to this was observed on slab 207 (EI) where potentials before and immediately after repairs were installed were similar. About 5.5 months after repairs were installed, potential readings on all slabs became more active than the pre-repair measurements and generally remained so for the duration of the exposure period. Uncracked ECR's exhibited the same general trends as cracked and repaired ECR's.

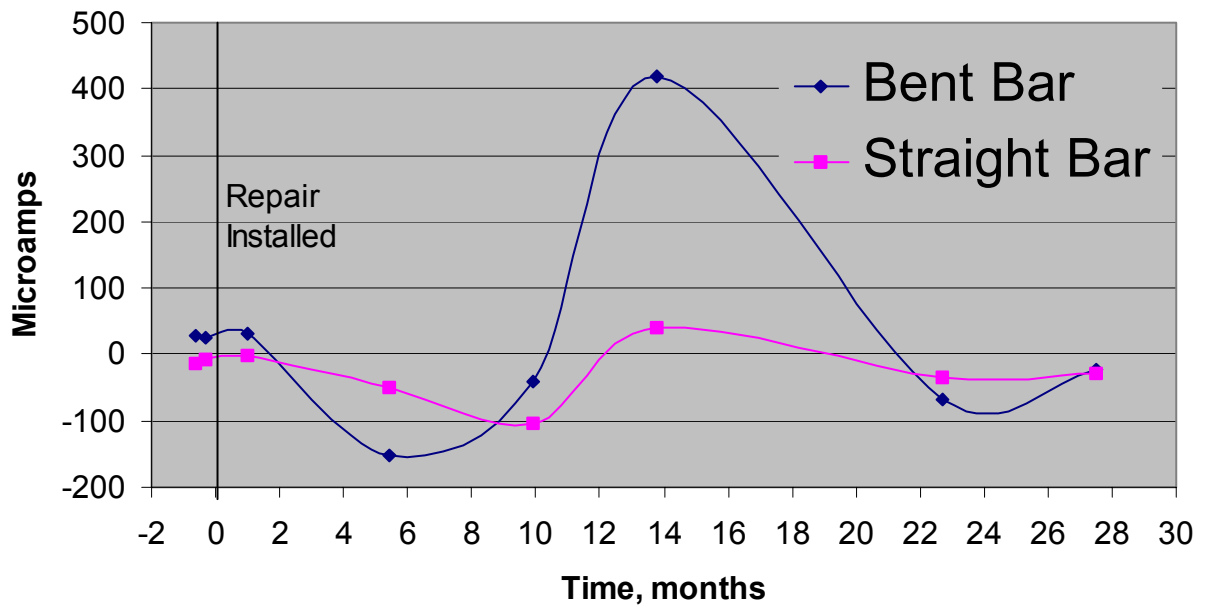
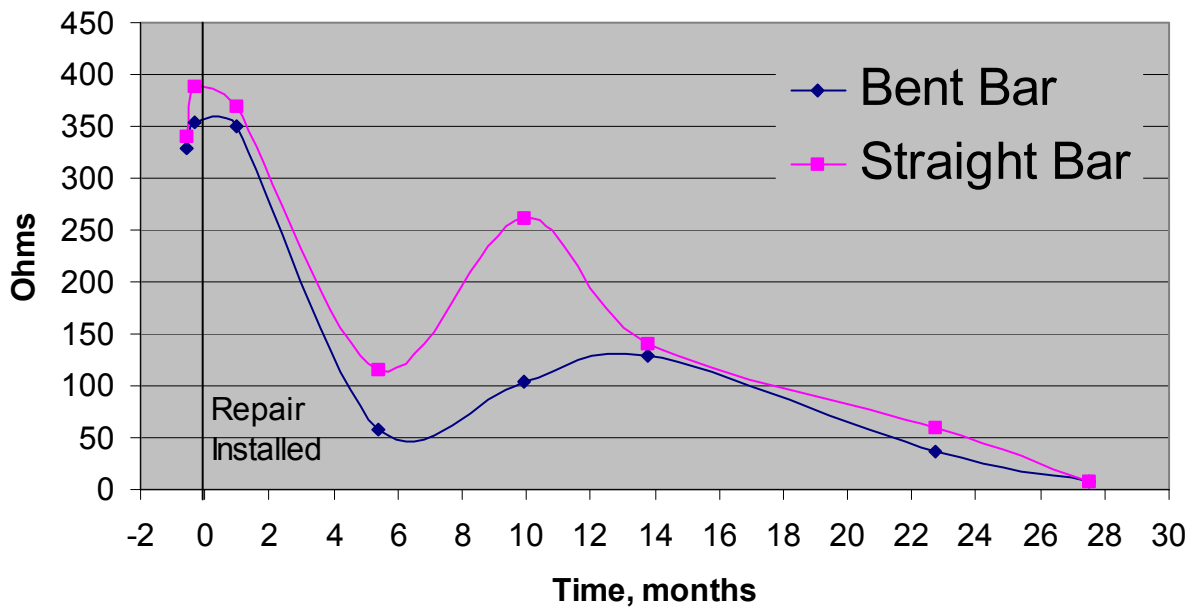
Figure C-19: Plots of macrocell current and AC resistance vs. time for slab N19-SE2

Macrocell current data show that the bent ECR was cathodic to the bottom steel before and immediately after the repair was installed while the straight ECR's were slightly anodic to the bottom steel during the same time period. Subsequently, with the exception of one data point, the bent and straight ECR's were anodic to the bottom steel for the remainder of the exposure {

period. Although the magnitude of the anodic current for the straight ECR's was comparatively less than that for the bent ECR, the currents were low in both cases. Resistance data for the bent and straight ECR's decreased with time throughout the exposure period. Potentials before and immediately after repairs were installed were similar for the bent and straight ECR's. After about 5.5 months of exposure following repair, all potential readings became more active and remained so for the duration of the exposure period.

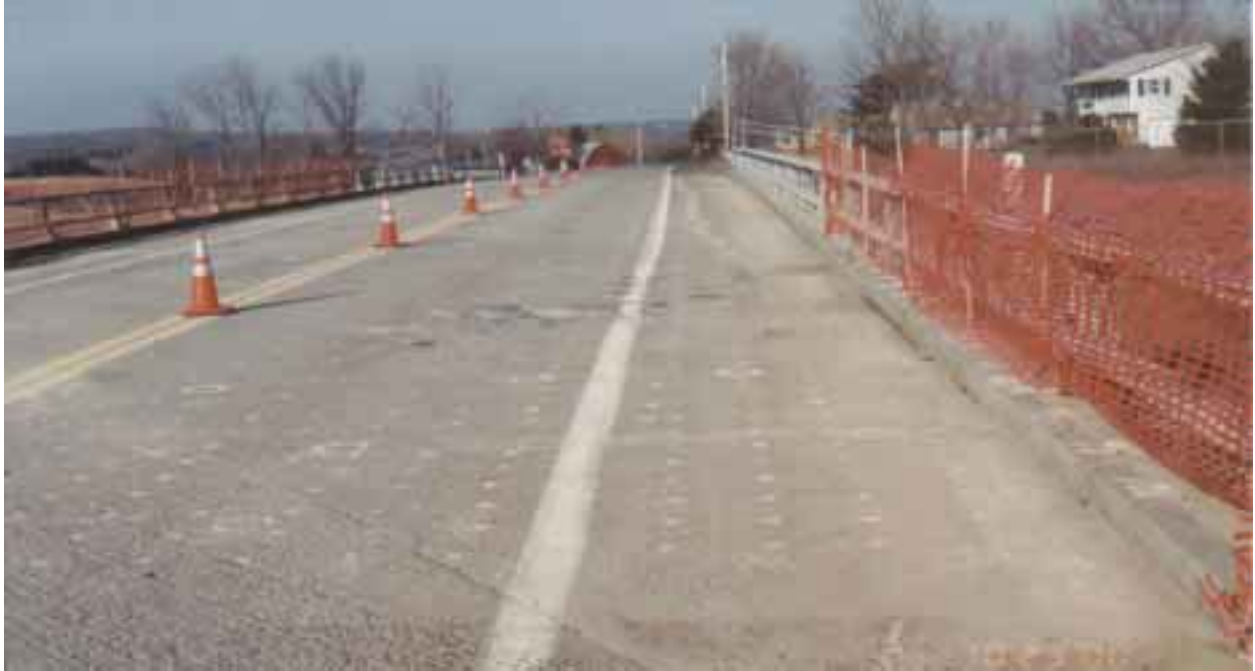
Figure C-21: Overview of bridge during the final evaluation.

Exposure (see Figures C-21 and 22). During the 12 month evaluation, a 406 mm (16 inch) long rust stain was observed approximately 152 mm (6 in.) to the side of crack C1. After 34.5 months of exposure, this area became delaminated and the delamination extended over crack C1. The delamination measured 203 mm by 305 mm (8 in. by 12 in). Other observations, outside the ten subject cracks, are described below.

During the first post-repair survey (12 months after repairs were installed), one of the cracks not included in the study had grown in length by about 305 mm (1 ft.), a large rust stain developed a less than a meter to the side of crack C9, and a new shallow spall was found. No new changes were recorded during the 25 month evaluation. After 34.5 months, a large diagonal crack and a new delaminated area with several small, shallow spalls were observed. In addition, a new delamination developed along a crack that had another delamination (in a different area) since the start of the study.

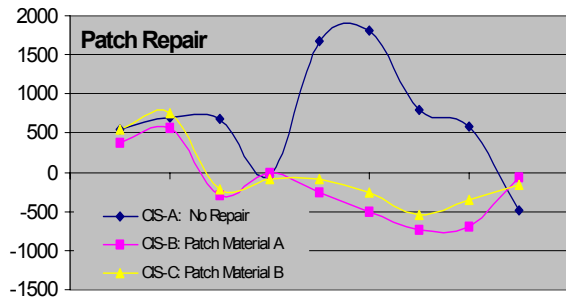
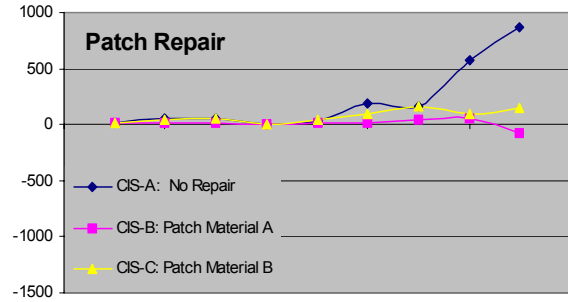
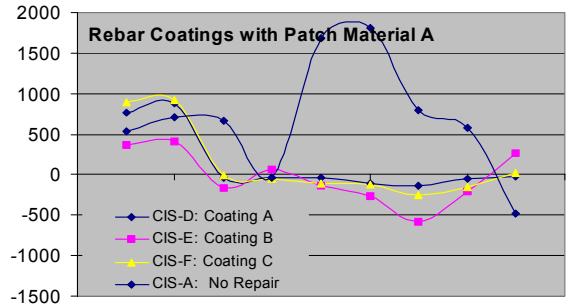
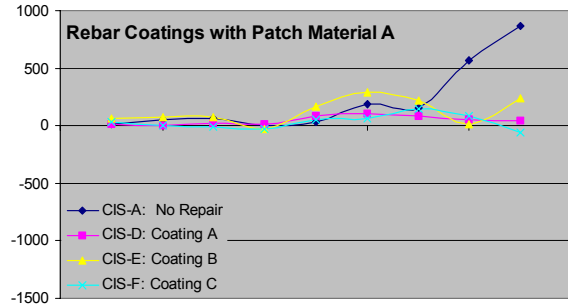
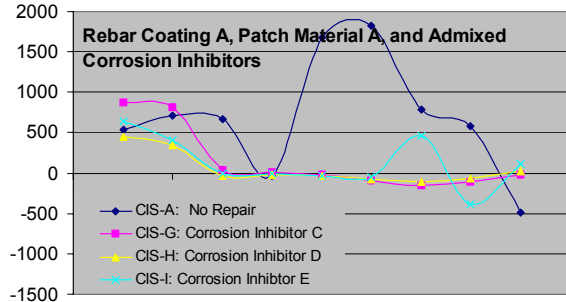
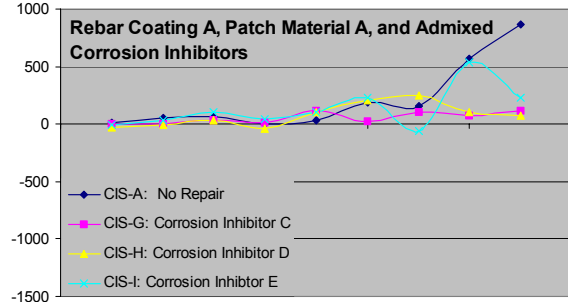
Figure D-6: Average macrocell current (μA) versus time.

and a small reduction in the adjacent ECR-to-bottom black steel current was also noted. No further reduction in macrocell current is apparent from the use of admixed and surface applied corrosion inhibitors. The lack of improvement from the use of corrosion inhibitors can be attributed to either a) the inhibitors are not effective or b) there was no room for further improvement. No improvement was also realized from the use of surface applied corrosion inhibitor when used in conjunction with Coating B. Thus, based on macrocell currents, it may be concluded that the use of corrosion inhibitors do not provide any beneficial effects when used in conjunction with rebar coatings.

Table D-5 lists results of a visual survey performed on the PCS macrobeams in November, 2000. Thus, the control specimen (PCS macrobeam number 1, no repair) showed the most damage; and Figure D-6 indicates that macrocell current for this specimen was greater than for the other macrobeams. With this exception, however, no correlation was apparent between visual condition and macrocell current. To illustrate this, Table D-6 lists the sum of absolute values for the average PCS-B and AJD-(PCS+B) macrocell currents from the last three data acquisitions for each beam compared to a condition rating. This correlation was attempted using the absolute value of current since it was reasoned that any electrochemical activity should have a negative impact in that a cathodic current upon one element indicates an anodic current elsewhere. The ranking was normalized such that Specimen PCS-1 (no repair) was a 1 and uncracked beams a 10. Figure D-10 presents a graphical representation of the Table D-6 results and indicates that

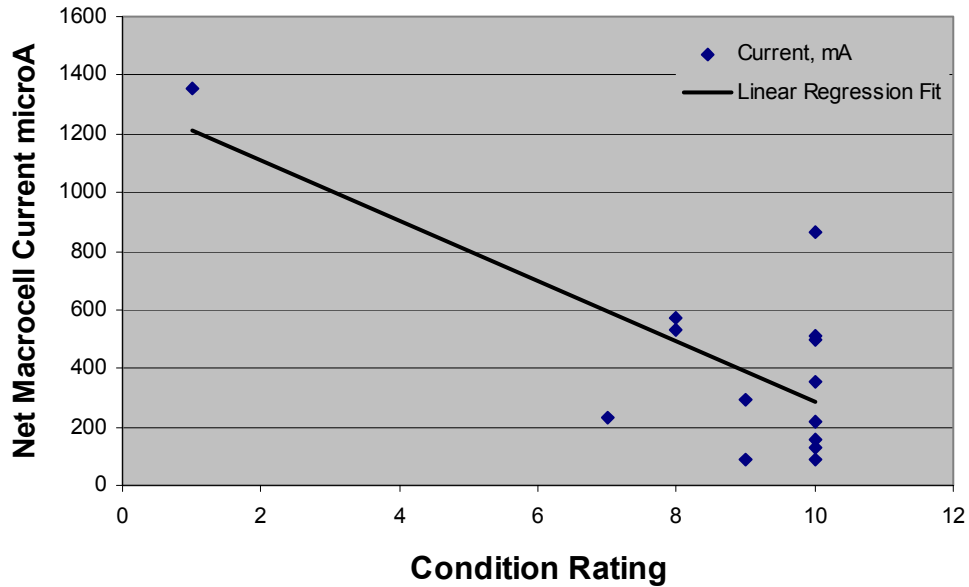
Figure D-10: Plot of net macrocell current versus condition rating.

the data scatter exceeds any tendency for these parameters (macrocell current and condition) to correlate. Other attempts resulted in no improvement in the correlation. As noted earlier, macrocell current generally varied inversely with resistance. This same trend was apparent also for the G-109 macrobeam data, as discussed elsewhere; and the same rationale for explaining this can be applied to both situations (G-109 and PCS macrobeams). Thus, a relatively low resistance is ascribed to either a high chloride uptake of the concrete or to development of coating defects upon the ECR (or both), whereas high macrocell currents presumably resulted from either these same causes or from the potential difference between the respective elements becoming relatively large. The observation that the average PCS-bottom black steel macrocell current for the individual specimens tended to be cathodic for a number of specimens at the time of the latter data acquisitions tends to support this. Further, the macrocell current data for the adjacent mat elements were normally positive, indicating that these ECRs were probably anodic to both the PCS ones and the bottom black steel. This indicates that, in many cases, it is corrosion activity stemming from the adjacent mats that should be of greatest concern. Of course, the adjacent mats were not repaired; but in some cases they were flooded with a corrosion inhibitor. However, the magnitude of current from adjacent mat elements of macrobeams in this latter category (flooded with a corrosion inhibitor) were about the same as for the non-flooded ones, as can be seen from Figure D-6 by comparing the current for treatments CIS-A through CIS-I (no inhibitor flooding) with that for CIS-J through CIS-N (inhibitor flooded).

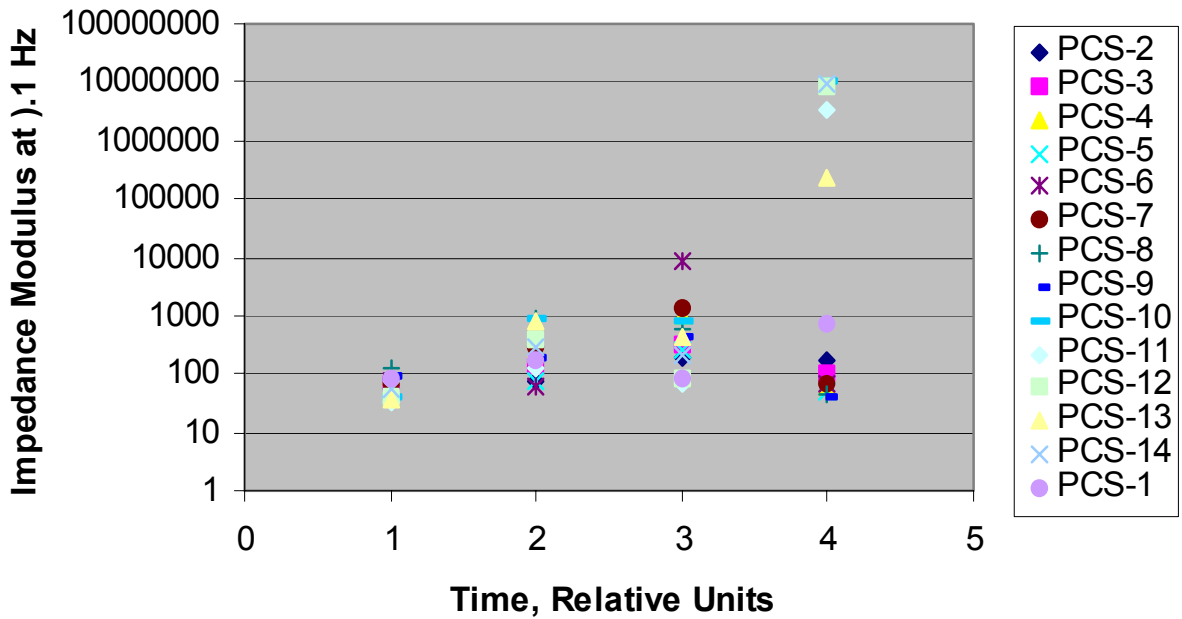
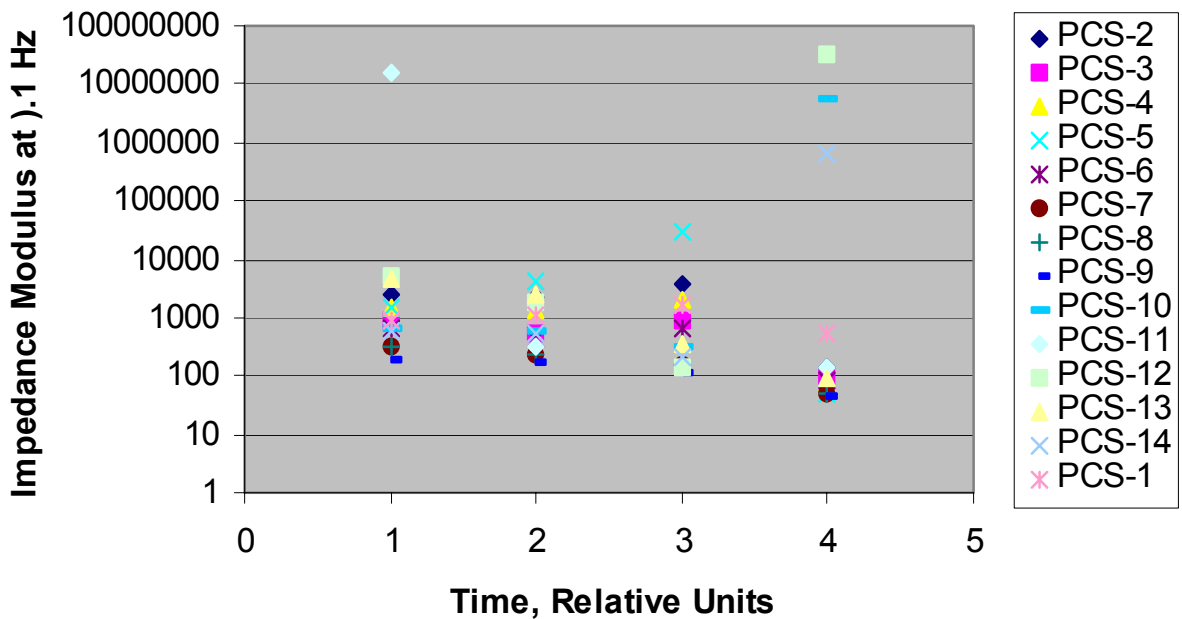
Figure D-11: Impedance modulus as a function of time for the PCS units.

Figures D-11 and D-12 present impedance modulus data at different times for the PCS and adjacent mat elements, respectively. The general trend here is one where elements of the no repair macrobeam exhibited the lowest impedance. For the repaired beams, impedance

increased, typically by an order of magnitude or more, once the repair was made. Subsequently, impedance increased with time and either remained constant or decreased at the time of the last data acquisition. This presumably reflects changes in the number and size of bare areas, as affected by the repairs, or changes in the coating capillary pore structure and resistivity. The fact that the final impedances for the repaired specimens were typically an order of magnitude or more greater than prior to repair indicates that the coating effectiveness was improved and that at least some of this improvement was retained at the time of the final data acquisition. The very high impedance exhibited by several specimens at certain times probably was a consequence of a low resistance connection not being made.

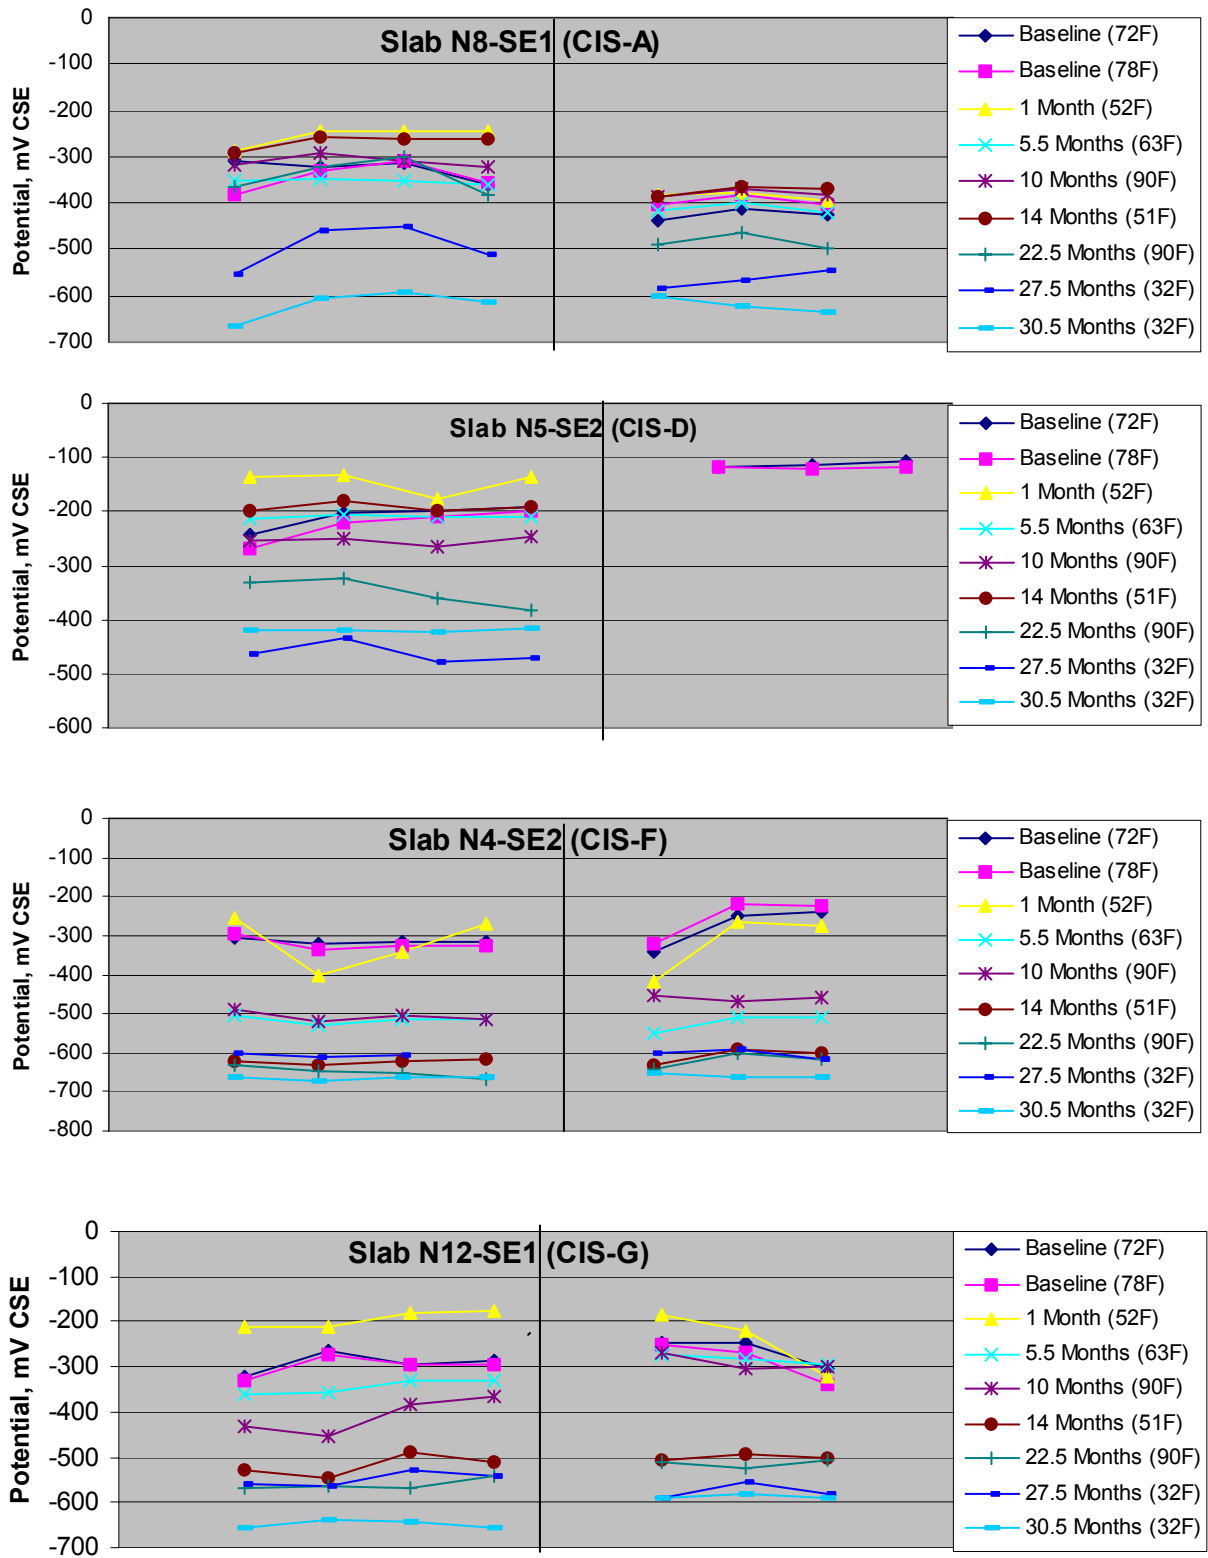
Figure D-15: Half-cell Potentials for all Slabs vs. Time.

About one month after repair, the macrocell current for slabs N4-SE2 (CIS-F) and N12-SE1 (CIS-G) generally increased (such that the ECR's were anodic to the uncoated bottom steel) with exposure time. Over the same period, the AC resistance between ECR's and uncoated steel in these slabs continually decreased. One month after repairs were installed, potentials measurements on slab N4-SE2 were generally similar to the pre-repair measurements, whereas on slab N12-SE1 potentials were more passive immediately after repair. Subsequently, for slab N4-SE2, potentials became more active and remained so for the duration of the exposure period and for slab N12-SE1, potentials became increasingly active through 30.5 months of exposure.

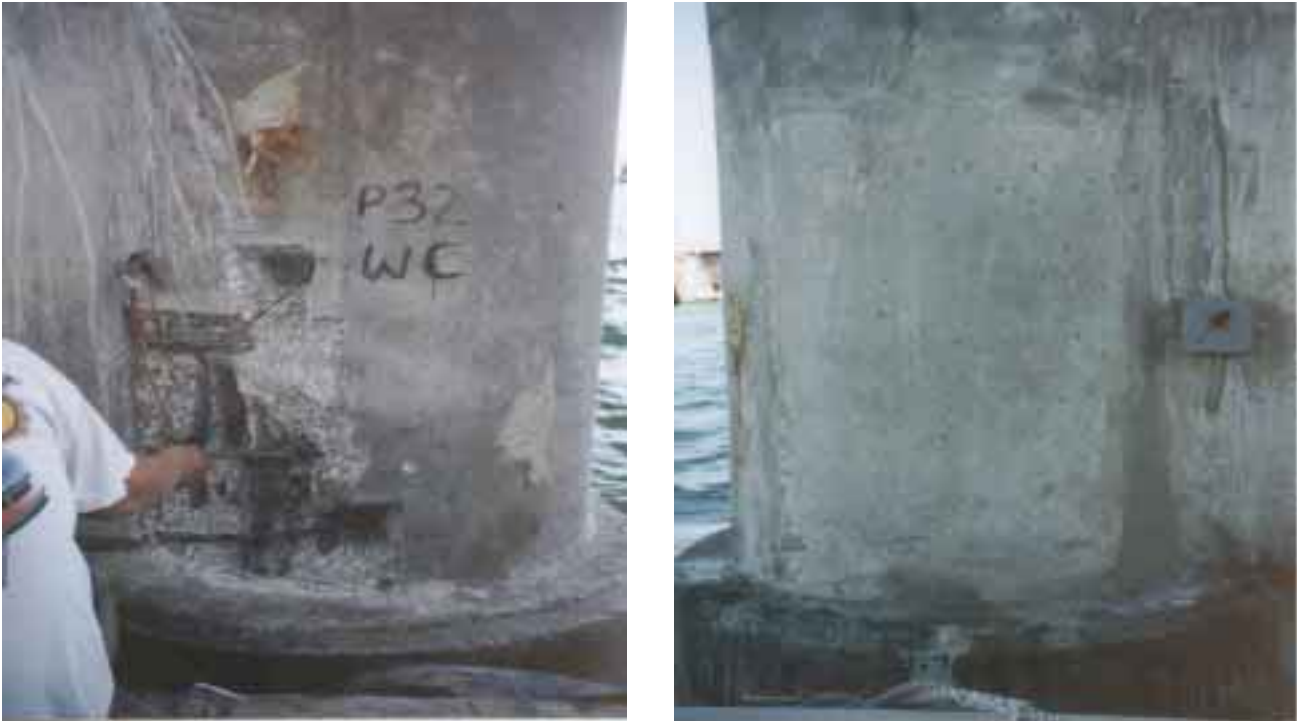
Figure D-17: Photographs showing installation of the probes and junction box for data collection.

Significant congestion of vertical reinforcement was encountered during construction. Consequently, the specified undercutting requirement was eliminated for vertical bars with a concrete cover exceeding 64 mm (2.5 in.) unless more than 25% of the circumference of the bar was exposed.

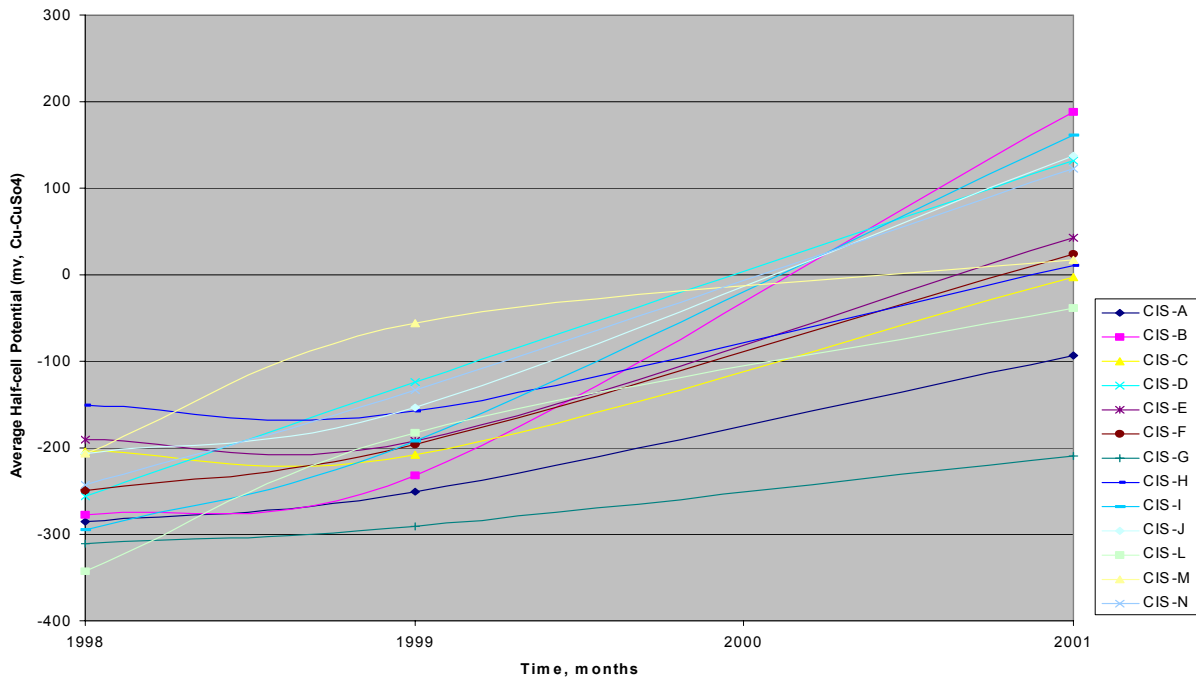
Figure D-18: Average Half-cell Potentials of Repair Options vs. Time.

Corrosion potential measurements obtained from Ag-AgCl reference cells (embedded in patched areas) are presented in Figure D-18. In each case, the average potential is shown for each repair strategy. The average potential for all repair options become more passive with time.

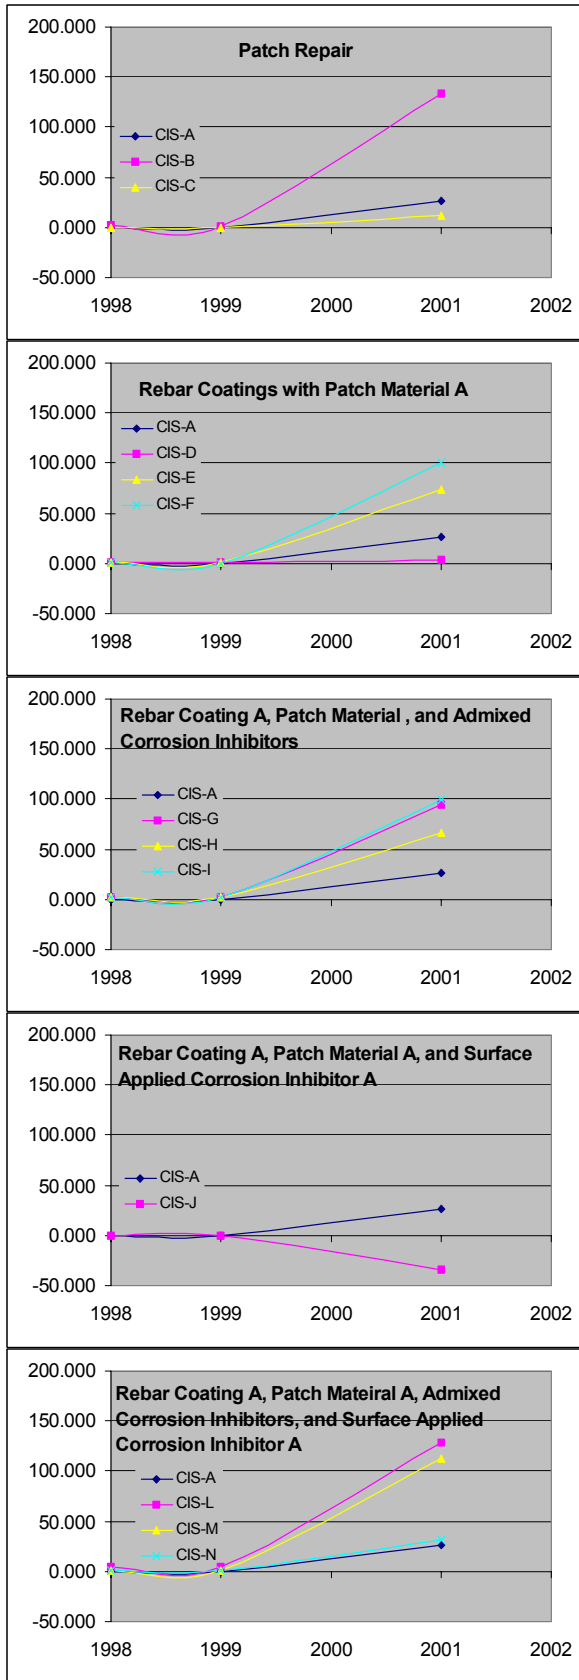
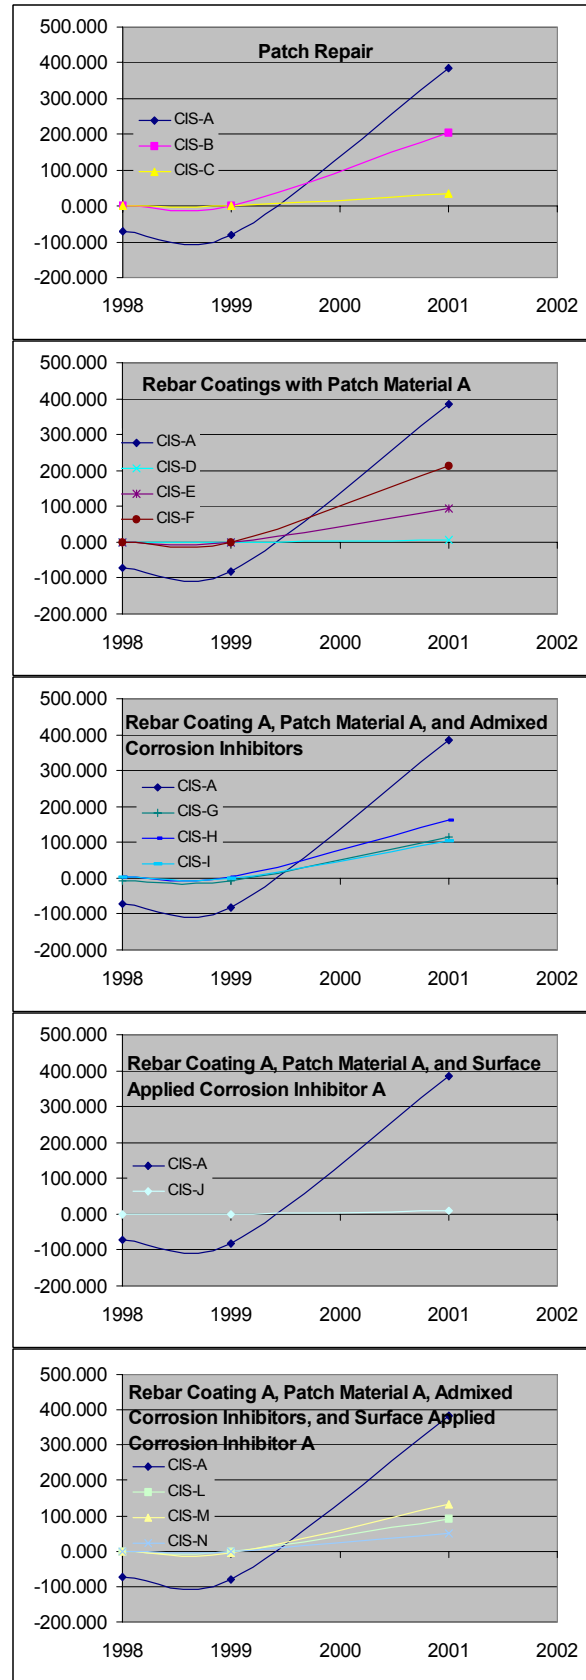
Figure D-19: Probe Current (μA) vs Time.

Figure D-19 shows the average rebar probe current density for probes installed in patched and unpatched areas for the various classes of repair options. Repair options CIS-C (Patch Material B) and CIS-D (Coating A and Patch Material C) exhibited probe currents closest to an ideal for

probes located inside repaired areas. Whereas, CIS-C, CIS-D, and CIS-J (Coating A, Patch Material C, and Corrosion Inhibitor A) exhibited very low average current for probes located outside the repair area. It should be noted that repair options CIS-G to CIS-N included the use of Coating A and Patch Material C in conjunction with admixed and/or surface applied corrosion inhibitor and these exhibited average probe currents much larger than that exhibited by CIS-D. This suggests that the use of corrosion inhibitors reduced the efficacy of Coating A when used in conjunction with Patch Material C.

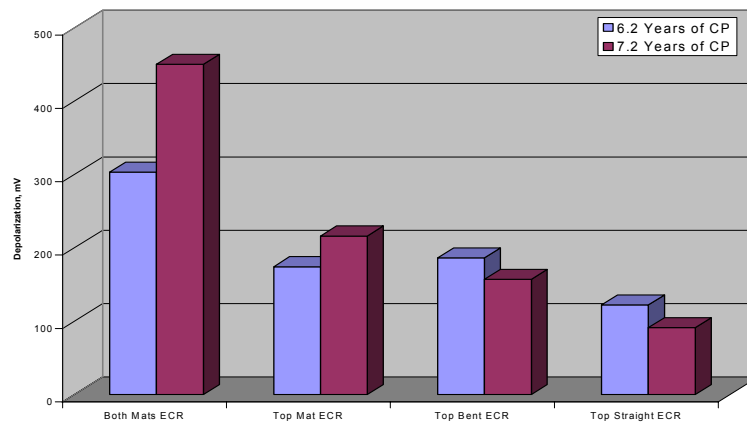
Figure E-6: Average 4-hour Depolarization Values after 6.2 and 7.2 years of CP.

Average 4-hour depolarization values (see Figure E-6) after a total of 6.2 and 7.2 years of cp exceeded 100 mV for slabs 1, 2, and 3. Four hour depolarization values for slab 4 exceeded 100 mV after 6.2 years of cp, but averaged less than 100 mV after 7.2 years of cp. However, the average 24-hour depolarization value for this slab after 7.2 years of cp was 237 mV.

Based on conventional criteria for effective cp of bare reinforcing steel, all top ECR's were adequately cathodically protected for a total of 7.2 years. At the conclusion of the study, visual and delamination surveys did not reveal any new corrosion induced concrete damage on the cp slabs. The reinforcing steel mats in the control slabs were inadvertently uncoupled for the last 17 months of exposure. In spite of this, these slabs exhibited progressive cracking, rust staining, and delaminations with slab 6 (ECR in the top mat only) showing comparatively more damage than slab 5 (ECR in both mats). Slab 6 had delaminations associated with both mats of rebar.
