A FIELD INVESTIGATION OF CONCRETE PAVEMENT IN TEXAS

W. B. Ledbetter and Alvin H. Meyer, Texas Transportation Institute; and
Harvey J. Treybig, Austin Research Engineers, Inc.

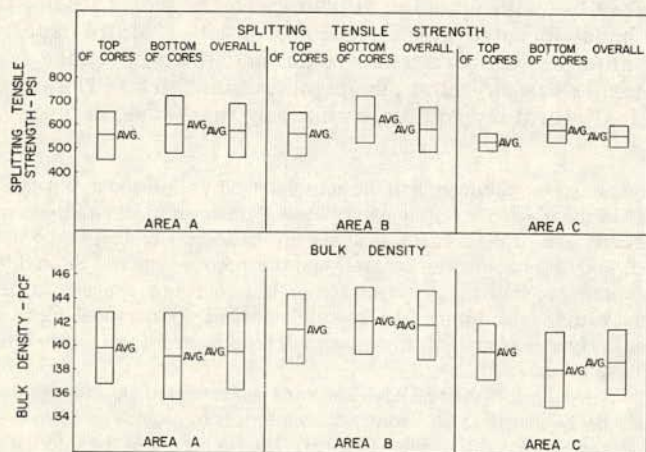
Figure 3. Comparison of splitting tensile strength and bulk density values of cores from 3 areas.

The average and standard deviations for splitting tensile strength and bulk density were compared for each area and are shown in Figure 3. The comparisons are in terms of top of core, bottom of core, and overall values. Figure 3 shows some interesting findings. First, considered as a group in each area, the concretes are of excellent quality as indicated by the high densities and high splitting tensile strengths. Second, the concretes sampled are uniformly consolidated as indicated by the very low standard deviations in density values. Third, although at first glance the standard deviations for splitting tensile strengths appear to be rather high (122 psi in one instance), this can be

easily explained by the few cores exhibiting low strength or honeycombing. The remainder of the strengths are uniformly high. Fourth, improper consolidation was found in only 6 of the 24 sites investigated. Thus, although improper consolidation was found in these 3 areas, it does not appear to be too widespread a cause for localized pavement distress, with the exception of distressed areas at construction joints on some of the older projects.

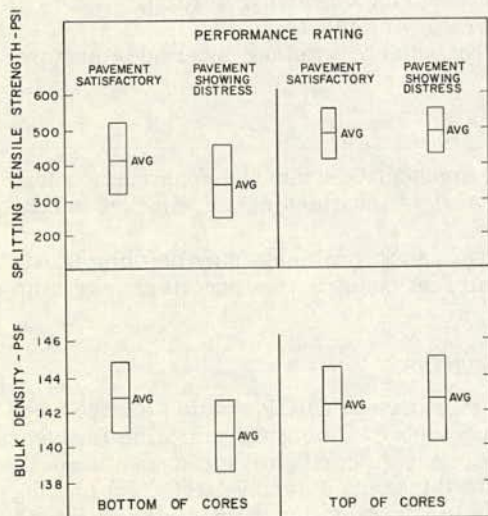
Figure 6. Comparison of tensile strength and bulk densities for top and bottom of concrete cores from good and poor performing pavement sections in area D.

A total of 40 cores were obtained, two at each location. One core was selected from a section of the pavement showing distress and another from an adjacent section that appeared to be performing satisfactorily. These data were analyzed statistically, and the results are shown in Figure 6. In the distressed sections, the average density of the bottom halves of the cores was 140.8 pcf, while the average density of the top halves of the cores was 142.6 pcf. Even though the density values were scattered, there is a difference in densities, indicating that the bottoms may have been poorly consolidated. This conclusion is verified by the splitting tensile strengths, also shown in Figure 6. Here the strengths of the bottom halves of the cores were significantly lower than the corresponding strengths of the top halves. One other point should be made. When the splitting tensile strengths of all the bottom halves of the cores in area D were compared, the average value was 382 psi, with a standard deviation of 100 psi and a coefficient of variation (C_V) of 26 percent. The average strengths of the bottom halves

of the cores in the other 3 areas were 605, 619, and 576 psi. These are significantly higher than the strengths reported for area D. It is dangerous to draw any firm conclusions from these data because of the variations in mix design and aggregate types, but it does appear that area D contained some weak concrete, which may have contributed to the many failures that occurred. This is more fully discussed in another report (12).
