TRANSPORTATION RESEARCH RECORD
482

Landslide Instrumentation

**5 reports prepared for the 53rd Annual Meeting
of the Highway Research Board**

Washington, D. C., 1974

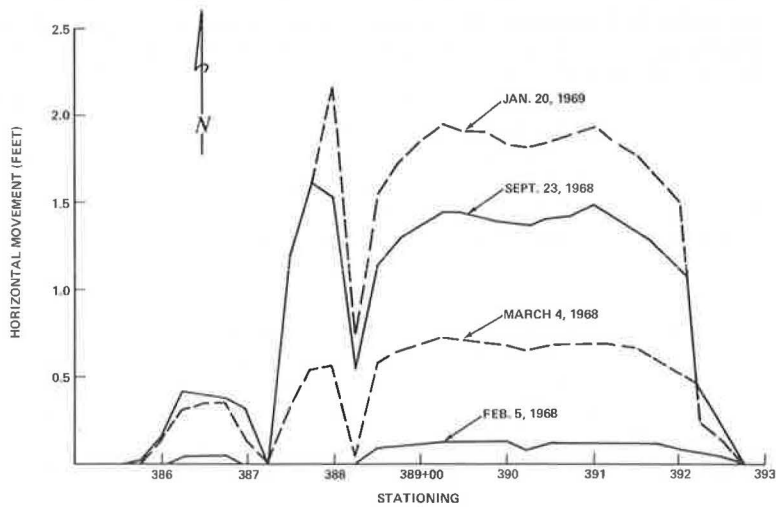
Figure 6. Highway horizontal movement.

Measurements of horizontal and vertical displacement along the existing highway and railroad were also made and correlated with the field instrumentation data. During a 1-year period (1968-69), a horizontal displacement of approximately 2 ft (0.6 m) along the highway and 1.5 ft (0.5 m) along the railroad occurred. Vertical displacement along the highway and railroad for the same period of time varied from 0.68 to 1.56 ft (0.21 to 0.48 m) respectively. Figure 6 shows the horizontal movement that occurred on a section of the Interstate from February 5, 1968, to January 20, 1969. As would be expected, the areas showing the greater horizontal movement were the areas where the slip plane inclination was greater. It was generally established that slip plane inclinations greater than 12 deg from the horizontal showed a definite higher movement rate. These are the areas where the railroad grade and alignment must be corrected on a day-to-day basis during the rainy season when the rate of movement is high.

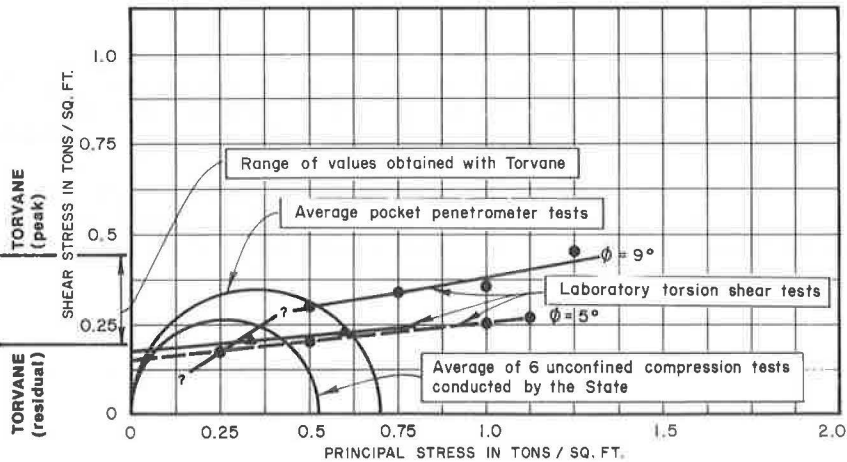
Figure 6. Summary of strength tests on failure zone materials.

The results of the laboratory torsion shear tests are summarized in Figure 6. The results of numerous pocket penetrometer tests and Torvane tests conducted in the various test pits are also shown in Figure 6, as well as the average of results of six unconfined compression tests.

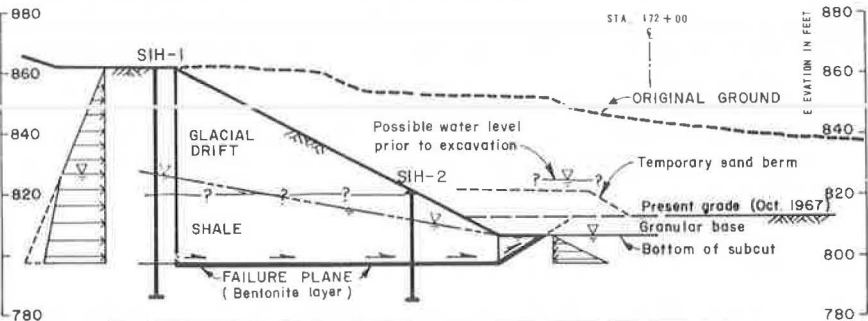
Figure 7. Stability analysis.

STATION	FACTORS OF SAFETY		
	AFTER ROADWAY EXCAVATION PEAK STRENGTHS AT REST PRESSURES	AUG. 1967 RESIDUAL STRENGTHS ACTIVE PRESSURES	WITH PROPOSED SLIT-TRENCH BUTTRESSES AND CANTILEVER RET. WALL
166 + 70	0.84	0.91	> 1.50
170 + 00 EXCAVATION TO SUBCUT LEVEL	0.85	0.87	—
170 + 00 WITH SUBCUT BACKFILLED	0.84	0.99	1.49
170 + 00 WITH TEMPORARY SAND BERM	—	> 1.15	—
172 + 60	1.05	1.00	> 1.50

failure surface was reduced as movement progressed. Therefore, a peak strength value of $c = 0.4 \text{ tsf}$ (0.4 kg/cm^2) was assigned to the clay for the condition immediately prior to the start of movement, but once movement remolded the clay, the strength dropped to the residual value of $c = 0.2 \text{ tsf}$ (0.2 kg/cm^2).

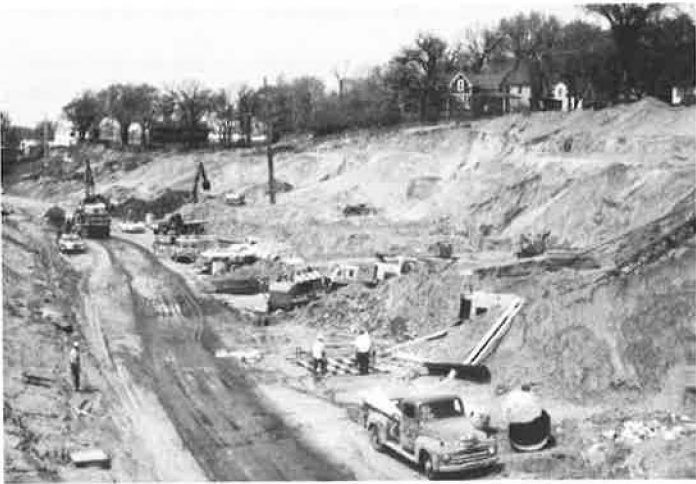
Figure 9. During construction, May 4, 1968.

It was anticipated that at least three buttress trenches could be under construction at any one time, without significantly reducing the stability of the area, so long as there was at least 50 ft between adjacent excavations. Figure 9 is a view of construction in progress, showing the many activities going on at any one time. After a few initial problems, construction proceeded in an orderly, systematic fashion.

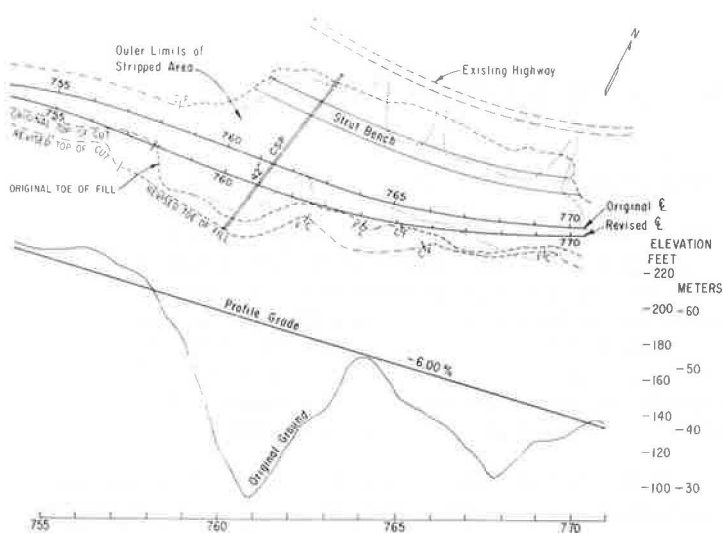
Figure 1.

The embankment in question was part of a highway project being built on US-101 on the north coast of California near the community of Orick. At this location, the alignment traverses a deep ravine (Fig. 1) requiring an embankment about 110 ft (33 m) high. The bottom of the ravine is composed of 15 to 30 ft (4.5 to 9 m) of weak organic silts and clays underlain by dense sand and decomposed shales and schists. The design called for the organic silts and clays to be removed, a 3-ft (1-m) blanket of permeable material and 8-in. (20-cm) diameter underdrains to be placed at the bottom of the stripped area to remove groundwater, and then construction of the embankment with material from excavation. The weak organic material was used to construct a 30-ft (9-m) high by 50-ft (15-m) wide strut on the downhill side of the embankment to provide additional stability.

Several methods of correcting the problem were considered. Removing the embankment and reconstructing it were rejected for reasons of cost and construction delay. Widening and raising the elevation of the existing strut would have provided stability. This alternative, however, would have required removing a portion of the existing strut and extending the stabilization trench toward the left to support the strut. Stability calculations indicated that the safety factor would be lowered to an unsafe level during the stripping operations, and therefore this alternative was rejected. Lowering the profile grade through the embankment area was not seriously considered because the roadway was already on the maximum 6 percent grade (Fig. 1).

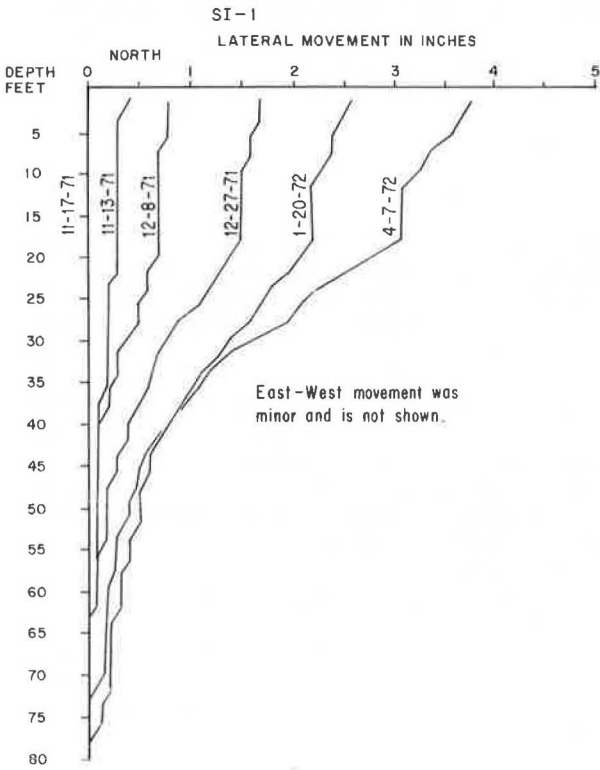
Figure 3.

Slope Indicator SI-2 (Fig. 4) and survey lines on top of the embankment showed that a maximum of $\frac{1}{2}$ in. (12 mm) of irregular lateral movement had occurred on the uphill (right) side of the embankment. Slope Indicators SI-1 and SI-3 (Figs. 3 and 5) revealed that movement was occurring in the weaker soil of Zone B on the downhill (left) side of the embankment. Survey lines on the strut indicated that the movement was primarily occurring between Stations 760 and 761. Vertical settlement of the embankment was a maximum of 0.20 ft (6 mm). No lateral movement was detected by the survey line between the toe of the strut and the existing highway.
