# EXPERIENCE WITH CONTINUOUSLY REINFORCED CONCRETE PAVEMENTS IN VIRGINIA

K. H. McGhee, Virginia Highway Research Council

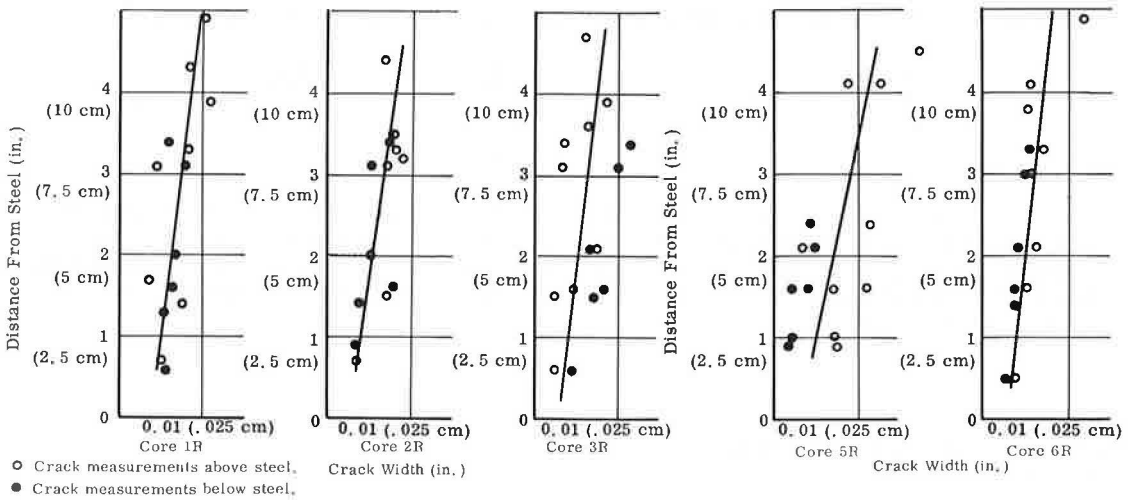
The results of crack measurements for 5 of the cores are shown in Figure 6. For the measured cracks, the width tends to decrease by approximately a factor of 2 as the distance from the surface of the steel changes from  $4\frac{1}{2}$  to  $\frac{3}{4}$  in. (11.4 to 1.9 cm). Although, as the scatter of points in Figure 6 shows, the correlation between crack width and distance from the steel is not high, definite trends can be seen in both the figure and in the visual examination of the cores. Projecting the crack measurements shown in Figure 6 to the surface of the steel suggests that at the steel a crack of approximately 0.003 in. (0.008 cm) still would exist. Visual examination (Fig. 5) showed that this was not the case and that no definite crack exists directly at the steel. Such a result has been reported in another paper (6) in which it was noted that in some cases cracks tend to diverge in the neighborhood of the steel and that it has been possible to find a zone around the steel where the concrete is not really cracked but is distended in a discontinuous manner. Such appears to have been the case with the cores in question. Figures 4 and 5 show that the cracks extend through the entire depth of the pavement but are discontinuous in the vicinity of the steel. Measurements indicated that whether cracks are located above or below the steel has little influence on the crack width and that the proximity of steel to the point of measurement is the determining factor.

Figure 6. Crack width versus distance from steel for 5 cores.
