NEW YORK'S EXPERIENCE WITH PLASTIC-COATED DOWELS

James E. Bryden and Richard G. Phillips,
Engineering Research and Development Bureau,
New York State Department of Transportation

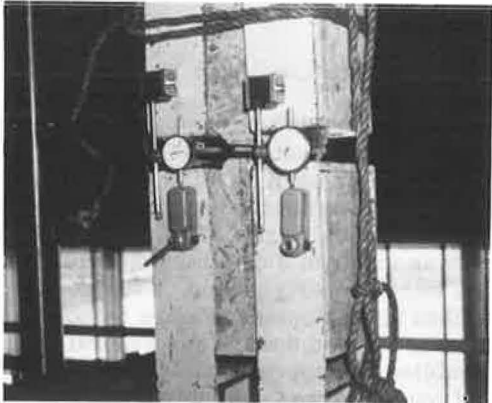
Figure 7. Pavement sample pullout test.

At the conclusion of paving at Point Breeze, joint samples were removed from the end of each of the 3 sections containing dowels for testing in the laboratory. The pavement was sawed full-depth with a diamond-blade concrete saw to form a block 2 ft (0.6 m) square along the edge of the pavement. These blocks, containing 2 dowels each, were bolted rigidly across the joint to prevent any movement during removal and shipping. In the laboratory, each sample was cut in half (each half containing 1 dowel) and prepared so the sample could be fitted into jigs for the pullout test (Figure 7).
