CONCRETE PAVEMENT JOINTING AND SEALING METHODS

Raymond J. Brunner, Walter P. Kilaeski, and Dale B. Mellott,
Bureau of Materials, Testing and Research,
Pennsylvania Department of Transportation

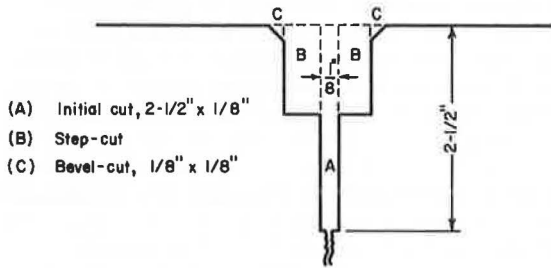
In addition to the normal $\frac{3}{8}$ -in. (9.5-mm) joint width, three sizes of step-cut joints were used (Figure 1). A fifth size of joint was used for neoprene only. The joint sizes were as follows:

Figure 1. Step-cut joints.

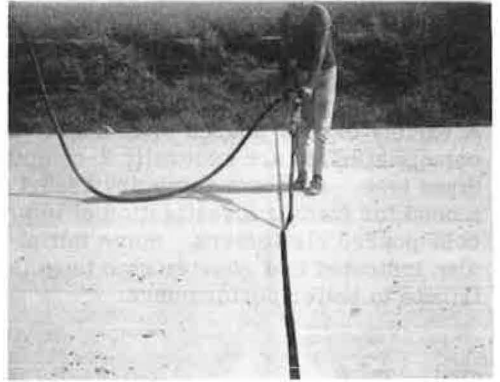
Figure 2. Sealing joint with rubberized asphalt.

Three different types of equipment were used to place the materials in the joints. The control material (hot) and the improved material (hot) were heated in a conventional truck-mounted kettle. This kettle was equipped with a motor-driven pump that forced the material through a hose and hand-held nozzle into the joint (Figure 2).
