PERFORMANCE EVALUATION OF UTAH'S CONCRETE PAVEMENT JOINT SEALS

Joseph C. McBride and Miles S. Decker, Materials and Tests Division,
Utah State Department of Highways

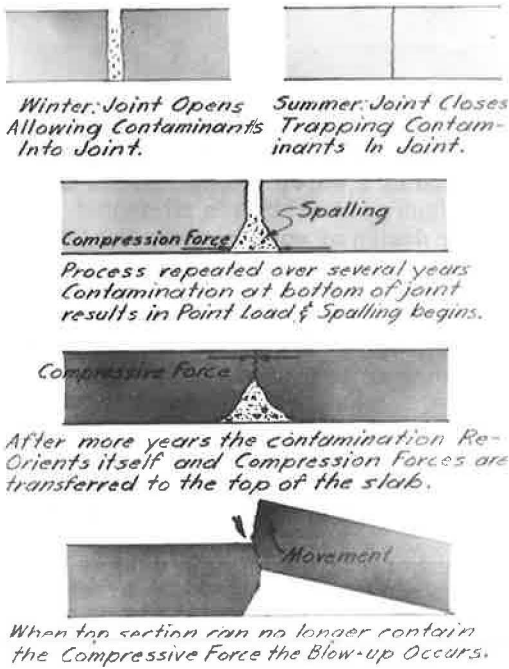
Figure 6. Mechanism for pavement blowup.

Concerning pavement distress in the form of pavement blowup (one of the most spectacular forms), Stott and Brook (2) describe the mechanism by which the blowups may occur: "This theory may be developed in detail. It supposes that material infiltrates into open joints during the winter months either from the upper surface of the road, from material in the base, or from dislodged material in the joint itself. This material settles at the bottoms of the joints due to gravity. The material creates local points of contact between the opposite faces of the joints when the joints close in sum-

mer and therefore local concentrations of compression arise which spall the joints. The spalled material is added to that already at the bottom of the joint and the process is repeated over several years with progressive spalling. After some years, the situation changes and the compression is transmitted through the relatively sound tops of slabs. This may happen because the infiltrated material reorients itself in the joints so that it will no longer transmit compression between the bottoms of slabs. The relatively sound tops of the slabs present a reduced area to the compression force and an upwards eccentricity so there is a much greater liability to blow-up than in the original sound slab." This phenomenon is shown in Figure 6. The deterioration of the pavement at the bottom of the joint is also a contributing factor in the faulting, cracking, and pumping of pavement slabs (4).

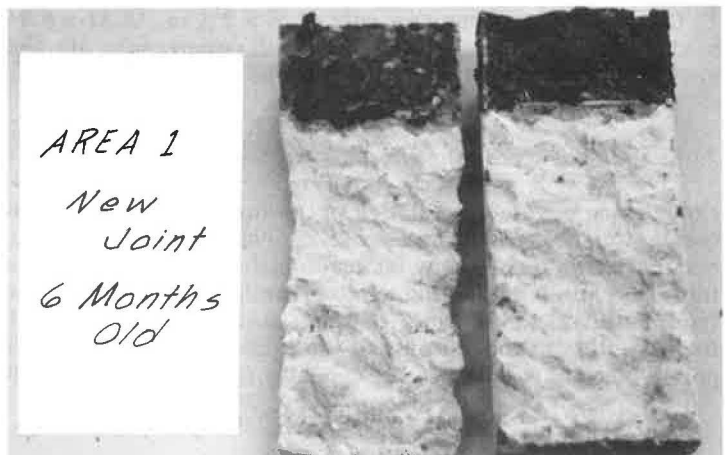
Figure 8. Core from section 1.

The pavement in section 1 was 6 months old at the time of coring. No pavement deterioration was evident from the top of the slab. During the coring process the water used in coring ran along the top of the joint, indicating that it was watertight. Of the 3 joints sampled, only 1 had cracked. The core from the joint that had cracked is shown in Figure 8. The seal in this core was in excellent condition as evidenced by the amount of cohesion. There was no deterioration of the joint walls or bottom. Only a slight discoloration was apparent on the joint walls.

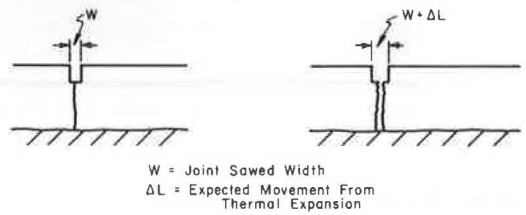
Figure 24. Estimated joint movement.

The coefficient of thermal expansion for ordinary concrete has commonly been assumed to be about 5 to 6×10^{-6} in./in./deg F. Because of subgrade restraint a practical calculation for anticipated joint movement for either plain or reinforced slabs can be made by modifying the expansion coefficient to 4×10^{-6} in./in./deg F (7.2 cm/cm/deg C) to compensate for restraint (1). A slab length of 18 ft was used to determine the expected movement instead of the average joint spacing of 15 ft so that the proposed seal design would perform in the worst condition. Thus, for a seal to be effective it must be able to extend a minimum of 0.112 in. (0.28 cm) or $W + \Delta L$ (Figure 24).

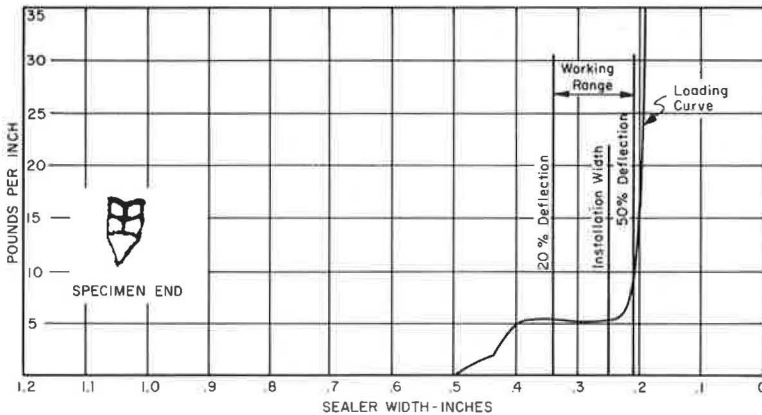
Figure 25. Force-deflection curve for typical $\frac{7}{16}$ -in. seal.

The size of preformed seal that would be compatible with the expected movement would be one $\frac{7}{16}$ in. (1.1 cm) wide. The seal would be installed in a joint $\frac{1}{4}$ in. (0.64 cm) wide. The working range of the preformed seal is shown in Figure 25, a force-deflection curve for a typical $\frac{7}{16}$ -in. (1.1-cm) seal. For a preformed seal the working

range is considered to be between 20 percent and 50 percent of the deflection of the seal; 20 percent deflection is used so that enough sidewall pressure is exerted by the seal to keep it in the joint if failure of the lubricant adhesive occurs. At 50 percent deflection the seal has not reached a rubber-on-rubber condition, which would eventually lead to web adhesion and failure of the seal. A sawed reservoir of $\frac{1}{4} \pm \frac{1}{32}$ in. (0.63 ± 0.07 cm) was chosen because the seal is to be installed during the summer months when in the future the joint would be closed, thus ensuring that the seal would not be overly compressed. Also, the $\frac{1}{4}$ -in. (0.63-cm) saw cut allows the contractor to use two $\frac{1}{8}$ -in. (0.31-cm) blades, which would save on sawing costs.
