## Evaluation of Concrete Safety Shapes by Crash Tests With Heavy Vehicles

E. O. Wiles, M. E. Bronstad, and C. E. Kimball, Southwest Research Institute, San Antonio

Three crash tests were made to evaluate concrete median barriers at speeds of approximately 70 and 90 km/h (45 and 55 mph) and angles of approximately 7 and 16° with an 18 000-kg (40 000-lb) intercity bus. The 61.0-m (200-ft) long installation was cast in place and reinforced with one number 4 bar placed 150 mm (6 in) below the barrier top. The freestanding barrier was restrained by a 25-mm (1-in) layer of asphalt placed at the installation bottom on the side opposite the impact. The results of the program include the following: The safety shape performed well at the lower angle impacts with no barrier distress or translation. The severe test [an impact speed of 85.1 km/h (52.9 mph) and an impact angle of 16°] showed that the concrete safety shape with minimum reinforcement and foundation restraint can redirect large vehicles at high impact speeds and angles. In the severe test, the rear-end impact during redirection was the principal cause of the extensive barrier damage and displacement.

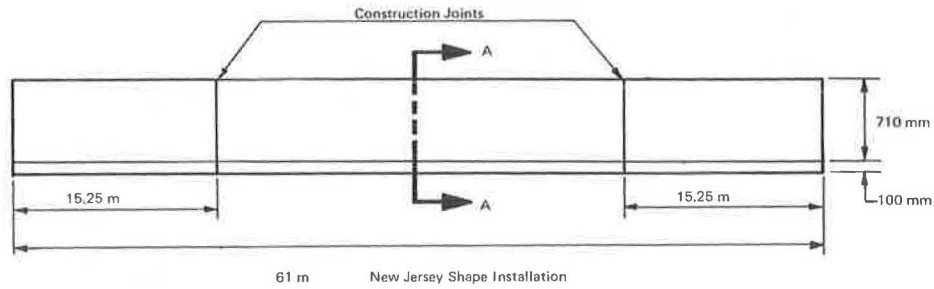
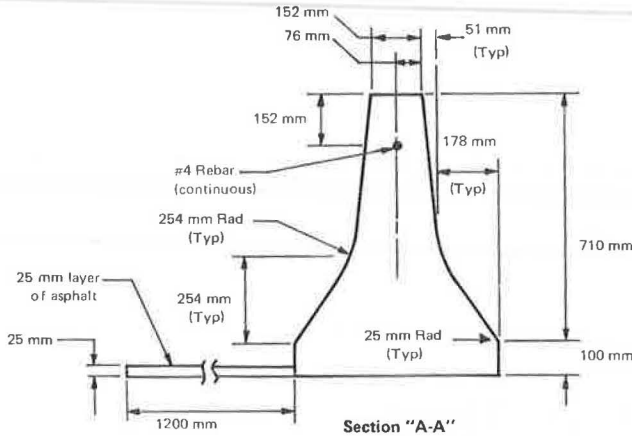
Figure 1. MB5 barrier.

Full-scale, heavy-vehicle crash tests of the CMB have been extremely limited (3). In this program, a series of tests was used to evaluate the performance of a lightly reinforced MB5 barrier with minimal foundation restraint when impacted by an 18 000-kg (40 000-lb) intercity bus. The cast-in-place installation, as shown in Figure 1, was 61.0 m (200 ft) long and was reinforced with one number 4 bar placed 152 mm (6 in) below the barrier top. Restraint of the freestanding barrier was provided by a 25-mm (1-in) layer of asphalt, 1.2 m (4 ft) wide, on the bottom of the installation on the side opposite the impact.

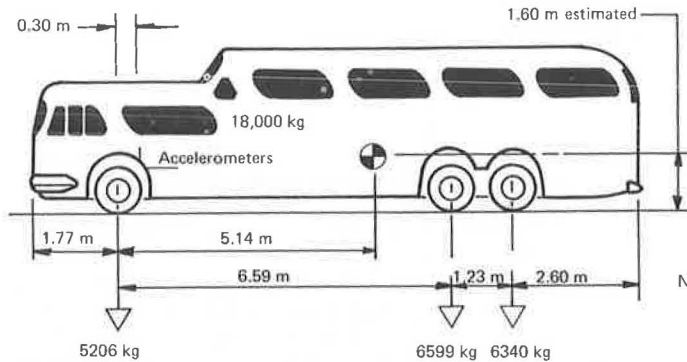
Figure 2. CMB test vehicle.

on the longitudinal centerline (Figure 2). The data were derived from two sources: micromotion analysis of high-speed film and accelerometers.
