Ponding an Expansive Clay Cut: Evaluations and Zones of Activity

Malcolm L. Steinberg, Texas Department of Highways and Public Transportation

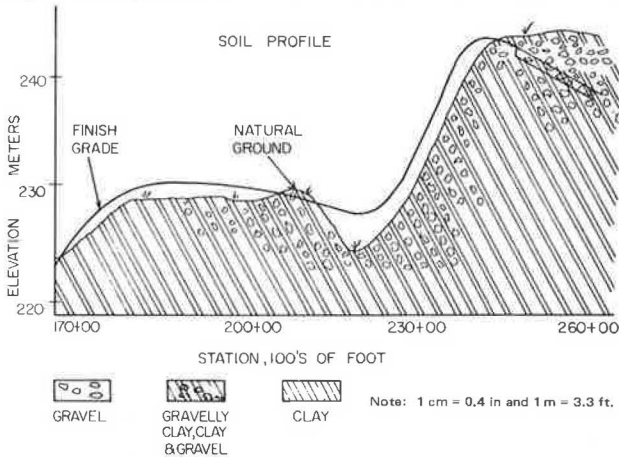
Figure 1. Soil profile.

A soil profile developed from area sampling is shown in Figure 1. The following data reflect samples taken from stations 170 to 258:

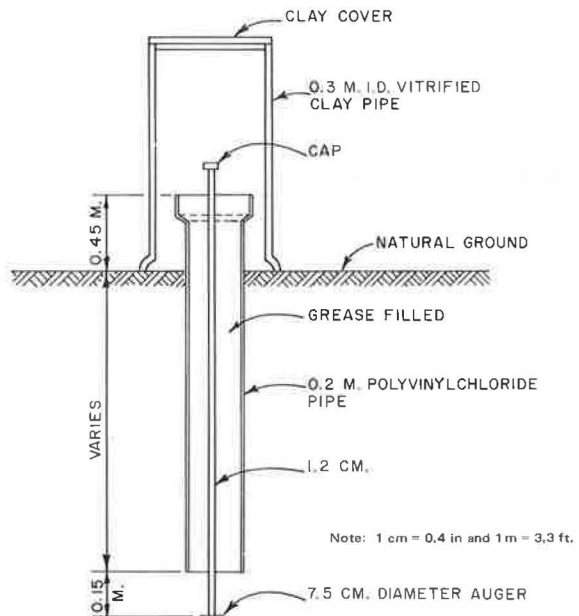
Figure 2. Elevation-rod device.

of the grease-filled hole, with the top of the pipe extending about 0.5 m (1.5 ft) above the casings. The entire assembly was protected by a 1.2-m (4-ft) long section of 0.3-m (1-ft) clay pipe, which was capped (Figure 2). A variety of evolutionary measuring rods and nuclear access tubes were also set for moisture and density readings. More conventional moisture measurements were made by drilling samples with a rotary bit and conducting laboratory tests.
