Laboratory Static Load Tests on Five Sunshine Skyway Bridge Girders

Morris W. Self, Department of Civil Engineering, University of Florida, Gainesville

The Sunshine Skyway that crosses the entrance to Tampa Bay south of St. Petersburg, Florida, on a 6.5-km (4-mile) bridge consists of two separate two-lane structures constructed primarily of prestressed concrete girders on reinforced concrete pile bents. The older of the two structures was completed in 1954 and was one of the earliest of its type in the U.S. The girders were post tensioned with steel bars grouted in steel conduits, but spalling and rusting were observed before the bridge was 20 years old. Florida Department of Transportation engineers investigated the structural integrity of the bridge and transported six girders to the University of Florida in Gainesville for laboratory tests. Five of these girders were tested under static loads to determine ultimate flexural capacities, and two were found to be extensively spalled with corroded prestressing bars. These two were the only ones to exhibit a premature fracture of the bars. The tests indicated that no serious loss of strength would be likely to occur before extensive

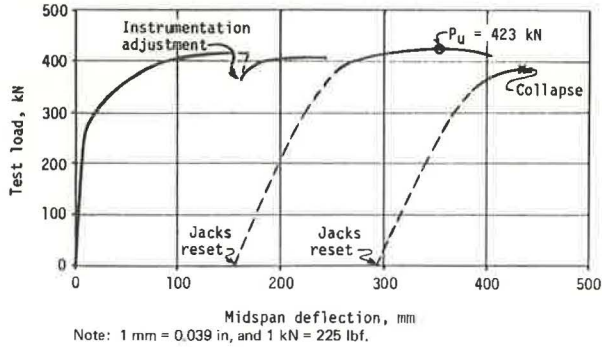
Figure 9. Test of girder 139-S1, midspan load.

The test ultimate capacity of both girders was 422.6 kN (95 000 lbf) compared to the predicted flexural strength of 420.8 kN (94 600 lbf). It is also interesting to note here that the test load developed an ultimate bending moment at midspan exactly equal to the ultimate moment that would be produced by a standard AASHTO

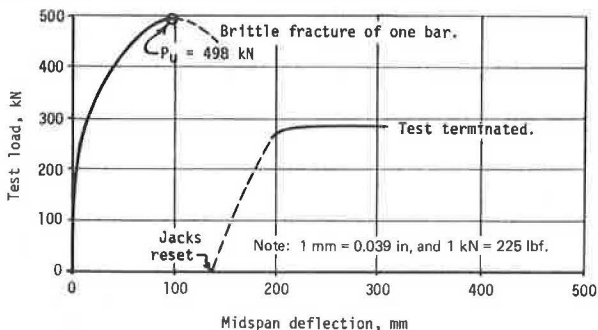
Figure 13. Test of girder 171-S2, one-third point load.

The test data are plotted in Figure 13. The cracking load was 245 kN (55 000 lbf). This girder showed more uniform and evenly distributed cracking than previously tested girders, where damaged areas occurred near the load point. At a load of 498 kN (112 000 lbf), the load fell off. An autopsy following the test revealed that the draped bar failed by brittle fracture at the load position in the span. At this point the conduit and bar were located in the girder web with about 25 mm (1 in) of concrete cover. No spalling was noted, but the conduit was extensively rusted on one side, and the bar was slightly pitted.
